**Barns at Old Burfa, Evenjobb,
Presteigne, Powys, LD8 2SH**

Bat Survey Report for Mr C. Duffgordon

Report type	Bat Survey Report
Report reference	IG2023OldBurfaBarns
Site	Barns at Old Burfa, Evenjobb, Presteigne, Powys, LD8 2SH
Grid reference	SO 27920 61406
Client	Mr C. Duffgordon
Date(s)/time(s)/type(s) of survey(s)	Scoping survey: 26 th May 2023 Dusk emergence survey: 29 th May 2023 between 21:00 and 23:20 Dawn re-entry survey: 18 th June 2023 between 02:50 and 04:55
Surveyor details	Scoping survey: Mr Iestyn Evans, Natural Resources Wales Licence number S090746/1 Activity surveys: as above with assistance from Mr Greg Evans, Ms Sharon Doherty, and Ms Bonnie Illingworth
Architect	Nidus Architects

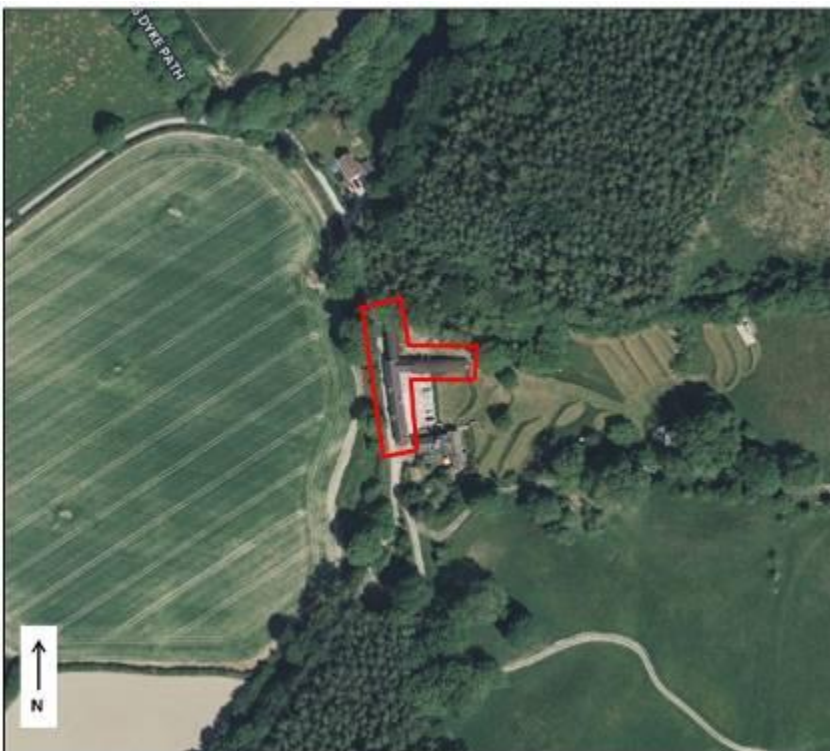
Figure 1: Aerial view of the **Barns** at the property which are outlined in red (from Apple® Maps)

1.2.2 The **Barns** at the property are subject to proposed plans for conversion (excluding **Barn 7**). Figure 1 shows an aerial view of the property, figure 2 on the following page shows the wider environment and figure 3 is a block and location plan. Additional plan drawings are included in appendix 5.

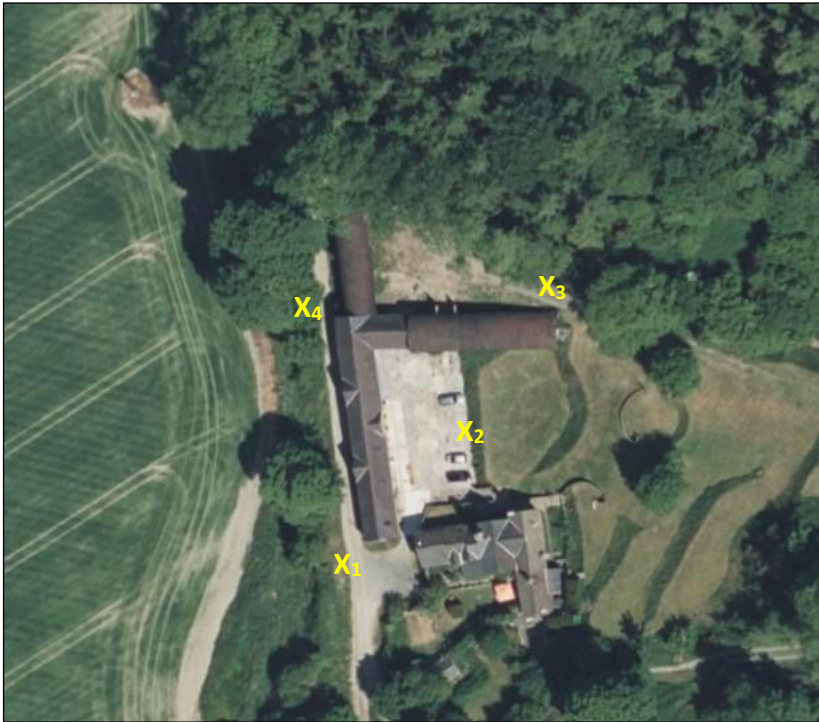
3.1.5 Figure 5 shows the position of surveyors during the activity surveys. Each surveyor had a Magenta 5 or an Elekon Batscanner bat detector to assist in identification and detection of bats and their behaviour. **Surveyors moved along the elevation they were watching during the surveys.**

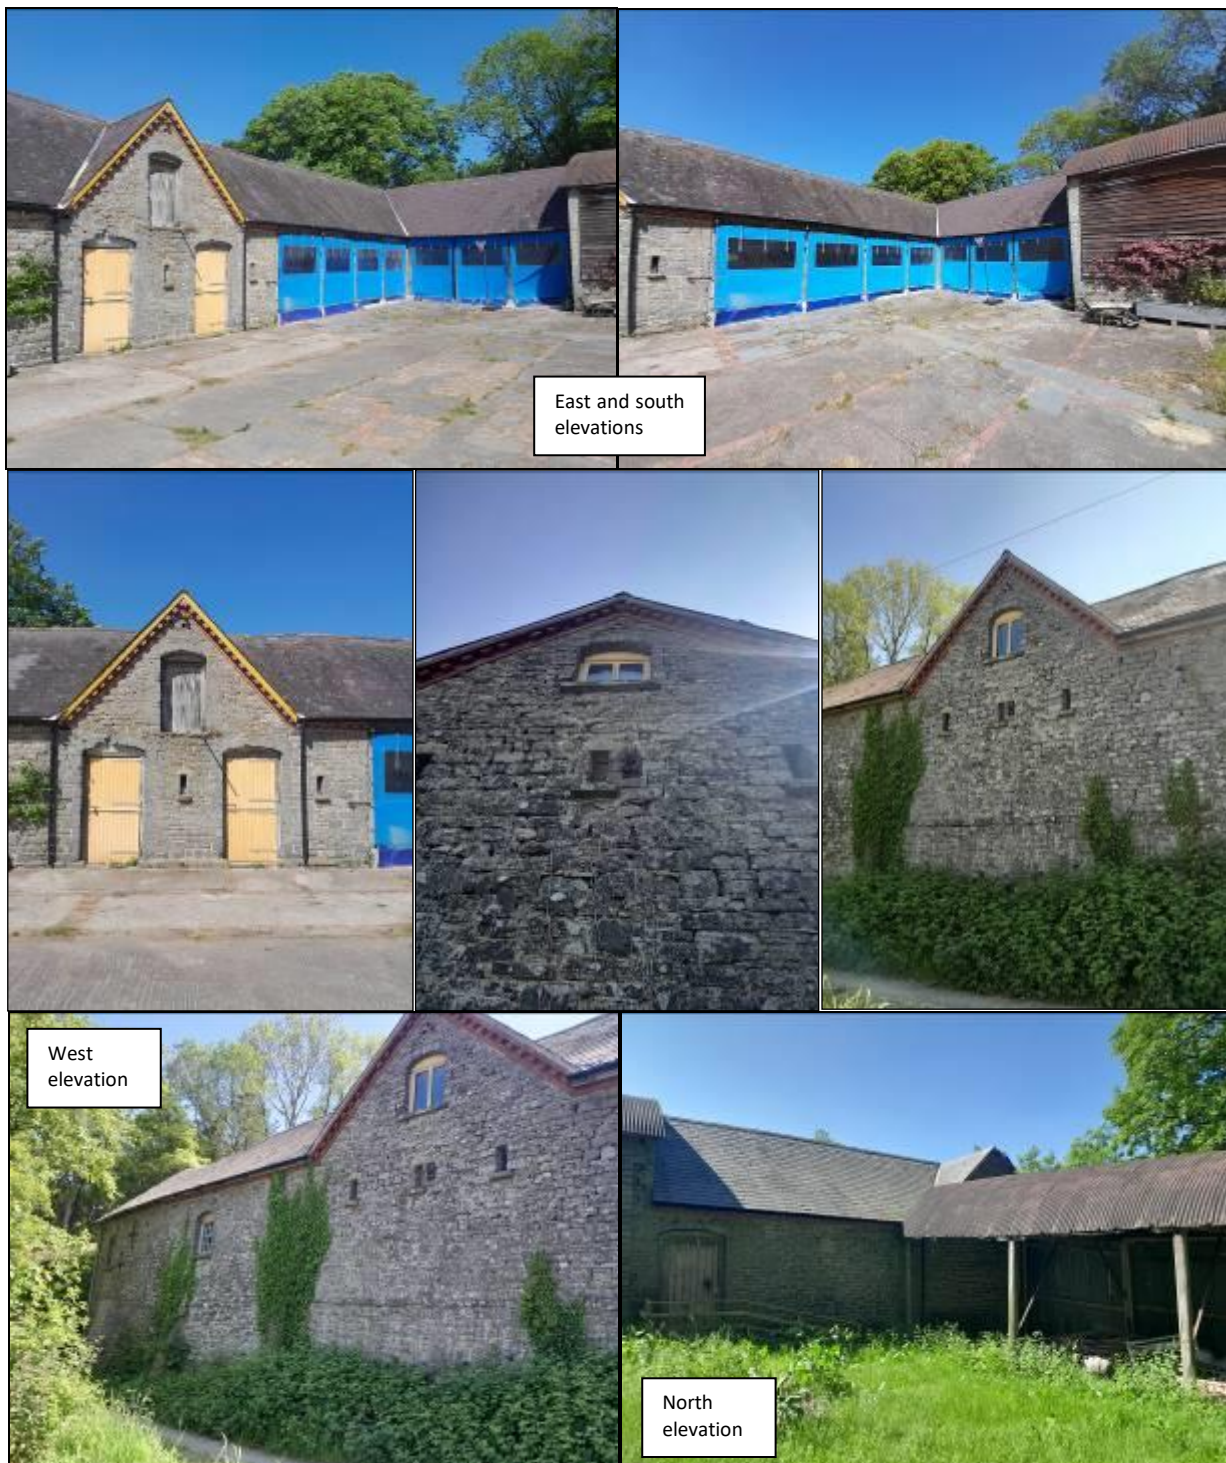
The 18th/19th century Grade II listed **Barns** are subject to proposed plans for conversion. The **Barns** form a T-shape with the southern section and part of the eastern section (**Barns 1 to 4**) being constructed of stone walls (some brickwork) with a pitched slate roof, timber framed windows and timber doors – the large openings on the corner of the southern and eastern section are currently covered with plastic/fabric sheeting. The eastern end of the eastern section (**Barns 5 & 6**) has horizontal timber cladding with a curved corrugated metal sheet roof and part metal/part timber doors while the northern section (**Barn 7**) has corrugated metal sheet walls on its western side, is open on the eastern side and has a curved, corrugated metal sheet roof. It is generally in good condition and well maintained (noting that some unauthorised works had taken place previously under different ownership).

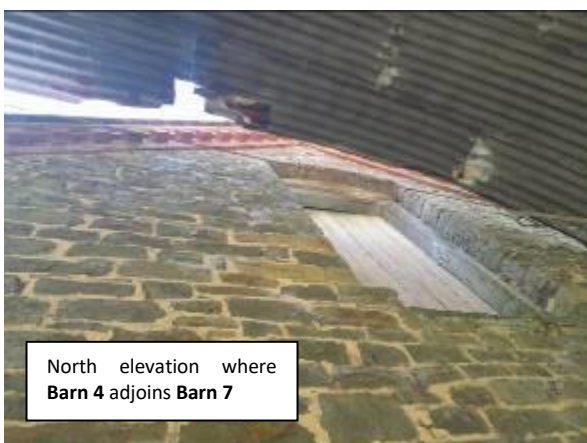
North elevation where
Barn 4 adjoins Barn 7

The walls are intact but there are potentially exploitable gaps within the stone walls as well as vent holes in the walls which could facilitate internal access for all bats as well as small gaps under the timber cladding. In addition, there are numerous wall top gaps as well as gaps around the door frames could enable access via the wall tops for crevice dwelling bat species.

- ✦ **Recommendation 3 (Bat Enhancement):** subject to listed building consent, retain at least 10 holes in the stonework to offer hibernation opportunities for crevice dwelling bats.

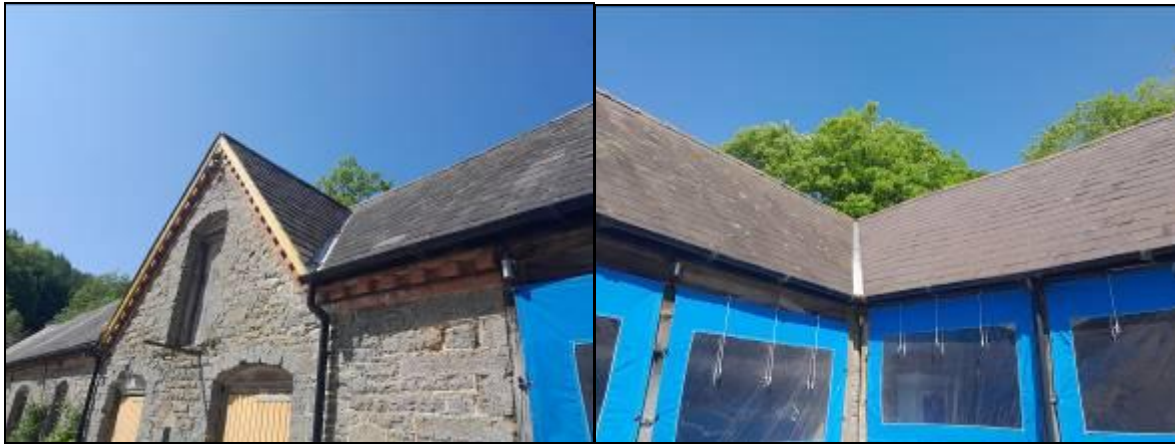
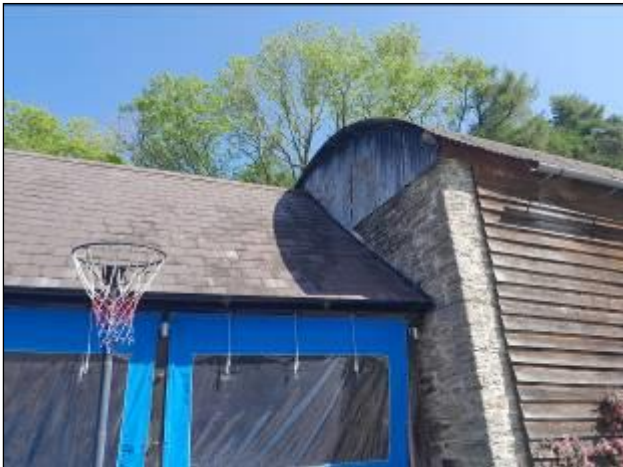
The roofs are also generally in good condition but there are a small number of raised slates and ridge tiles that could offer potential for crevice dwelling species.

The roofs are part unlined/part non-bitumen roofing membrane lined with some areas also having fabric. The lining is in good condition with no damage but the fabric has areas which could offer opportunities for roosting bats. The spaces are used for storage and droppings were found throughout **Barns 1 to 4**, with the largest amount being found stuck in cobwebs at the wall tops.

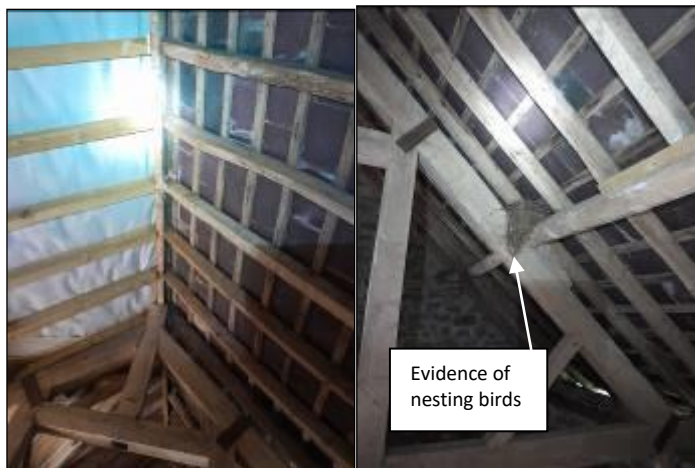
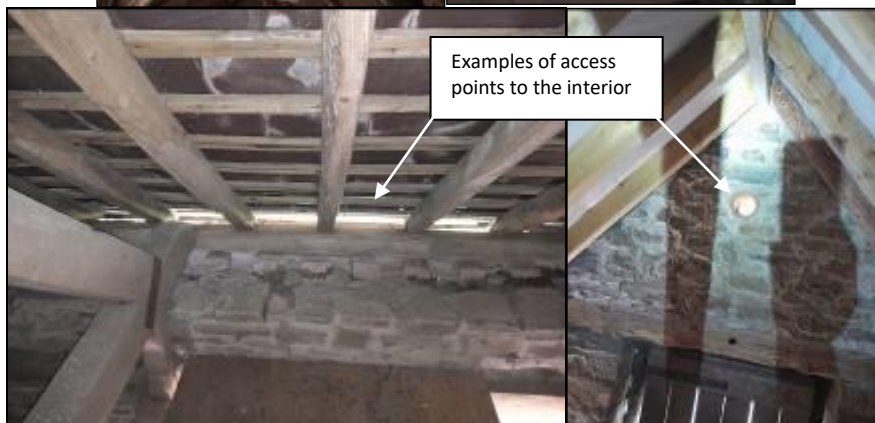
Only droppings characteristic of *Pipistrellus* species were found and DNA analysis confirmed that they were from *P. pygmaeus*. There was also evidence of nesting birds.

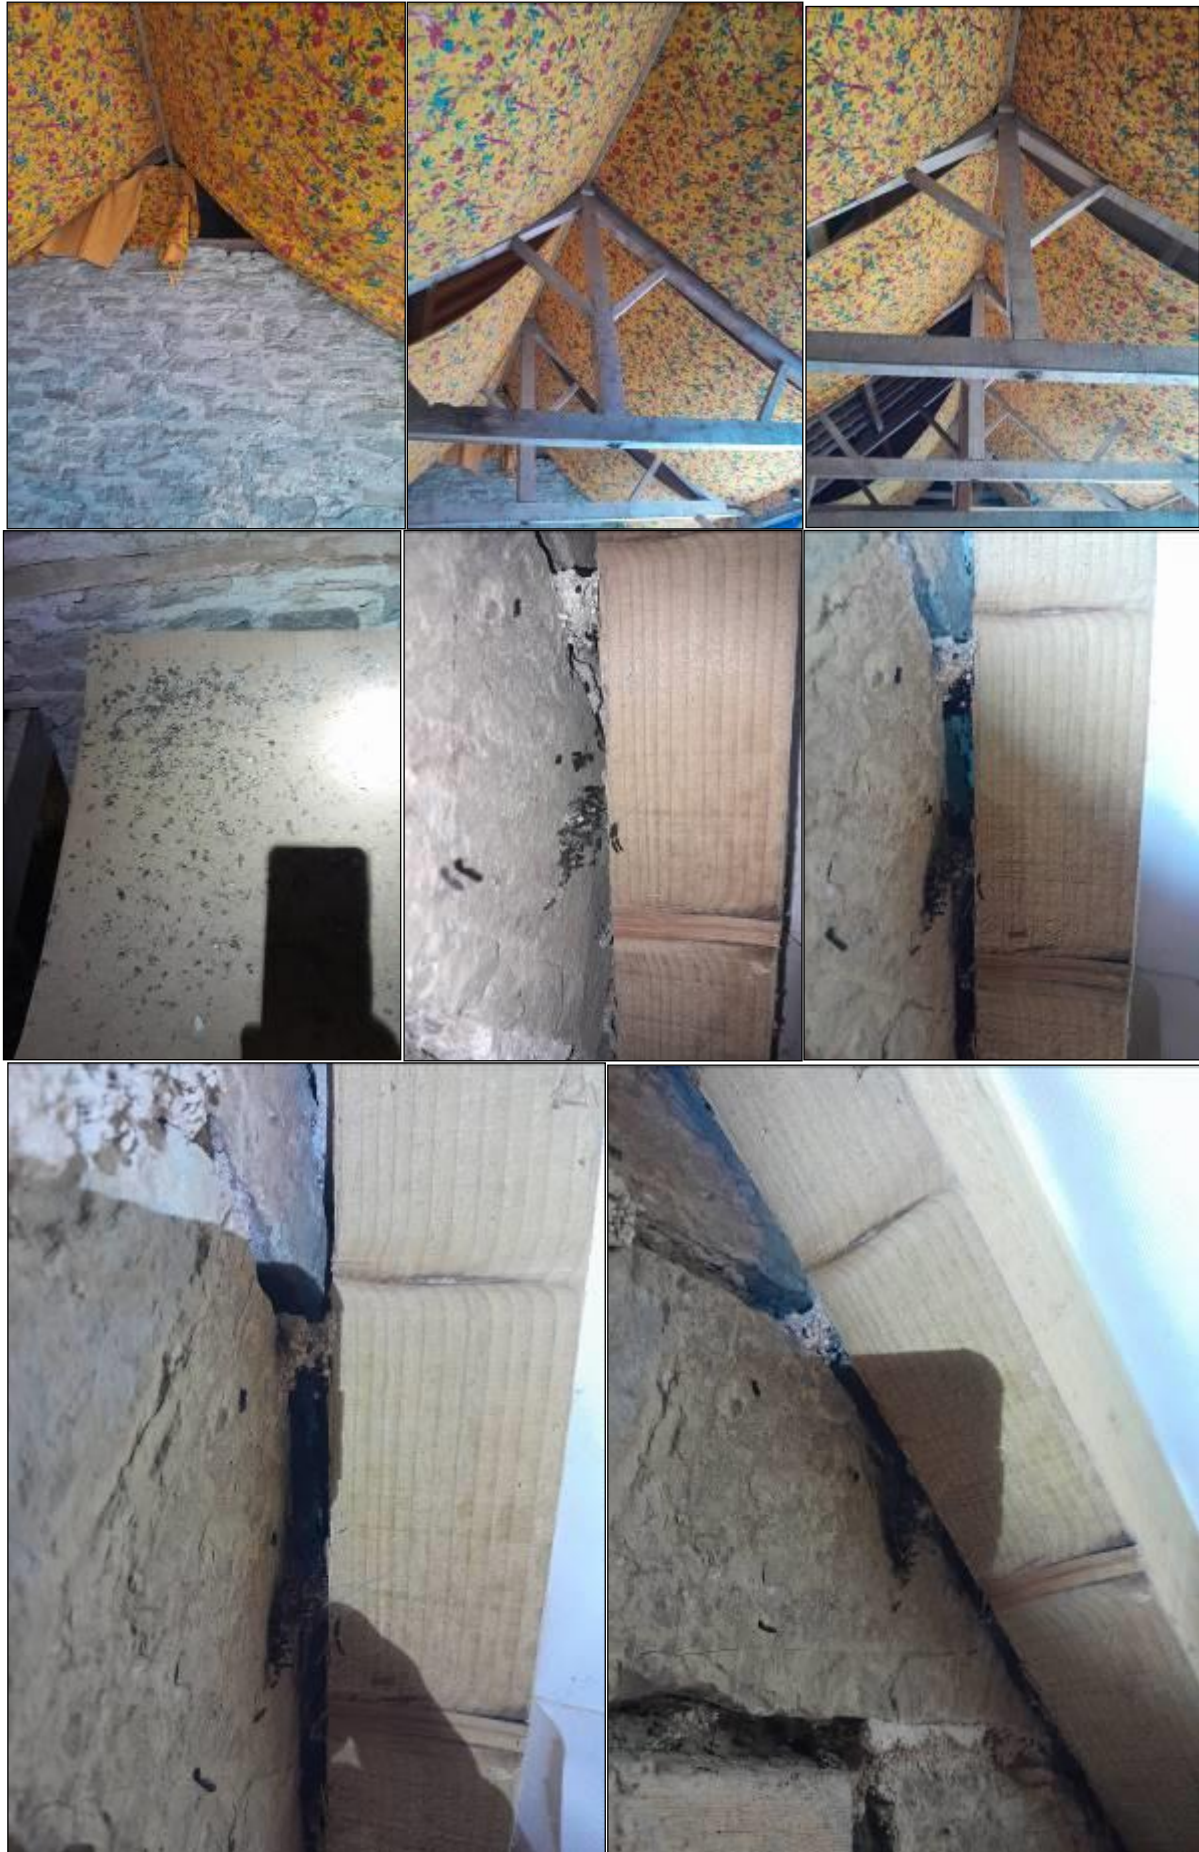
Additional interior images showing the droppings within the **Barns**.

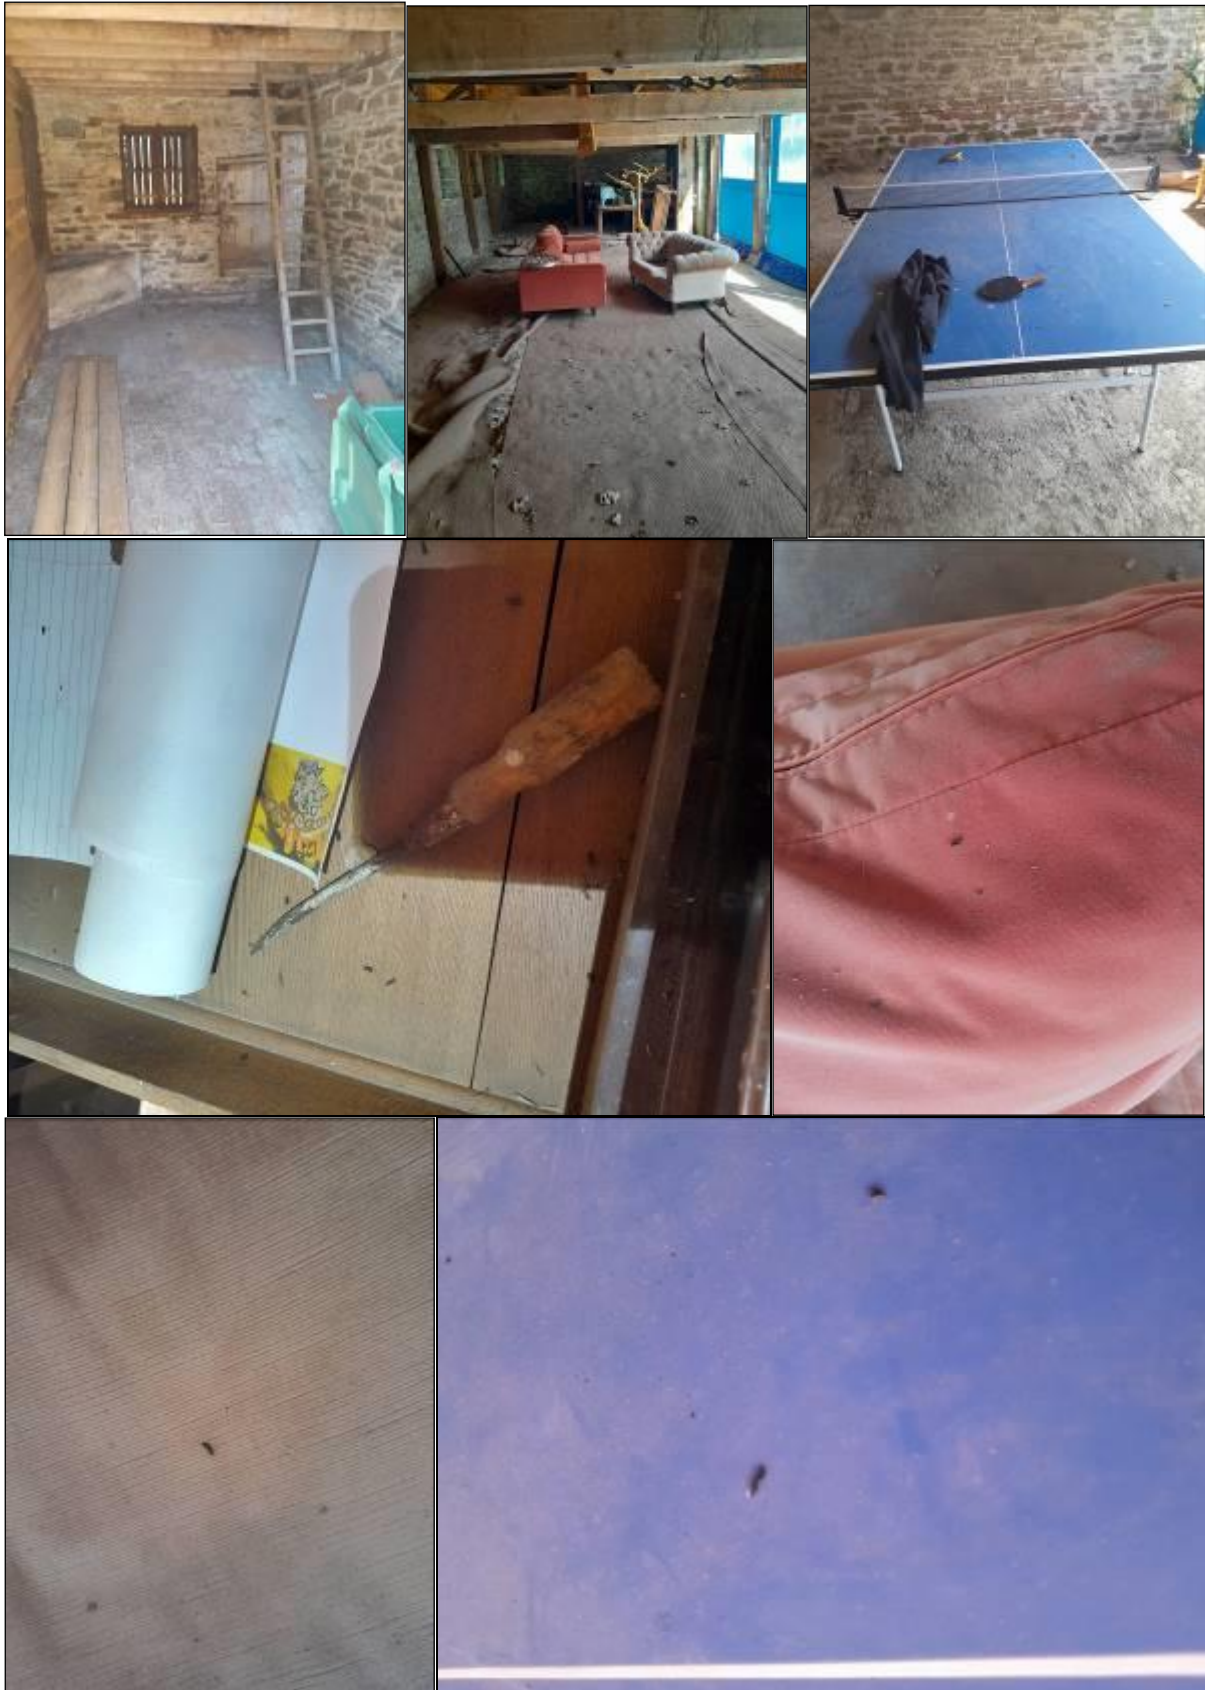
Additional interior images.

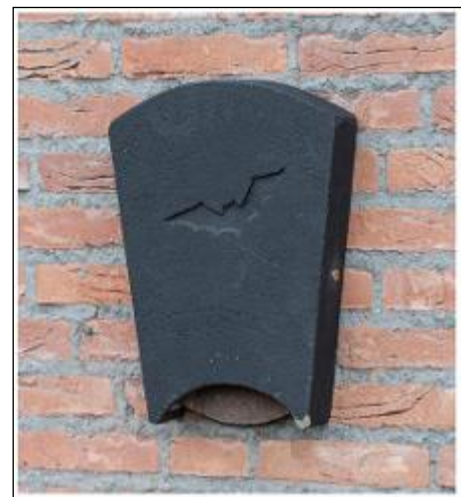
Right: The Beaumaris Bat Box is made from 100% WoodStone which is very durable so this product has a lifetime warranty. The attractive design is suitable for crevice roosting bats and has a rough interior to provide lots of grip. Bats need to increase their body temperature before flight so prefer warm roosting spots, which is why many of our bat boxes have a black exterior to absorb heat from the sun. WoodStone isn't just strong, it also has good thermal insulation, reducing temperature fluctuations inside the box and helping to make this an ideal roost site.

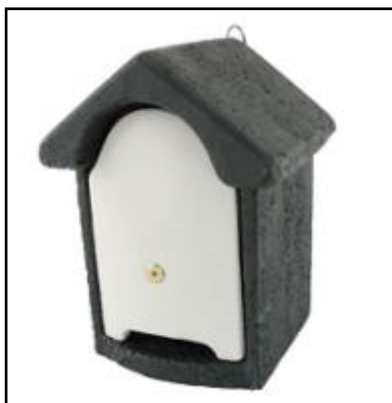
Left: The Harlech WoodStone bat box offers excellent insulation with a minimum of condensation for roosting bats. WoodStone® is a mixture of sawdust from FSC wood sources and concrete, and it is designed to last for years. It is breathable so there will be no problems with condensation and Woodstone maintains a consistent temperature inside, providing excellent insulation for roosting bats. Height 24cm x width 19cm x depth 18cm; Weight 4.4kg; Colour: Black with White front panel; Hook for hanging; Removable front panel for inspection/cleaning; and 10 Year Manufacturers Guarantee.

- ✦ **Recommendation 1 (Site Bat Enhancement):** Prior to works commencing, x 2 Harlech Woodstone (or similar) and x 1 Improved Maternity (or similar) bat boxes to be affixed to mature trees to be retained within the curtilage of the property. See [Putting up your box - Bat Boxes - Bat Conservation Trust \(bats.org.uk\)](https://www.bats.org.uk/putting-up-your-box-bat-boxes-bat-conservation-trust)

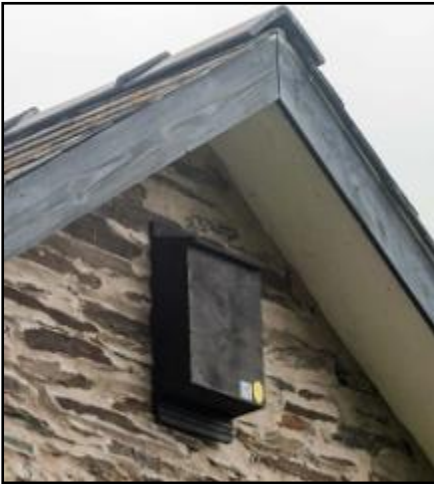
Left: The Improved Roost-Maternity Bat box is a large 3 crevice box suitable for larger roosts or maternity groups of the small British crevice-dwelling bats such as Pipistrelles. All external panels precision cut from 12mm Exterior Grade FSC plywood, for improved heat insulation. Exterior surface stained with black water based wood stain for improved thermal input, whilst avoiding any possibility of deterring use by bats due to vapour from the stain. Overhanging roof with additional internal insulation for protection from UK weather, and to seal crevices from internal airflow. 3 separate crevices each with different temperature characteristics. Wide entrance with accurately sized opening. Ideal for Pipistrelles and deters unwelcome birds etc. Internal ceramic heat sinks ensure improved temperature stability in crevices. Improved "Bat Ladder" at base of box facilitates bats landing and climbing into box. Ladder continues inside box, while textured internal surfaces ensure bats find it easy to move around inside box and hang in crevices. Ladder acts as "convector heater" for box - when sun shines on ladder, warm air rises into the box, but does not come out when the outside cools. Easy and safe to erect box on walls or trees. Rectangular back plate facilitates fitting boxes side to side to increase colony size. Improved aesthetics - looks good to humans as well as bats. Suits any building or tree. See [Improved Roost-Maternity Bat Box | NHBS Practical Conservation Equipment](#).

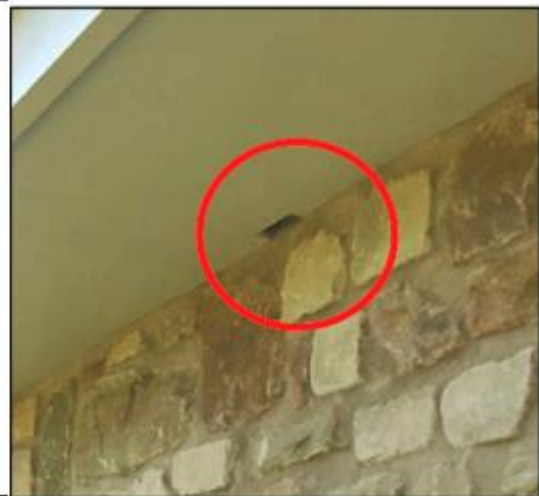
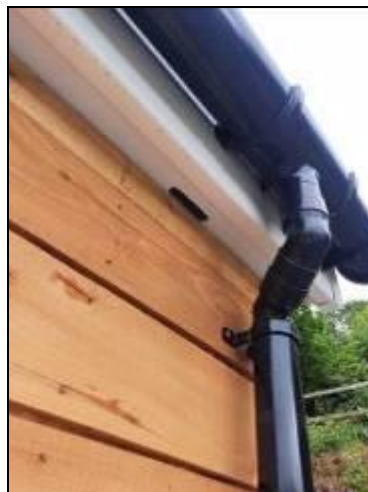
Below: Examples of soffit gaps

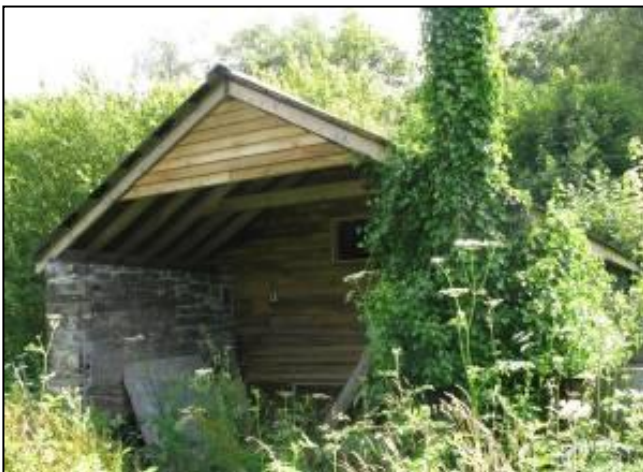
As nocturnal mammals, bats are **light-sensitive** and adapted to low light conditions. Consideration must be made to reduce light spill close to roosting areas. Horseshoe bats typically emerge approximately 30 minutes after sunset and during emergence they often fly in and out of the roost repeatedly before leaving. This behaviour is termed "light sampling" and has an important social function prior to the bats leaving the roost. This behaviour can be seen in the video below. Mitigation schemes can try to create a covered area where bats can undertake this behaviour as shown in the image on the left.

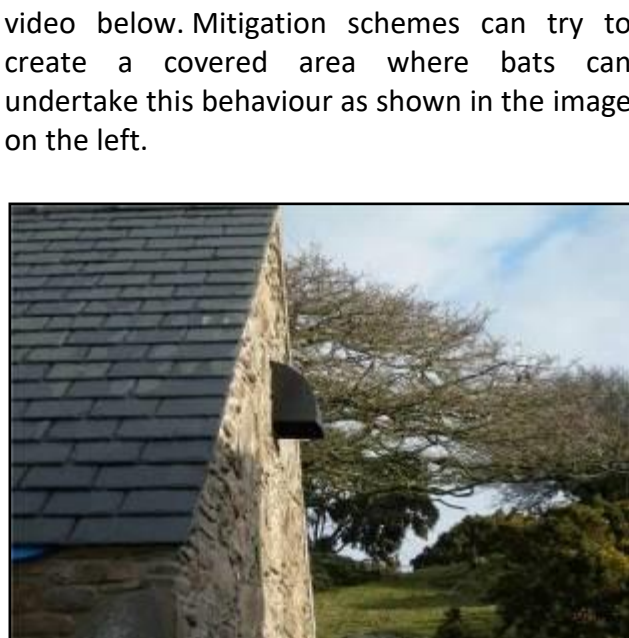
Right: example of a cowled hood for horseshoe bat access

Access points are key to the success of horseshoe roost sites as horseshoe bats directly fly into a roost. They need access points of 30cm (width) x 20cm (height) for **Lesser horseshoe** and 40cm (width) x 30cm (height) for **Greater horseshoe**.

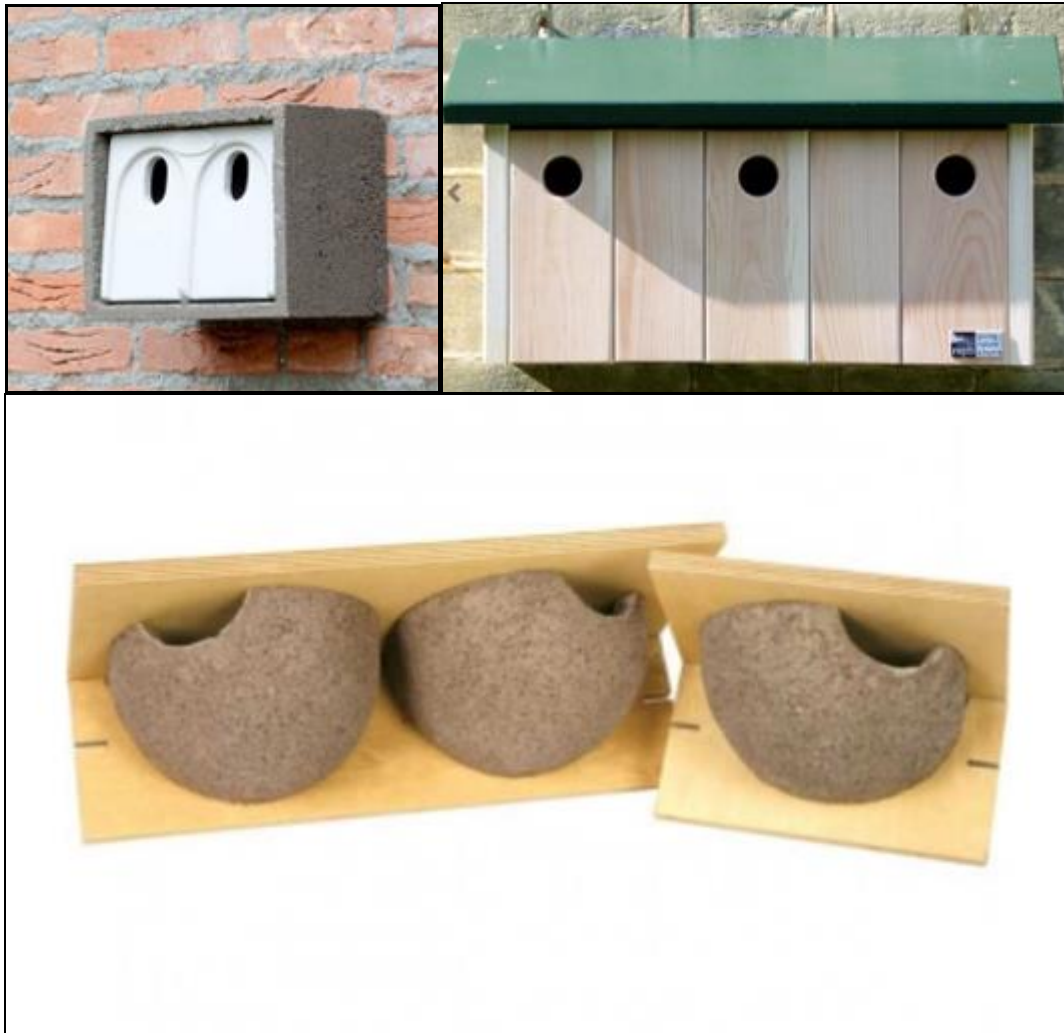
Examples of Small-holed and Open-fronted nest boxes. Siting advice can be found at [Where To Put A Bird Box | Nestboxes - The RSPB](#)

- ✦ **Recommendation 4 (Passerine Bird Mitigation):** Prior to works commencing 2 x Small-holed nest boxes and 2 x Open-fronted nest boxes to be affixed to mature trees within the curtilage of the property (or other buildings on site). See [Where To Put A Bird Box | Nestboxes - The RSPB](https://www.rspb.org.uk/where-to-put-a-bird-box-nestboxes-the-rspb)

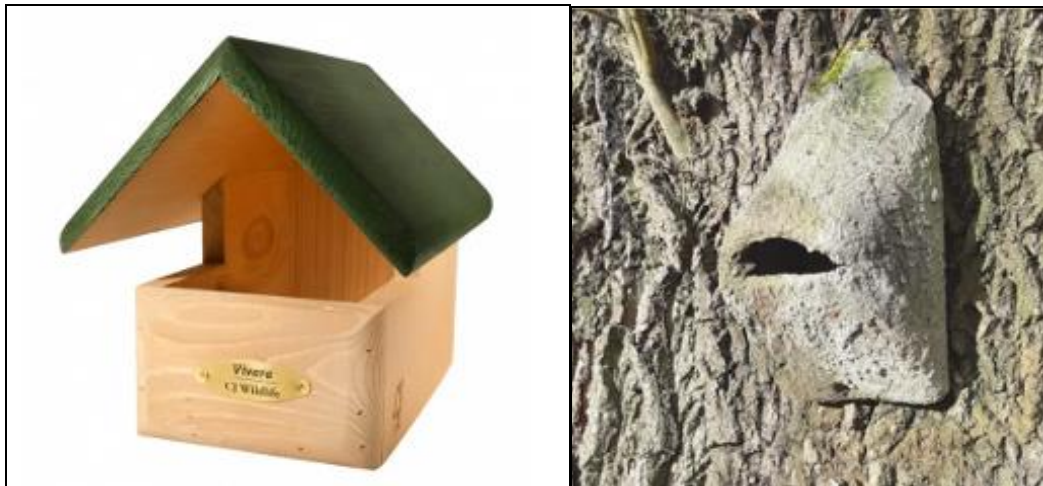
Examples of Open-fronted nest boxes. Siting advice can be found at [Where To Put A Bird Box | Nestboxes - The RSPB](#)

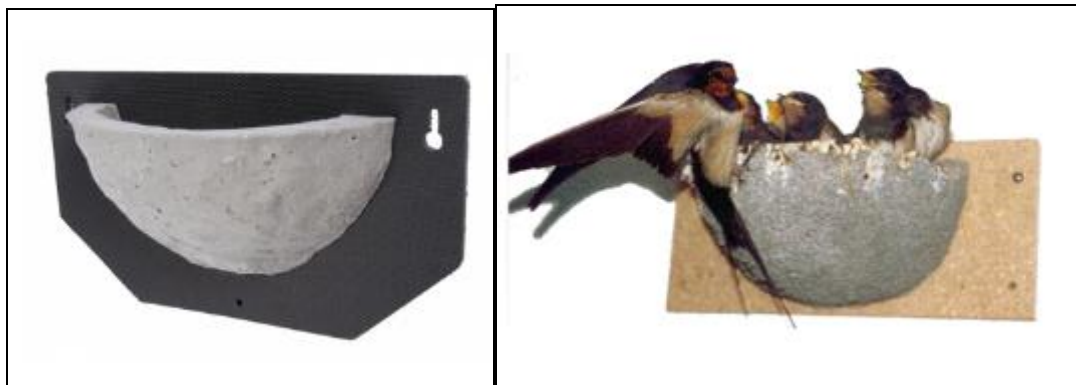
Examples of Swallow nest cups. Siting advice can be found at [Attracting Swallows to Nest Sites in Outbuildings - The RSPB](#)

- ✦ **Recommendation 5 (Swallow Mitigation):** x 2 Swallow nest cups to be affixed internally within a building on site with access or an area where there is a 200mm+ overhang. All nests must be confirmed vacant prior to works commencing. See [Attracting Swallows to Nest Sites in Outbuildings - The RSPB](https://www.rspb.org.uk/attracting-swallows-to-nest-sites-in-outbuildings-the-rspb)
