PROPOSED SPECIFICATION FOR REMOVAL OF POTENTIALLY HARMFUL CONCRETE IN BARN 4 EAST WING

Old Burfa Barns

Barn 4 Floor Condition Survey

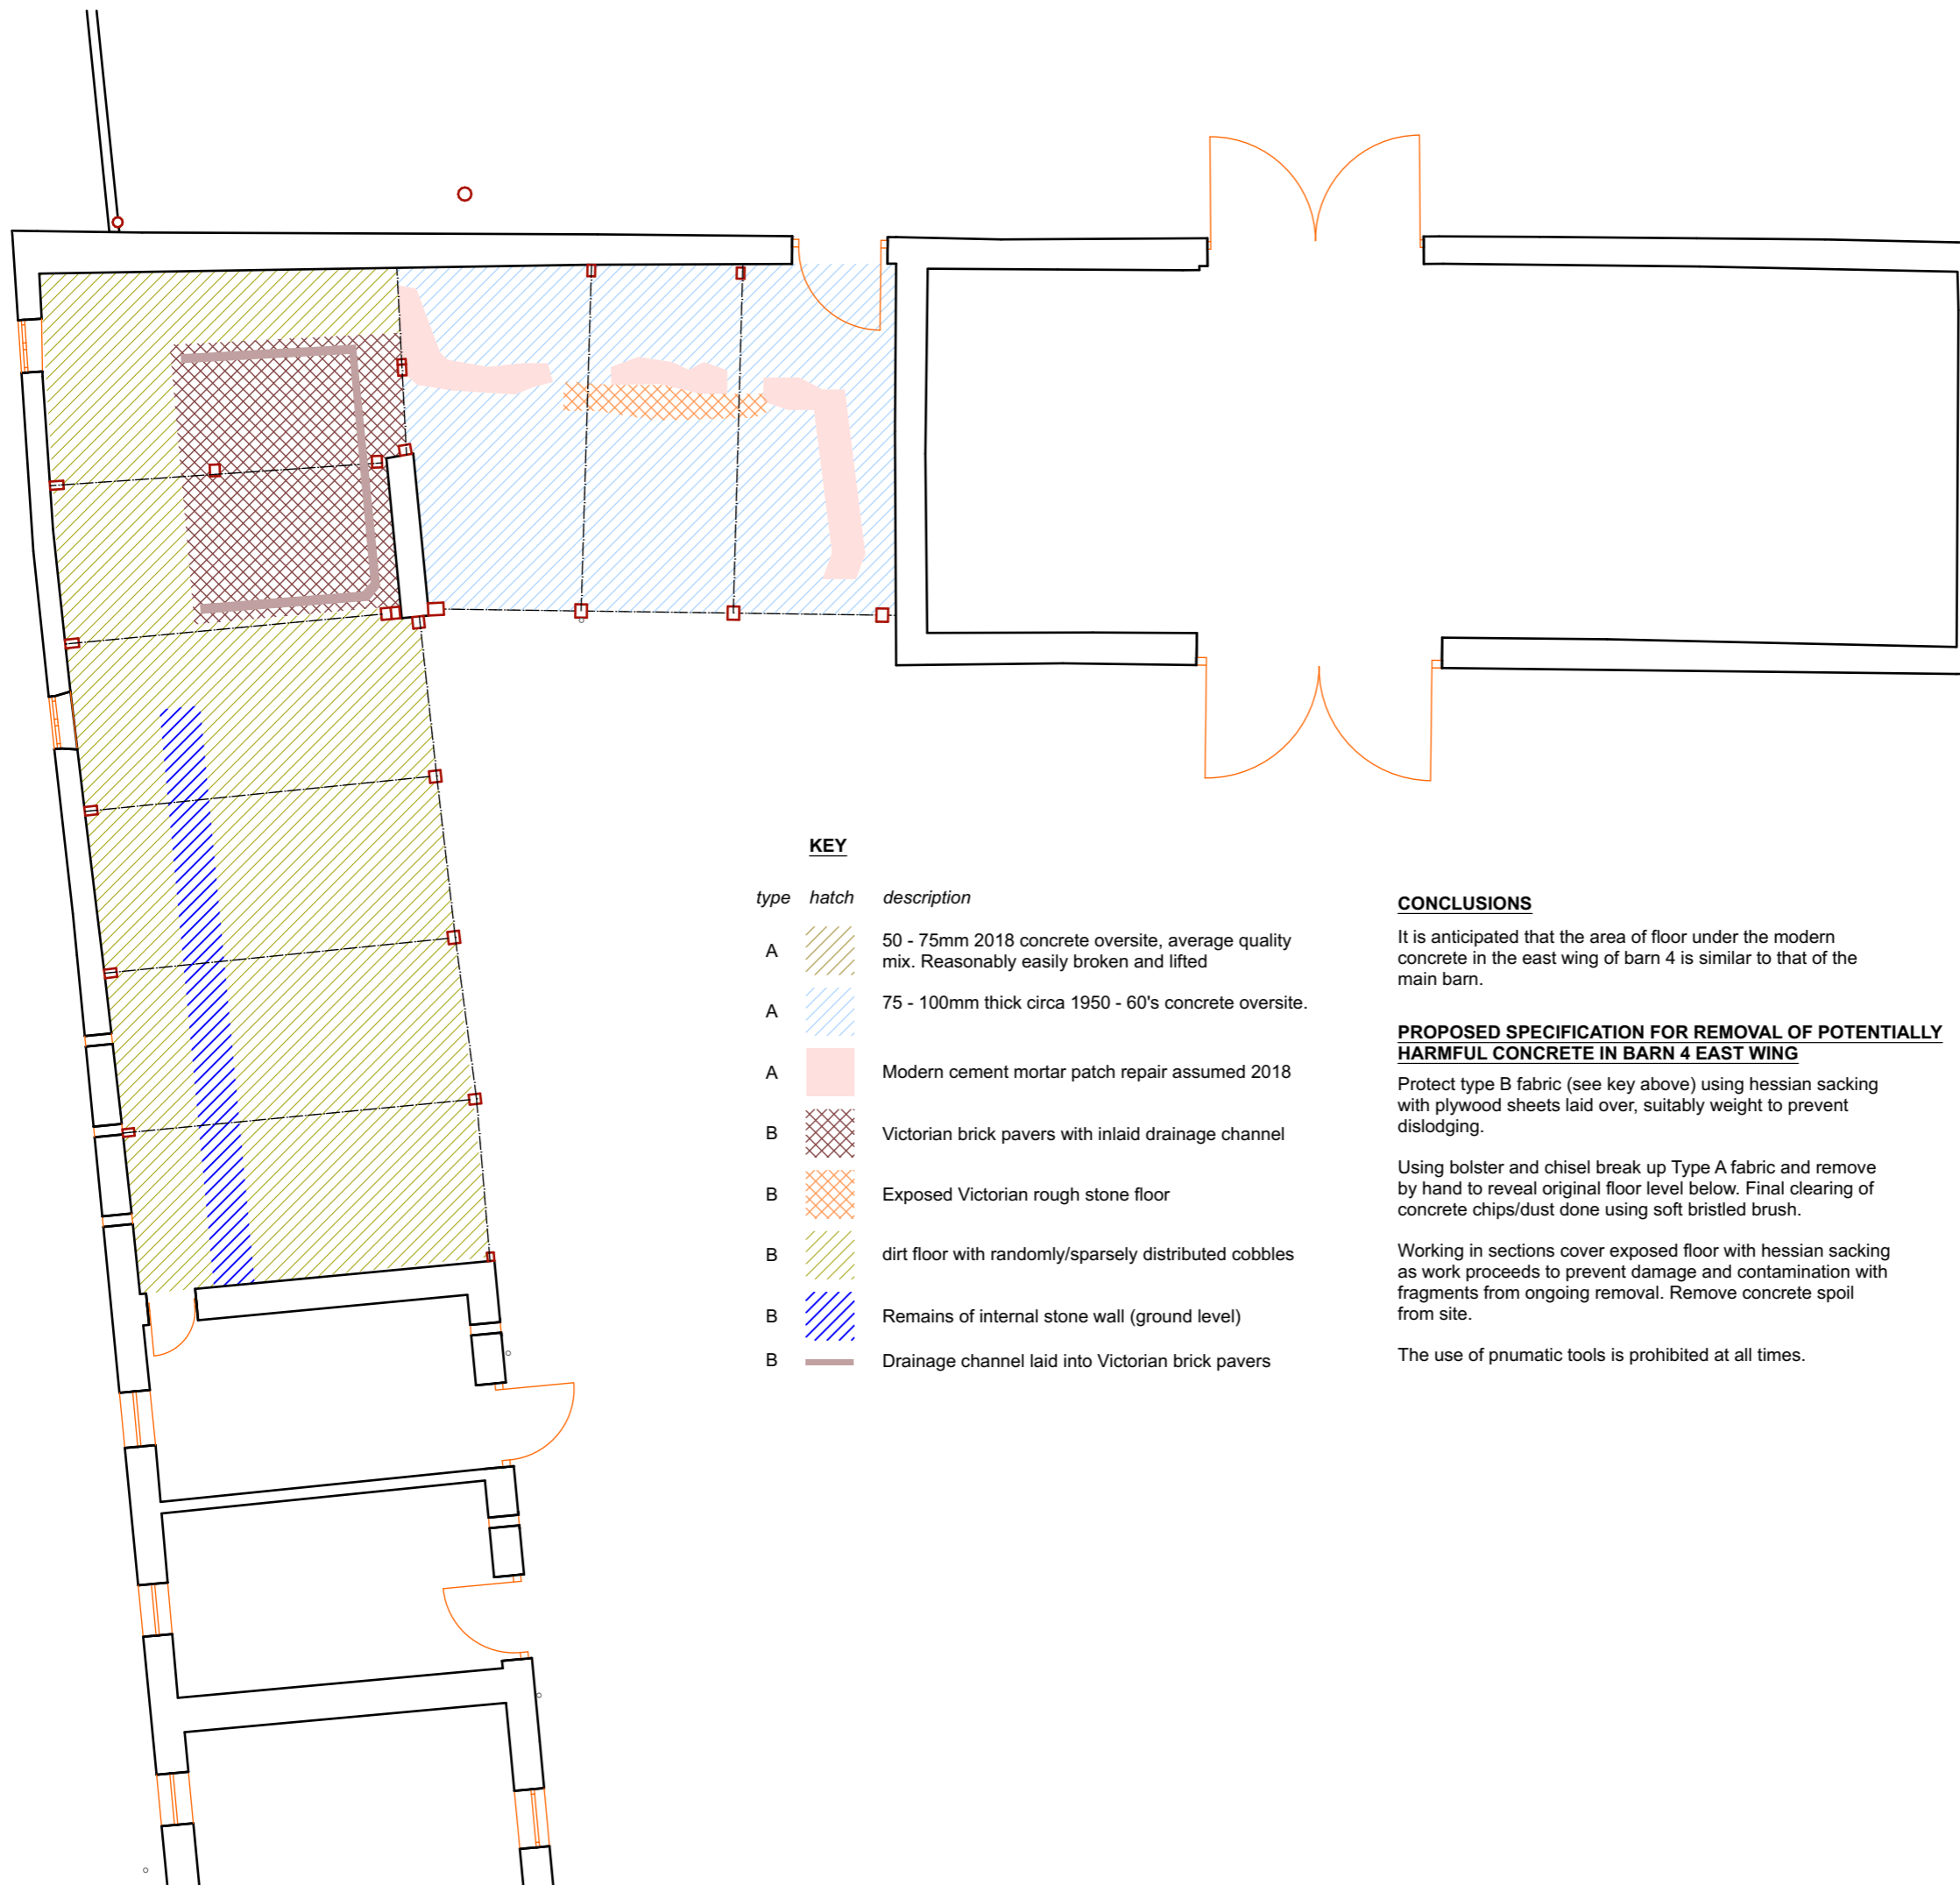
project	number	rev
2019	EX.12	01

type	hatch	description
A		50 - 75mm 2018 concrete oversite, average quality mix. Reasonably easily broken and lifted
A		75 - 100mm thick circa 1950 - 60's concrete oversite.
A		Modern cement mortar patch repair assumed 2018
B		Victorian brick pavers with inlaid drainage channel
B		Exposed Victorian rough stone floor
B		dirt floor with randomly/sparsely distributed cobbles
B		Remains of internal stone wall (ground level)
B		Drainage channel laid into Victorian brick pavers

It is anticipated that the area of floor under the modern concrete in the east wing of barn 4 is similar to that of the main barn.

Protect type B fabric (see key above) using hessian sacking with plywood sheets laid over, suitably weight to prevent dislodging.

Using bolster and chisel break up Type A fabric and remove by hand to reveal original floor level below. Final clearing of concrete chips/dust done using soft bristled brush.

Working in sections cover exposed floor with hessian sacking as work proceeds to prevent damage and contamination with fragments from ongoing removal. Remove concrete spoil from site.

The use of pneumatic tools is prohibited at all times.
