Preliminary Ecological Appraisal Including a Protected Species Assessment at: Cherry Cottage, Stoke Road, Clare, Suffolk.

Pryke Developments Ltd.

August 2023

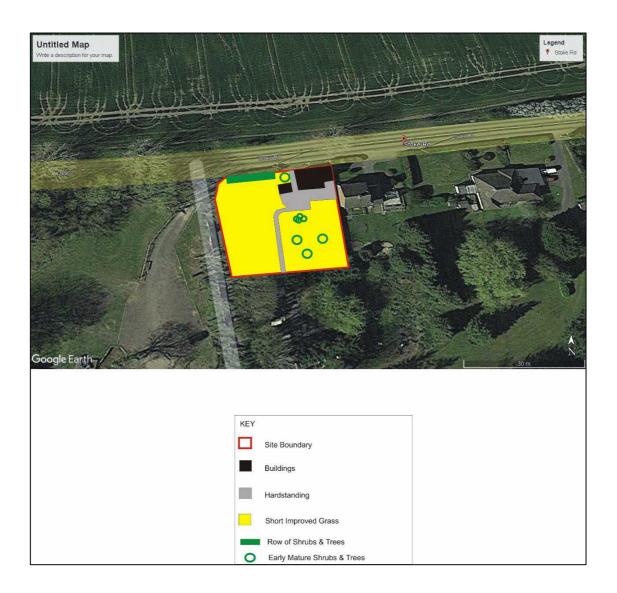
Figure 1: Habitat map.

- 3.4.1 Habitats included a building, hardstanding, short improved grass, scattered early mature shrubs and trees and line of shrubs and trees (too short to be considered a hedgerow).

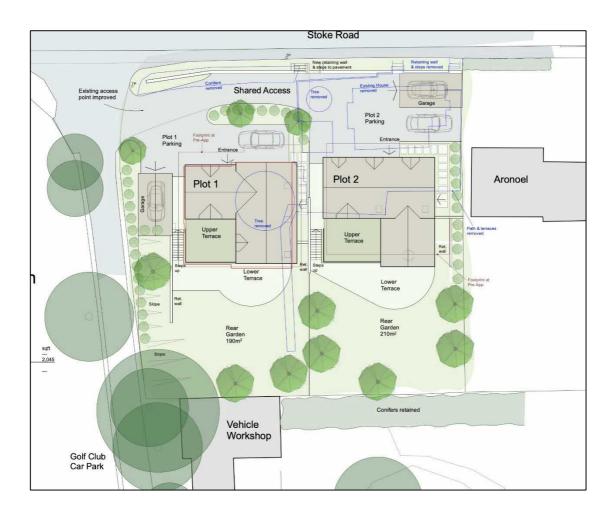
Figure 2: Proposed development

- 1.1.1 Skilled Ecology Consultancy Ltd. was commissioned by Pryke Developments Ltd. to undertake a Preliminary Ecological Appraisal including a Protected Species Assessment at Cherry Cottage, Stoke Road, Clare, Suffolk. The report is required to accompany a planning application for demolition of the existing cottage and replacement with two new dwellings.

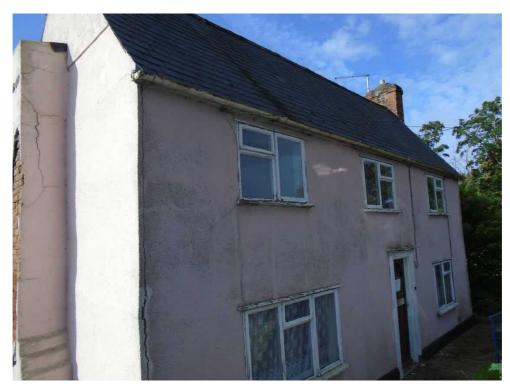
Photograph 1: North elevation at Cherry Cottage

- 3.1.1 The site includes: a detached, double-storey, brick cottage with a pitched, slate roof and a detached, small single-storey, brick, shed with a flat roof, as well as gardens including short improved grassland with a small number of early mature trees and shrubs. A short length of mature hedgerow is present on the northern (roadside) boundary. The hedgerow is less than 20m and technically this makes it not a true hedgerow, simply a line of shrubs and trees. This line of shrubs and trees if proposed for removal. A patio with a former brick pond -now dry was also present.
- 3.1.2 Immediately adjacent to the site habitats included: residential properties to the east, arable field north (across Stoke Road), a mechanics workshop to the south, golf course to the west, beyond an access track.
- 3.1.3 Waterbodies identified within 250m included:

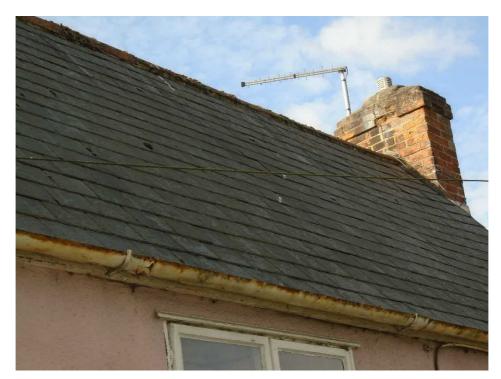
Photograph 2: Close up roof on north elevation at Cherry Cottage

- 3.4.6 No signs or evidence of bats or bat activity were found. The house, shed and trees were all considered negligible in suitability or potential for roosting bats. The house roof was in good condition with tiles flush to the roof, no noticeable gaps sufficient is size to allow entry to bats were found. The shed was well-sealed with a flat roof.
- 3.4.7 The site may be visited on occasions by foraging/commuting bats, though was not considered significant foraging/commuting habitat. The surrounding landscaping including lakes and the River Stour were high in ecological value for local bat populations.

Roof materials should be removed by hand. If at any point bats or evidence of bats (droppings) are found works should stop and an ecologist called for advice;

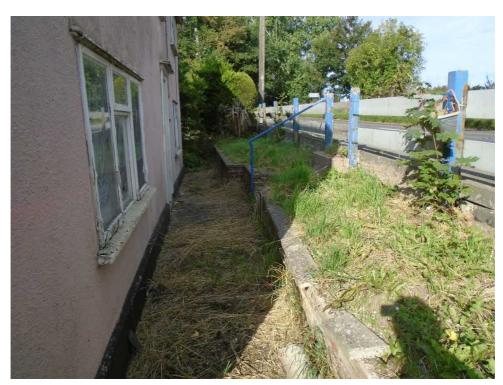
Photograph 3: Northern boundary at Cherry Cottage

- 3.4.4 The row of shrubs and trees on the northern boundary included: sycamore *Acer pseudoplatanus*, hawthorn *Crataegus monogyna*, elder *Sambucus nigra* and leylandii cypress *Cuprocyparis leylandii*.

- 5.1.2 Shrub and tree reduction should be outside of the main bird season (March to end of August). If this is not possible or impractical then a nesting bird survey should be undertaken before felling.
- 5.1.3 If an active bird nest was found, it would be necessary to protect the nest from harm or disturbance until the bird had finished nesting.

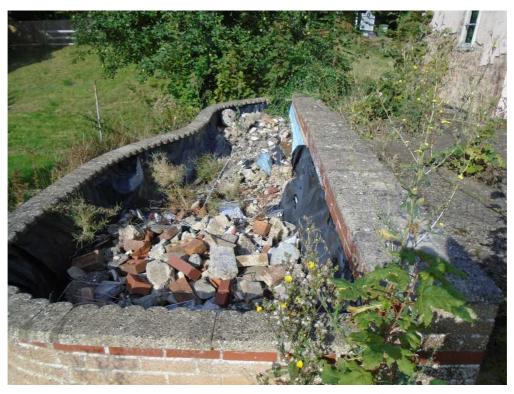
Photograph 5: Former pond at Cherry Cottage

- 0.3 The site includes: a detached, double-storey, brick cottage with a pitched, slate roof and a detached, small single-storey, brick, shed with a flat roof, as well as gardens including short improved grassland with a small number of early mature trees and shrubs. A short length of mature hedgerow is present on the northern (roadside) boundary. The hedgerow is less than 20m and technically this makes it not a true hedgerow, simply a line of shrubs and trees. This line of shrubs and trees if proposed for removal. A patio with a former brick pond -now dry was also present.
