Mrs Leanne Megson Brown and William Brown  
Appletree cottage, Gildersome Lane, Gildersome Leeds, Ls277BJ  
Application number: **22/06682/FU**

LKC Reference: LKC 23 1535 - Gas Risk Assessment & Hand Pit Investigation

**RE: Appletree Cottage, Gildersome Lane, Morley –  
Soil Contamination, Hazardous & Ground Gas Risk  
Assessment**

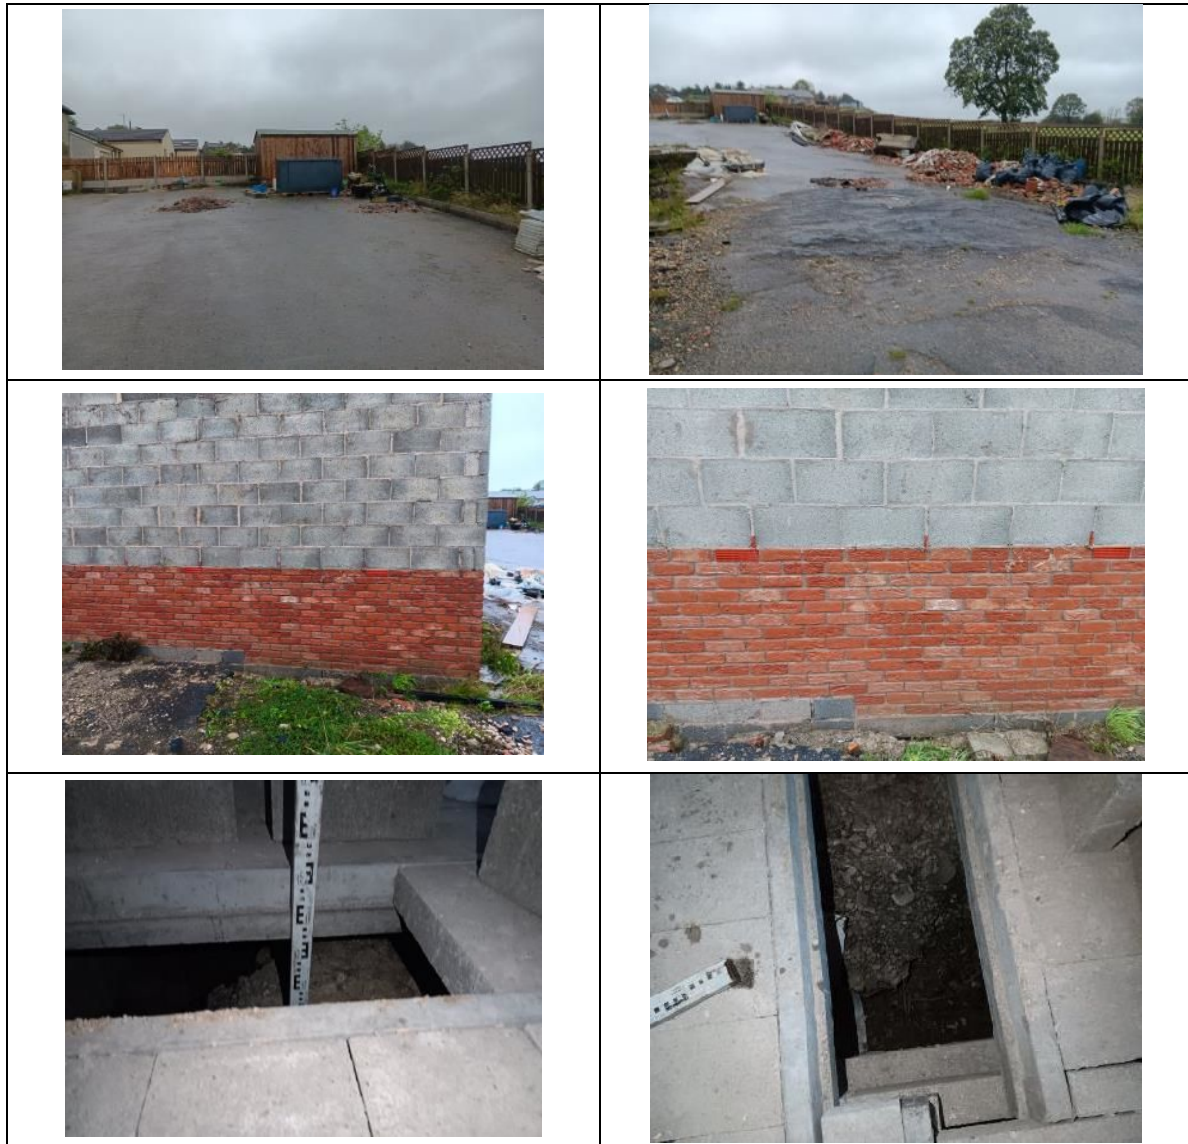
Plate 2-1: Site visit photos

The site is shown to be covered by mixed hardstanding and generally slopes to the north-east. The existing structure is a modern barn of brick and cinderblock construction with a clear void below a suspended block and beam floor. The void is externally ventilated with air bricks at c.2m centres.

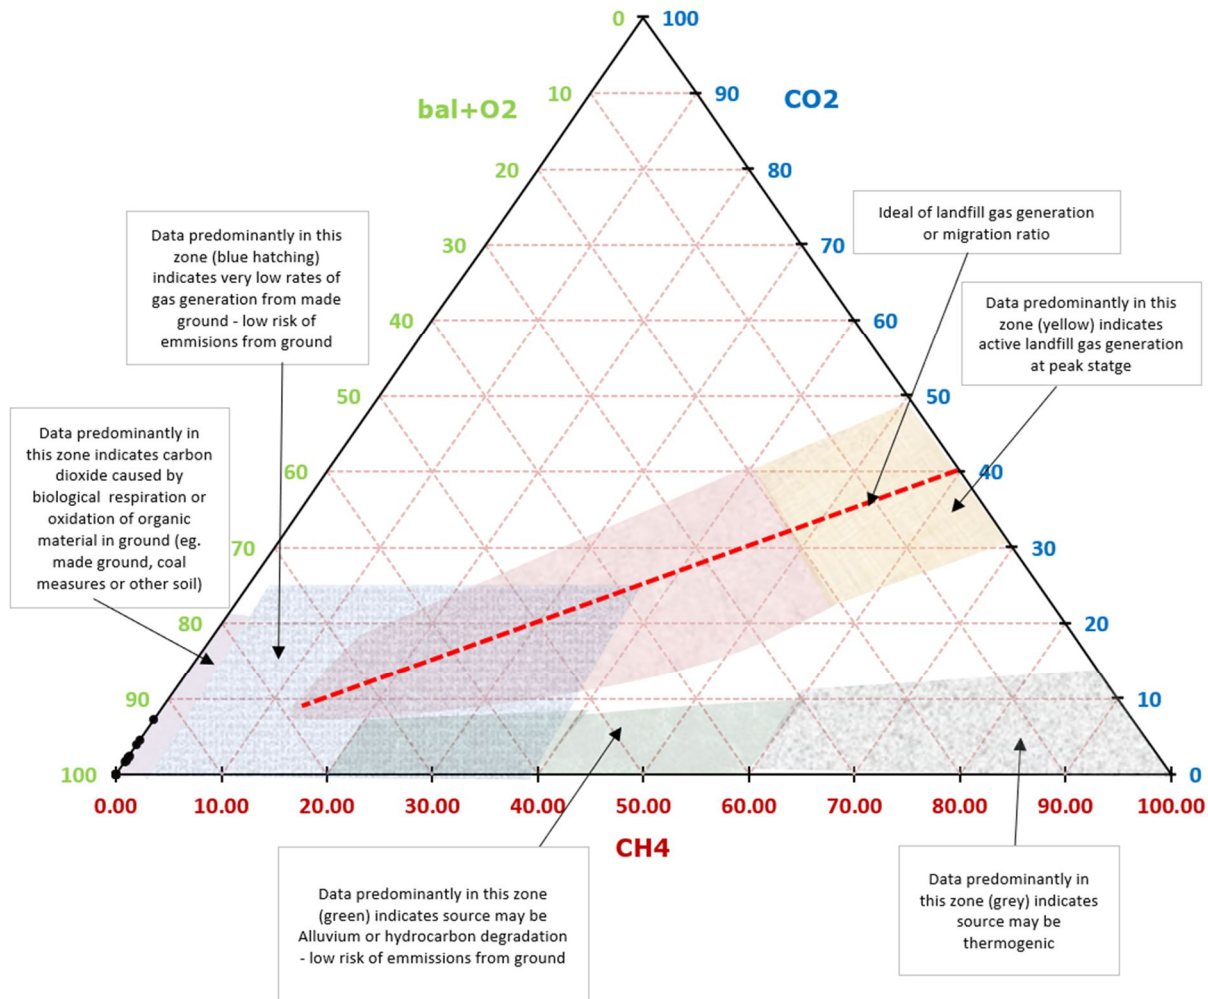
Plate 5-1: Ternary Plot Showing AE Gas Monitoring Data.

A ternary plot assessment of the gas monitoring results has been undertaken, as shown in Plate 5-1, this indicates that what gas has been produced, is derived from oxidation of organic materials in made ground/coal.

Interpretative zones taken from NHBC 2023 and Wilson *et al.*

From the above, LKC consider that there is no significant source of gas in influencing the site of interest, as no significant gas has been observed in any of the responses zones in various strata, including Pennine Lower Coal Measures and deep made ground. On the basis of the lack of significant gas, the study site is not deemed at risk from ground or hazardous gas based on the data from the Hillycroft investigation.

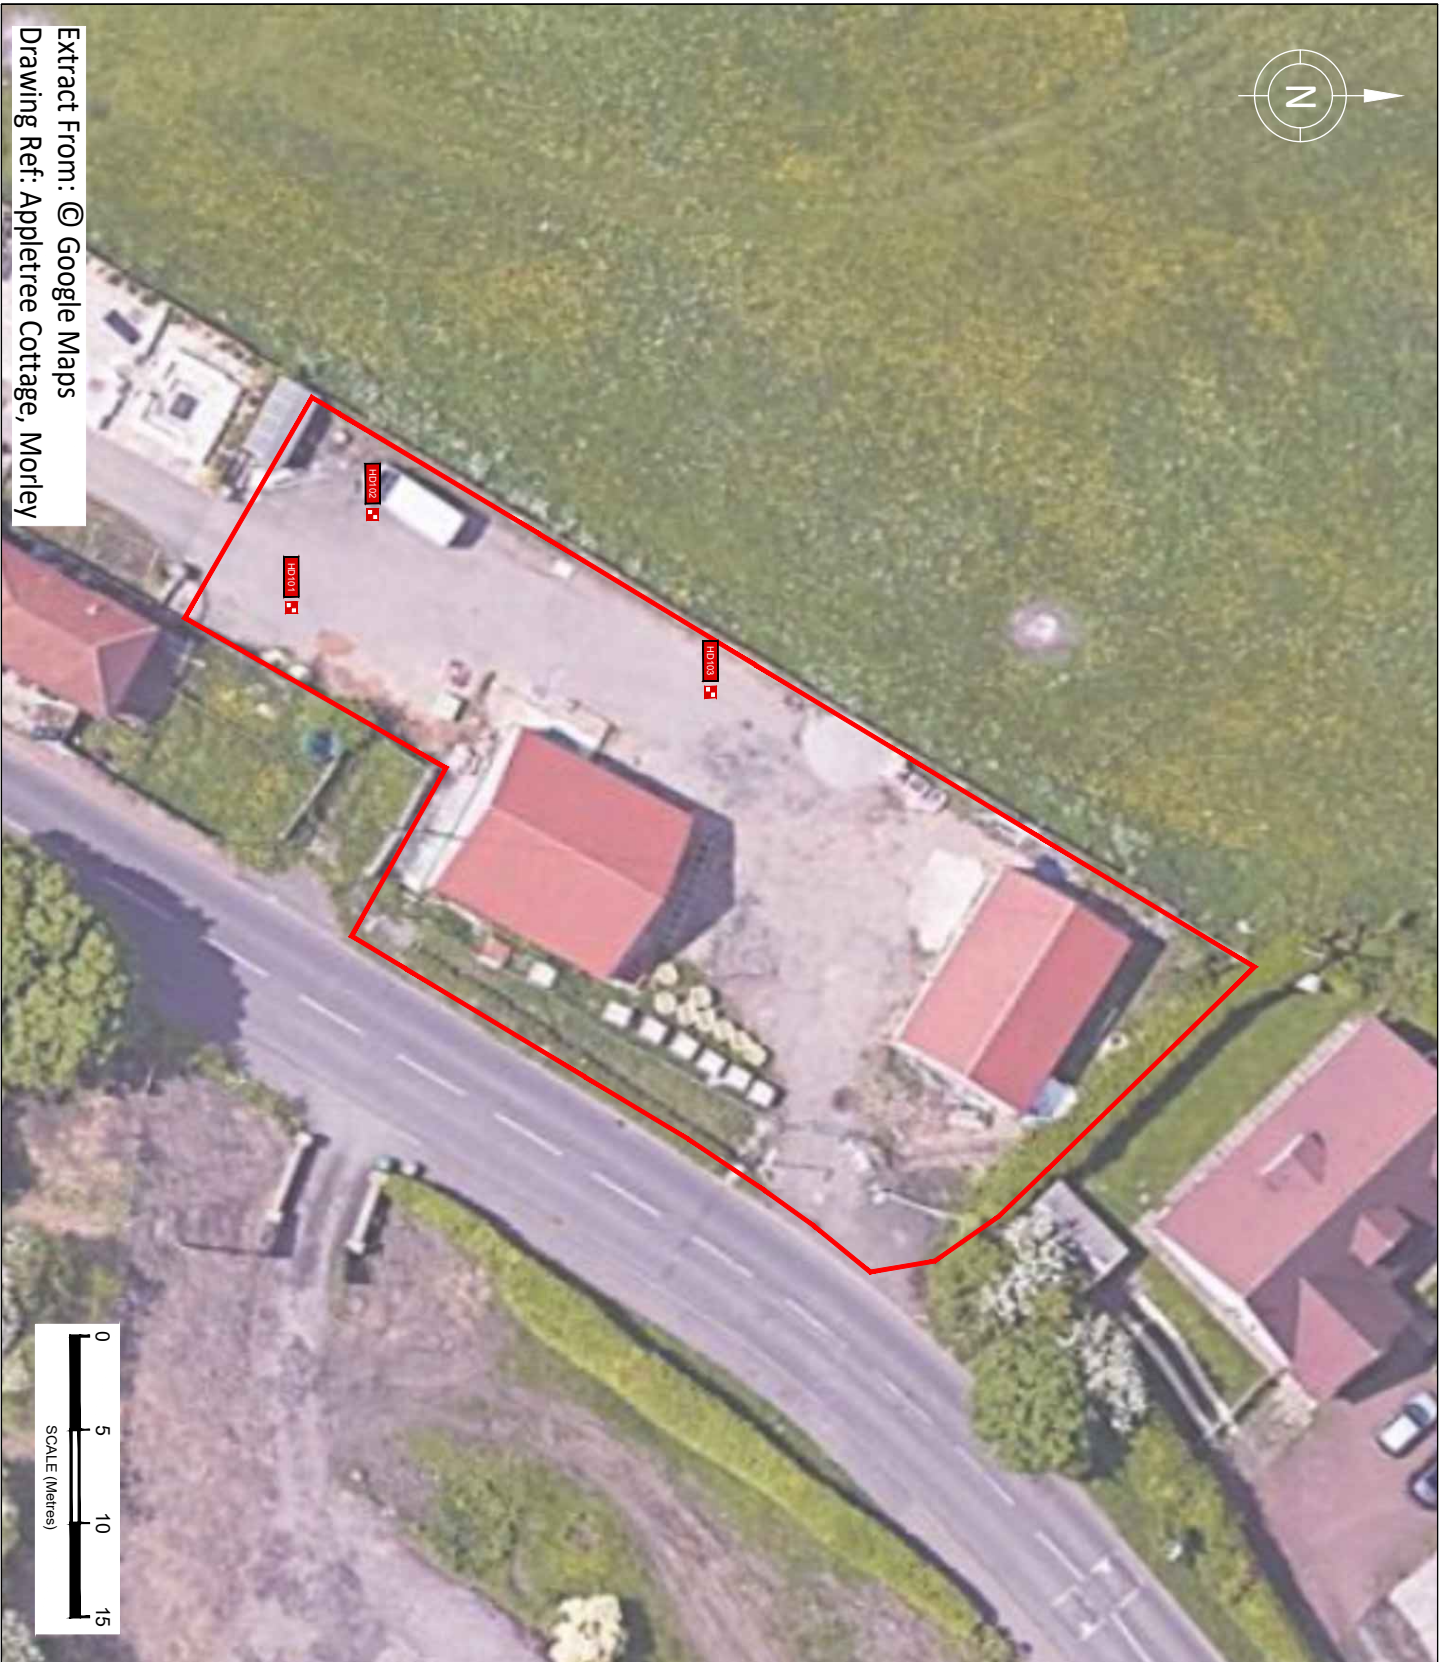
Extract From: © Google Maps  
Drawing Ref: Appletree Cottage, Morley

Sampling locations and features annotated by LK Consult Ltd are approximate and are based upon observed measurements unless otherwise stated. Do not scale from this drawing and work from marked dimensions only. All dimensions and features should be confirmed on site by the Contractor. Where this drawing includes information provided to LK Consult Ltd by others, LK Consult Ltd gives no warranty, representation or assurance as to the accuracy of such information.
