Remediation Strategy

Chapman Way
Tunbridge Wells
TN2 3EF

November 2023

561063.0000.0000

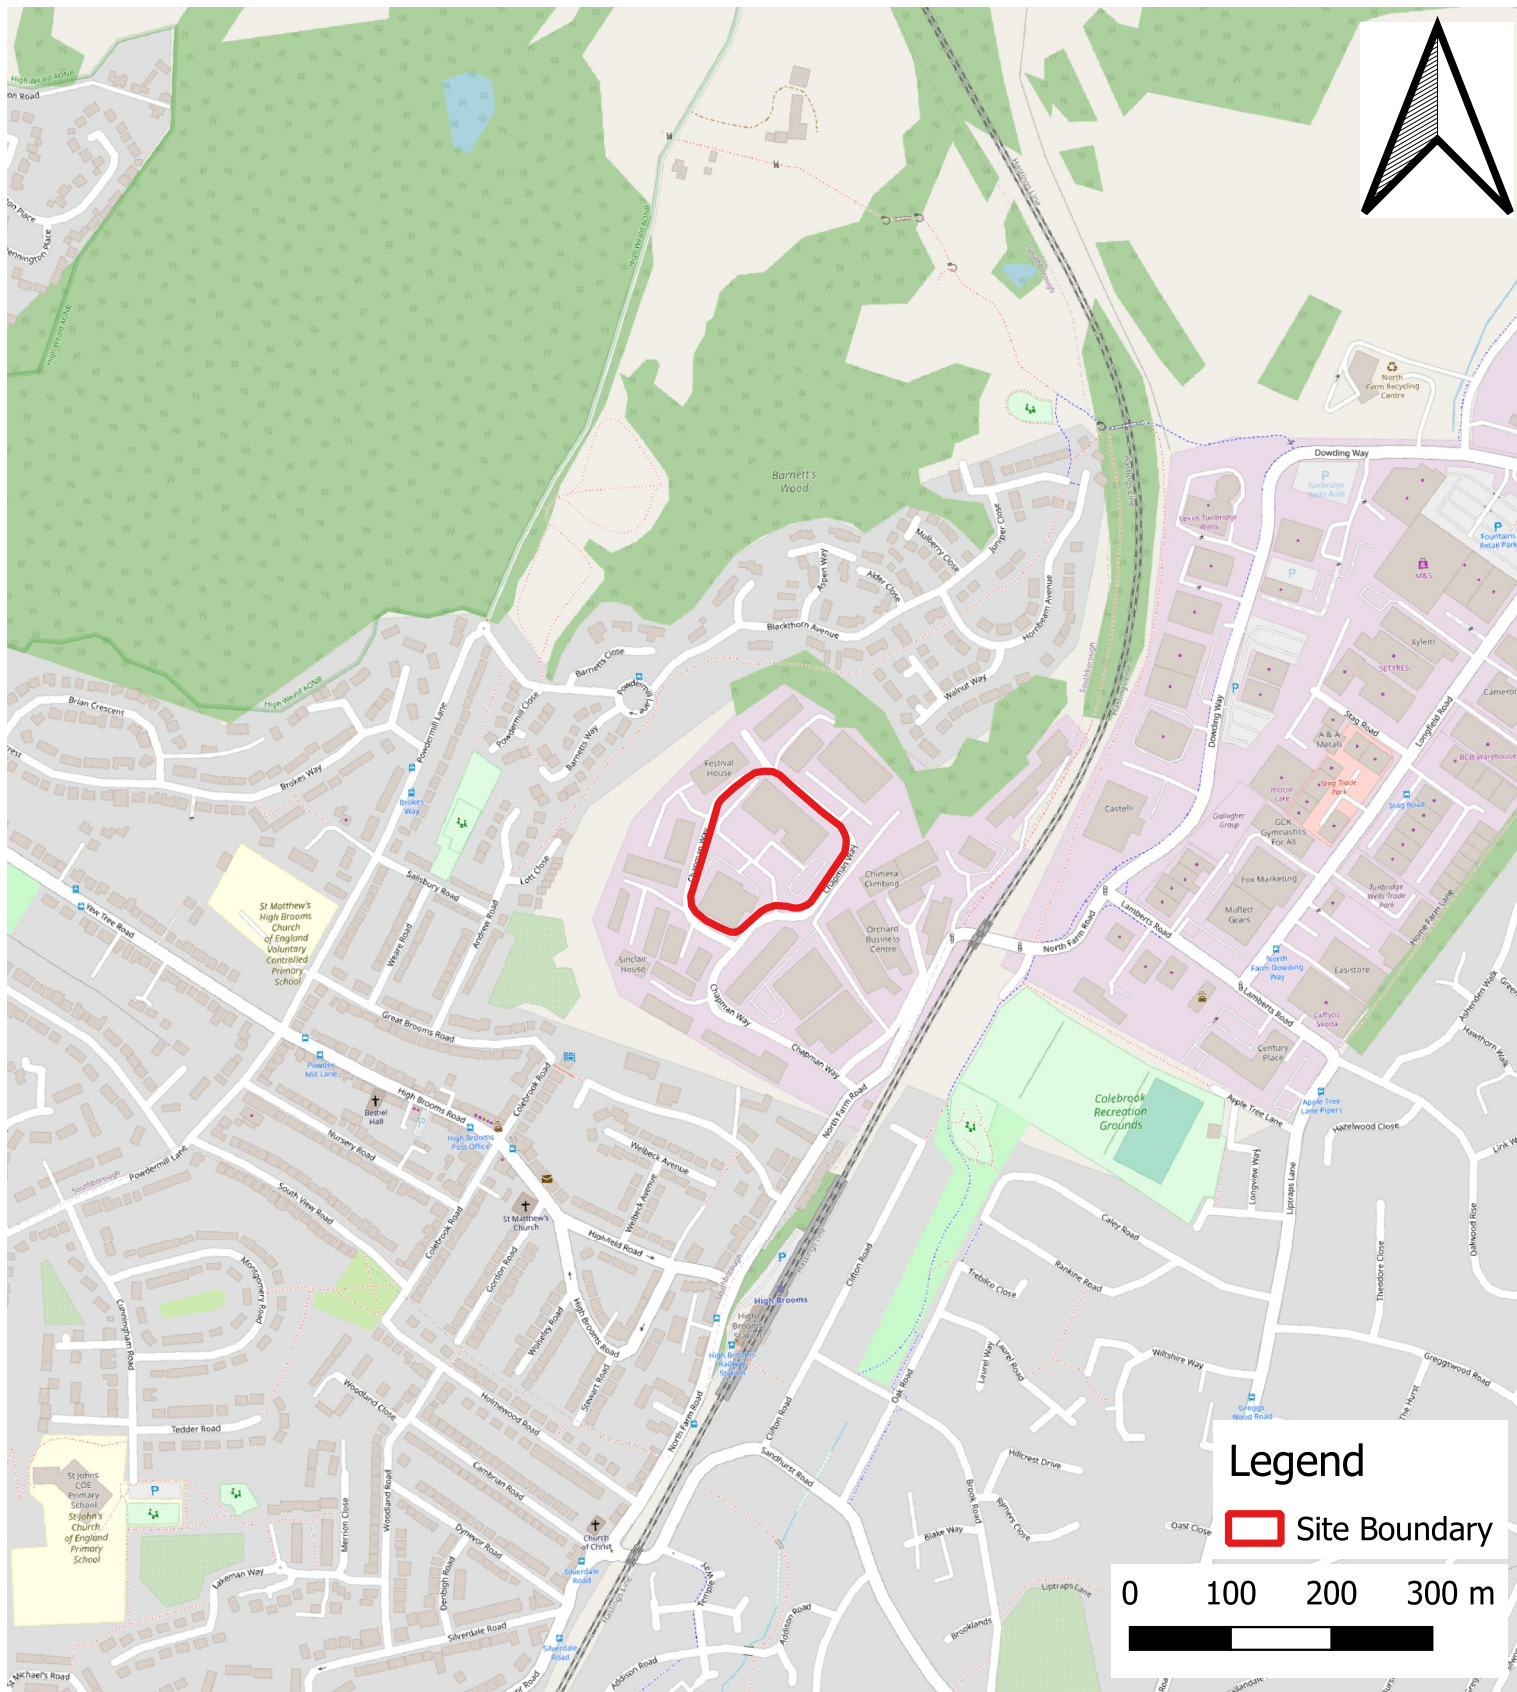
A Site location plan is provided as Figure 1 in Annex A.

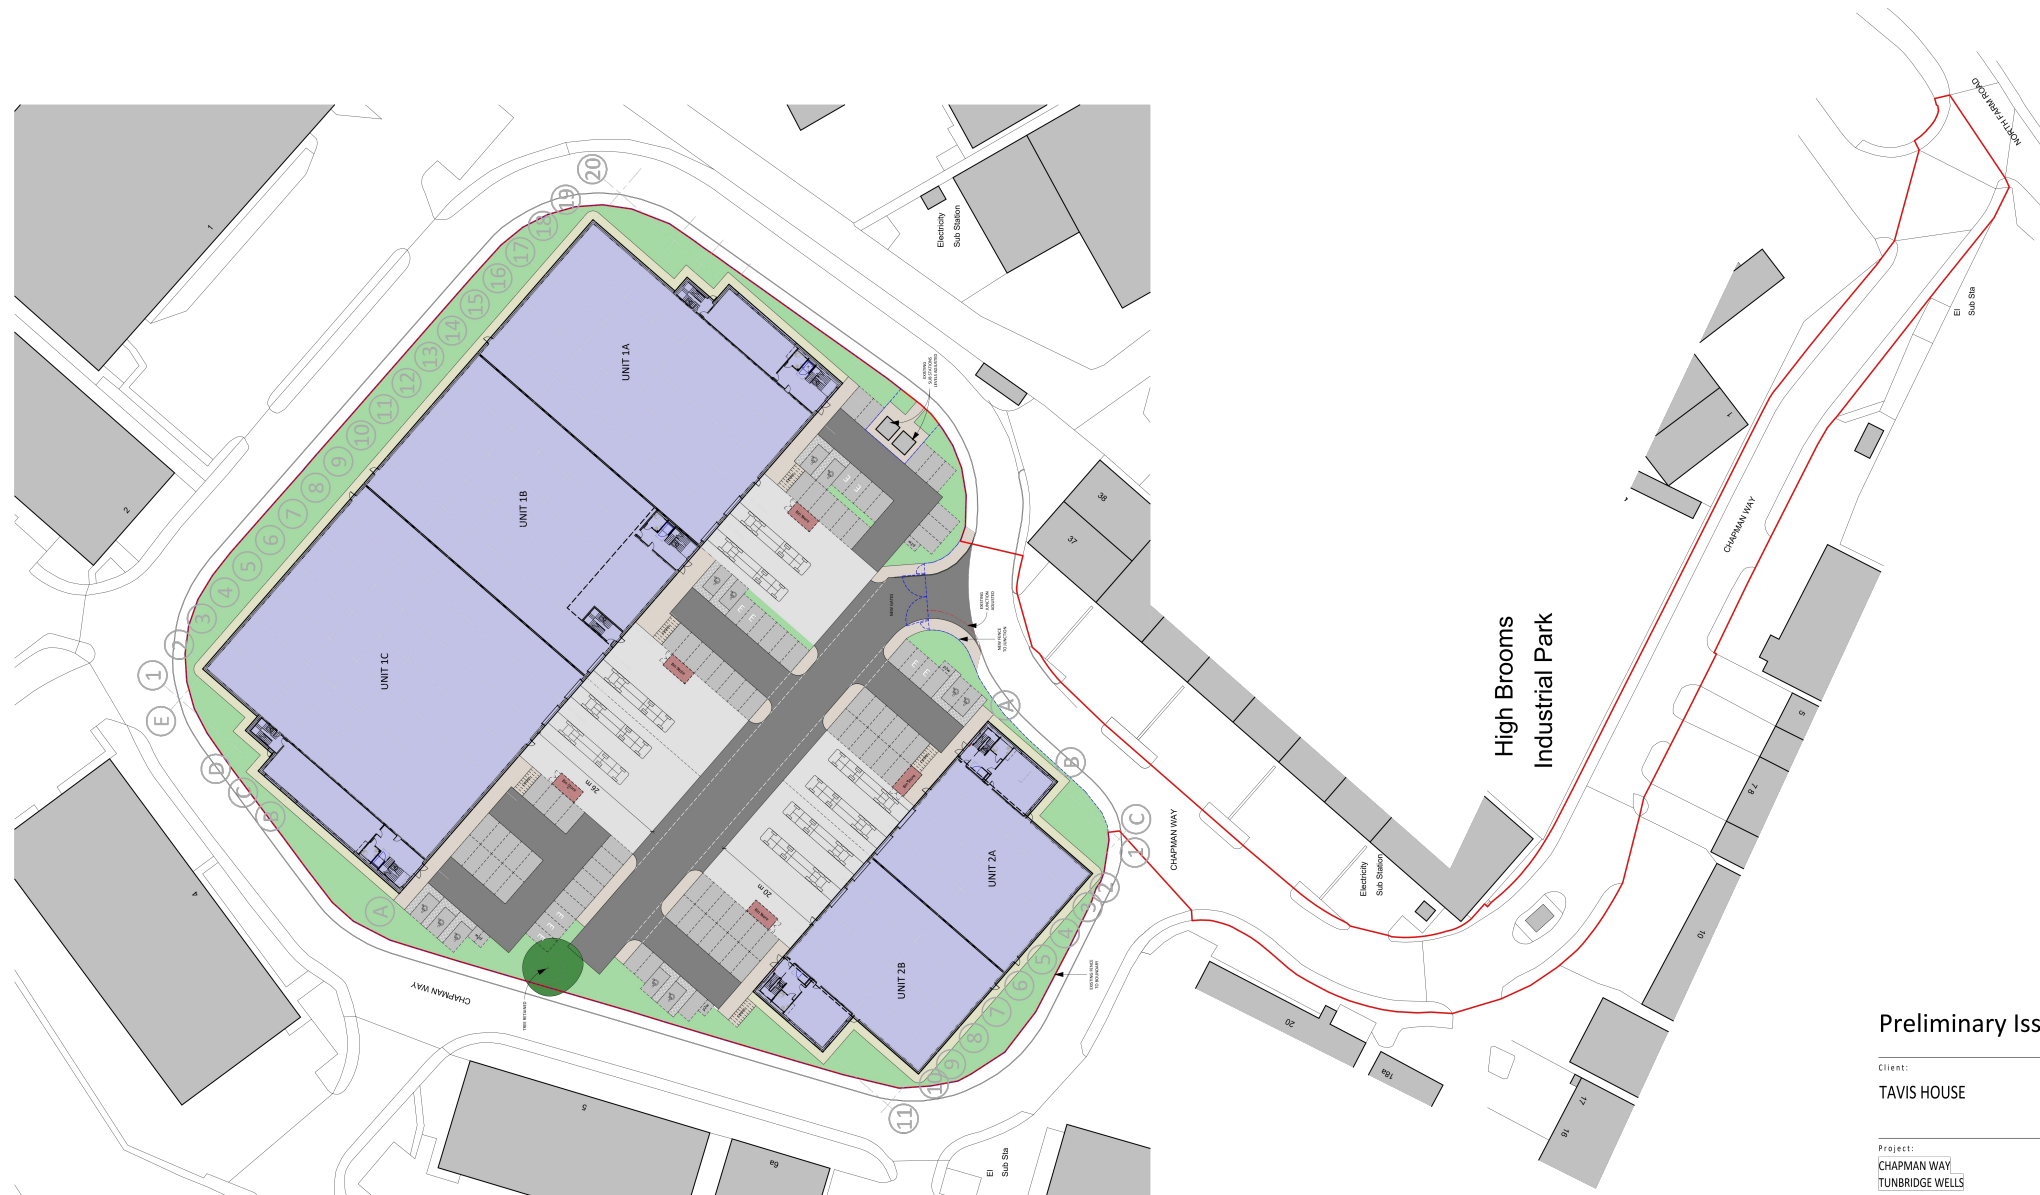
The proposed development comprises the demolition of the existing buildings and construction of three large adjoined warehouse units in the northern portion of the Site and two large adjoined warehouse units in the southern portion of the Site. Each unit will have associated car parks, service yards and landscaping, as indicated on PRC Architects drawing reference number 11476 / TE_12-100 Rev T2, dated 28/4/2023.

A proposed development plan is presented as Figure 2 in Annex A.
