EXTENDED PHASE 1 ECOLOGICAL AND BAT
ROOST ASSESSMENT

SOAKE FARM, SOAKE ROAD, DENMEAD, WATERLOOVILLE, PO7 6JA

FINAL REPORT

September 2023

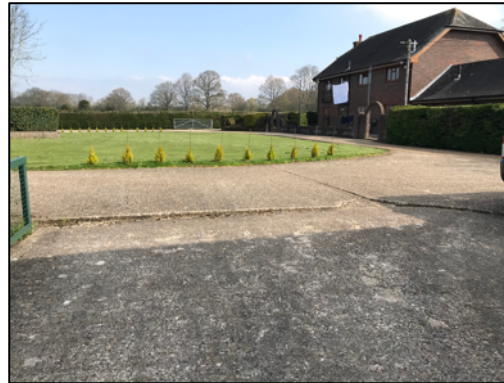
The northernmost section of the site supports an area of amenity grassland that is well managed to a short uniform sward (Figure 1). The grass species recorded include perennial rye *Lolium perenne* with interspersing herbaceous species dominated by daisy *Bellis perennis*, with ragwort *Jacobaea vulgaris*, forget-me-not *Myosotis sp.*, dandelion *Taraxacum sp.* and cat's-ear *Hypochaeris radicata* also occasionally recorded. Two ornamental trees are present within the lawn.

Figure 1 – grassland in the northernmost section of the site, with immature scattered trees

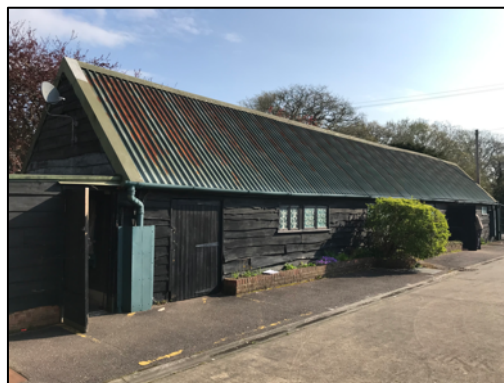
Raised flower beds are present against the southern elevation of Building 1 (Figure 2) and the northern elevation of Building 2. The species present include *Cotoneaster sp.*, bramble *Rubus fruticosus*, ivy *Hedera helix* and adria bellflower *Campanula portenschlagiana*.

Figure 2 – raised bed with shrubs in front of Building 1

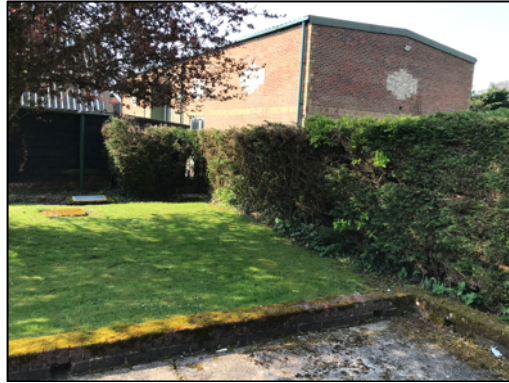
Species poor defunct hedgerow (J2.2.2) forms the northernmost sections of the western and eastern elevations (Figure 3). The species include *Leylandii sp.* and cherry laurel *Prunus laurocerasus*, with common nettle *Urtica dioica*, ivy, lords-and-ladies *Arum maculatum*, bindweed *Convolvulus sp.* and nipplewort *Lapsana communis*.

Figure 3 – short length of hedgerow in the northern section of the site

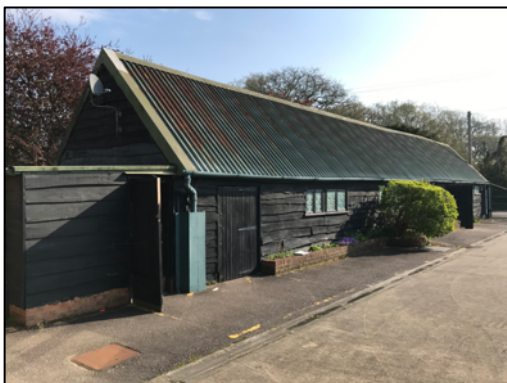
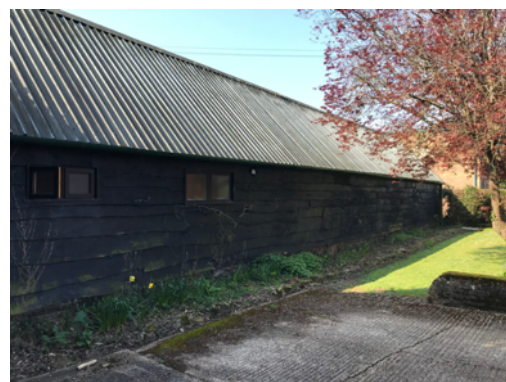
The office comprises a long single-storey wooden framed structure which rises to a pitched and gable end design roof clad with corrugated tin roofing sheets (Figures 4 & 5). The building is oriented south to north. The roof extends beyond the wall plate and the eaves are enclosed with wooden underboards and fascias, closely adjoined to plastic guttering on the southern elevation. The elevations are clad with wooden weatherboarding on top of bitumen felt. The southern elevation supports windows set in wooden frames, which are tight fitting to the surrounding woodwork. A small mono-pitched extension extends from the western elevation. As with the main structure, the extension is clad with corrugated tin roofing sheets and wooden weatherboarding.

Figure 4 – the office southern elevation

Figure 5 – the office northern elevation

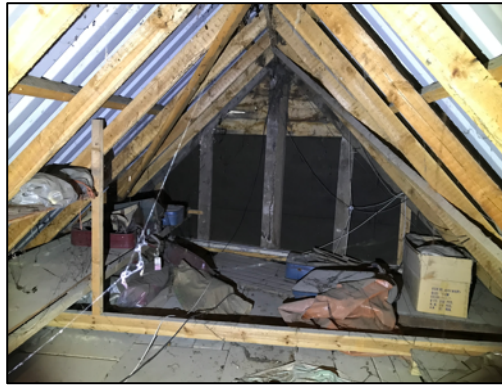
Internally, the office supports a single roof void (Figure 6), accessed via a hatch in the eastern end of the building. The roof is unlined with the underside of the roofing sheets visible. Timber beams support the roof, with a ridge beam set down from the roof cladding. Bitumen lining and wooden boards are present at the gable ends. The void is part boarded. Heavy cobwebbing was present.

Figure 6 – the office roof void

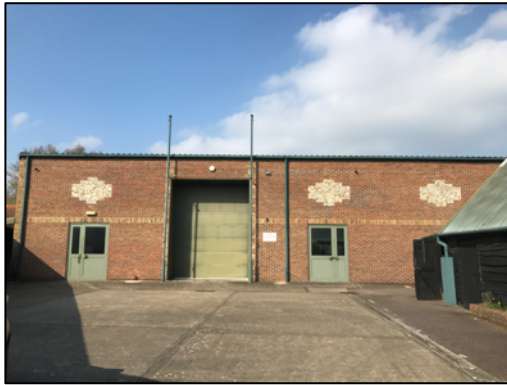
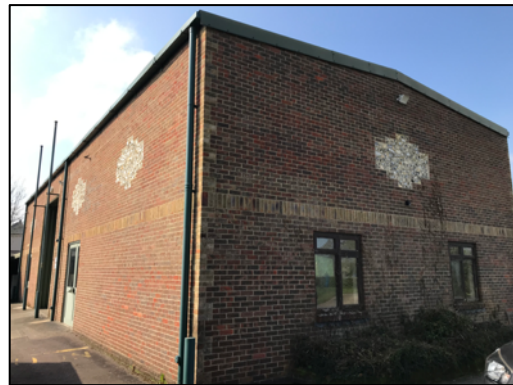
The warehouse comprises a large brick-built structure which rises to a shallow pitched and gable end design roof clad with metal roofing sheets, and ridge and verge caps (Figures 7 & 8). The building is oriented east to west. The eastern elevation supports two single metal doors and one large recessed metal roller door, with metal sheets cladding the sides of the recess. The northern and western elevations support two windows and one window set in wooden frames respectively; the windows are tight fitting to the surrounding brickwork. A corrugated plastic shelter extends from low down on the southern elevation and connects to the roof of Building 3, creating a covered shelter between the two buildings (Figure 9).

Figure 7 – the warehouse eastern elevation

Figure 8 – the warehouse northern elevation

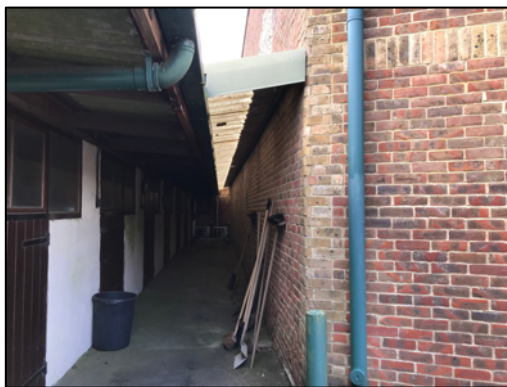
Figure 9 – covered shelter between buildings 2 and 3

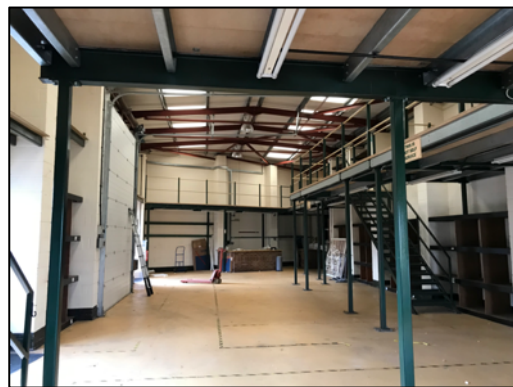
Internally, the warehouse does not support a roof void (Figure 10). The elevations are double-skinned, with blockwork walls internally. The building is supported by a metal frame. A mezzanine level is present around the northern, western and southern elevations. The warehouse was disused at the time of survey.

Figure 10 – internal space of the warehouse

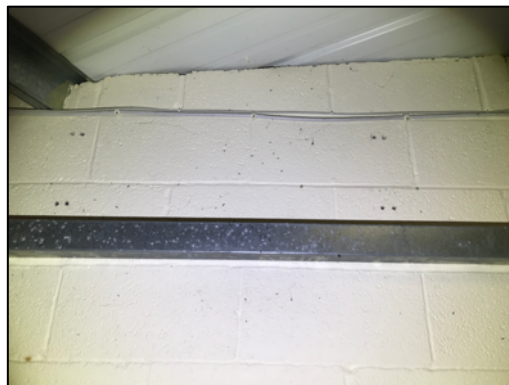
gaps above the wall plate. Further droppings were also scattered throughout the building. The number of droppings and the size of some of droppings suggest it is a maternity roost.
--	--

Figure 11 - gaps above the wall plate within the warehouse with pipistrelle droppings

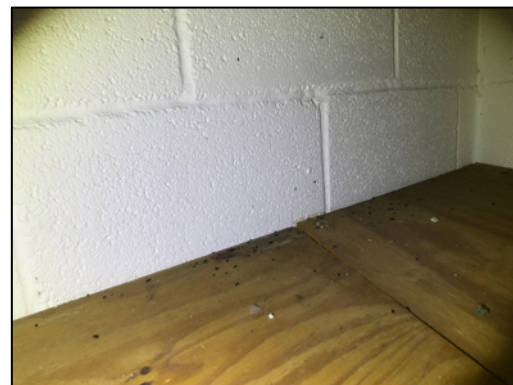
Figure 12 – hundreds of pipistrelle type droppings within the warehouse

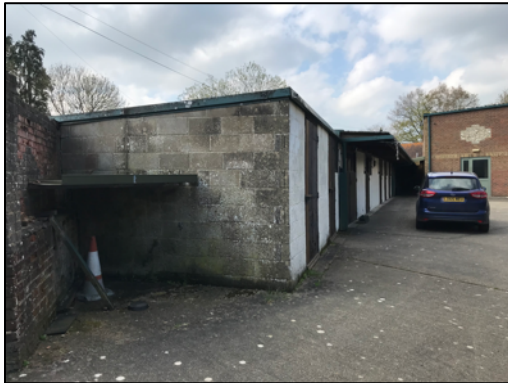
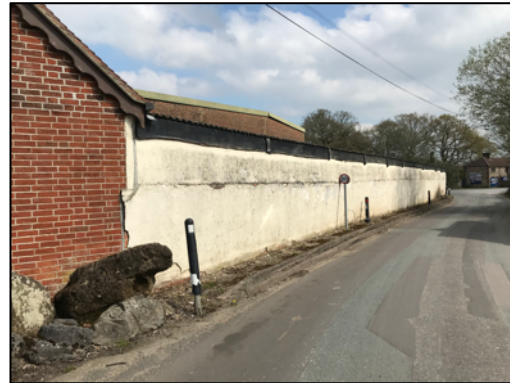
The stables comprises a long brick-built stable block which rises to a shallow mono-pitched roof design clad with asbestos type corrugated roofing sheets (Figures 13 & 14). The building is oriented north to south. The northern elevation is rendered and painted and supports wooden stable doors. The southern elevation forms the boundary of the site with Soake Road; the top of the elevation supports wooden weatherboarding while the bottom section is also rendered and painted. The western elevation adjoins to a cottage outside the application site. A blockwork extension extends from the eastern elevation. The roof of the extension is clad with corrugated tin roofing sheets and the elevations remain as exposed blockwork. A corrugated plastic shelter extends from northern elevation and connects to the southern elevation of Building 2, creating a covered shelter between the two buildings (see Figure 9, above).

Figure 13 – the stables northern and eastern elevations

Figure 14 – the stables southern elevation

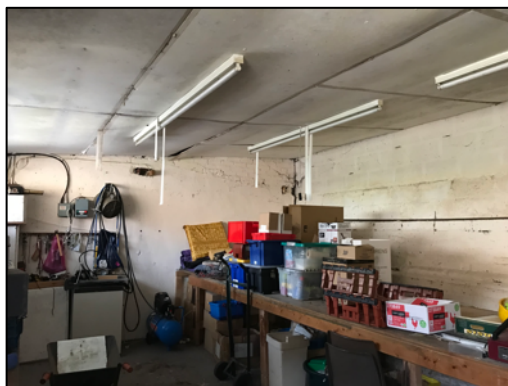
Internally, the easternmost stables have been converted into storage rooms with a false ceiling installed and the elevations clad with wooden sheets (Figure 15). The westernmost stables are open to each other, separated with three-quarter height walls (Figure 16). Access above the eastern false ceiling is present from the centre stable.

Figure 15 – internal view of the eastern stables

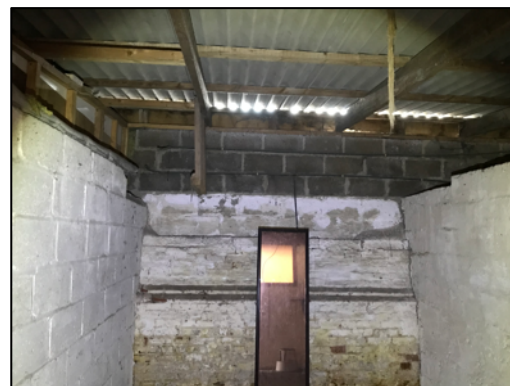
Figure 16 – internal view of the western stables

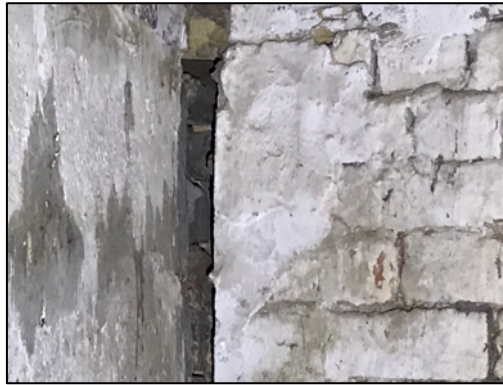
Figure 17 – crevices in the brickwork on the eastern end of the stables
