RE: MELKSHAM COTTAGE, STINCHCOMBE, GL11 6AR

ECOLOGICAL ASSESSMENT

Date: 24/11/2023

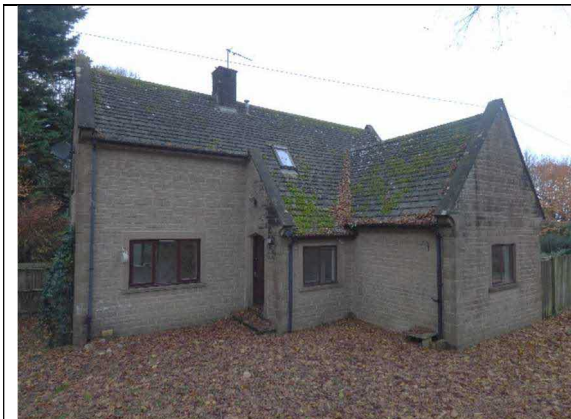
Photo 1: The existing structure was found to be in a good state of repair.

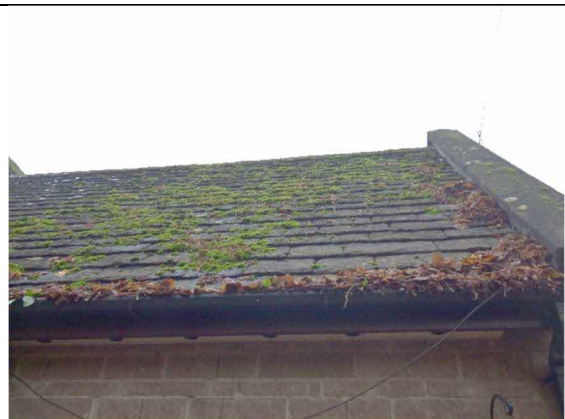
Photo 2: Roof tiles were found to be tightly overlapped.

No designated site will be directly or indirectly impacted by development activities. In terms of bat roosts, the structure was considered to offer negligible potential for roosting bats. The rationale for this was a lack of gaps and crevices at roof edges as well as the tightly fitting nature of the reproduction roof tiles.

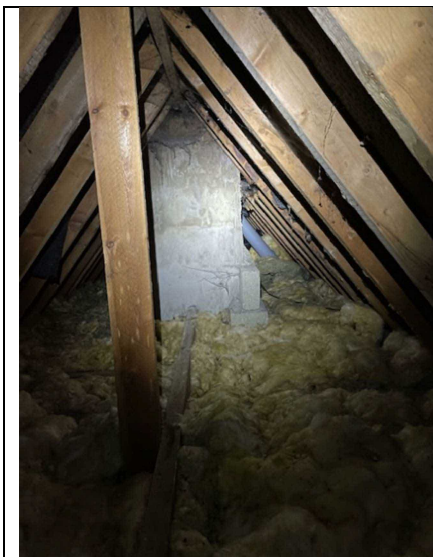
Internally, traditional bitumen roofing felt was evident over roof timbers and rockwool insulation was present within the loft void. No evidence of bats was found.

Photo 3: Roof void with chimney visible.
