Preliminary Ecological Assessment (Bat and Nesting Bird Survey)

Proposed works: Two-storey extension to northwest elevation of house

Site: Melberry House, Moor Lane, Poltimore, EX4 0AQ.

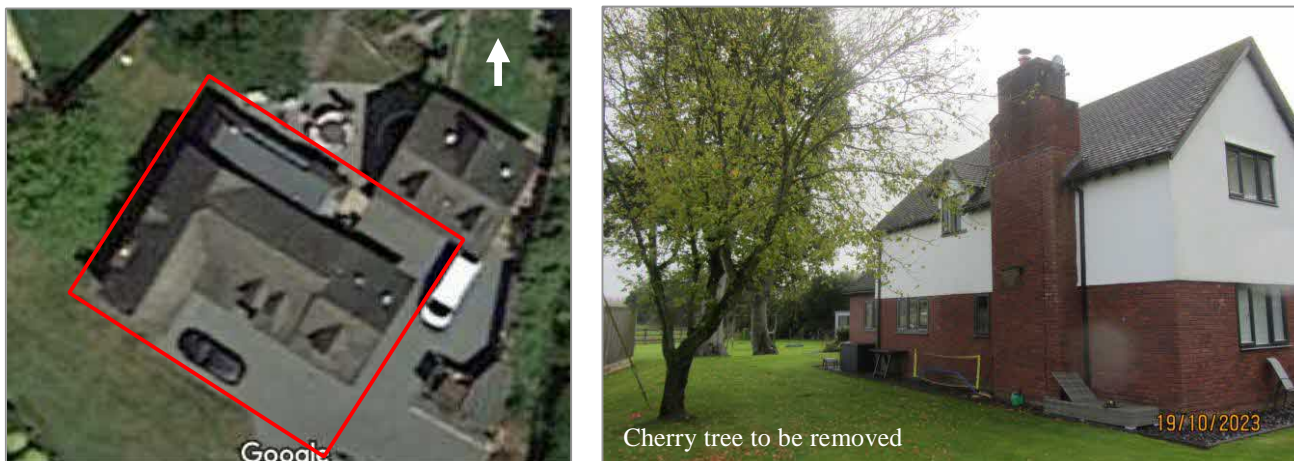
Fig.1. Application building (Google). Fig.2. Northwest elevation and southwest gable.

The property is a detached house of cavity-wall block construction, believed to have been built in the late 1980s/early 1990s (Mr Chown, pers.com). Externally, the upper walls are rendered with brickwork below and to the northwest chimney. The southeast end of the building, which can be seen to have a disjunctive ridge line, and the rear flat-roofed kitchen extension are later extensions dating from 2021.

The original roof is of trussed and braced construction, i.e. with a ‘cluttered’ timber interior and no ridge beam, and is L-shaped with a central, primary ridge line between what was the southeast gable wall and the northwest hip junction and a secondary ridge line runs to the southwest gable. The roof is intersected by two pitched-roof dormers in the southwest slope and one in the northwest slope, near the large brick chimney. The roof covering is of small, flat concrete tiles and concrete ridge and hip tiles lined with traditional 1F bitumastic roof felt. The tiles can be seen to be flat and flush-fitting and the ridge hip lines predominantly solid and well-bedded. The smaller southeast roof is a cut roof with a single ridge line between the former gable wall and the new wall. The roof covering has matching small flat concrete tiles but these are lined with a modern grey breathable roof membrane. The eaves comprise sloping timber soffits to all elevations.

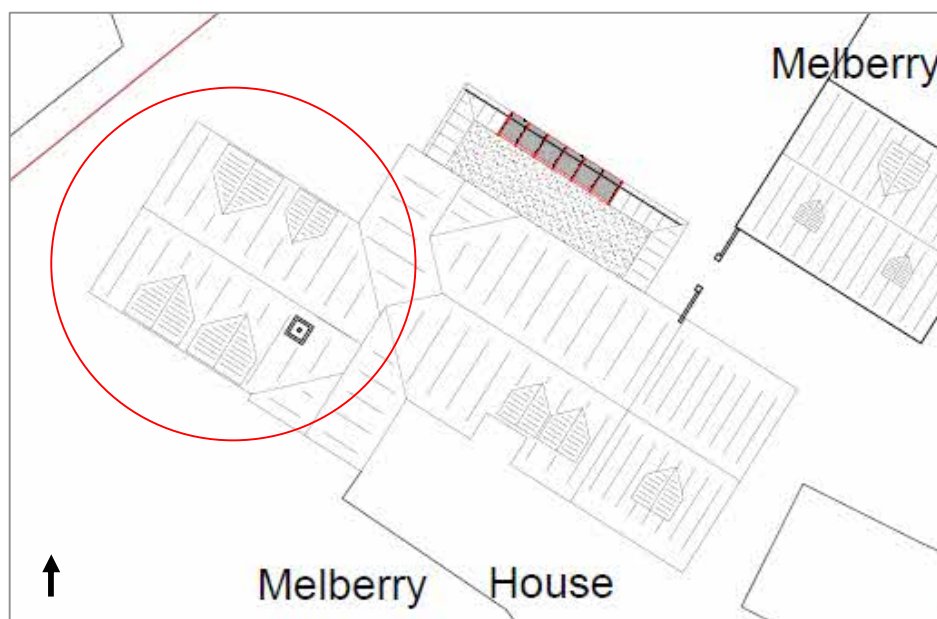
Fig.3. proposed extension

I have seen the drawings as proposed and I understand that the application is for a full-height, two-storey extension at the northwest side of the house. The extension roof will be pitched with the ridge tying-in at the existing ridge height and will support four new dormers, two in each slope and matching the current dormer style. The chimney will be retained. The extension will involve the removal of a medium-sized ornamental cherry, assessed separately by a tree expert to be of low [arboricultural] significance.

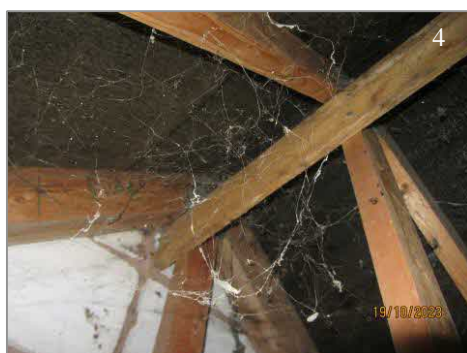
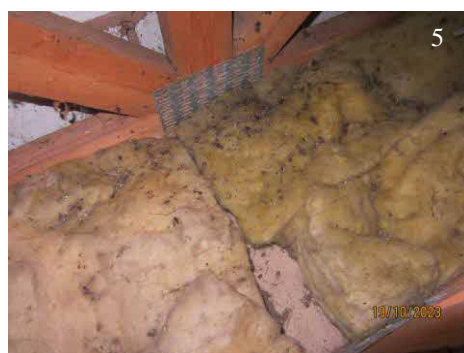
No evidence of bat use was found in association with the roof or eaves of the house. The roof tiles are flush-fitting and well bedded and the underside of the roof and the inner timber-panel faces of the dormers can be seen to be heavily cobwebbed. Evidence of mice and dead flies are conspicuous and a mummified rat was also noted. The sloping timber soffits, particularly along the northwest eaves appear to be sealed, and no discernible access features were identifiable at the chimney or dormer roof intersections on this elevation. No potential roost features were identified in association with the cherry tree.

Figs.4 & 5. Cobwebs at apex of inner southwest gable and mixed invertebrate and dead fly material below. Fig.6. Cobwebs inside northwest-facing dormer. Fig.7. House martin mud nest scar, northwest soffits next to chimney. Fig.8. Likely house sparrow nest material and feathers in former house martin nest, northeast gable apex. Fig.9. Historic nest material, probably house sparrows, southeast dormer of original part of house.

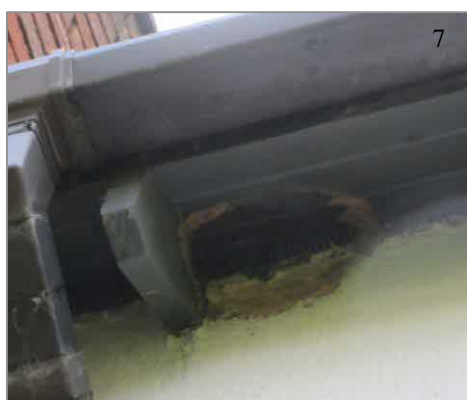
- Evidence of bird nesting activity was confirmed.
- Nest cups and old mud scars from house martins were identified on the southwest, northwest and northeast elevations, with at least one of these active during 2023.
- On the northwest elevation, two old mud nest scars are evident.
- The remains of two house sparrow nests were identified: One in a house martin nest cup at the apex of the rear gable, with loose grassy material and feathers indicating nesting in 2023, and other, older and historic grassy nest remains inside the roof intersection of the top southeast dormer cheek at the southeast side of the original part of the house.

- In this particular case this would mean fixing robust plastic sheeting across the northwest soffits (*only* the northwest soffits) to prevent birds nesting.

Prior to the 2024 nesting season and any measures that may be taken to deter nesting under the northwest soffits no less than **2 x artificial nest cups** are to be affixed. I recommend the following locations:

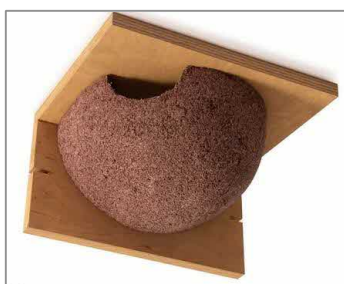
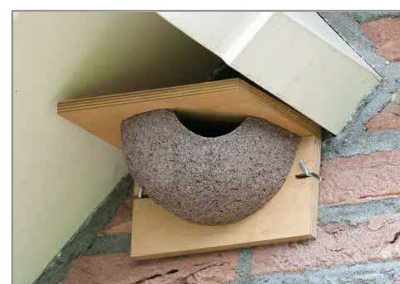
Fig.10. House martin nests with left-sided hole (left) and right-sided hole (right)

- 1 x nest cup under the southeast face of the front wing, to right of window.
- 1 x nest cup under the northwest elevation, at the far north end which will be at distance from scaffolding.
- Ensure you purchase 1 x left-sided hole and 1 x right-sided hole, as shown below.

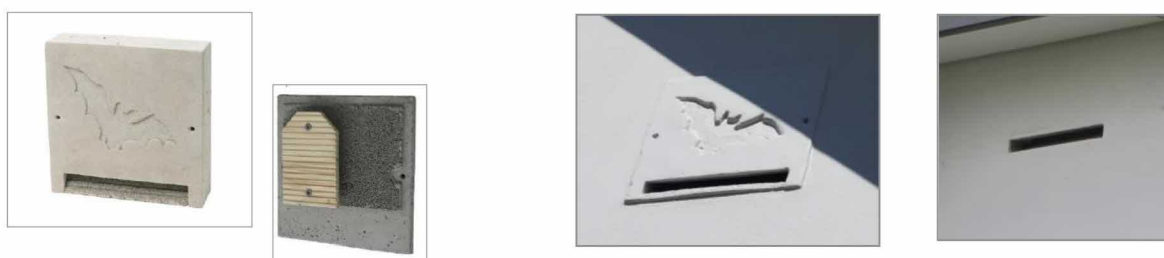
Schwegler 1FE access + back panels; examples with and without bat motif showing.

1 x Schwegler 1FE bat access + back panel

To be installed at the apex of new northwest gable of extension.

- These boxes are designed to be built into the wall fabric with the access slot at the front flush with the wall surface. They are NOT designed to be affixed onto the outer wall face.
- The box is in TWO components: a front access panel and a rear cavity panel.

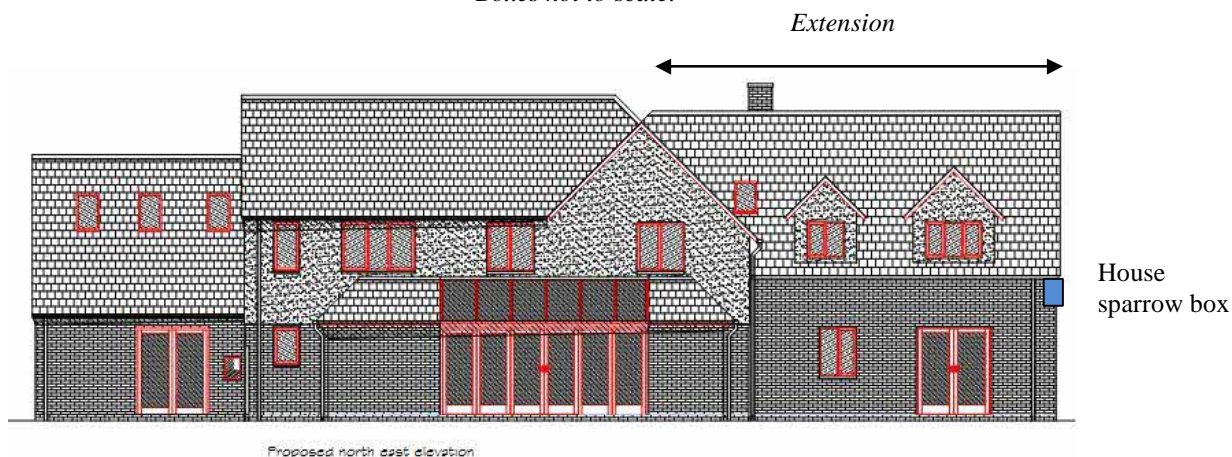
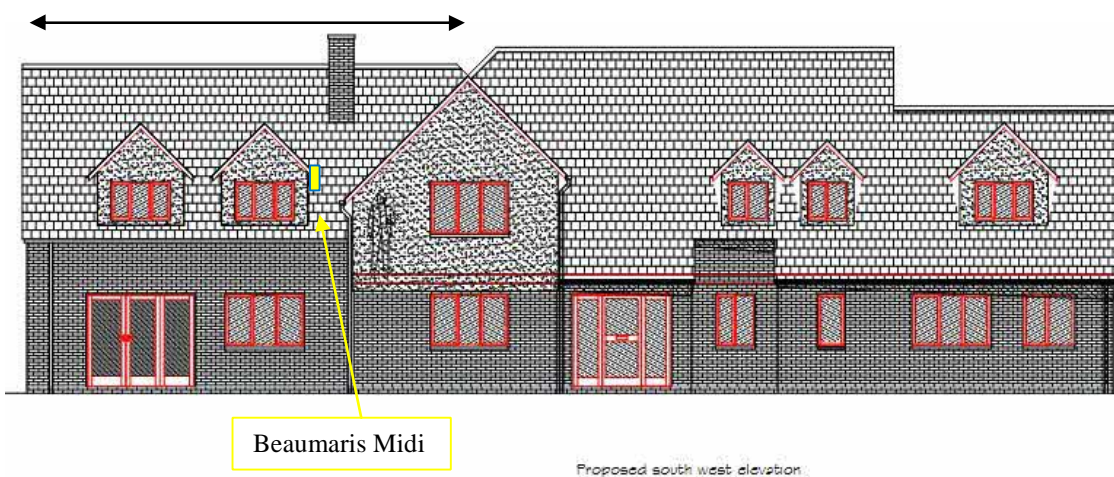
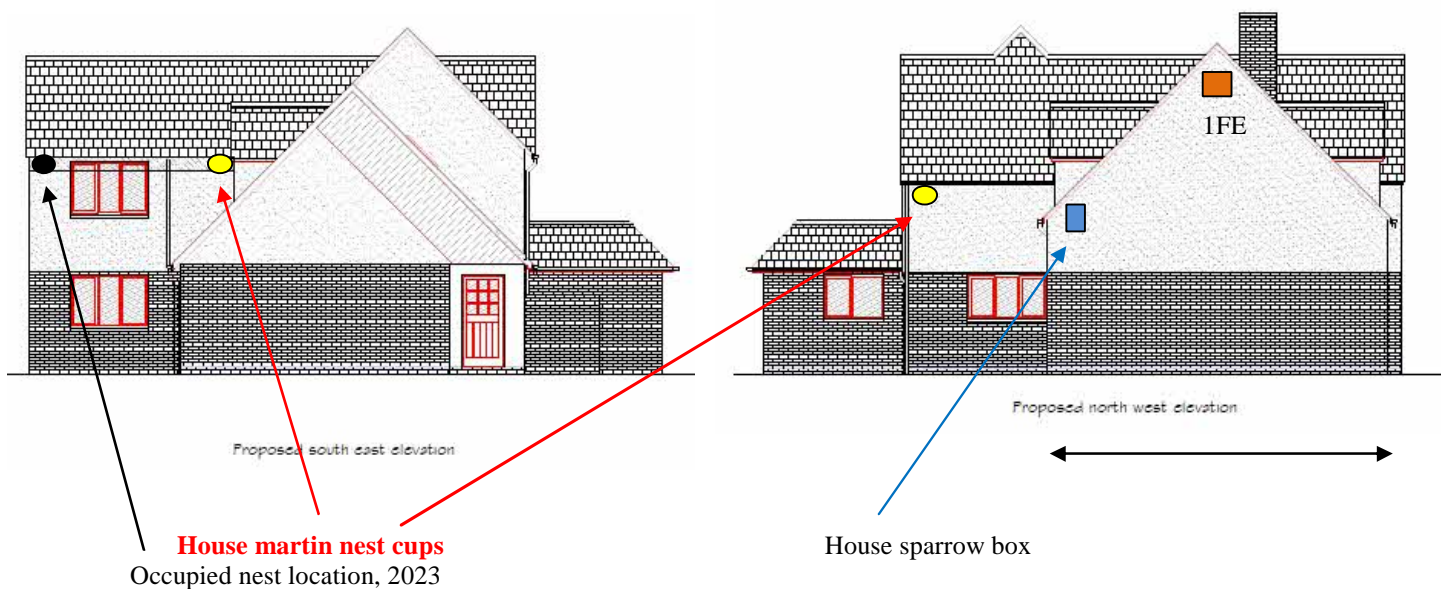
Recommended bat box locations *(drawing courtesy of Barry Blaker)* *Boxes not to scale.*

To be affixed under the eaves of the southeast cheek of the SE dormer at the front of the new extension.

Affix while scaffolding is still in place under the northeast eaves of the extension at the north corner, and at the NW gable verge, near the boundary hedge.
