Ref: P0355/LR01/SHS

GUIDE POST FARM, ARDLEIGH

Please find below my report relating to the removal of contaminated ground within the proposed garden area at the above site.

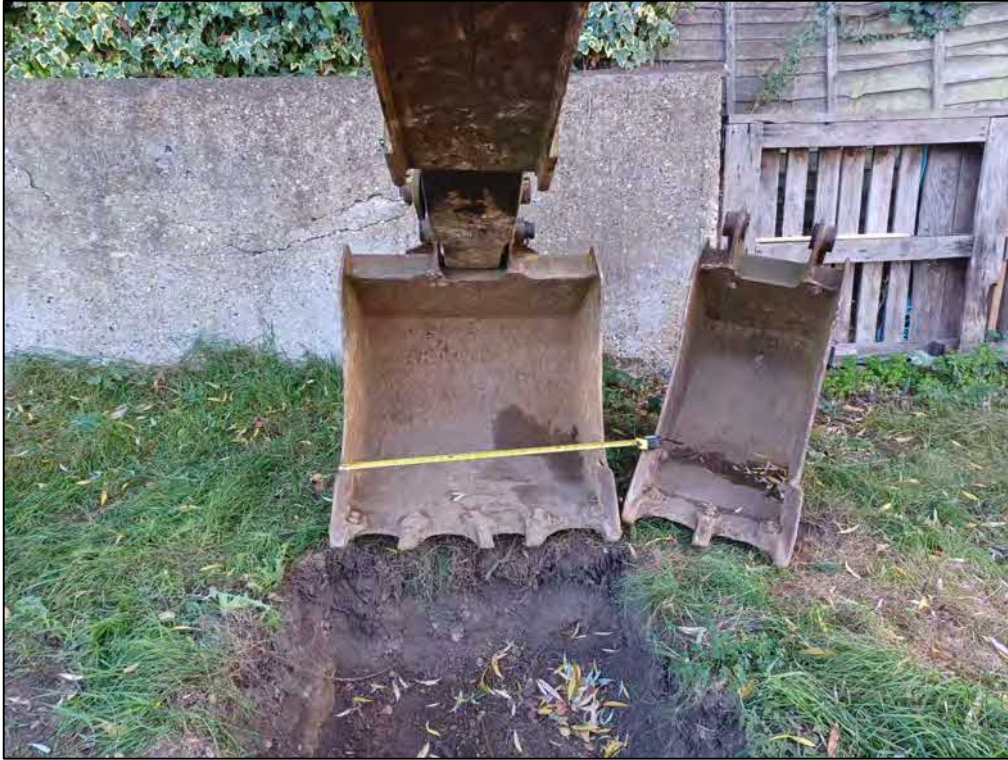
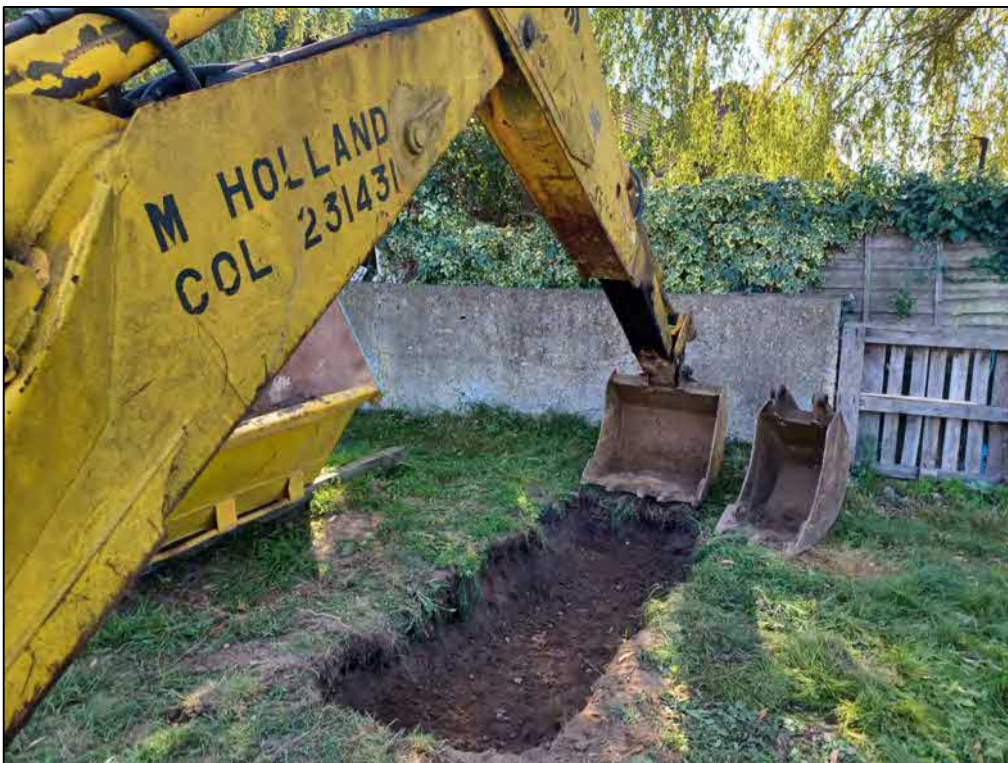
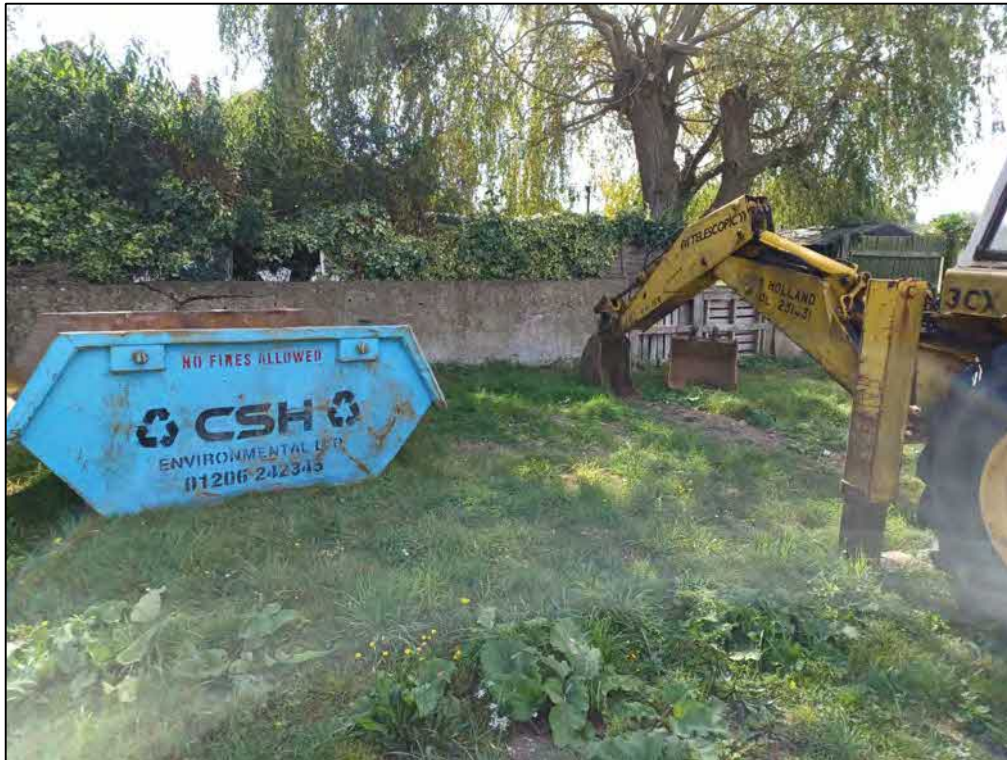
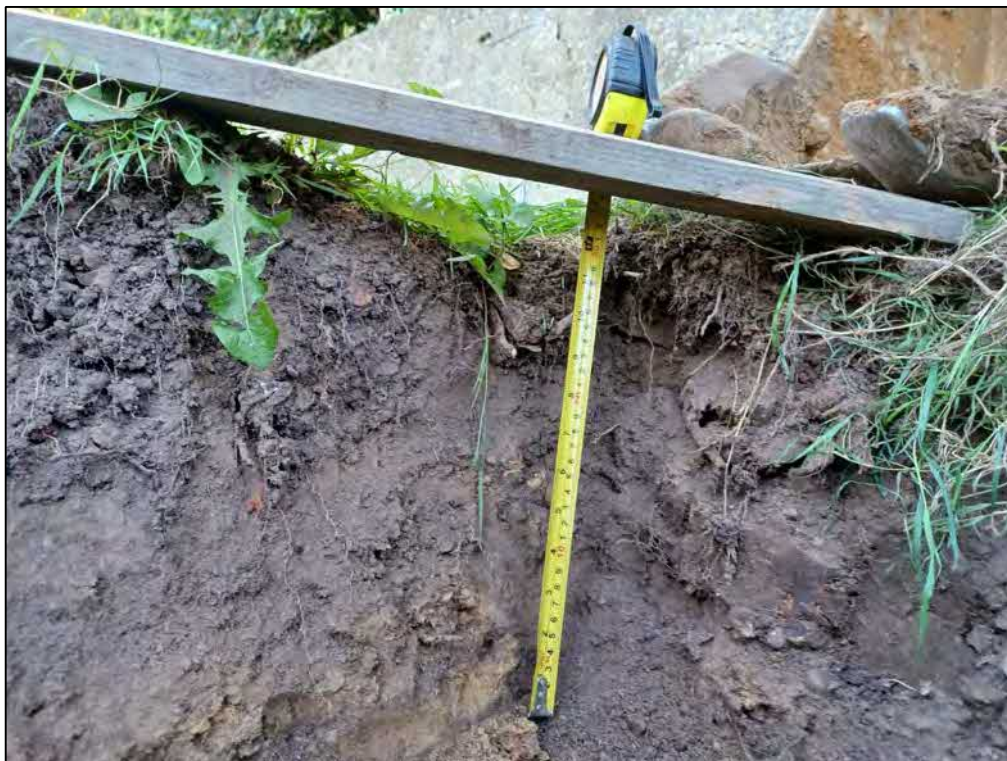
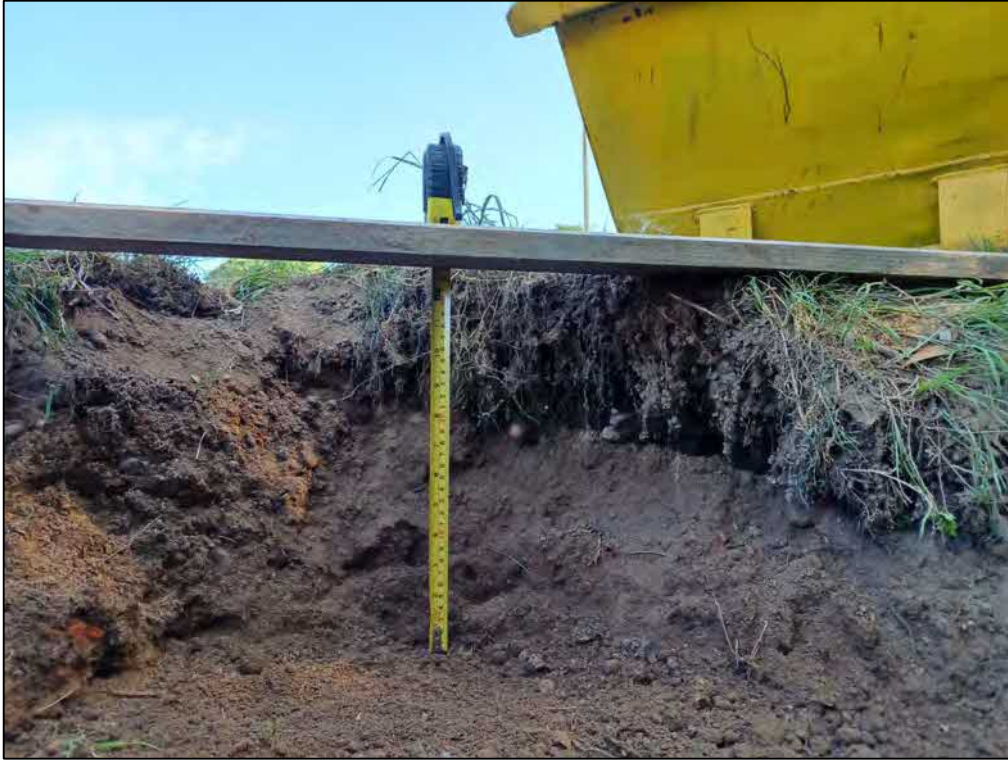
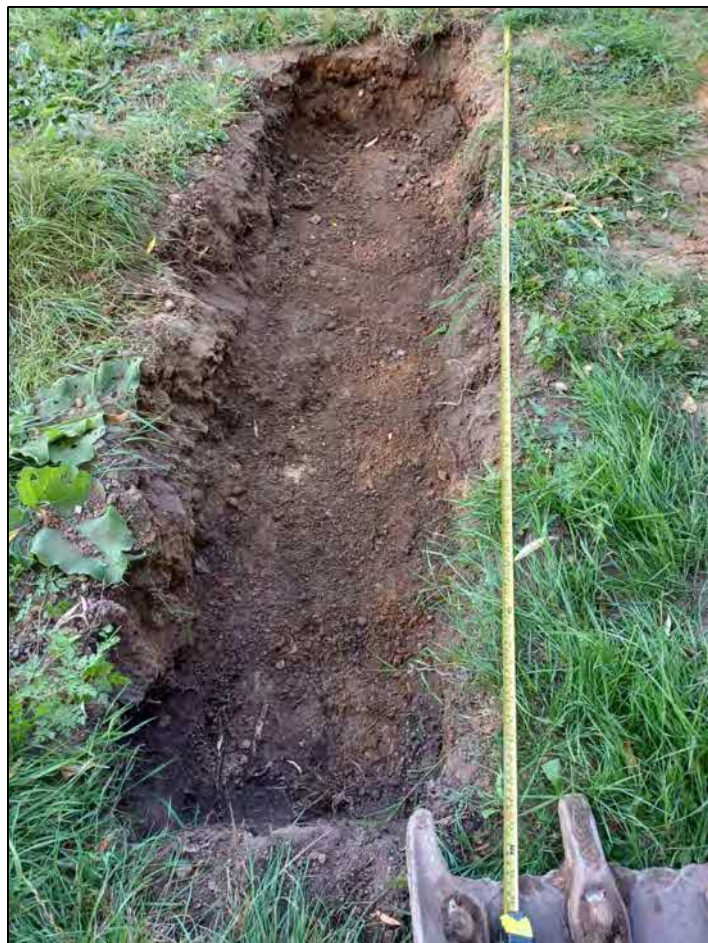
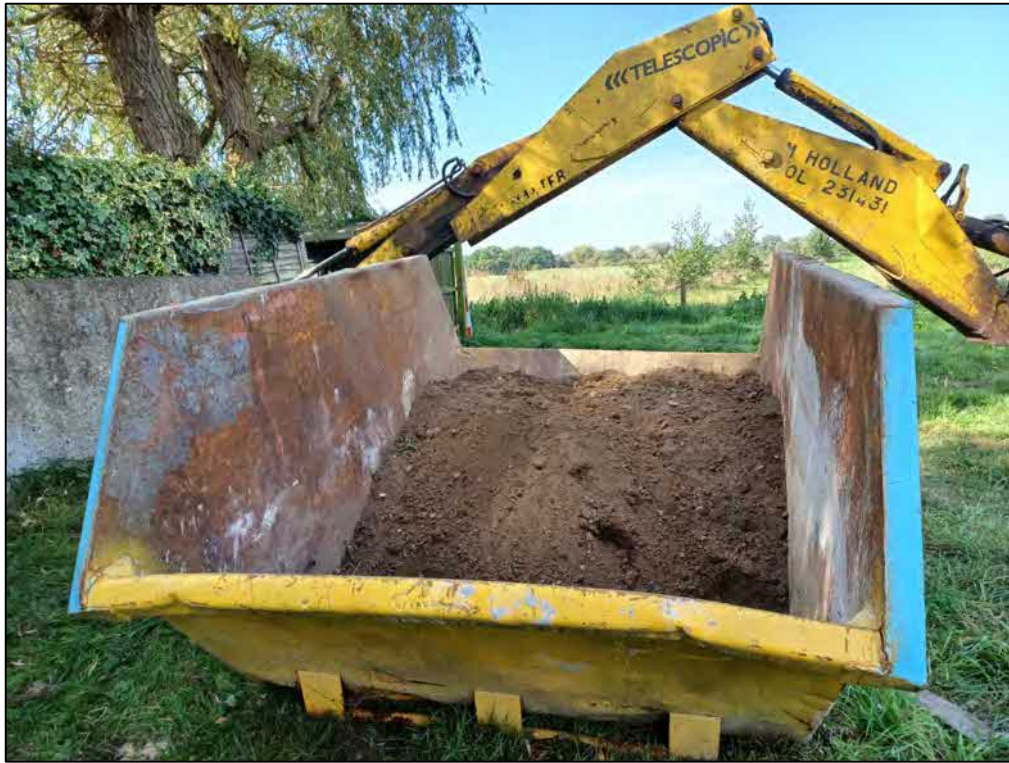
Photographs of the excavated area.

- 2.2 Mr Martin Holland carried out the remedial works on 15 September 2023, which involved the removal of Made Ground in the area of TP4. The excavation measured 0.75m x 1.5m and extended to a depth of 0.3m bgl when natural ground encountered. Photographs of the remedial works are included as Appendix A of this report.

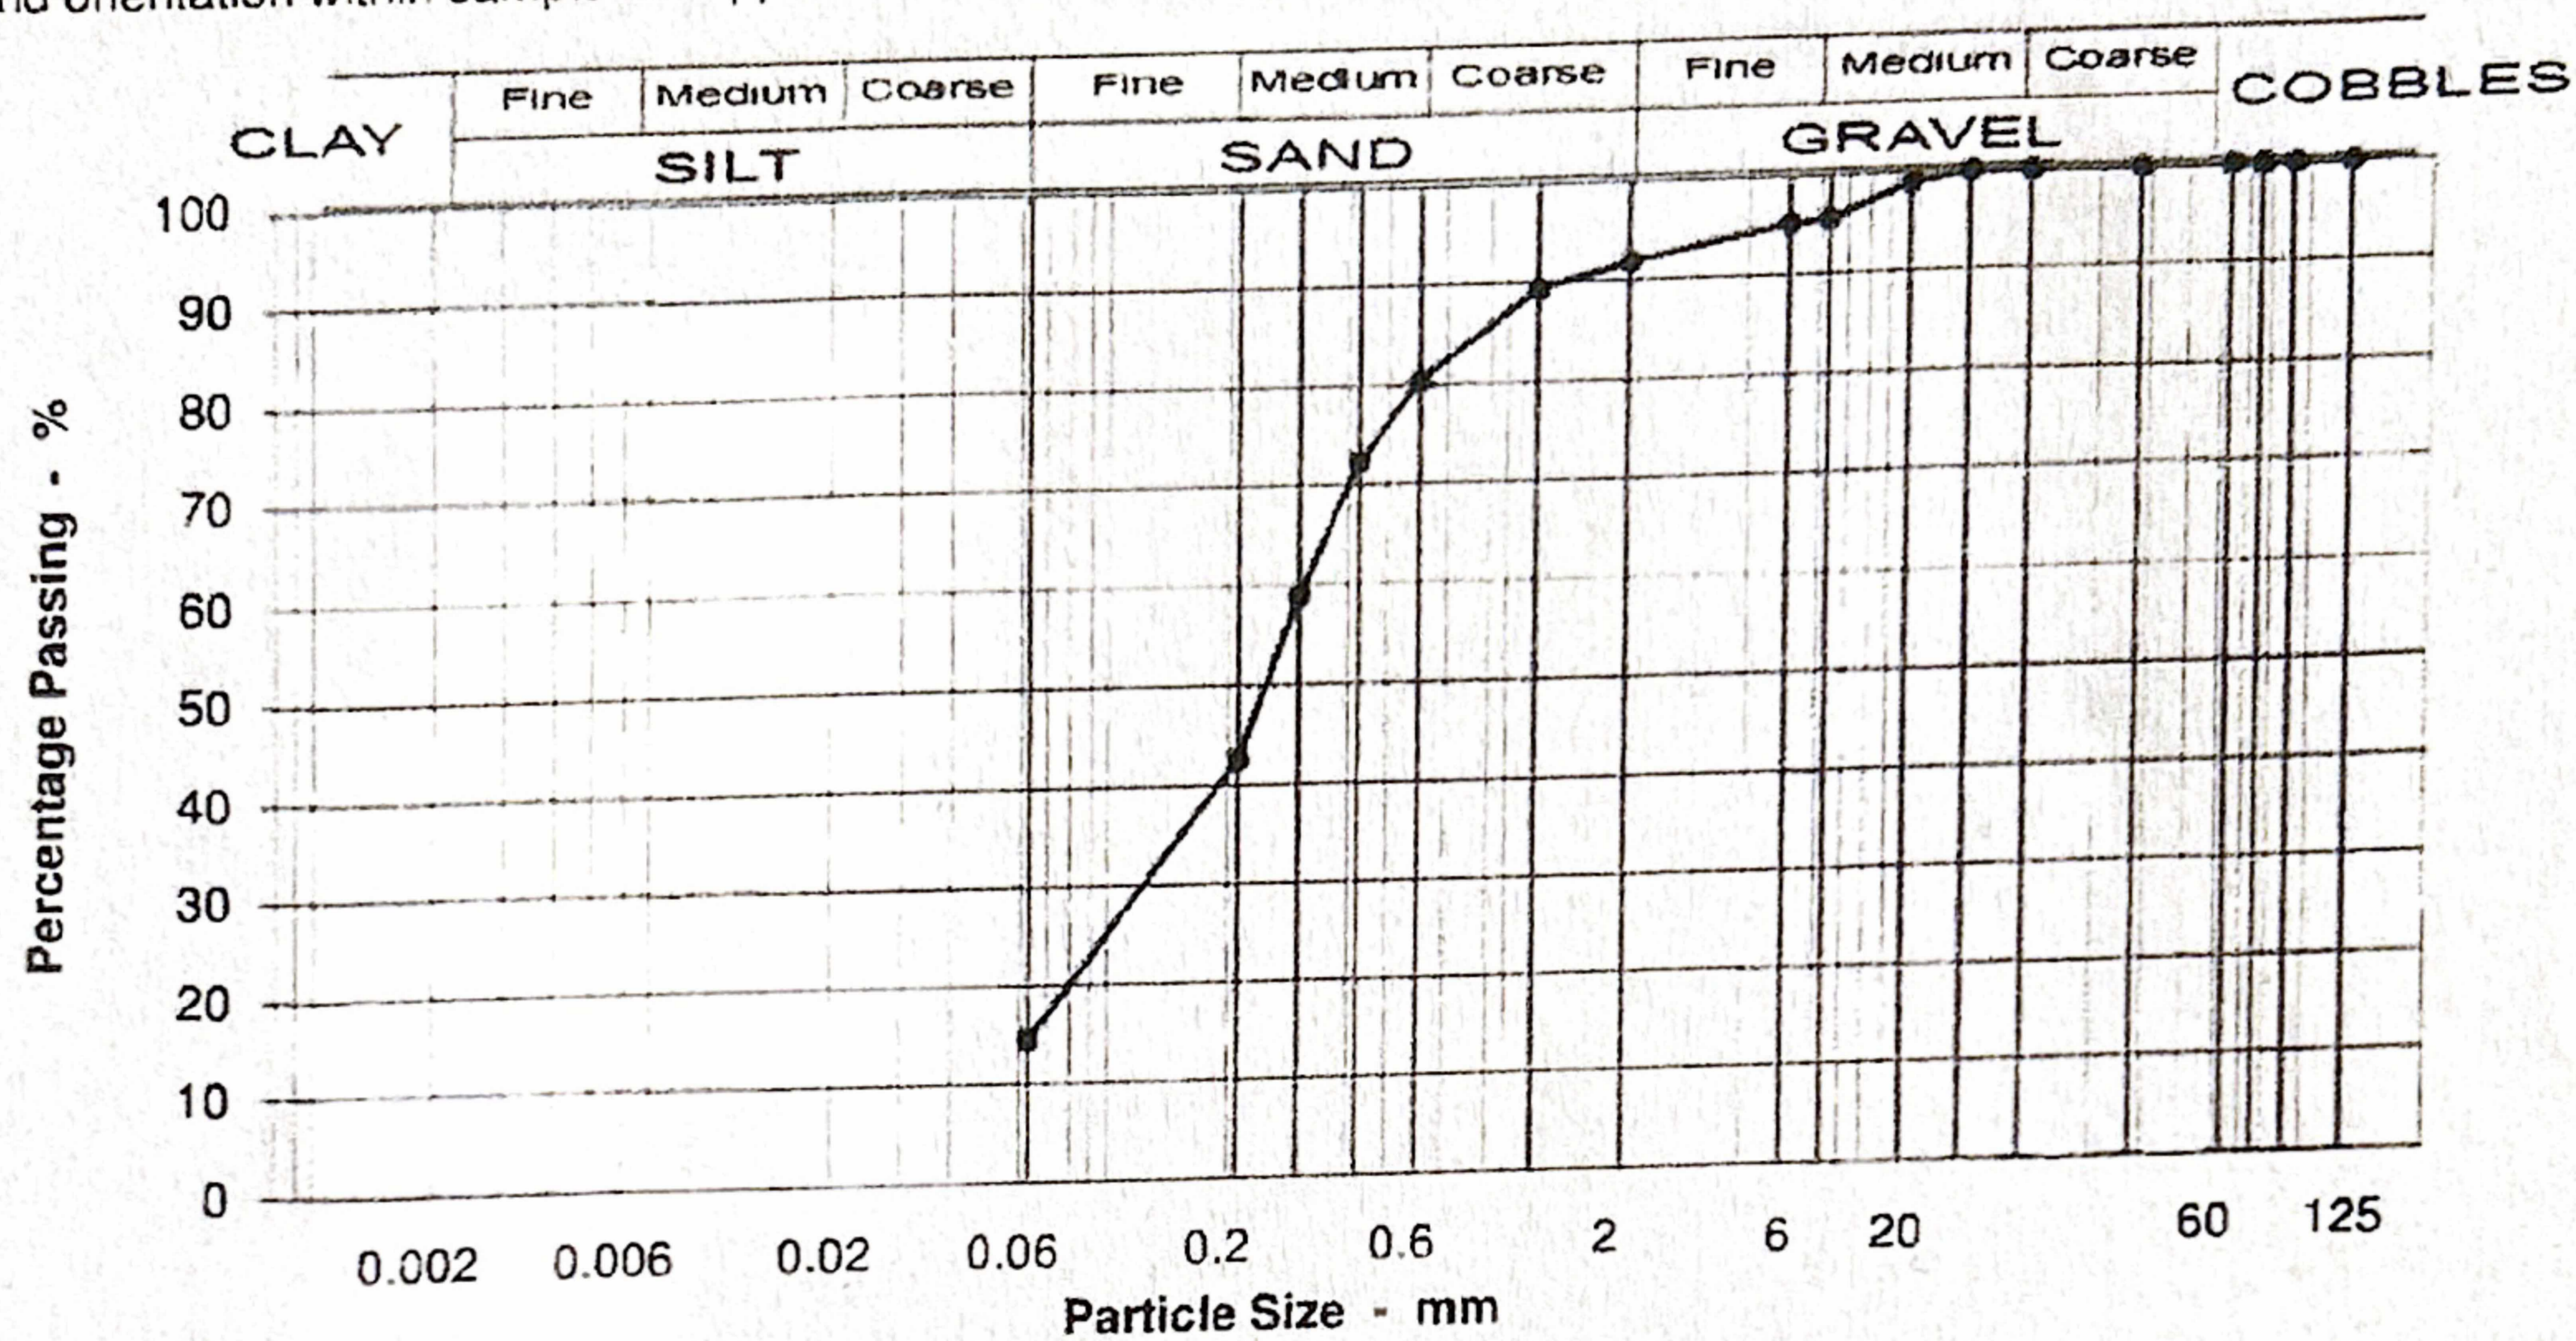
Particle Size Distribution to BS 1377 : Part 2 :1990 Section 9

Sieving	
Particle Size mm	% Passing
125	100
90	100
75	100
63	100
37.5	100
20	100
14	100
10	99
6.3	96
5	95
2	92
1.18	89
0.600	81
0.425	72
0.300	59
0.212	43
0.063	15

Sample Proportions	
BOULDERS	0
COBBLES	0
Coarse GRAVEL	0
Medium GRAVEL	4
Fine GRAVEL	4
Coarse SAND	11
Medium SAND	38
Fine SAND	28
Silt & Clay	15

Grading Analysis	
D100	10
D60	0.31
D10	0.05
Uniformity Coefficient	6

Description	
Brown slightly silty fine medium and coarse SAND.

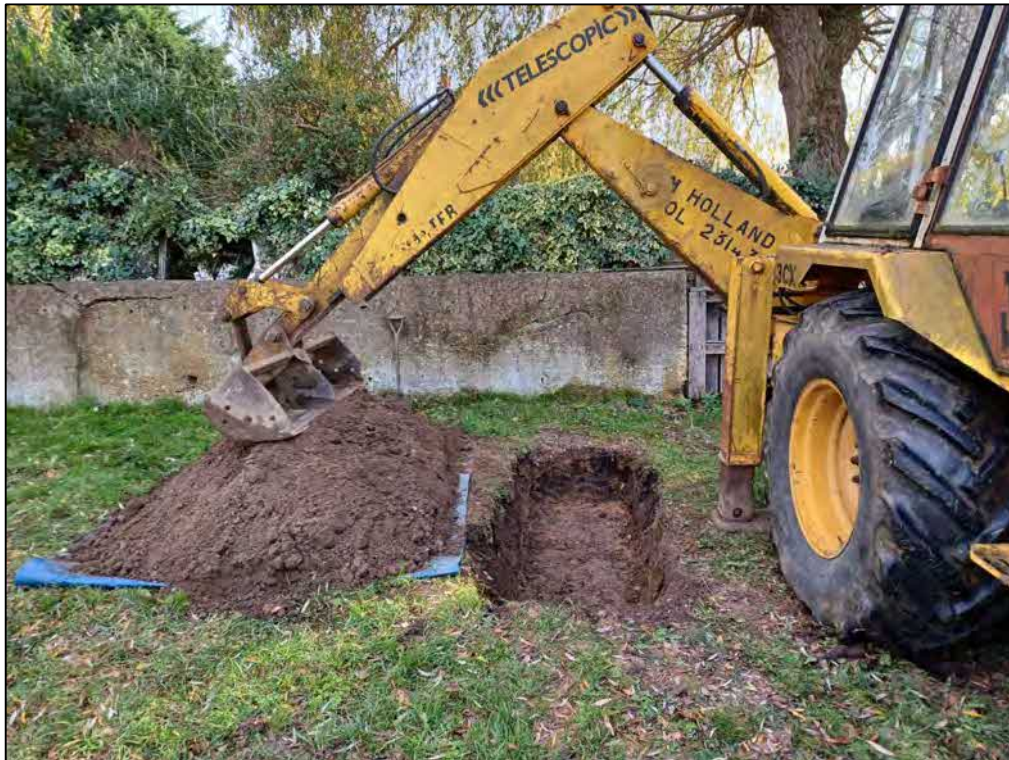
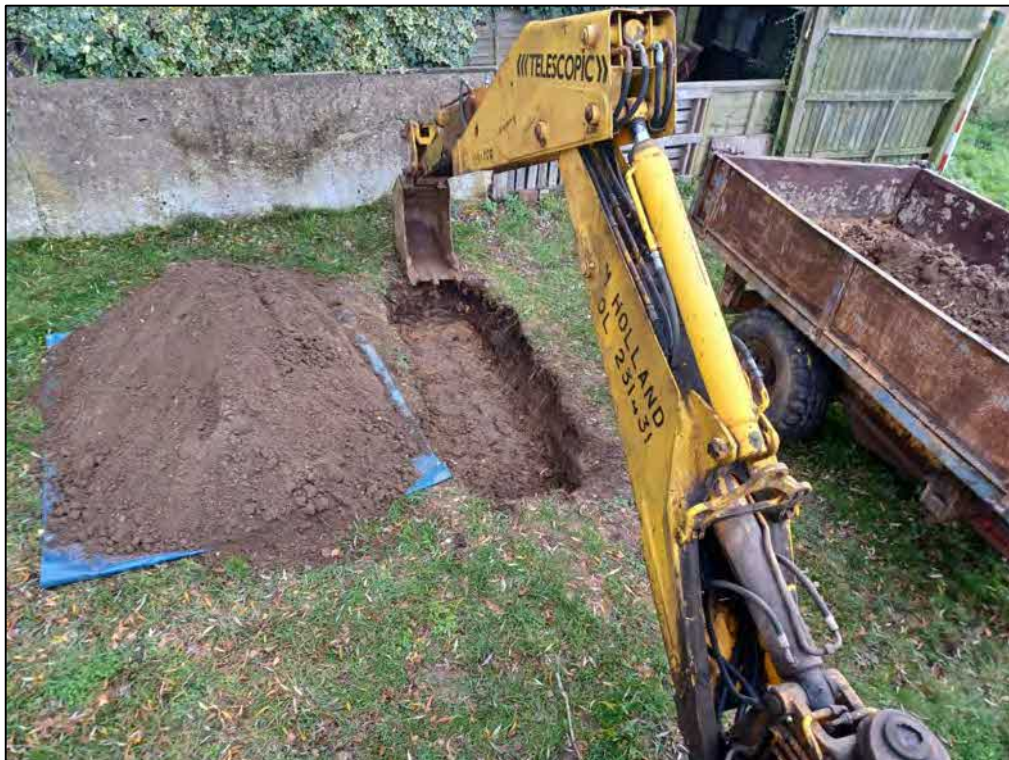
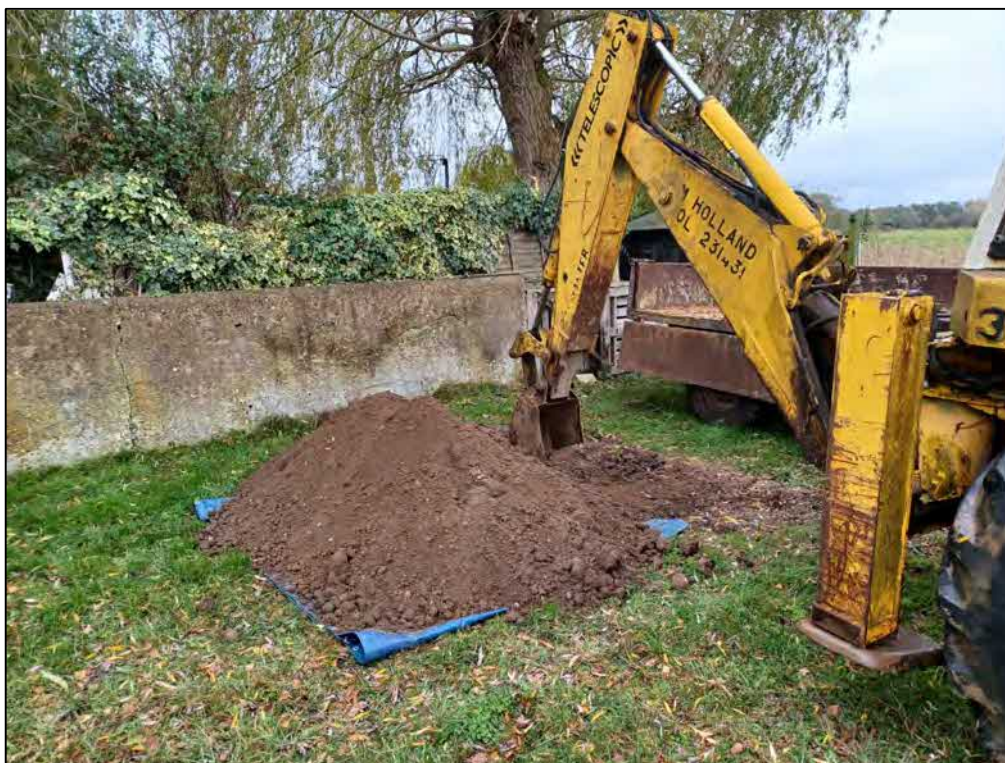
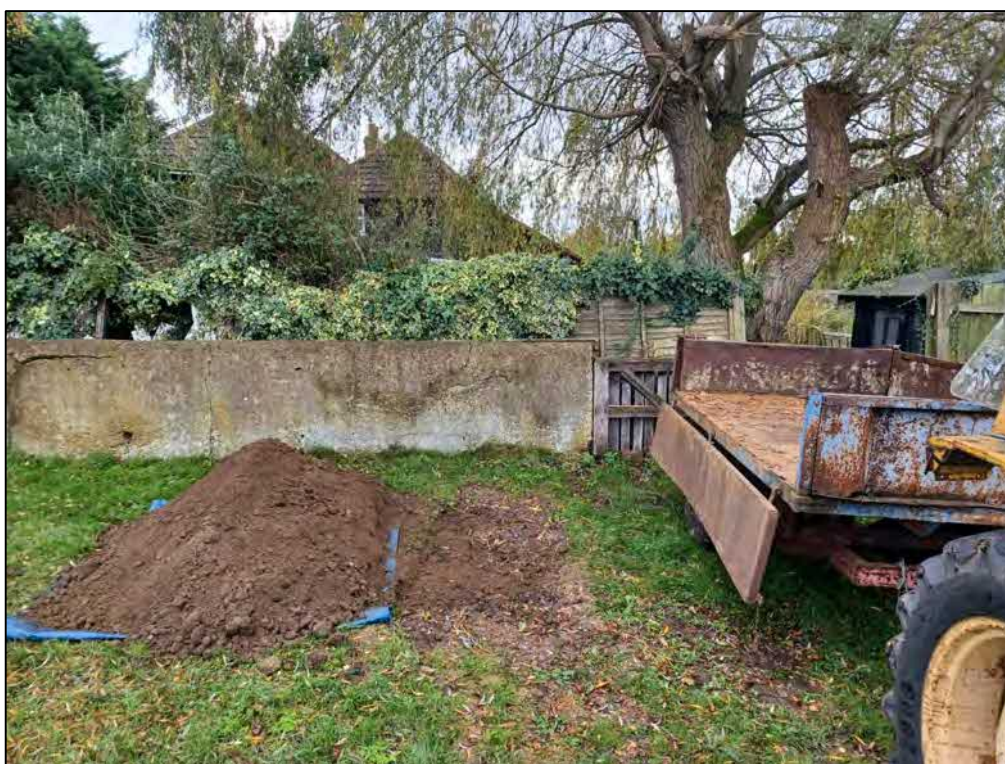
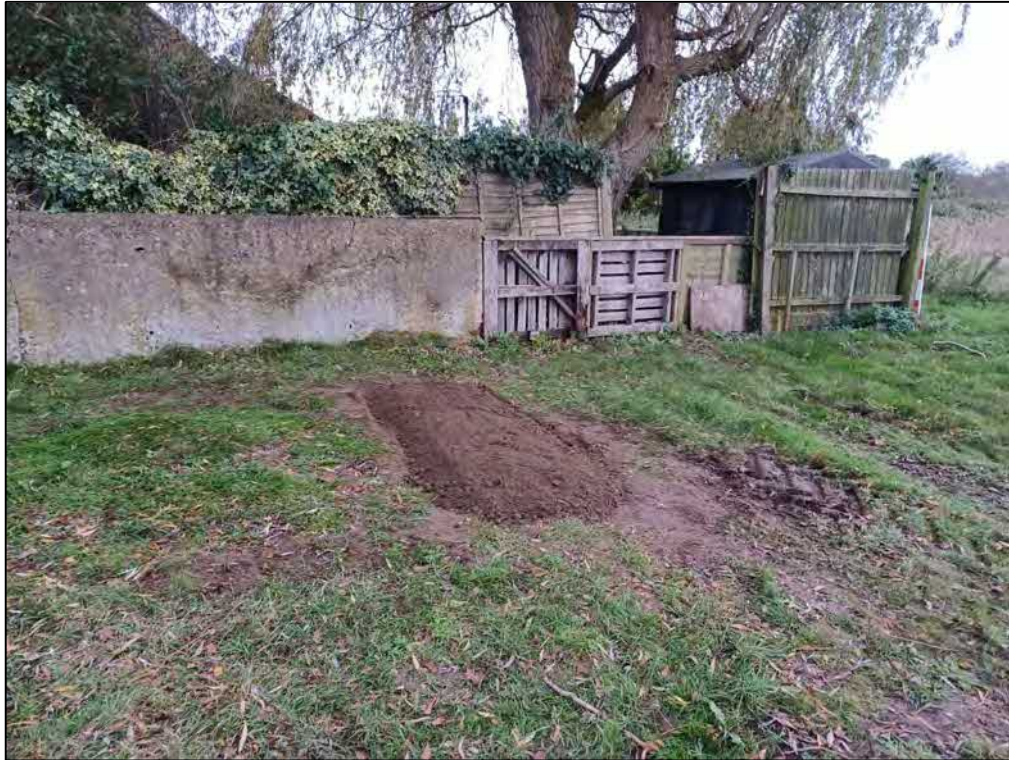
Appendix C – Photographs showing the backfilling of the excavated area with imported clean soil that was placed on the tarpaulin to the left of the area.

- 3.1 Following recommendations as a result of the Phase 1 Desk Study and Ground Investigation Reports prepared by Sue Slaven, contaminated material within one area of the site was excavated by Mr Martin Holland and disposed of off-site by CSH Environmental Limited. A total of 600kg of contaminated soil was disposed of at a landfill site in Kings Cliffe operated by Augean. The excavation was subsequently backfilled with 1,000kg of imported clean soil.
