GUIDE POST FARM
ARDLEIGH

REPORT ON
GROUND INVESTIGATION

August 2023
Report No. P0355/R01 Issue 1

Prepared for:
Mr G Milleare

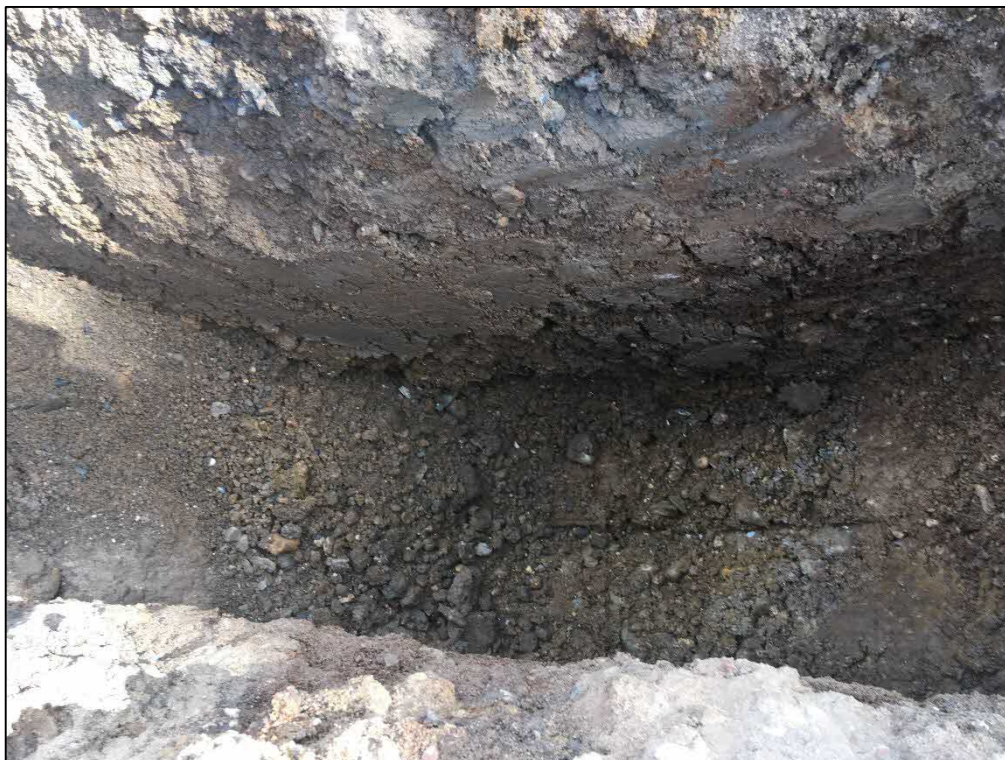
Photograph 1: TP1.

- 3.3.2 Ground cover at three locations, TP1 – TP3, comprised hardcore of crushed concrete and brick, within the footprint of the proposed dwelling. The Made Ground at locations TP1 and TP2 consisted of dark brown gravelly sand / sandy gravel with occasional brick and concrete. This was subsequently underlain by dark brown / reddish brown / light brown gravelly sand. At TP3, beneath the surface cover of hardcore, the ground consisted of gravelly sand.

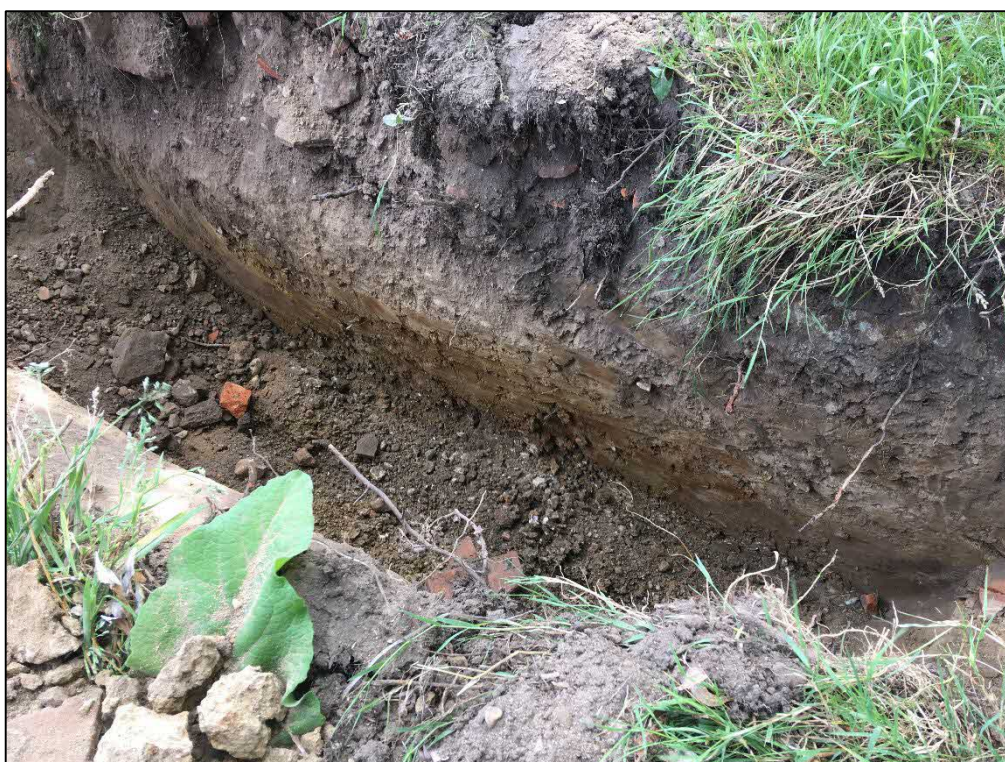
Photograph 8: TP4.

- 3.3.3 Ground cover at TP4 and TP5 comprised grass, which is proposed as the garden at the new dwelling. The Made Ground at these locations comprised dark brown silty sand soil with bricks, brick fragments, roof tile fragments, clay pots, etc. Beneath the Made Ground was reddish brown / light brown gravelly sand.

5.2.4 PAHs (benzo(b)fluoranthene and dibenzo(ah)anthracene) were identified at concentrations in excess of the relevant GAC at one location, TP4, which was excavated within the proposed garden.

5.2.5 Asbestos was searched for within the soil samples and was detected as loose fibres of chrysotile within one sample collected from TP4.

Removal of the Made Ground from the proposed garden area.

Provision of a suitable capping layer (i.e. 600mm of clean subsoil/topsoil) that may consist of imported material to provide a suitable medium for plant growth.

A watching brief for asbestos containing materials within the ground should be maintained and if encountered, should be removed from site and disposed of at an appropriately licensed waste management facility;

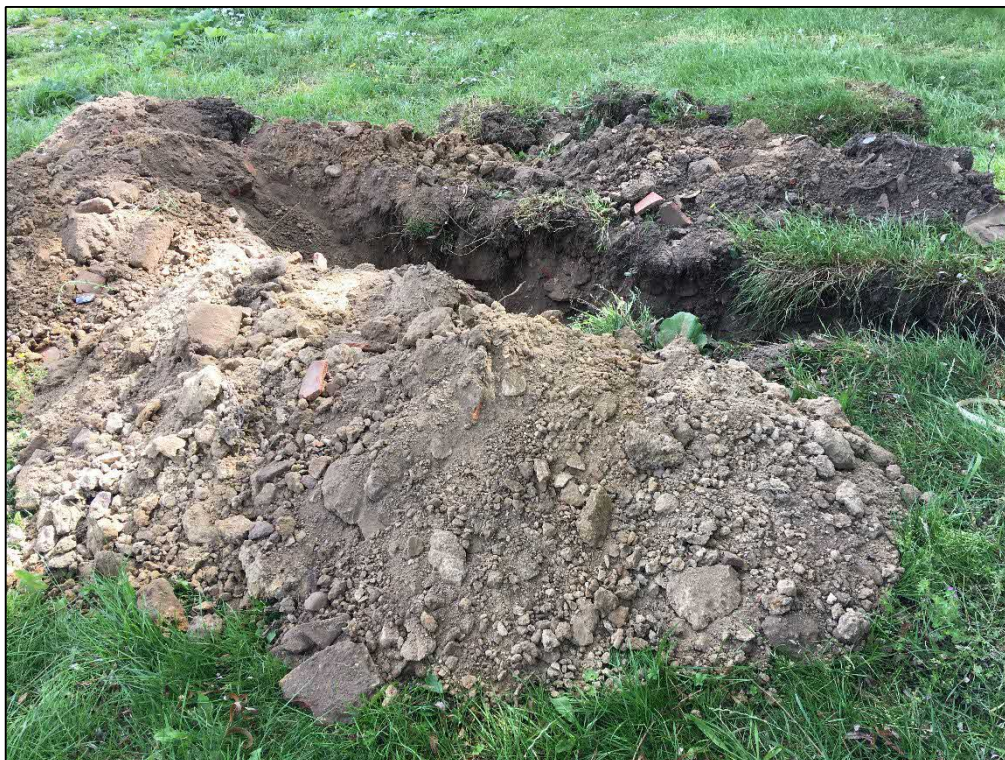
Photograph 9: Arisings from TP4.

5.3.4 Asbestos was also detected within one sample (TP4) and was identified as chrysotile (white asbestos) as loose fibres. Chrysotile was one of the main asbestos types to be used until its import ban in 1999. This indicates that there is a risk to human health, including future site occupiers and construction workers, from asbestos in the ground. The principal pathway is inhalation of airborne fibres, the release of which can occur through ground disturbance either during site development or site use, e.g. gardening or children playing.
