# Butler Ecology

**BAT & NESTING BIRD SURVEY  
15, TREVERBYN ROAD**

**PADSTOW  
PL28 8DW**

**17<sup>th</sup> October 2023**

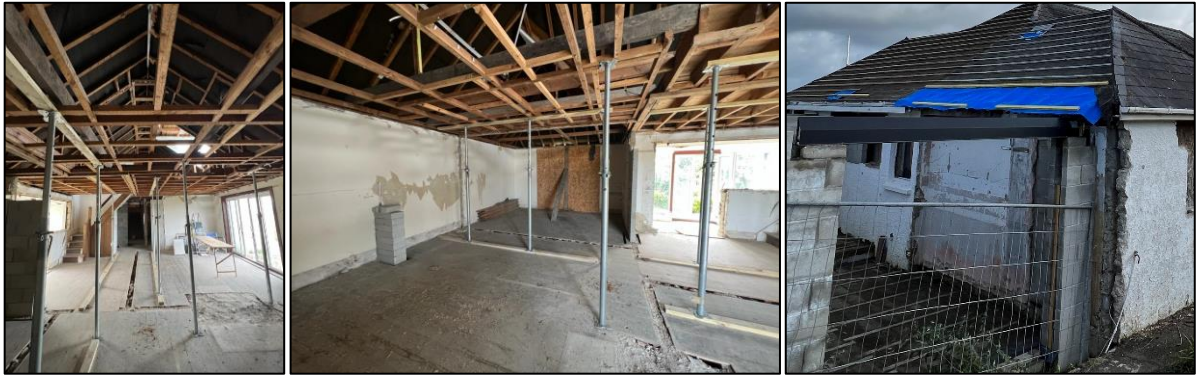
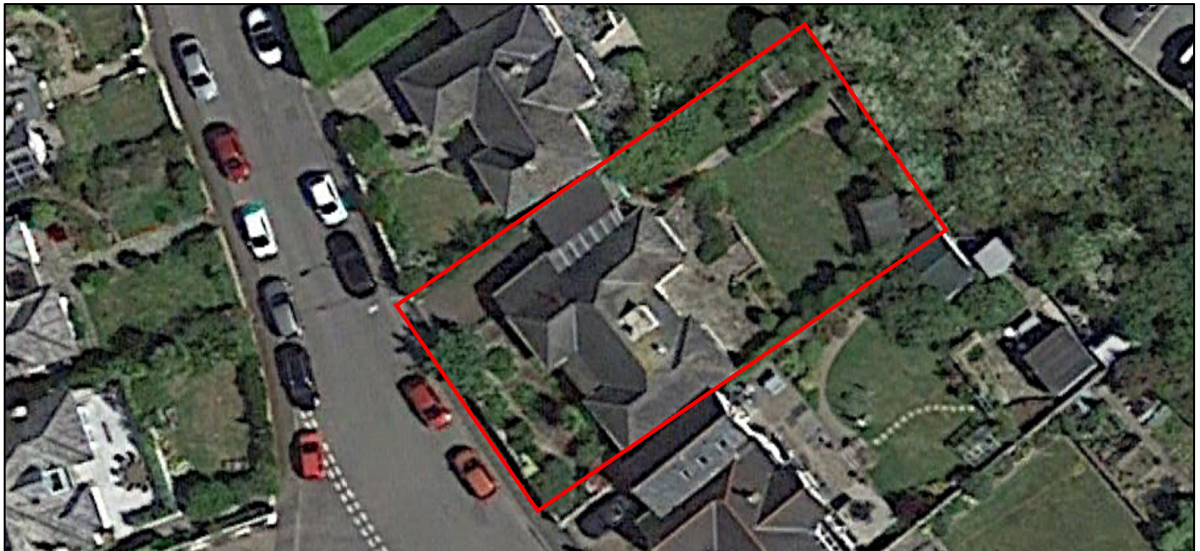
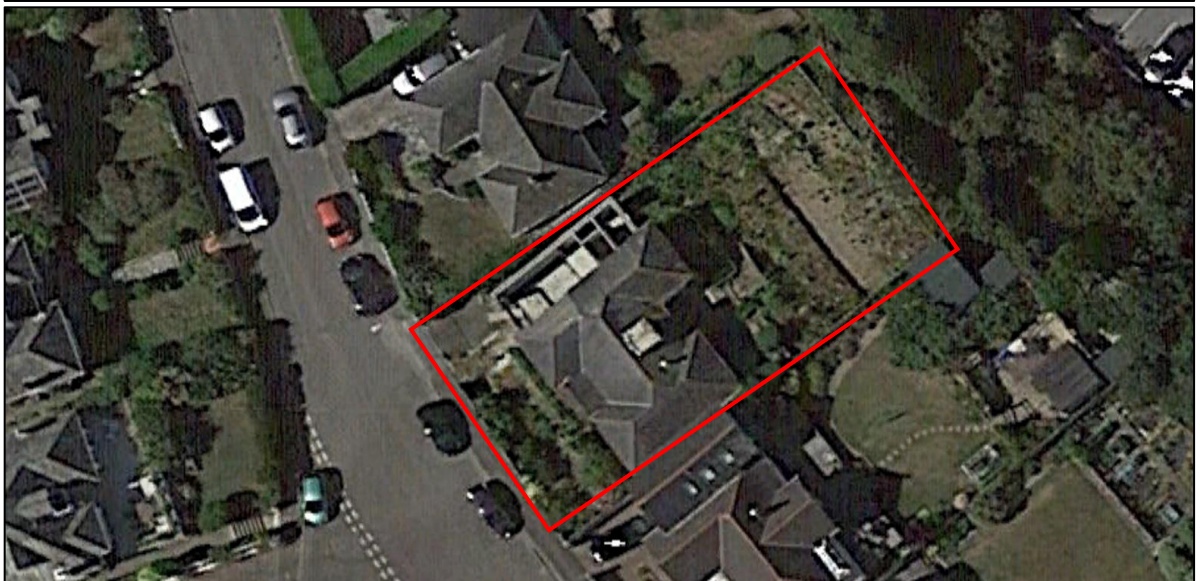
**2020:** The detached single-storey bungalow sits towards the front of the plot with an area of lawn to the rear. It is built of rendered / pebble-dashed brick with a pitched slate roof hipped at both ends and with hip-roofed extensions at the front and rear (two at the front and two at the back), and a flat-roofed dormer in the middle of the rear pitch. The central part of the original loft has been converted to living space, with a vaulted ceiling. There is a flat-roofed garage on the north-west side of the bungalow, with a covered walkway linking the buildings.

**2023:** Following planning consent in 2020 some works were initiated (e.g. demolishing the garage, stripping out the ceilings, removing some window frames, removing part of the roof covering).

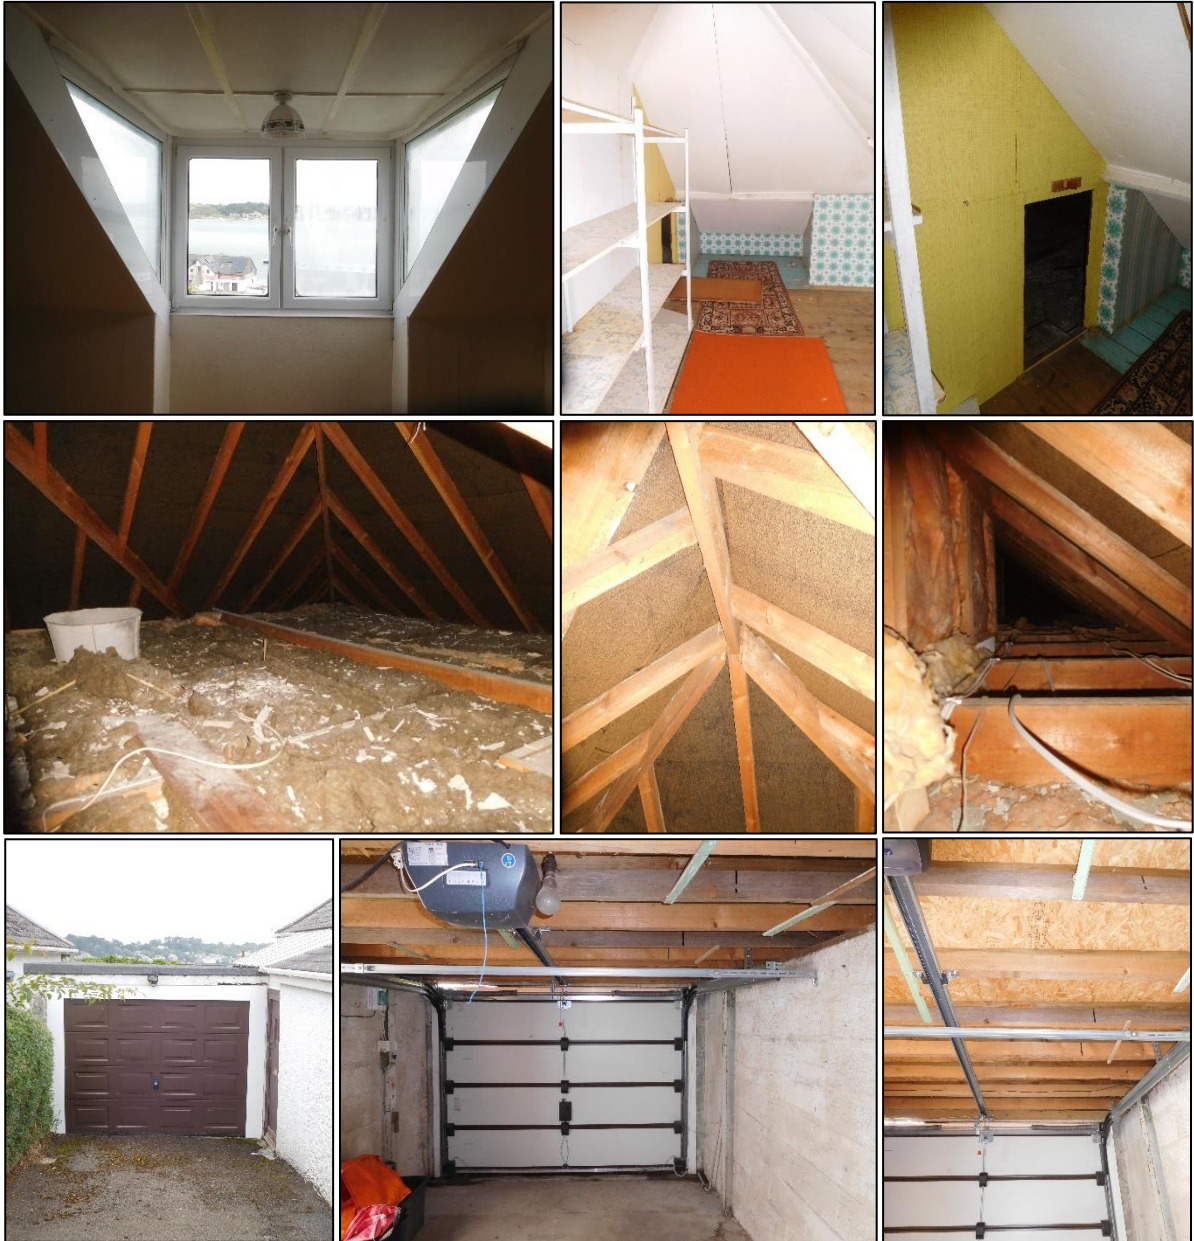
- **2020:** No bats or signs of bat activity (e.g. droppings and /or feeding remains) were found in the roof voids of the bungalow (the main original loft area has been converted, leaving eaves voids and voids under the hipped dormers at front and back).

- The presence of bats was originally assessed to be highly unlikely. Following works to the inside and outside of the house (in 2020), the building is unfavourable for roosting bats.
- The demolition and replacement of the bungalow **would not cause disturbance to bats** (as defined), **would not result in the loss of / disturbance / obstruction to any roosts**, **would not affect the distribution or abundance of local populations of bats**, and **would not affect any potential commuting routes**.

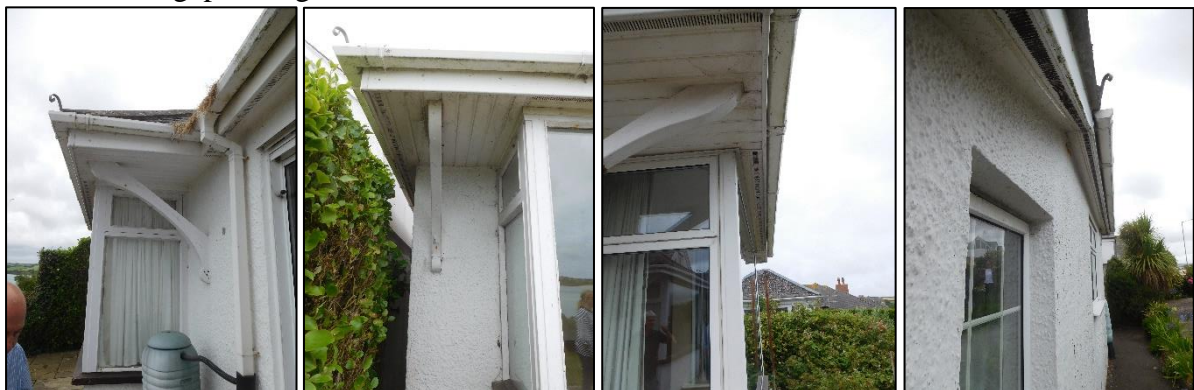
- No suitable gaps (for crevice-dwelling bats) were detected around the outside of the building. There are no gaps along the eaves.

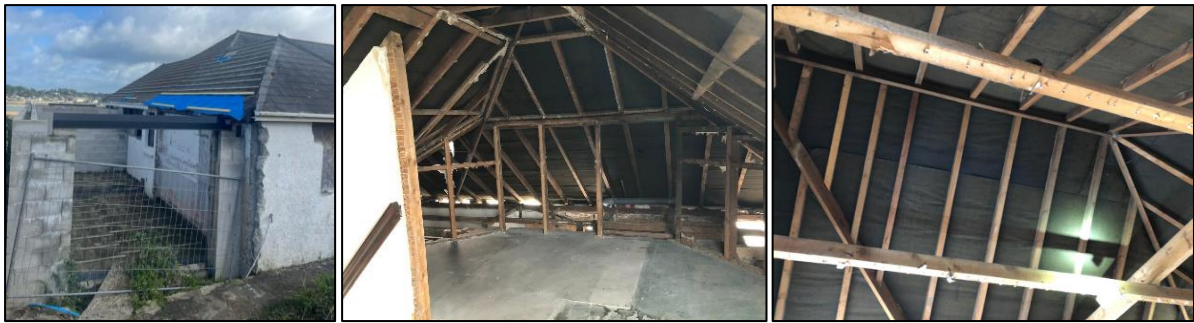
- **2023:** No bats or signs of bat activity (e.g. droppings and /or feeding remains) were found in the bungalow or around the outside of the building.

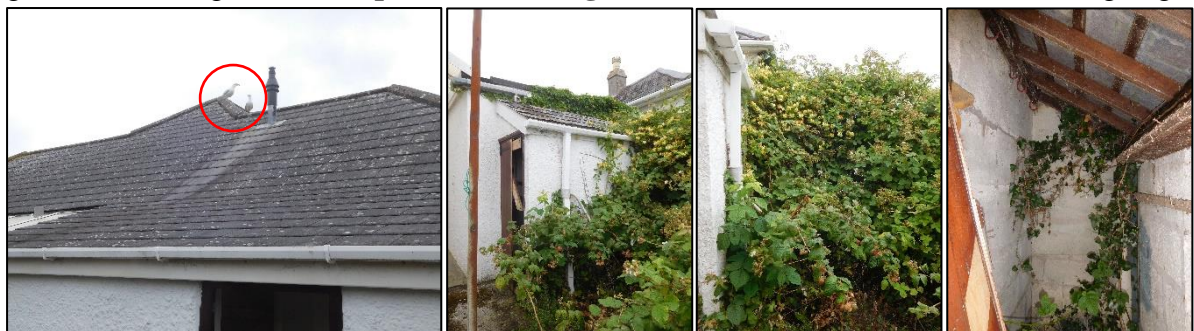
- **2020:** There was evidence that seagulls had nested on the roof and raised a chick (which was grounded in the garden), and **potential nesting habitat** was noted at the east end of the garage.

- Potentially disturbing works should be timed to avoid disturbance to nesting birds (i.e. carried out outside the nesting season, between late August and March).
- If potentially disturbing works have to be carried out during the nesting season then a **pre-works survey** must be carried out by the ecologist no more than 24 hours before works start.
- If evidence of active nesting is observed, then potentially disturbing works must be postponed until all fledglings have left the nest(s).
- Once plans for the new house have been drawn up, these should be reviewed by the ecologist to determine what bird boxes might be appropriate.

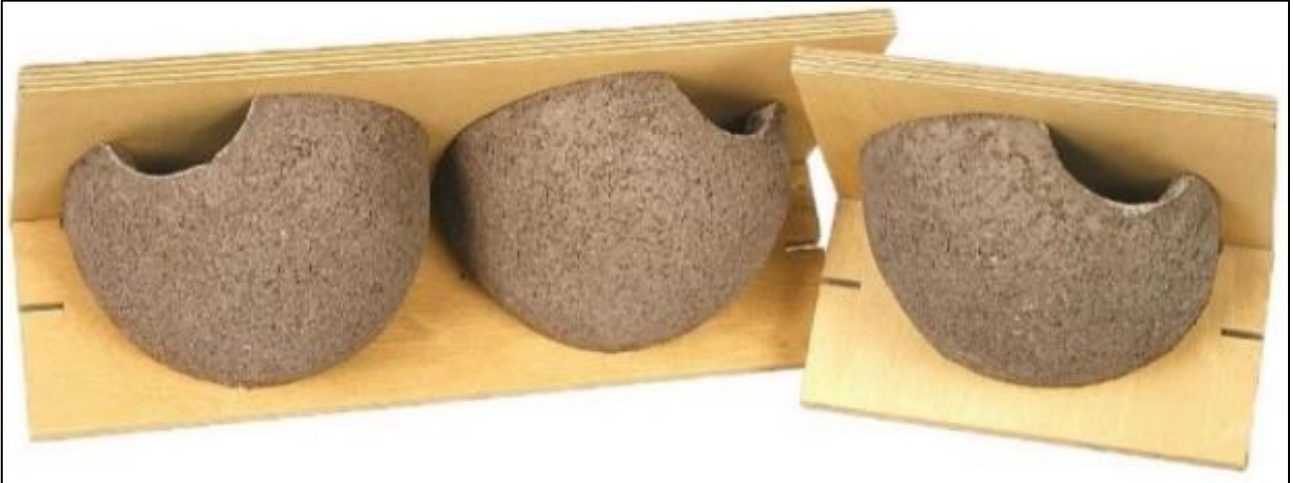
### APPENDIX 3: HOUSE MARTIN NEST CUPS

House Martins build nests constructed from mud under the eaves of buildings often in colonies averaging five nests. Changes to house construction and roof design mean that suitable nest sites have dramatically declined. Providing an artificial nest provides a great alternative and house martins will readily use artificial nests and encourage other birds to nest nearby. These nests have been specially designed to appeal to house martins and are constructed from exterior grade plywood and WoodStone, a mixture of FSC wood fibres and concrete. The backing to the nests is exterior grade plywood, making them lightweight and easy to fit, but hard-wearing. These nests should be sited underneath the eaves on exterior walls of your house, at a minimum height of 2m above the ground. The nests are available in single units, with either a right-hand or left-hand entrance or as a double unit with two nests side by side.

**Specifications: Single nest:** Dimensions (H) 115 x (W) 200 x (D) 160mm, weight: 900g. Material: Exterior grade plywood and WoodStone. **Double Nest:** Dimensions (H) 115 x (W) 380 x (D) 160mm, weight 1.8kg. Material: Exterior grade plywood and WoodStone
