ECOLOGICAL ASSESSMENT REPORT

17th July 2023

Martinique Farm, East Martin,
Fordingbridge, Hampshire SP6 3JS

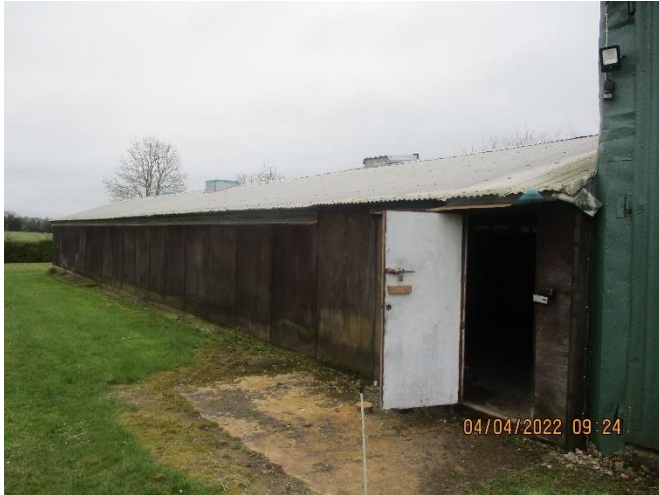
Photo 1: East elevation of 'B1'.

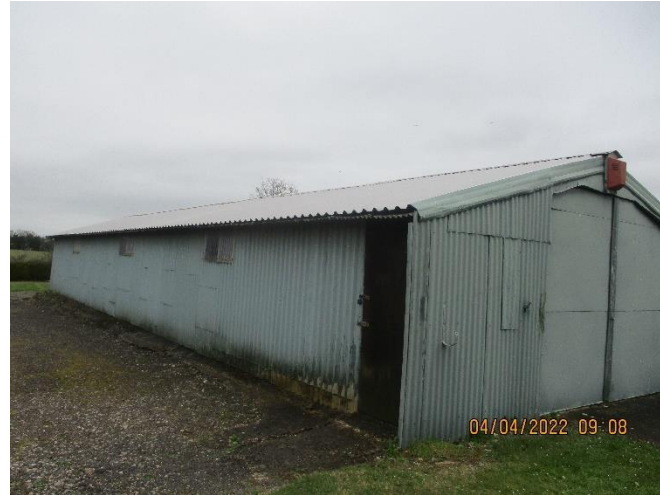
Photo 2: East elevation of 'B2'.

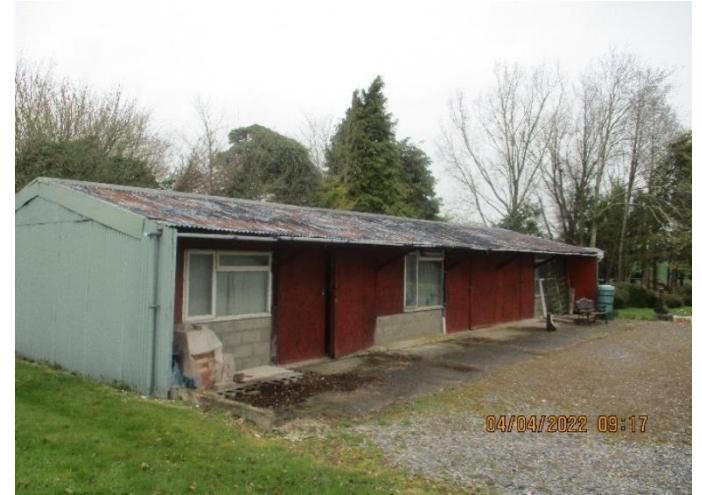
Photo 3: East elevation of 'B3'.

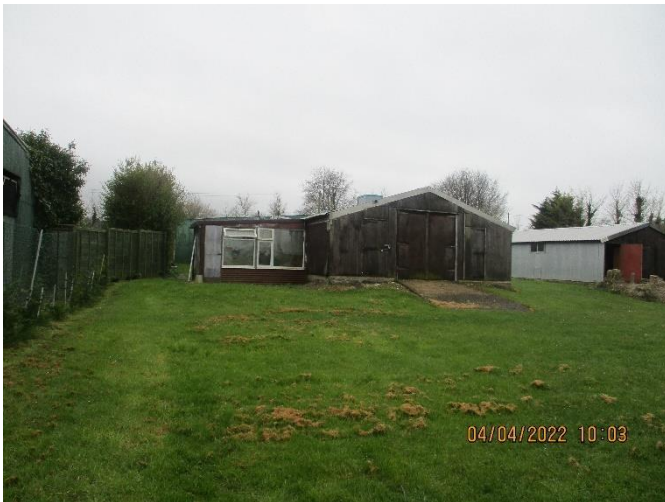
Photo 4: North elevation of 'B1'.

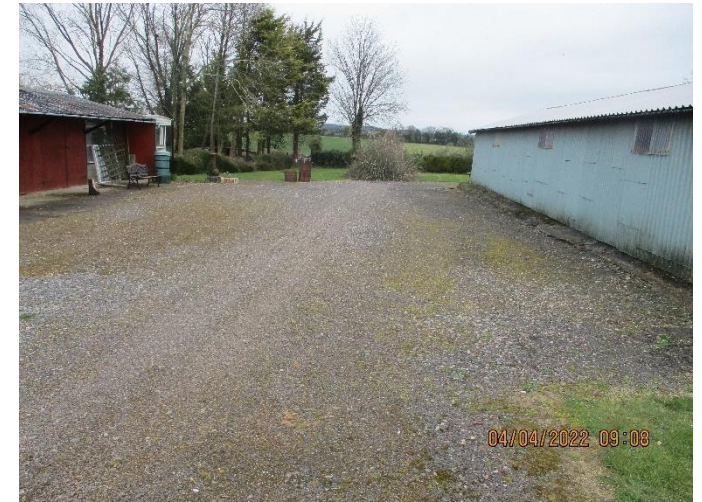
Photo 5: West elevation of 'B4'.

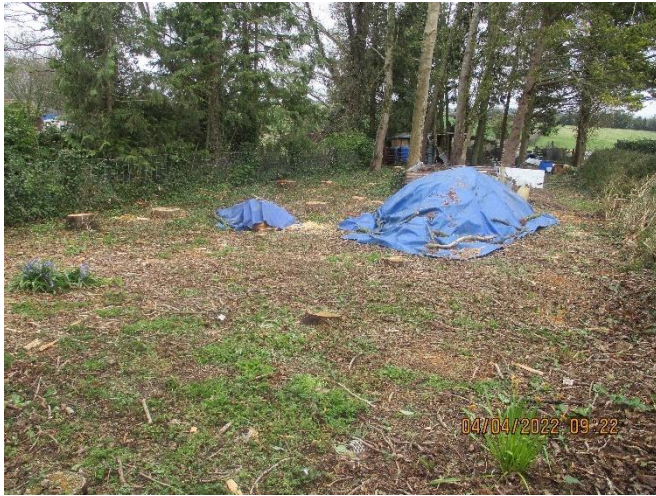
Photo 6: Hard standing between 'B2' and 'B3'.

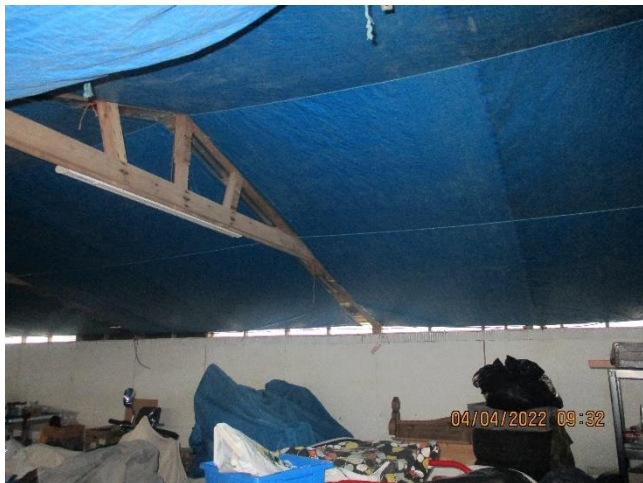
“Barn 1’ - The internal space is split into three storage areas and is boarded throughout but has no insulation. Multiple gaps were evident. No evidence of use by birds was observed in any of the three sections. From NE to SW; in the first section ~6 droppings of a small bat, most likely pipistrelle sp., were observed; in the second section no evidence of bats was observed; in the third section ~3 droppings of a small bat, most likely pipistrelle sp., were observed.”

Photo 13: Interior of 'B1'.

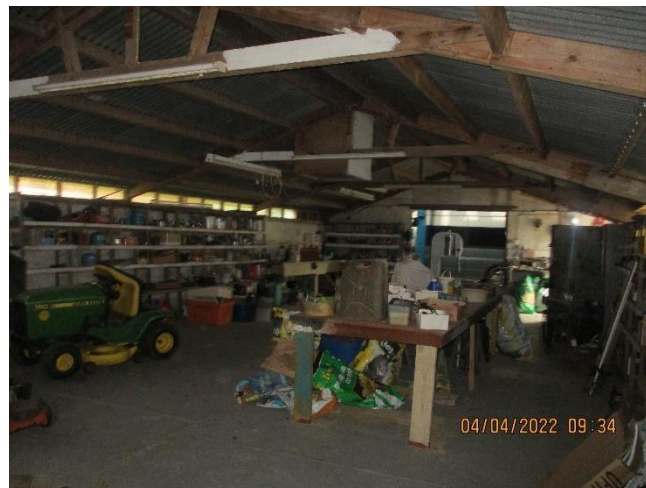
Photo 14: Interior of 'B1'.

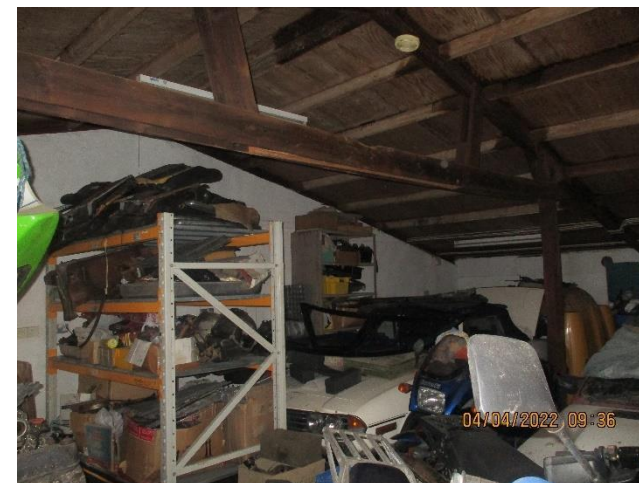
“Barn 3’ – The internal space is single skin corrugated iron with no boarding or insulation. ~2 droppings of a small bat, most likely pipistrelle sp., were observed.”

Photo 15: Interior of 'B3'.

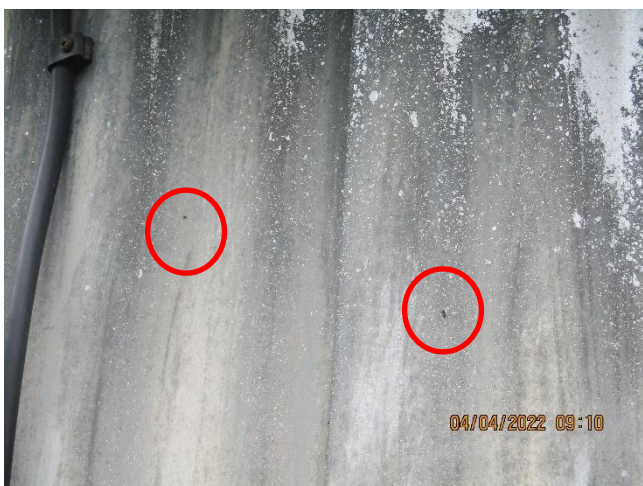
“Barn 2’ – The building is a single skin of corrugated iron overlaying wooden panelled walls with an asbestos roof overlain with corrugated iron. ~6 bat dropping were observed on the corrugated iron wall panelling on the SE side of the building.”

Photo 16: Bat droppings on external of 'B2'.

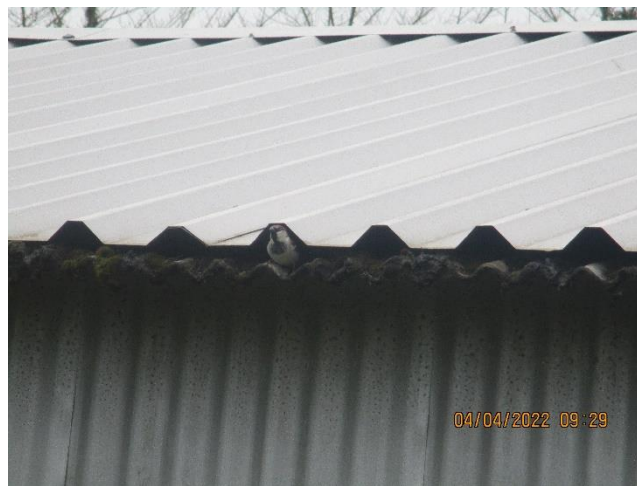
Photo 17: House sparrows nesting in 'B2'.

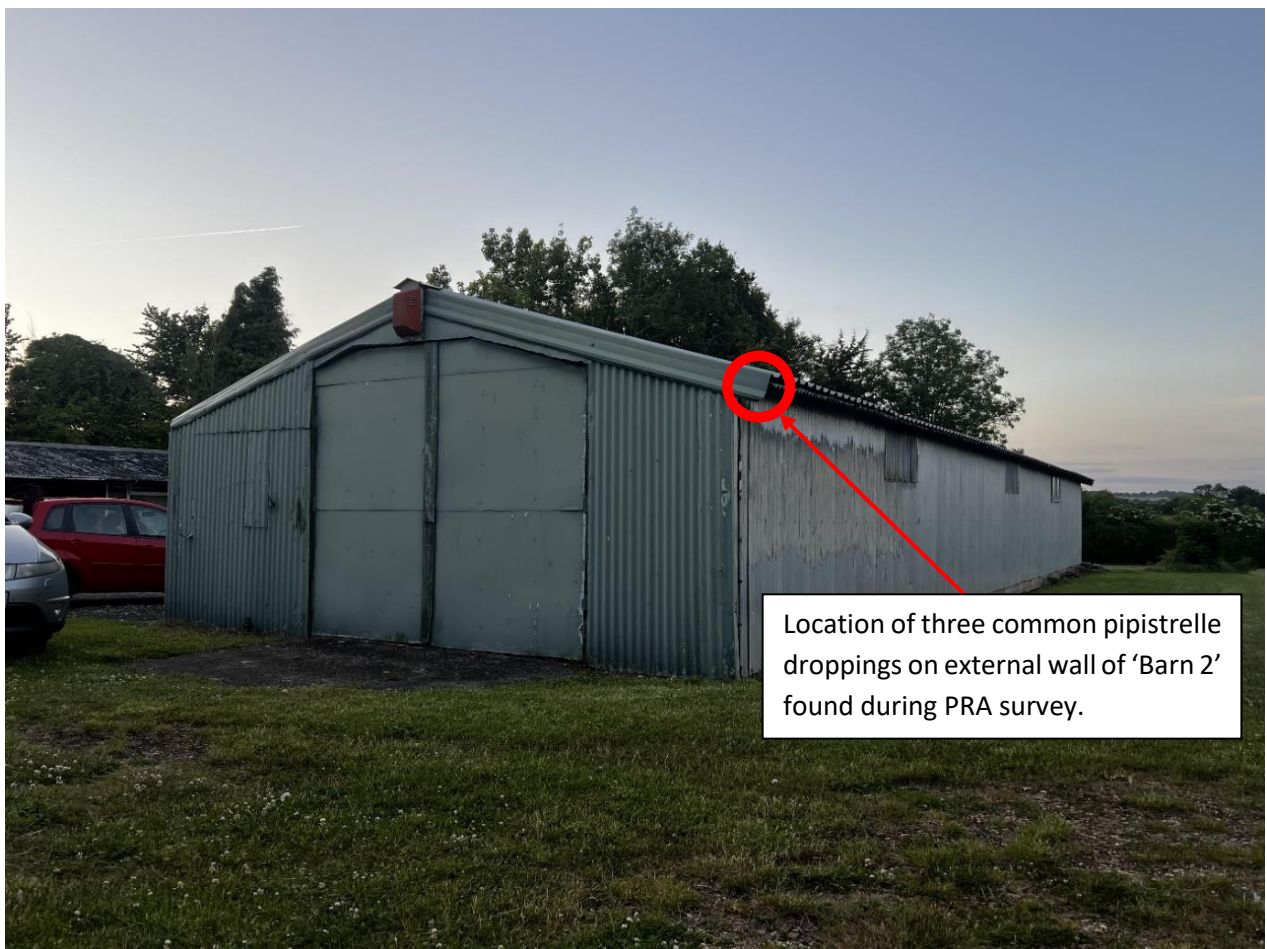
22:11	Serotine	1	Commuted west to east over 'Barn 2' towards hedgerow.

22:14	Serotine	2	Commutated southwest to northeast between 'Barn 2' and 'Barn 3'.
22:15	Common pipistrelle	1	Heard not seen in the south.
22:29	Serotine	1	Heard not seen in the north.
22:31	Serotine	1	Commutated west to east over 'Barn 2' towards treeline.
22:34	Serotine	1	Heard not seen in the north.
22:37	Soprano pipistrelle	1	Heard not seen in the north.
22:41	Serotine	1	Heard not seen in the north.
22:47	Common pipistrelle	1	Heard not seen in the north.

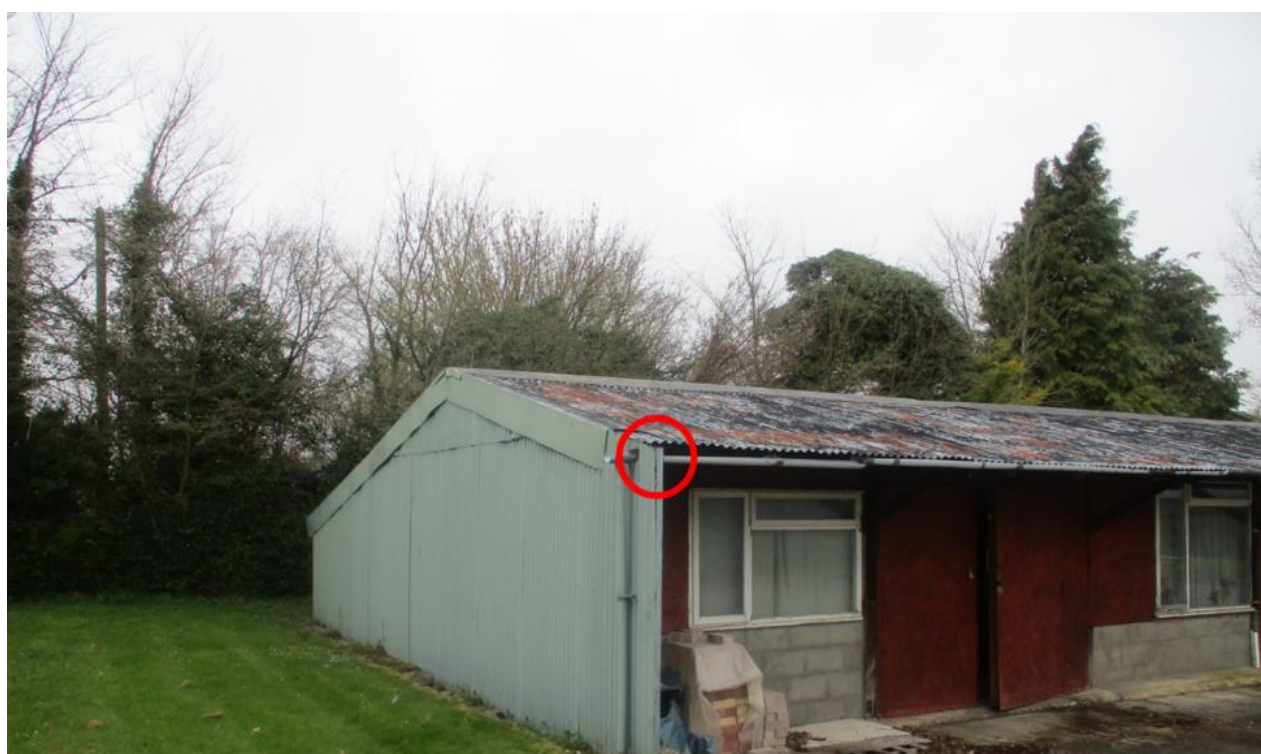
11th July 2022- Dawn re-entry survey ('Barn 1')

04:21	Common pipistrelle	1	Committed over 'Barn 2' from southwest and circled around.
04:23	Common pipistrelle	1	Re-entered the southeast of 'Barn 2' at the eaves (see red circle in image below).
04:24	Common pipistrelle	2	Circling the north end of the building.
04:30	Common pipistrelle	1	Committed from southwest to north behind me.
04:31	Common pipistrelle	1	Re-entered at southern elevation of 'Barn 2' under the eaves (see red circle in image below).

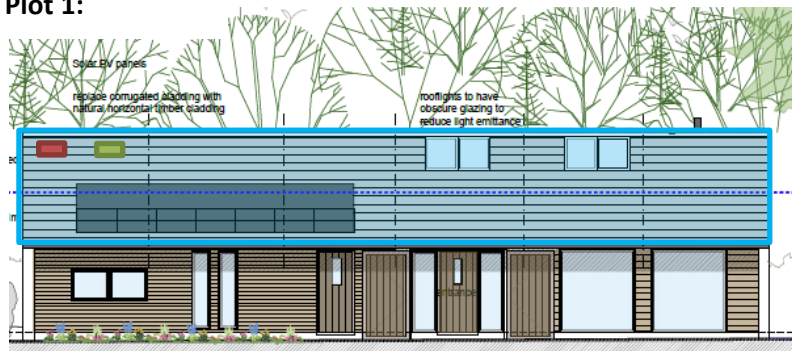
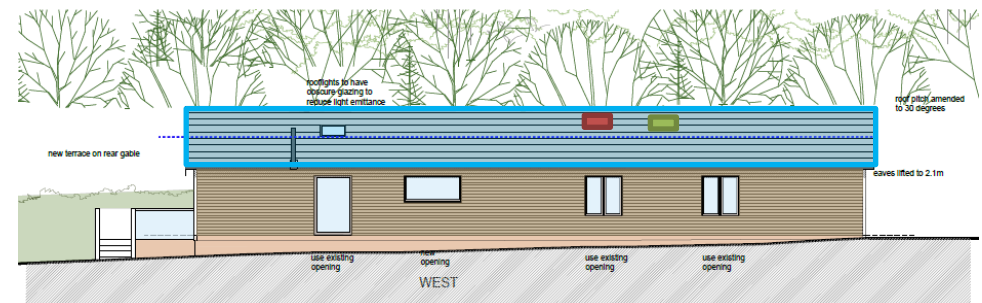
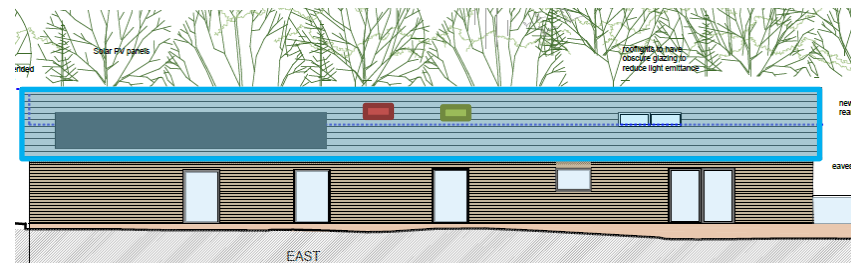
Figure 1: Raised bat access tile design

The new roofs of all the new dwellings (Plots 1-3) **must be lined exclusively with bituminous 1F type roofing felt; Breathable Roofing Membranes (BRMs) are non-woven and are NOT suitable for roosting bats.**

- **The new roofs of all the new dwellings must be lined exclusively with bituminous 1F type roofing felt; Breathable Roofing Membranes (BRMs) are non-woven and are NOT suitable for roosting bats**, this is due to loose fibres 'fluffing up' over time and resulting in entrapment/injury and eventual death of roosting bats (Waring *et al.*, 2011). Natural England licences will be granted where breathable membranes will be used.

- No lighting will be erected within 5m of the replacement access tiles. Any proposed external lighting within the site will be motion triggered and directed away from the roof and hooded/cowled towards the ground (see below for full lighting strategy).
