# Detailed Unexploded Ordnance (UXO) Threat & Risk Assessment

Meeting the requirements of *CIRIA C681* 'Unexploded Ordnance (UXO) A guide for the Construction Industry' Risk Management Framework

The Client has defined the Study Site as “Avon Street, Bristol, BS2”. The Site is located at NGR 359956, 172551.

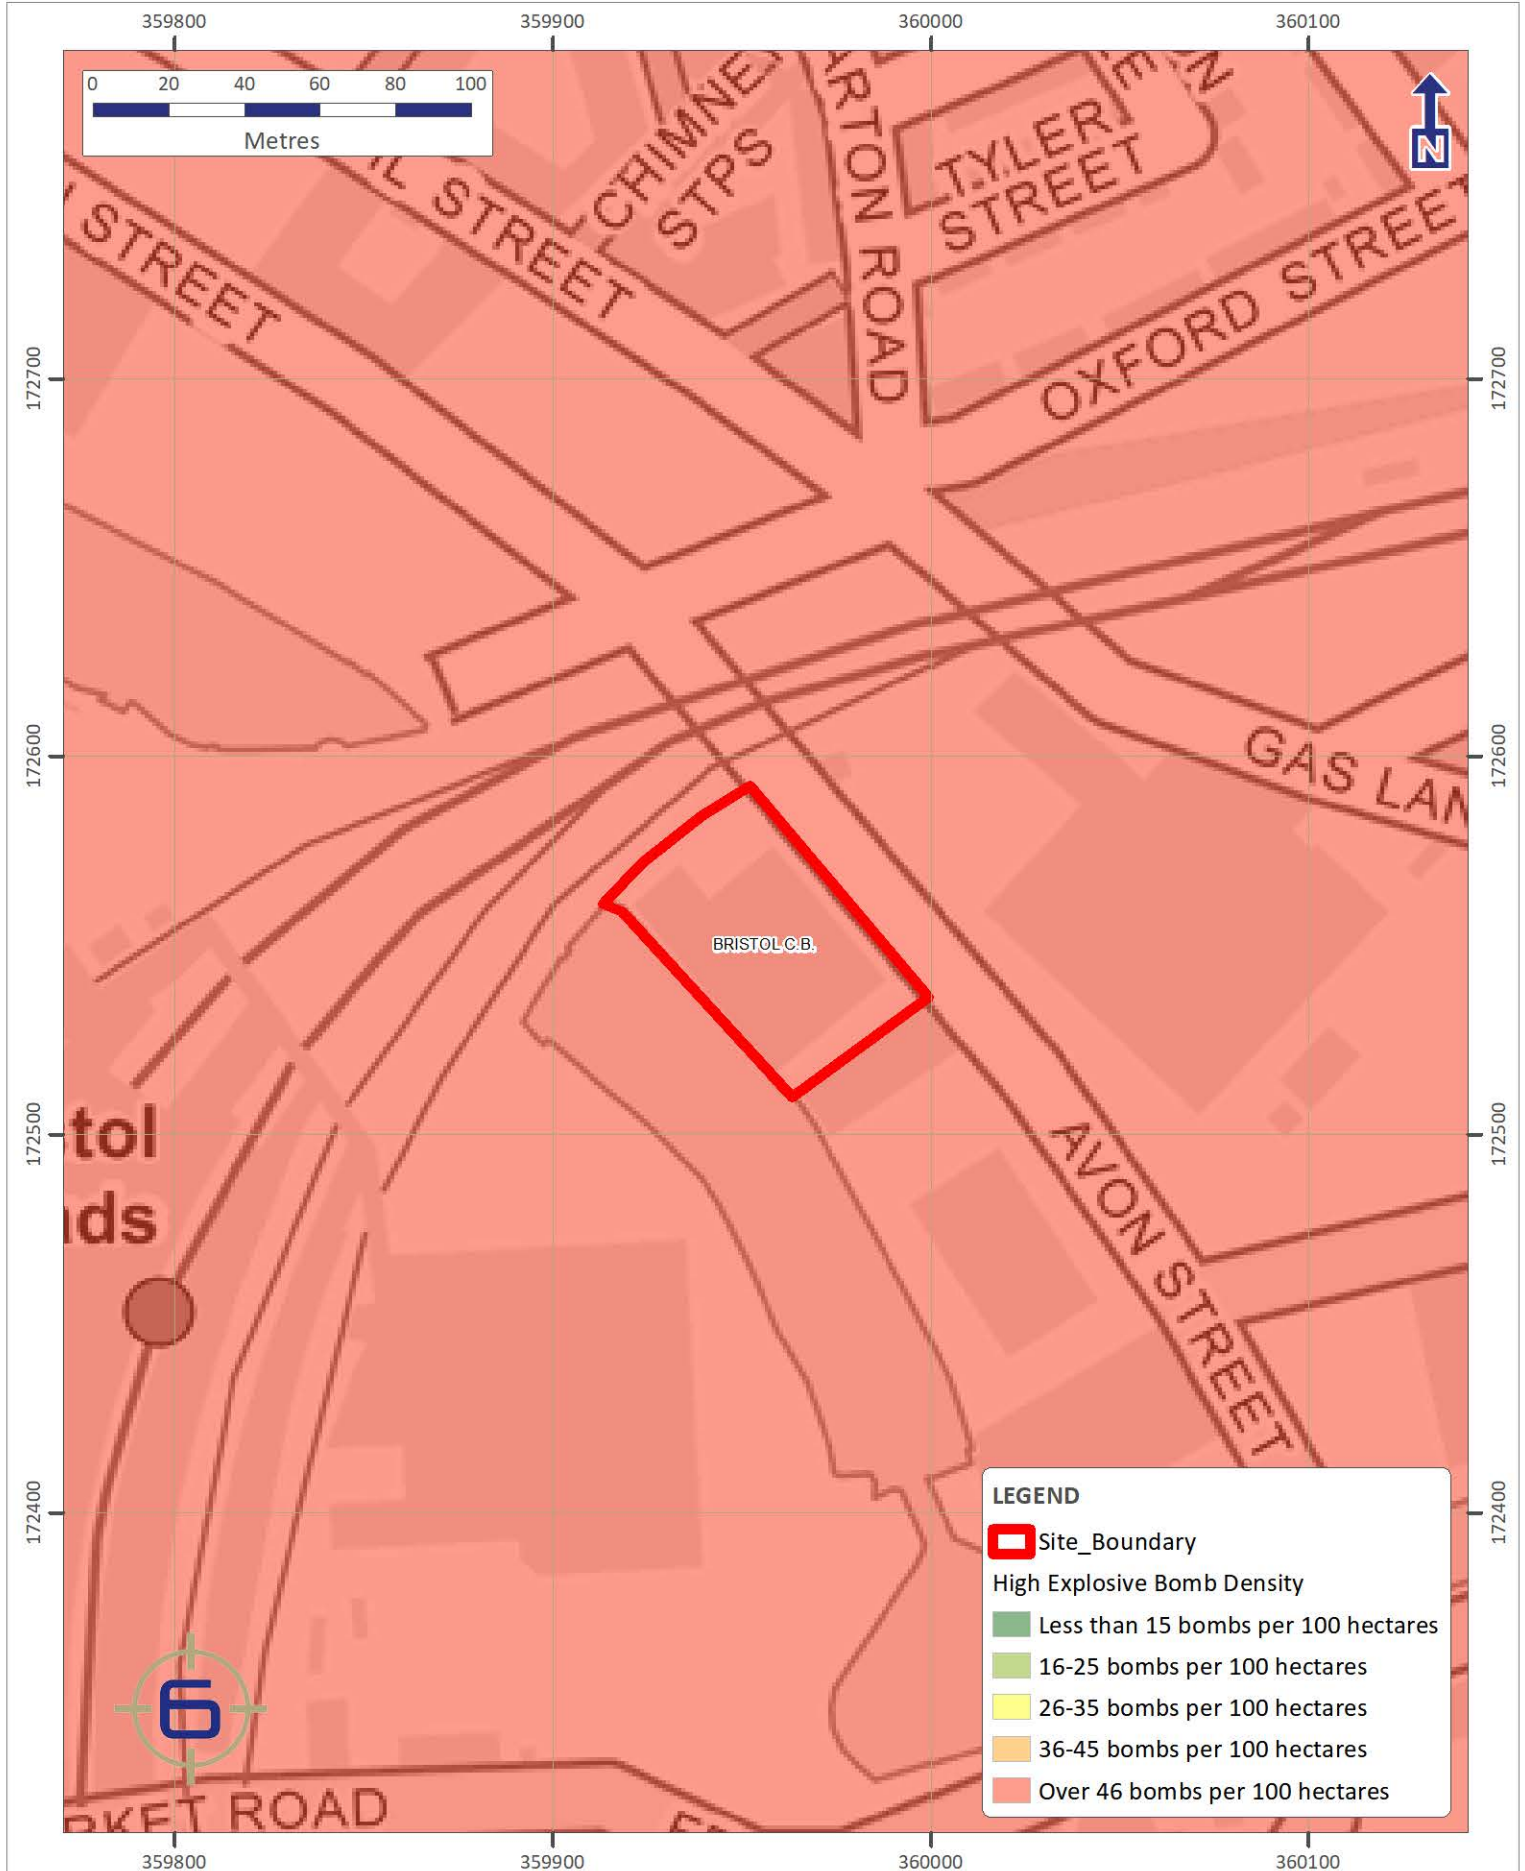
# WWII High Explosive Bomb Density

The Study Site was located within *Bristol County Borough*, which recorded 63 HE bombs per 100 hectares, a very high level of bombing. However, given that the Site was situated adjacent to a number of primary bombing targets during WWII, the localised bombing density may in fact have been much greater.

During WWII, the Study Site was situated within *Bristol County Borough*, which recorded 63 HE bomb strikes per 100 hectares, a very high level of bombing. However, given that the Site was situated adjacent to a number of primary bombing targets during WWII, the localised bombing density may in fact have been much greater.
