DESCRIPTION & CONDITION OF THE BUILDING FABRIC

BRIEF

PROPOSAL & SCHEDULE OF WORKS

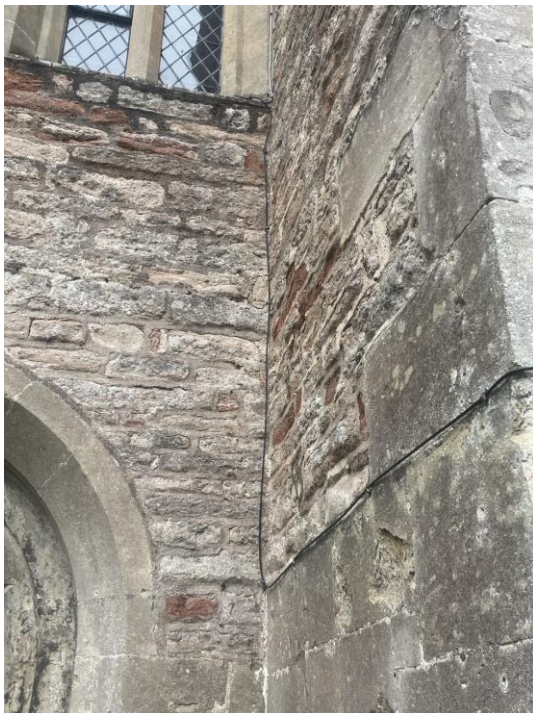
Cable route, to remain unchanged

A replacement four pair cable supplied by BT to follow existing route along the South East Elevation. The cable would be payed out through the office and fixed to the wall at the highest accessible point from a step ladder. The existing cable enters the office through a hole in the window pane which is not safe. BT propose to drill a 2 inch diameter hole in the South East Elevation wall at a depth of 5 inches.

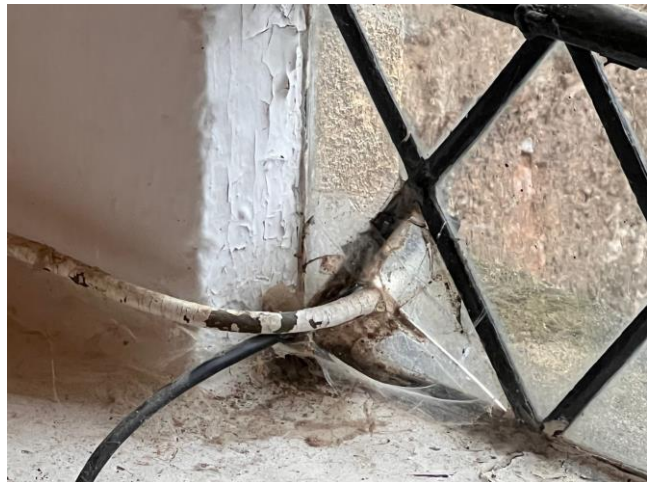
Current route through windowpane

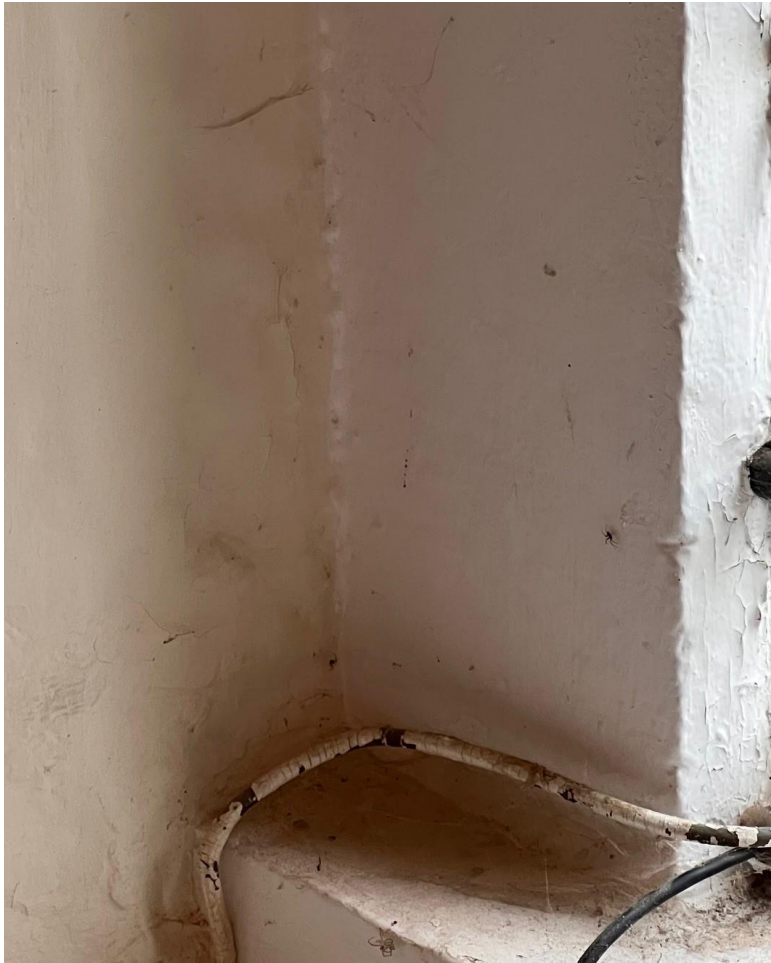
Proposed site for cable access, 2-inch diameter hole through 5-inch-thick window surround.

A hole of 2 inch diameter to be drilled through the 5 inch stone window surround to safely feed cabling through supplied by BT. This work will take one day.
