LICHFIELD DRIVE / BLABY GOLF COURSE, BLABY
PHASE II SITE APPRAISAL
FOR
DAVIDSONS DEVELOPMENTS C/O ANDREW GRANGER &
CO LTD

Project Ref:
P7791

Date:
January 2021

Site Appraisal for Lichfield Drive, Blaby Golf Course, Blaby

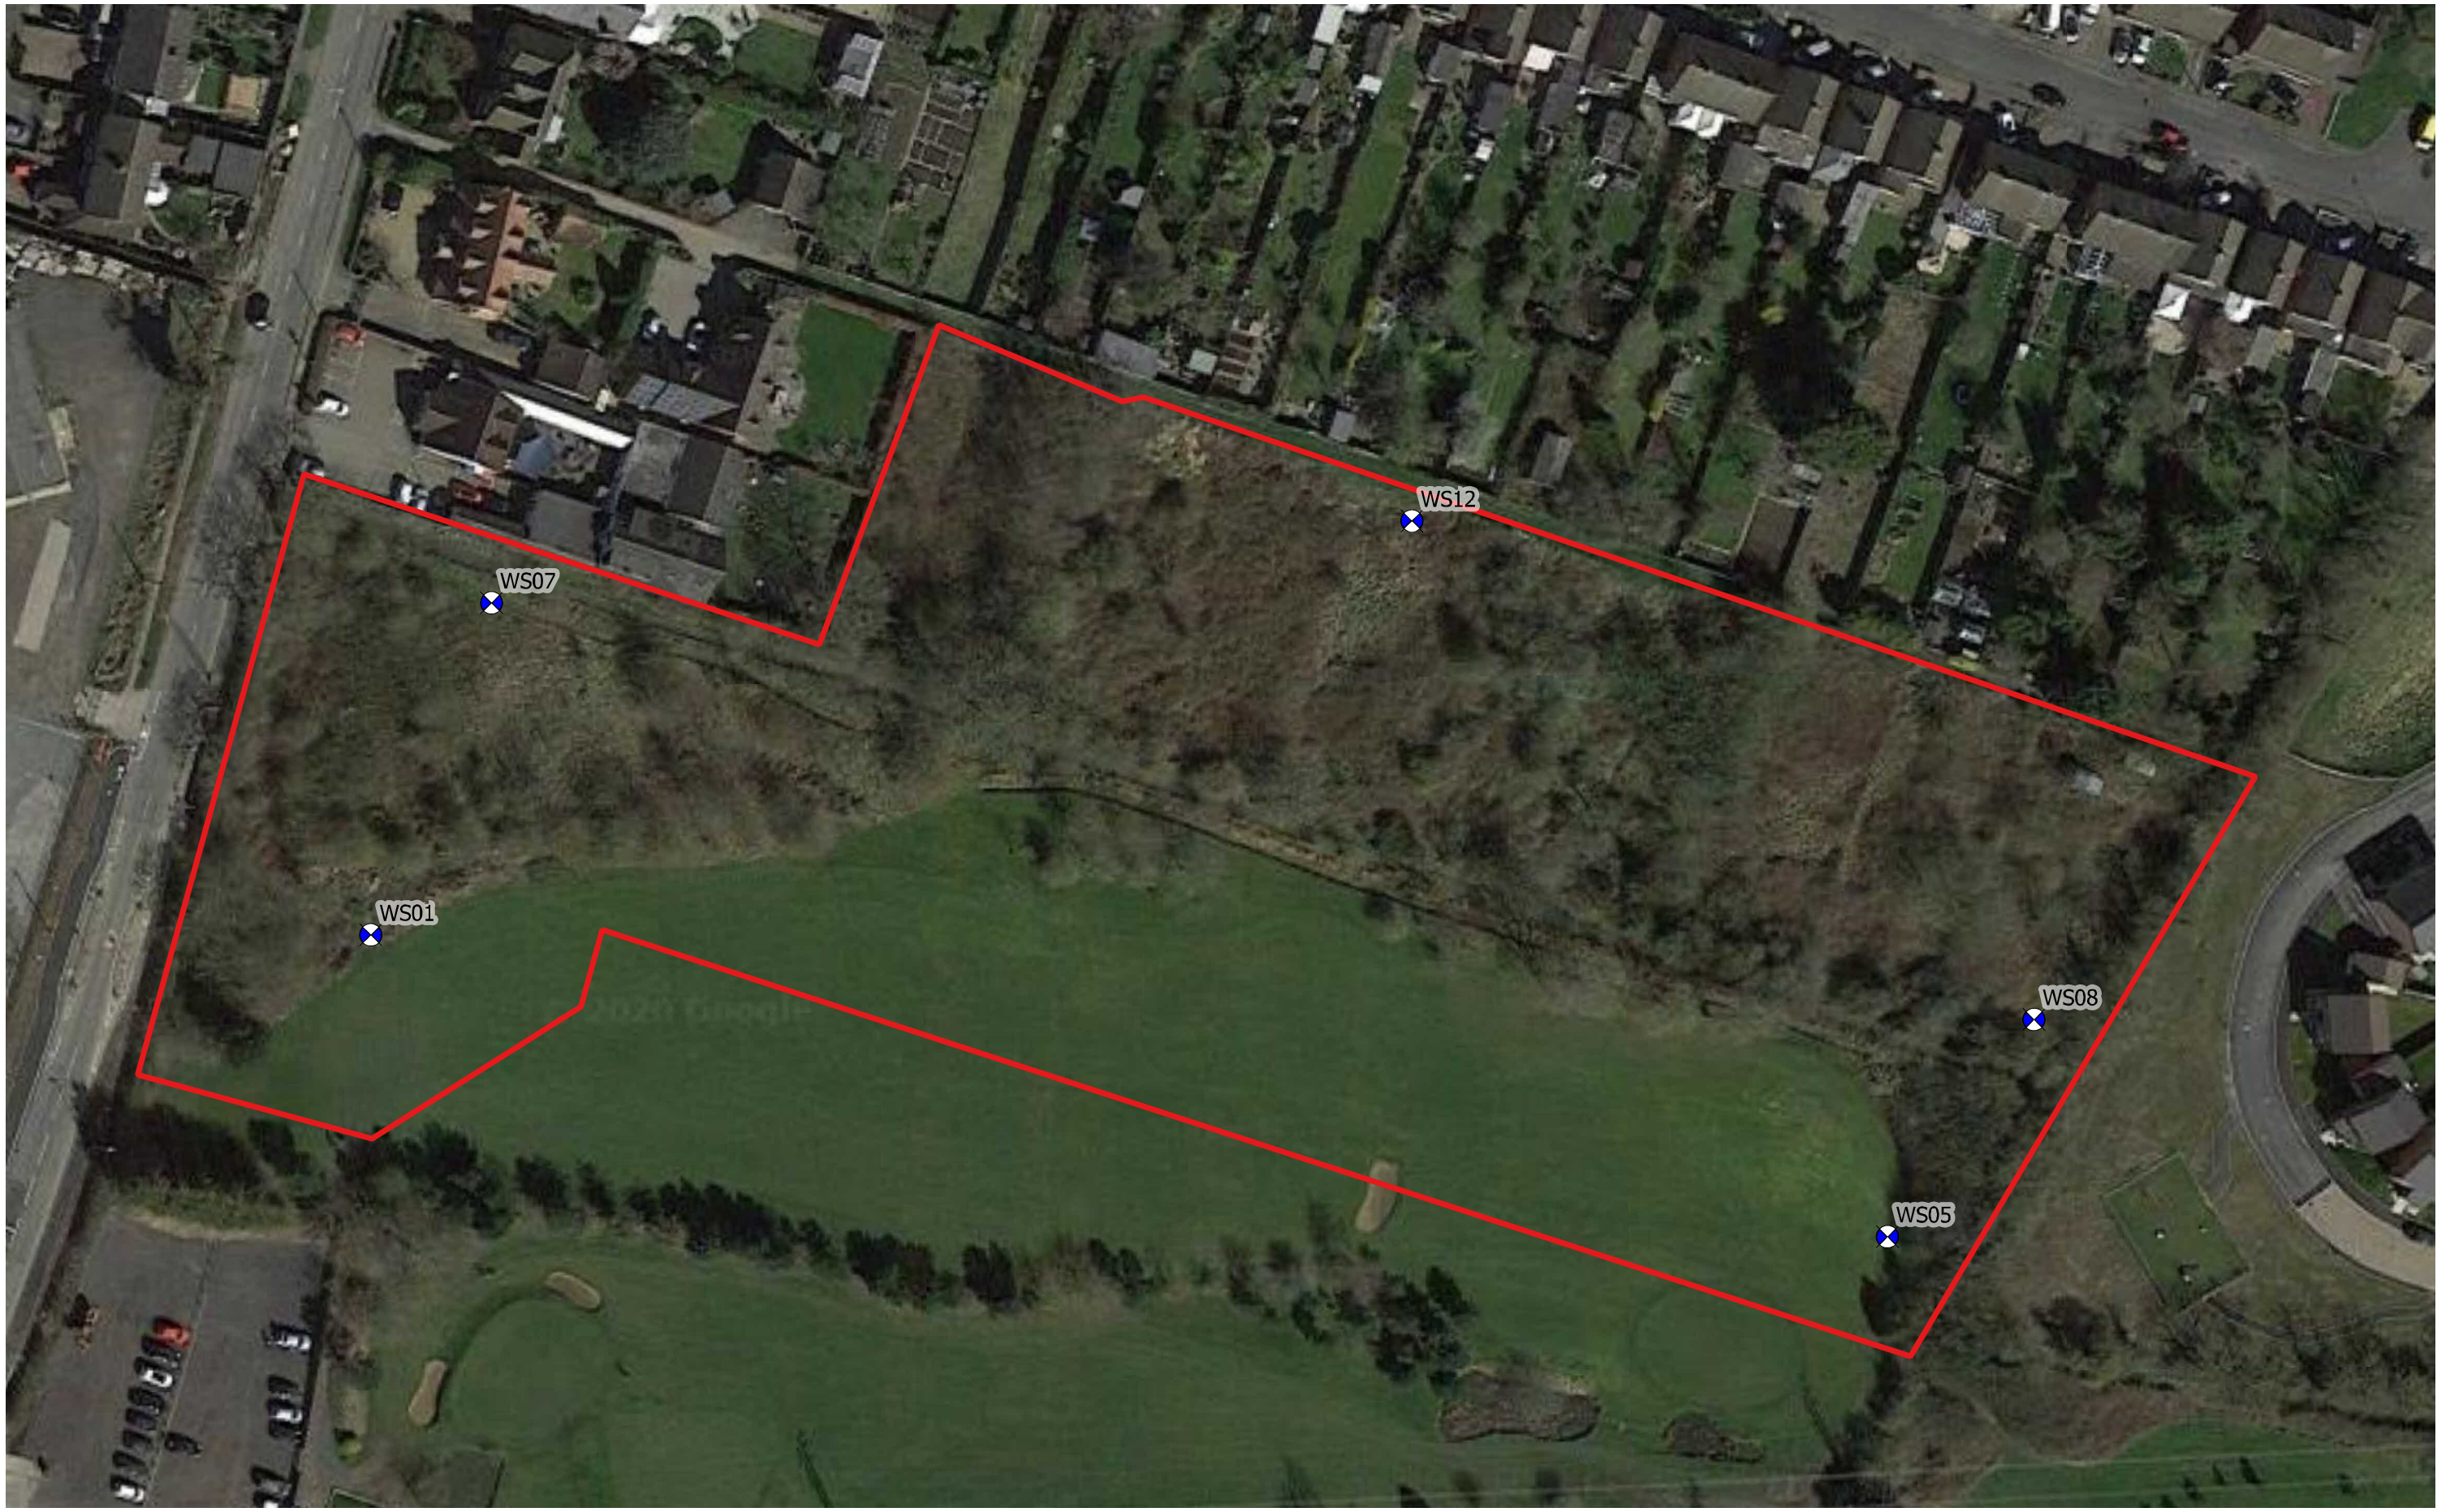
GRM Development Solutions Ltd Tel: 01283 551 249 mail@grm-uk.com www.grm-uk.com	
	TITLE:	Gas Monitoring Plan	© GRM Development Solutions Ltd © Crown Copyright. AL 100014100

NOTES:	CLIENT:	Andrew Granger & Co	PROJECT No:	P7791	DATE:	December 2020	DESIGN/DRAWN:	CMM
	PROJECT:	Lichfield Drive/ Blaby Golf Centre	DRAWING NUMBER:	3	ISSUE:	FINAL

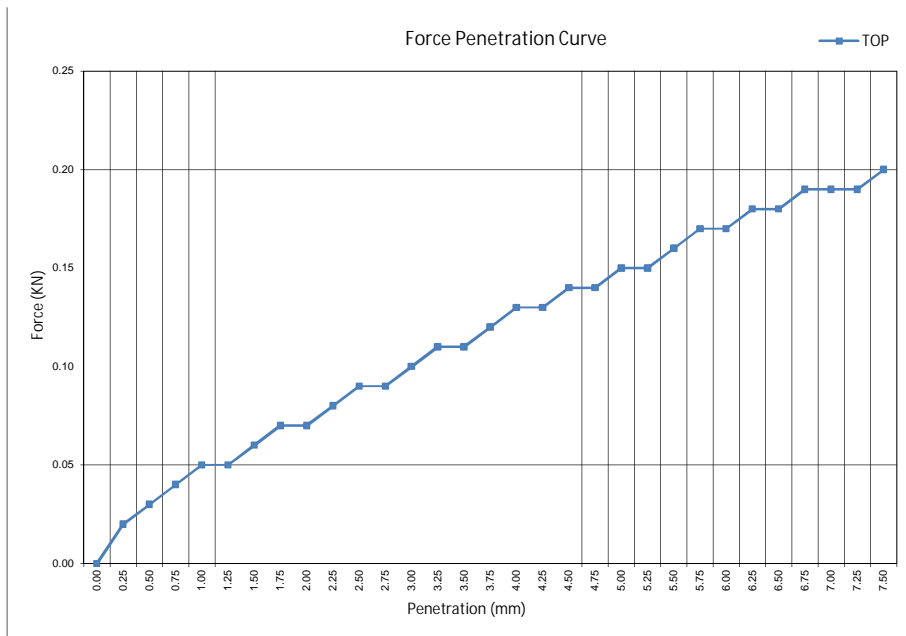
NC Reference	126531
--------------	--------

Client Sample ID	HP01	Depth (Top) (m)	0.40
Client Sample Location	HP01	Depth - Bottom (m)	0.50
Visual description :	Brown silty sandy gravelly clay with occasional shale		
Sample type:	Disturbed		
Initial Bulk Density (Mg/m3) :	2.03	Initial Dry Density (Mg/m3) :	1.69
Material retained on 20mm test sieve (%) :	7	Moisture content after test (%) :	20
California Bearing Ratio (%) :	0.8

1. Testing was in accordance with BS 1377 : Part 4 : 1990 : Clause 7.
2. Sample preparation was in accordance with cl.7.2.4.4 method 5 - 2.5Kg rammer
3. The test specimen was not soaked prior to testing

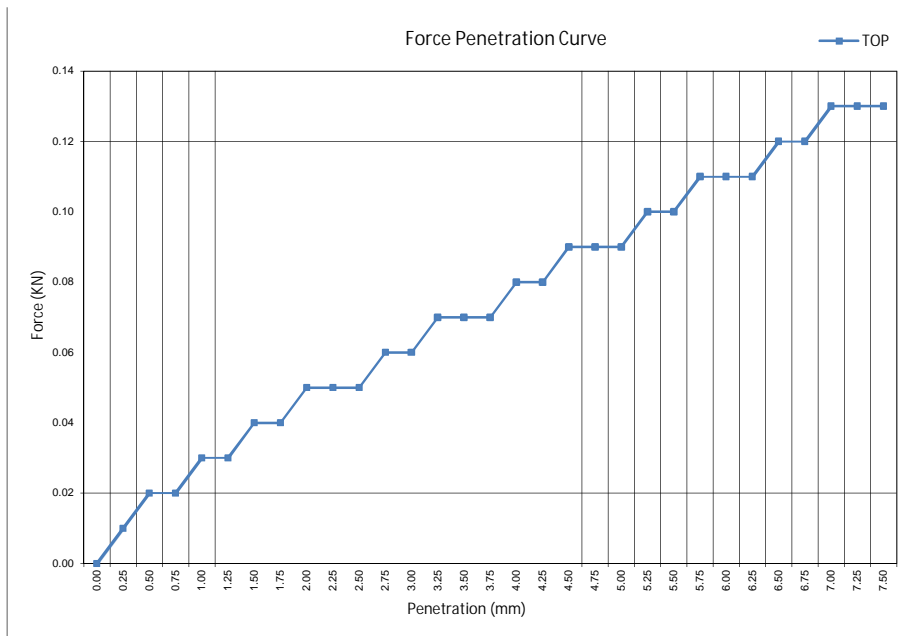
NC Reference	126532
--------------	--------

Client Sample ID	HP02	Depth (Top) (m)	0.40
Client Sample Location	HP02	Depth - Bottom (m)	0.50
Visual description :	Brown silty sandy clay with occasional gravel and crushed brick		
Sample type:	Disturbed		
Initial Bulk Density (Mg/m3) :	2.00	Initial Dry Density (Mg/m3) :	1.65
Material retained on 20mm test sieve (%) :	10	Moisture content after test (%) :	21
California Bearing Ratio (%) :	0.5

1. Testing was in accordance with BS 1377 : Part 4 : 1990 : Clause 7.
2. Sample preparation was in accordance with cl.7.2.4.4 method 5 - 2.5Kg rammer
3. The test specimen was not soaked prior to testing

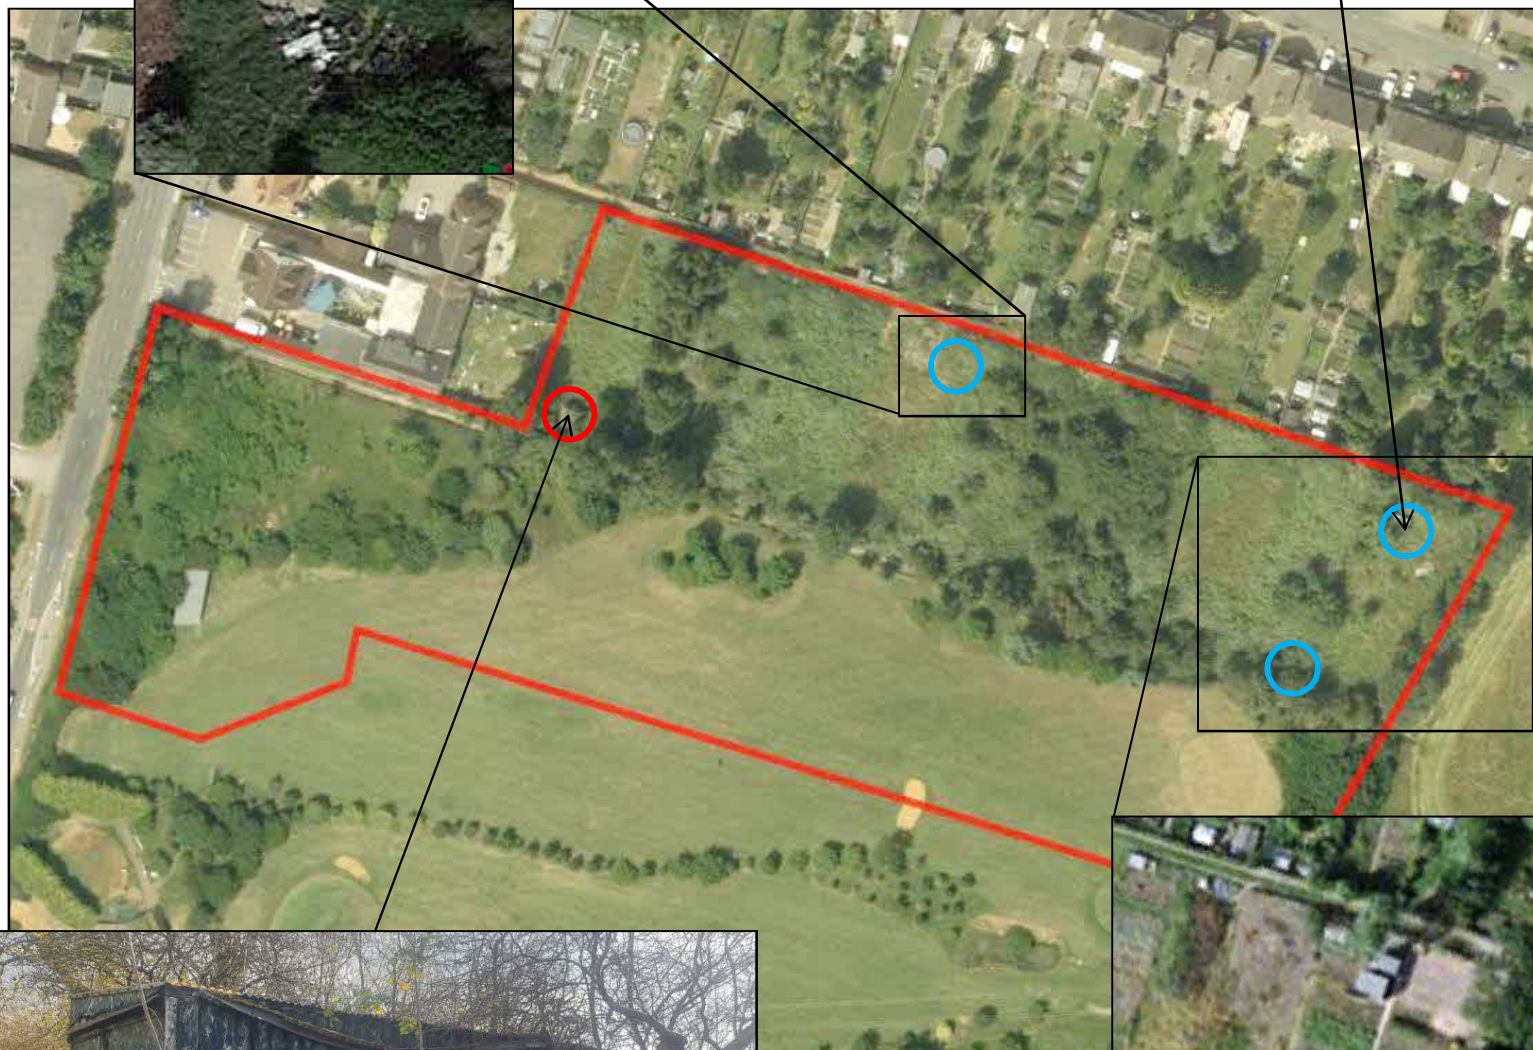
Asbestos recorded in WS12; potential historic fly tipping or demolition of historic shed.

No asbestos recorded in WS09

It is recommended that the further sampling is undertaken after the removal of the potential asbestos shed present in the western corner of the allotment area, so that the underlying soils can also be assessed.

It should be noted that the asbestos contamination is likely to be localised to the source; such as below historic sheds, or where historic fly tipping has been undertaken. In this case a suitable form of remediation would be either localised source removal; estimated to be 200m³ or localised capping; estimated to be >400m² with a minimum thickness of 600mm, and possibly up to 1m thick depending on concentration and EHO requirements.

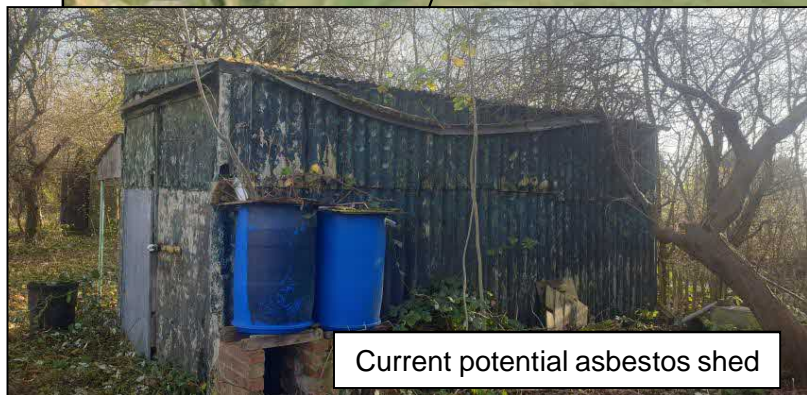
Current potential asbestos shed

There are existing structures on the site including derelict sheds and containers in the allotments area. The derelict shed located in the south western corner of this area was observed to be made out of potential ACMs.

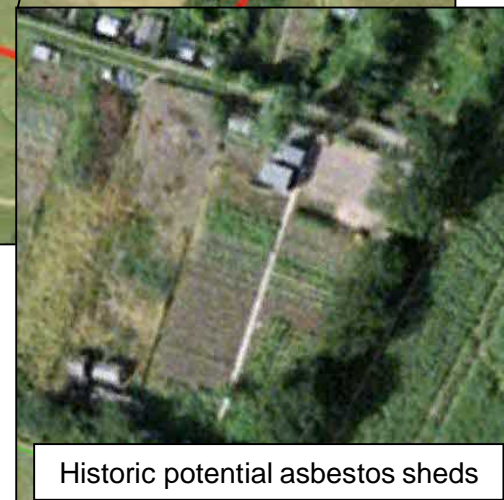
Historic potential asbestos sheds

The quantification result recorded loose fibres of chrysotile are present at a concentration of 0.002%. It is conjectured that the source of the asbestos is from sheds or small structures which were historically present onsite; similar to the current derelict shed in the south western corner of the allotment area. It is also considered that the presence of asbestos in the soil is unlikely to be an isolated hotspot and its presence could be indicative of more asbestos being present where historic sheds were situated.
