# *Preliminary Roost Assessment*

12 Wattisfield Road, Walsham Le Willows,  
Suffolk,  
IP31 3BD

**Abrehart Ecology**

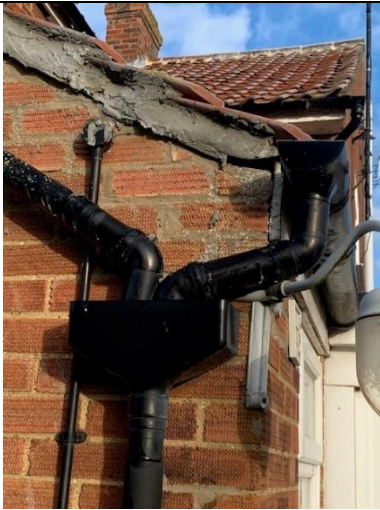
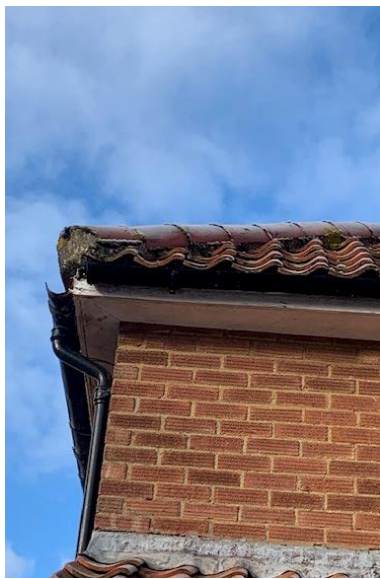
On the first storey roof to the south was an area of concrete under the tiles, and there was a large hole above the brick.

On the south-east corner there was an area of rot on the wooden fascia board under the hipped edge.

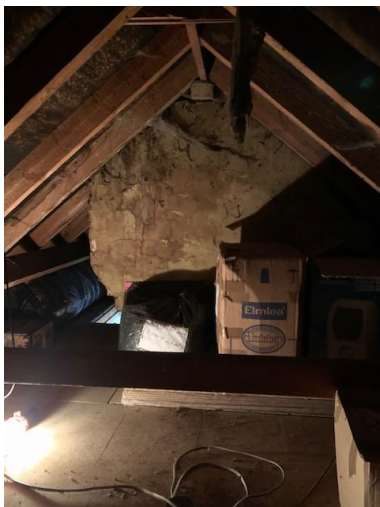
### *Loft inspection*

The loft space had boarded floors (with some areas of insulation), roof lining which was mostly intact, and no insulation on the roof. The southern aspect of the roof will be altered for the proposed extension. The loft height varied from 0.5m – 1.7m.

- The loft space had many exposed rough wooden beams with gaps observed between joints. These could provide roosting opportunities for bats.
- On the northern end there was gaps in the brick mortar which could provide roosting opportunities.
- Bat droppings were observed in the loft (5 max), and these have been collected and sent to SureScreen Scientifics.
- No bats were seen at the time of survey.

- 4.2 The residential building was suitable for supporting roosting bats, with many features noted throughout the external an internal survey. Some bat droppings were also observed within the loft space which have been sent off for analysis. **Therefore, it is recommended that full surveys are carried out – consisting of three emergence/return to roost surveys**, designed or led by a level 2 bat licenced ecologist (to BCT Guidelines). These surveys can be carried out between May and September (weather dependent) but two are to be undertaken between May-August. Further survey should also include the DNA analysis of the droppings.

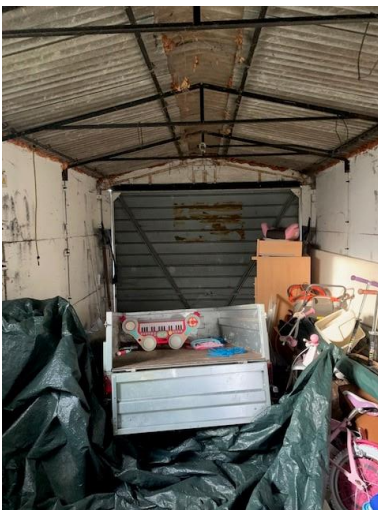
### ***The Garage***

The garage had concrete sheeted walls which were held together by metal bolts and brackets, and there was a window on the southern wall. The roof was pitched with a metal frame, the single layer roofing sheets were potentially asbestos. Around the metal front garage door were significant gaps which allowed a draft through the garage and under the wooden door was a significant gap where the wood had rotted away. The garage was light cold and draughty.

- Gaps and holes were present in multiple places, but these were all significant gaps around doors and joins.
- The concrete and asbestos offered no insulation.
- No bats were seen at the time of survey and the floor and items were searched thoroughly and no bat droppings were observed.

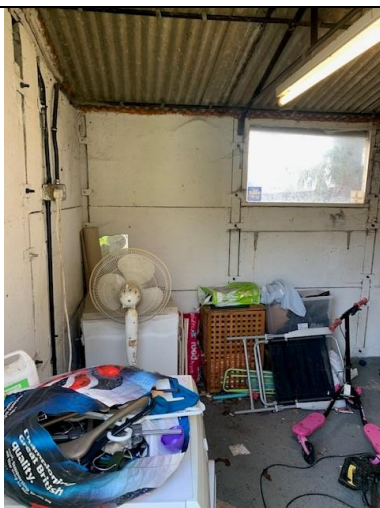
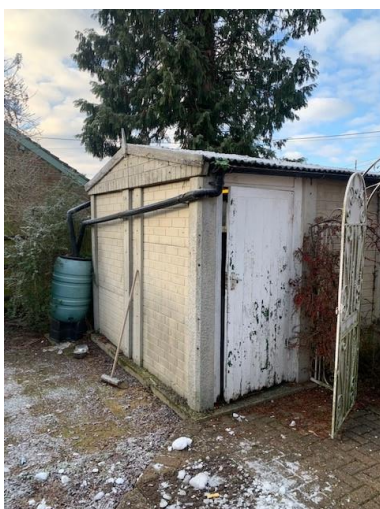
<p>Rotted wood under the side door of the garage.</p>	<p>Concrete sheeted walls of the garage held together metal bolts and plates. Single skin roofing was potentially asbestos.</p>

<p>Garage with gaps around the metal door.</p>	<p>Holes under the edge tiles on both stories and gaps between the brick and mortar.</p>

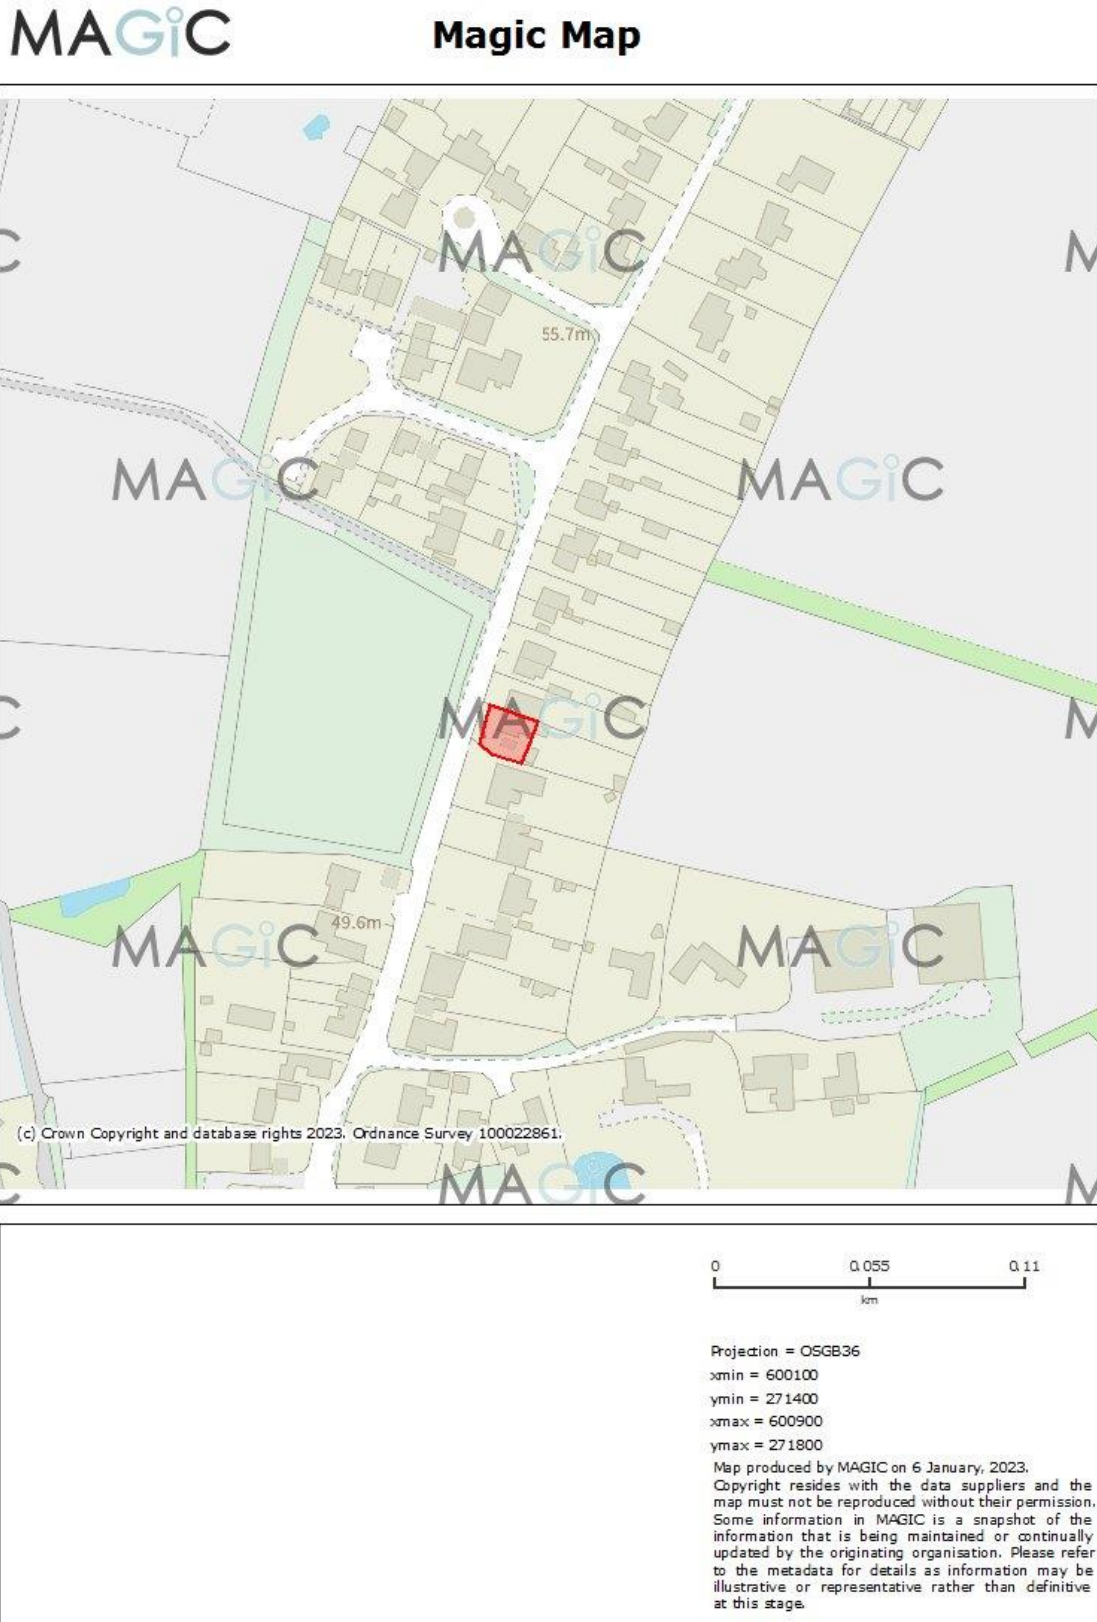
Location of surveyed buildings (red lines indicate surveyed buildings)

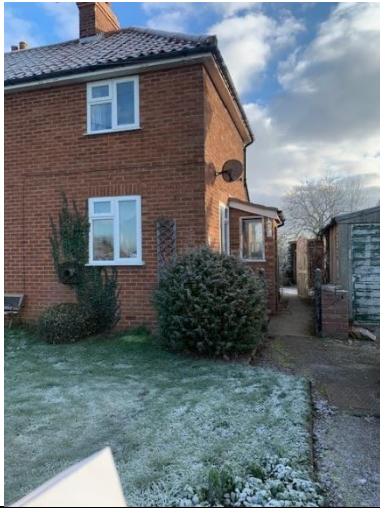
View of house, garage, hardstanding, ornamental shrubs, and amenity grassland from the road.

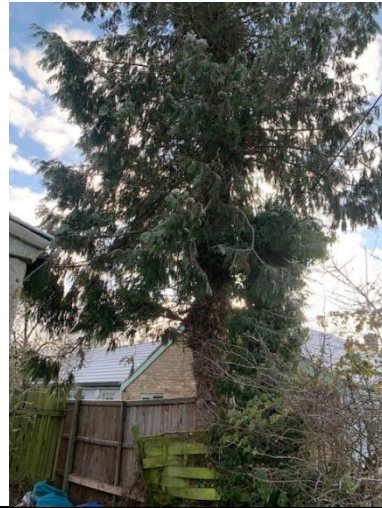
Mature cypress tree to the south of the garage on the boarder of the property. Appeared to of had extensive pruning.
