**ECOLOGICAL IMPACT ASSESSMENT**  
**and Bat Activity Survey**

Wernfach,

Llandefalle,

Powys

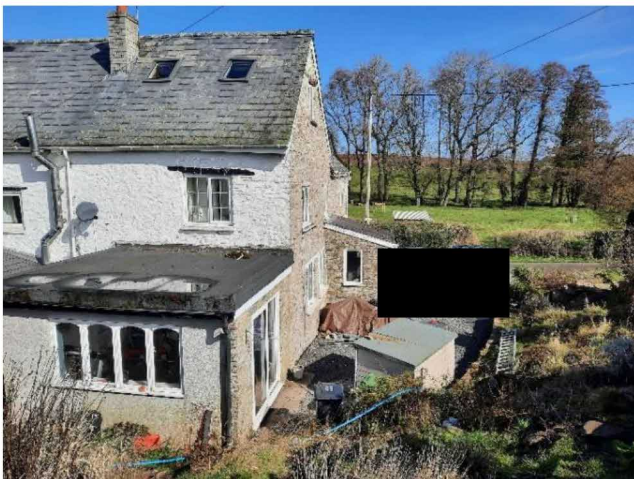
Plate 1: Looking east across the site towards Triffrwd. Plate 2: Looking north across the site to the southeast gable.

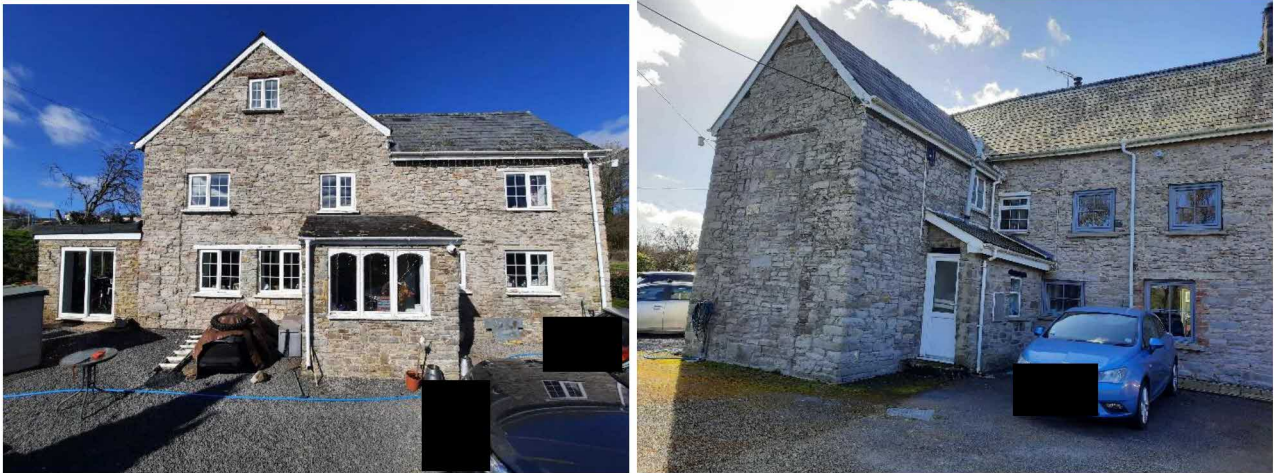
Plate 3: Showing the southeast gable and elevation. Plate 4: Northeast gable and northwest elevation.

The Site is exposed stonework on all elevations. The roof is pitched over the main section and northeast elevation. The roof is clad in slate. The slates of the northeast extension are in place on both elevations. There are three ridge tiles with raised edges. Across the main roof, there are slates with what appear to be superficial gaps on the northeast elevation. On the southwest elevation of the main roof there are slates with edges. The ridge tiles of the main roof have crevices leading under tiles, particularly two tiles at the southeast gable.

The southeast elevation eaves of the northeast extension are open, with access into the loft space. There are significant gaps and crevices leading between the stonework and bargeboard timber of the northeast gable, particularly at the gable ridge. There are gaps between the roof tiles and bargeboard tile.

There are significant gaps and crevices leading between the stonework and bargeboard timber of the southeast gable. The gaps are present along the full length of each bargeboard. There are gaps between the roof tiles and bargeboard tile, particularly at the west corner where the second tile up has slipped and lifted.

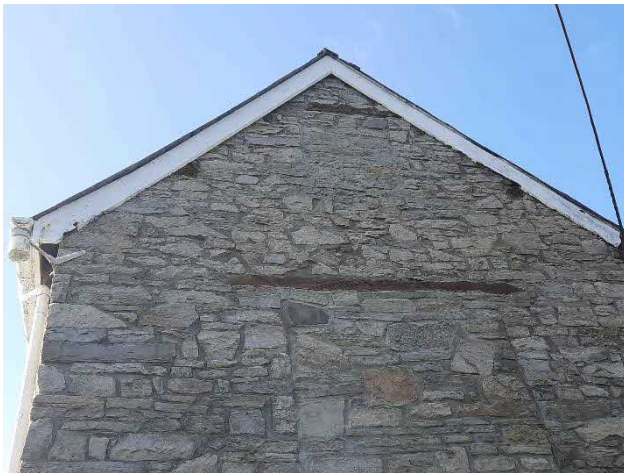
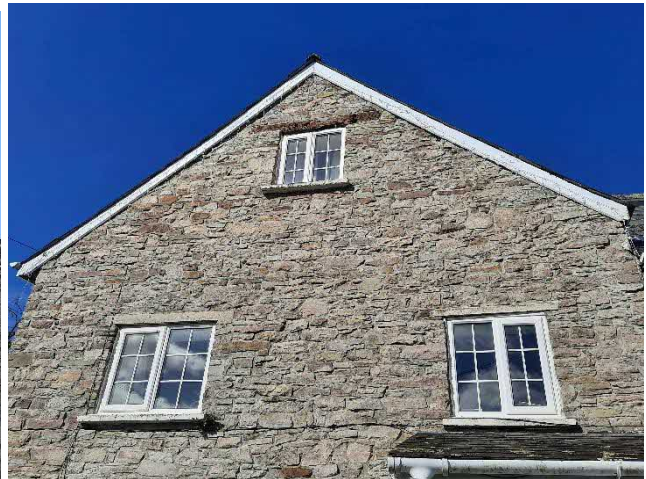
Plate 5: Northeast gable end of northeast extension. Plate 6: Southeast gable of main house

The stonework of the northeast gable wall is intact. There are crevices between the purlin timbers and stone.

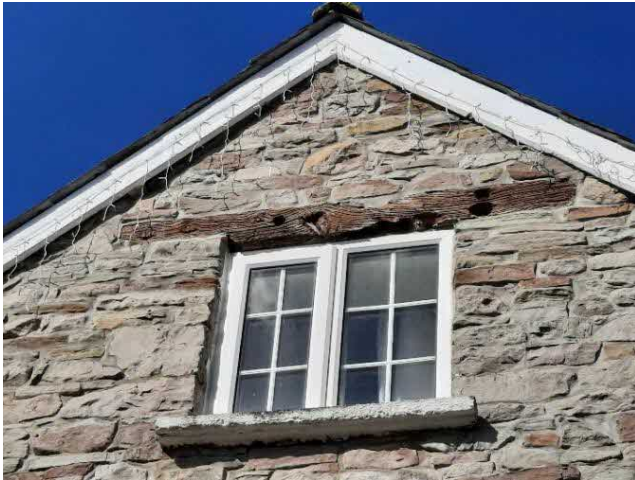
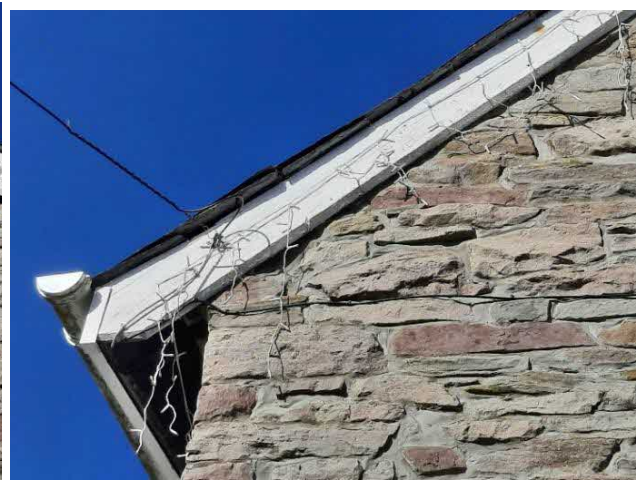
Plate 7: Second floor window and gable apex of southeast gable. Plate 8: West corner of southeast gable.

The stonework of the southeast gable is intact. There is a single crevice around the second-floor window, located between the lintel timber and window frame.

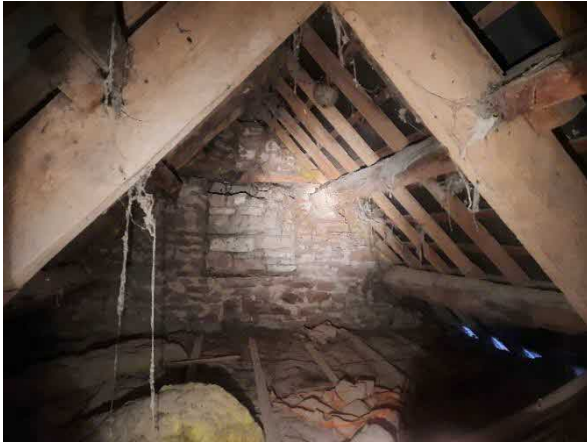
Plate 9: Loft of northeast extension. Looking northeast to gable end.

Internally the Site has a single loft space over the northeast extension. The roof slates are unlined on the southeast elevation. There is a breathable roofing membrane fitted under the tiles of the northwest elevation, the membrane is in place throughout. The loft has fibre insulation throughout.

There is a single principal rafter frame within the loft, supporting four purlin timbers. At the southwest end of the loft there is a stepped section where the loft meets the wall of the main building, with small sections of a lath and plaster wall and exposed timbers from the main house roof.

The northeast gable is exposed stonework. There are significant gaps between the stonework and roof timbers.

All the timbers, loft floor, and gable wall have a thick cover of dust. There is heavy cobweb cover along the ridge beam.

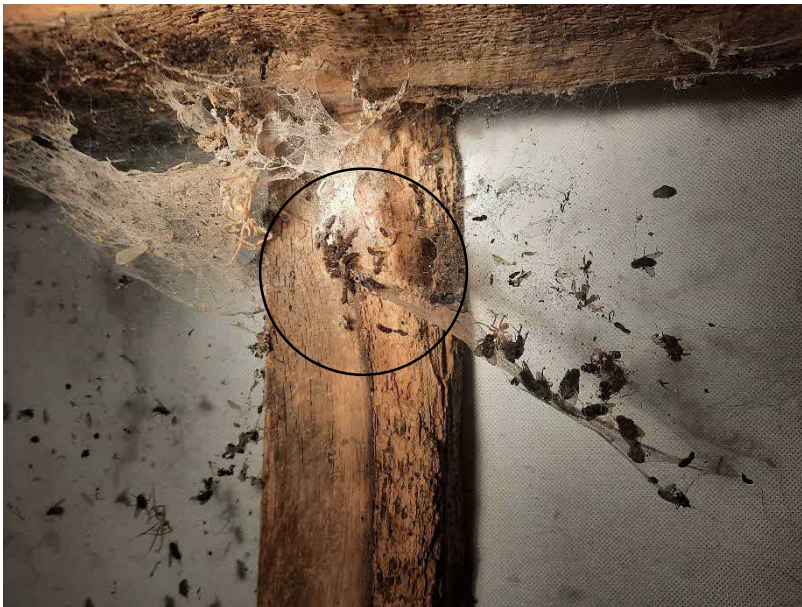
Bat droppings were found inside the loft of the northeast extension. x50 bat droppings were found caught in cobwebs on the northwest side of the ridge timber, with c.200 bat droppings collected directly below this point on the wool insulation. The bat droppings all had a dull and dust covered appearance indicating they are old (over one season old).

Plate 11: Bat droppings caught in cobwebs against the ridge timber in loft (within circle).

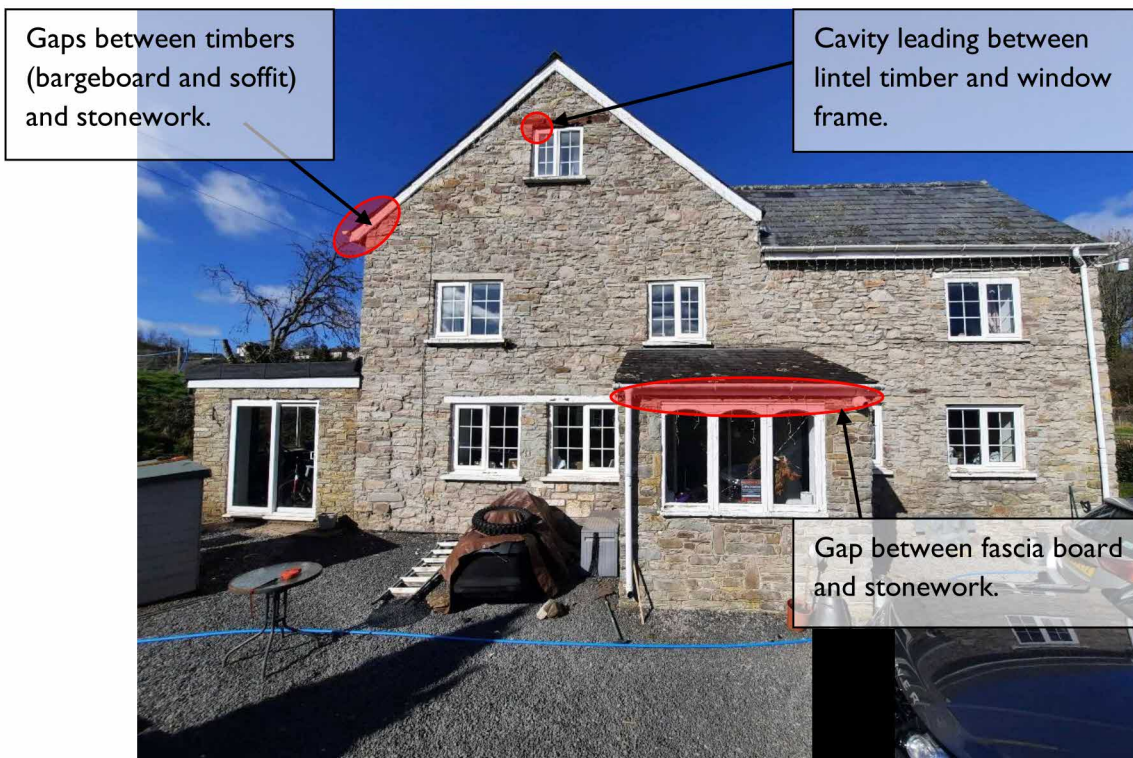
There are features that offer bat roost potential in external features of the Site. There are ridge tiles and slates with lifted edges, there are significant gaps leading under roof tiles, and between the bargeboard timbers and stonework. There is a crevice between the lintel timber and window frame of the second-floor window of the southeast gable.

Figure 3: Features located within the proposed work area which offer Low to High suitability as a bat roost.

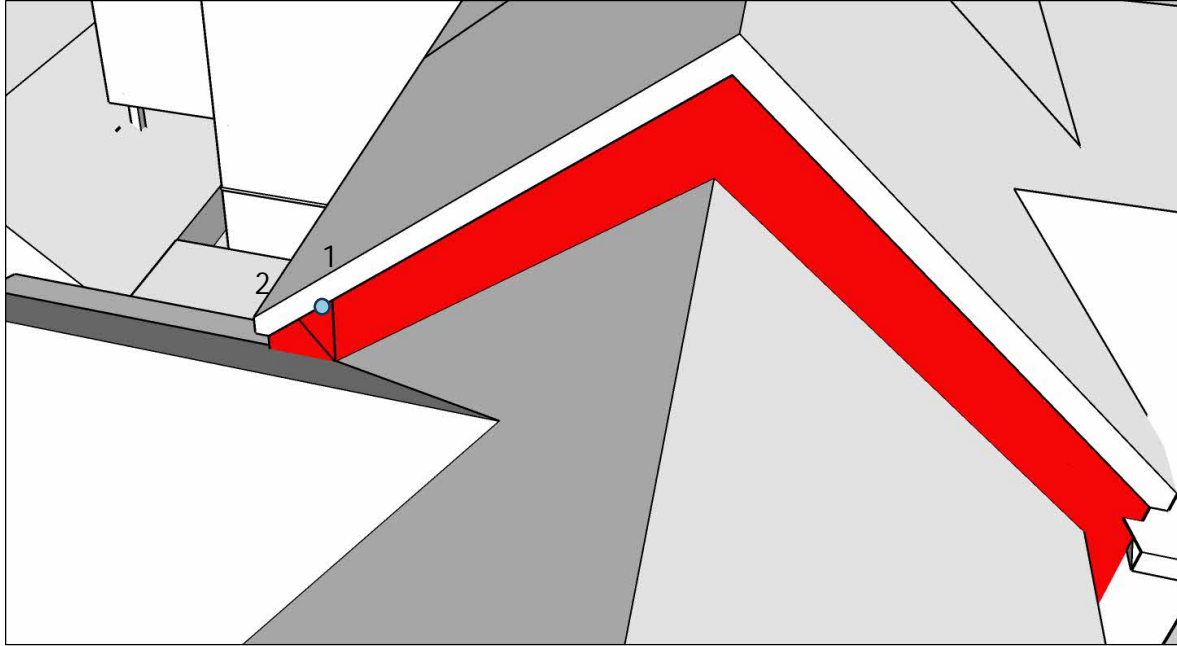
Figure 4: Illustration showing retained southeast gable in red. Vertical line (1) measures 670mm, the diagonal line (2) measures 508mm, both measurements taken from the intersection of the roof. Blue dot indicates approximate location of Roost 5.

- Construct a design that retains the existing bargeboards of the southeast gable, with proposed new build features a minimum of 500mm radius (horizontally and vertically) from the base of the existing bargeboards to allow for bat access routes. See Figure 4 below.

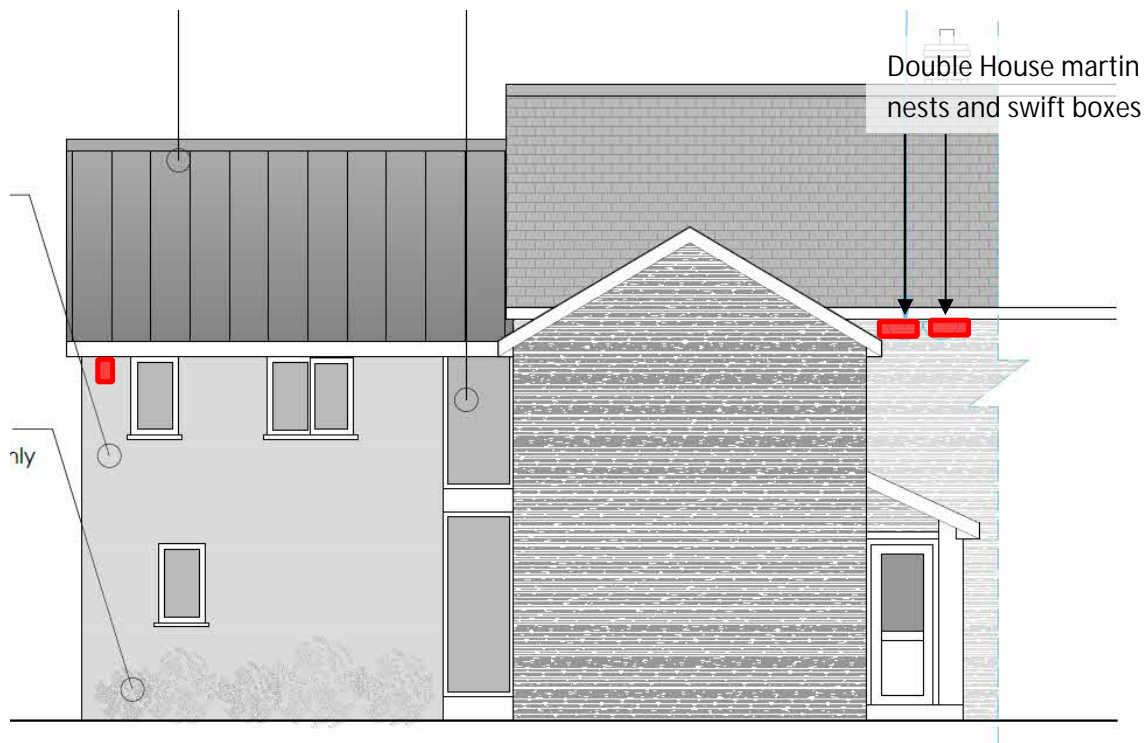
Figure 6: Northeast elevation of the proposed extension showing proposed location for an integrated bat box in proposed extension, and external house martin and swift nest boxes on the existing building.

x2 Swift next boxes - two single, or a single double nest design to be fitted to the northeast elevation, against the eaves (Figure 6).

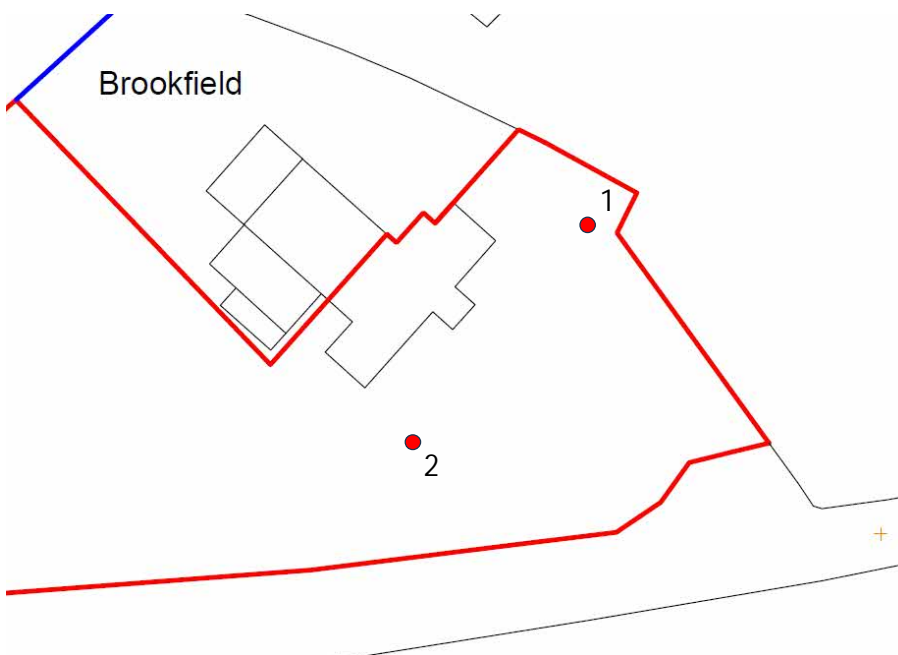
Surveyor locations over each survey:

Personal for each survey and location

Location	Dusk 1	Dusk 2	Dawn
1	Alicia Leow-Dyke	Joshua Evans	Kaite McMinn
2	Katie McMinn & Infrared camera rig	Katie McMinn and Infrared camera rig	Infrared Camera rig

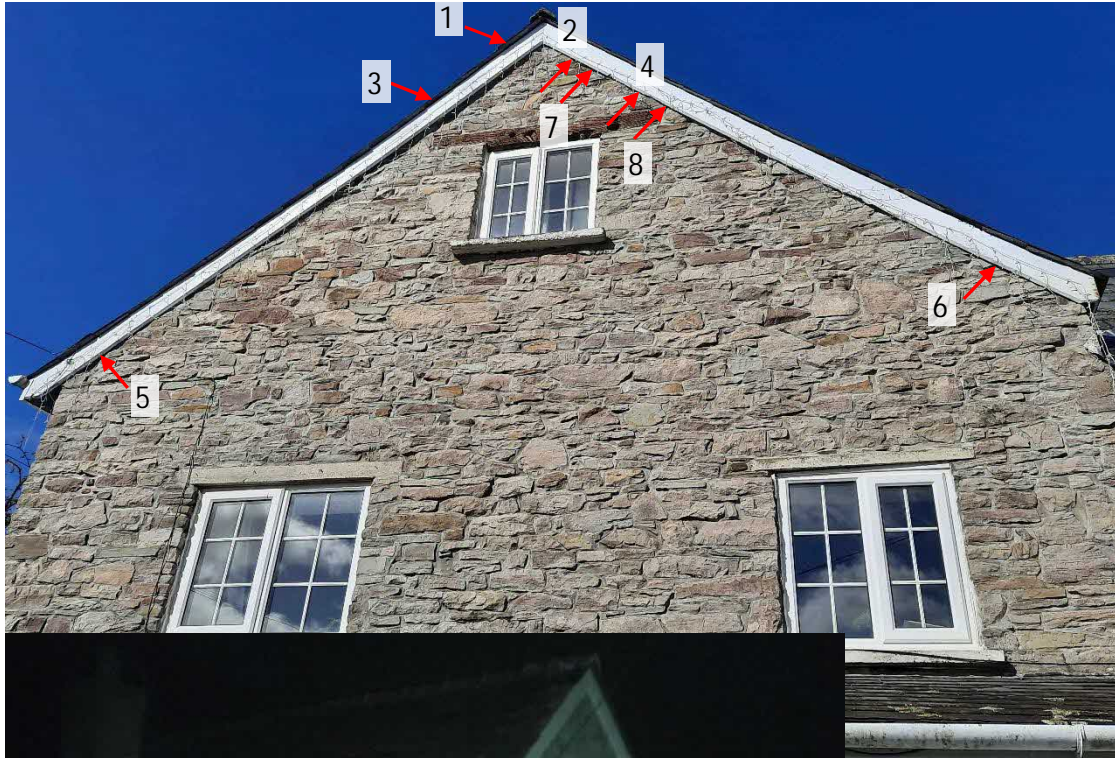
### Southeast gable

#### **Roost location 1:**

Crevice between tile and bargeboard of first roof tile below ridge.

**Roost location 8:** Crevice between stonework and bargeboard.

Dawn x1 Soprano pipistrelle 04:48

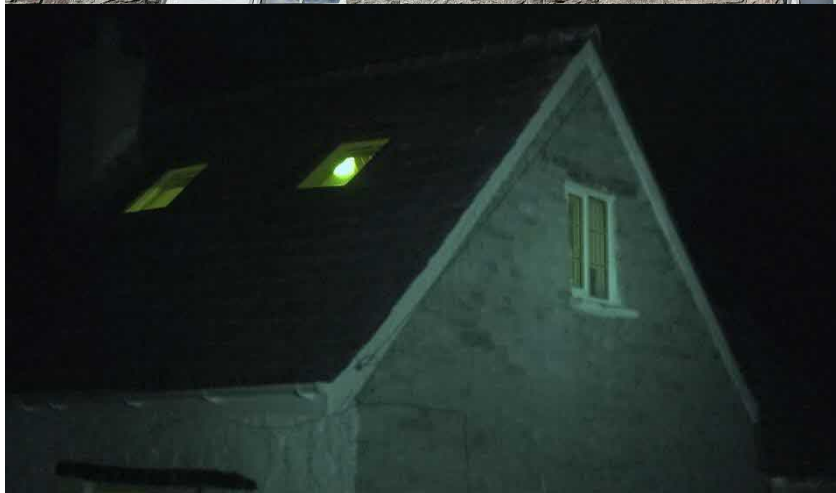
Image showing view of the south east gable, as seen at the darkest point through the infrared camera in the Dusk 1 survey.

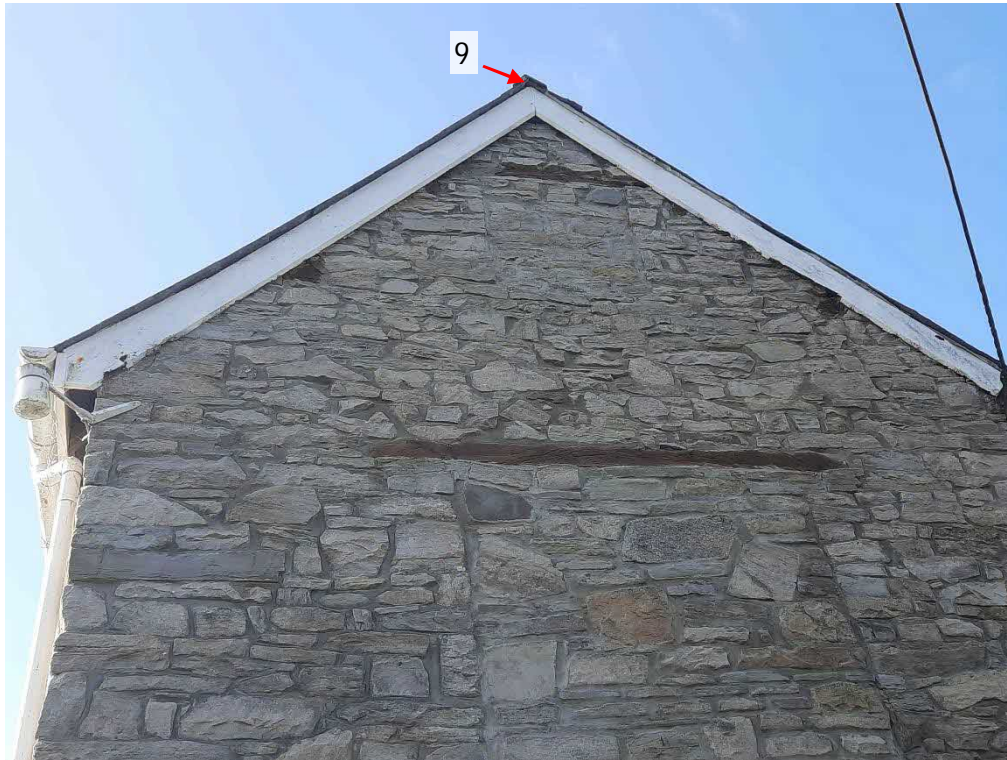
Northeast gable

**Roost location 9:** Crevice under ridge tile.

Dawn x1 Common pipistrelle 04:36
