**Bat Emergence and Nesting Bird  
Survey Report  
The Grange & Garage  
Treviades  
Falmouth  
TR11 5RG**

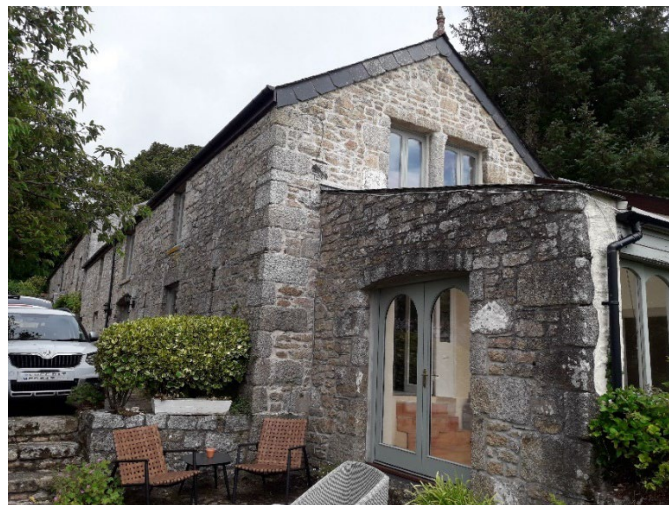
**Figure 1. The Grange.**

The Grange and Outbuilding are stone built, which are both covered with a part bitumen and breathable under-lined, slate roof. The Grange is two storied, which has been extended on the southern and eastern aspects. The Outbuilding is in use as a store and laundry room.

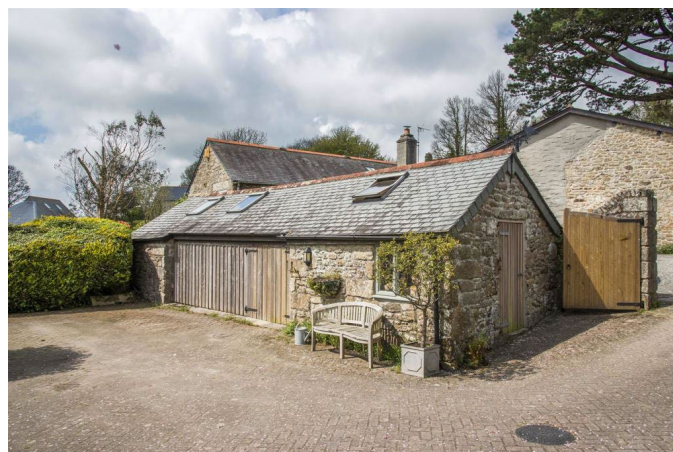
**Figure 2. Outbuilding.**

The interior of the building is divided into two separate sections, one is in use for storage while the other is in use as a laundry room. The floor, walls and stored items within the building were searched for evidence of use by roosting bats, which was followed by a search of the exterior. No evidence of use by bats was noted but the gap beneath the slate verge could not be fully accessed.

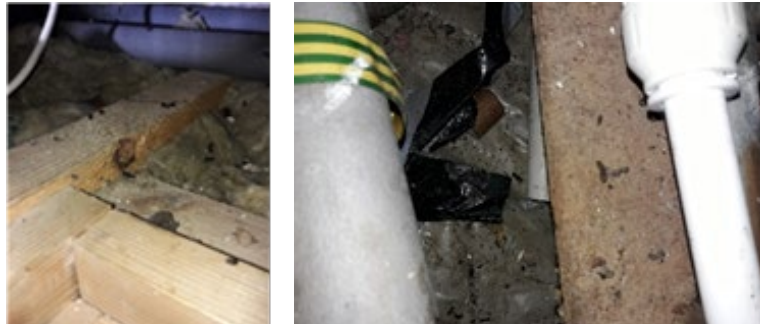
**Figure 4. Droppings found within roof voids.**

Droppings from use by bats were noted within three roof voids which appear to have fallen from gaps within the bitumen felt, lining the underside of the roof.

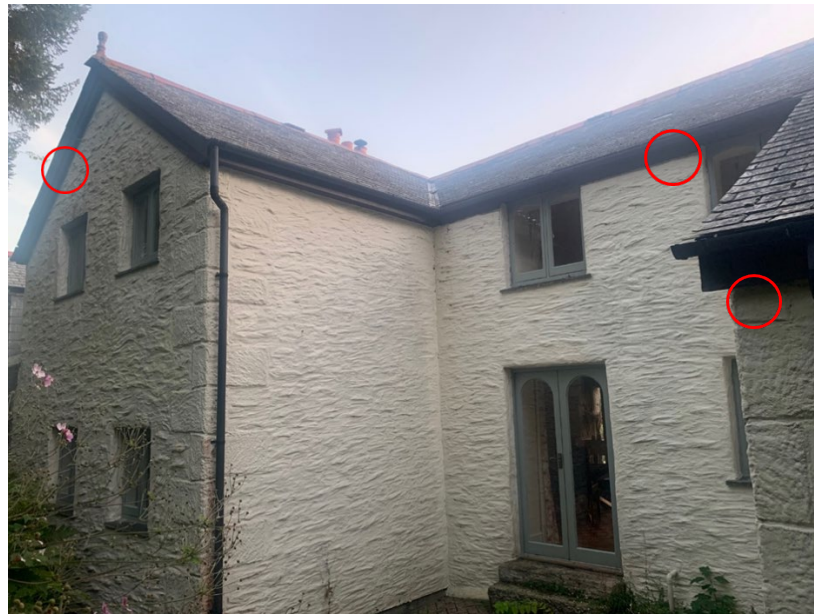
**Figure 5. Bat emergence points, eastern elevation.**

Sunset was at 20:14 and the surveyors were onsite at 19:55. The first bat recorded was a common pipistrelle (*Pipistrellus pipistrellus*) bat which was noted to emerge from beneath a fascia board on the eastern elevation (Fig. 5) of the building at 20:13. This bat was quickly followed by another common pipistrelle at 20:17 close to the first emergence point. At 20:20 a common pipistrelle bat emerged from under the fascia board fixed to the lower floor extension.

The surveyor located at the eastern elevation (Fig. 5) recorded single common pipistrelle bats emerge from beneath gaps within the fascia boards at 20:14, 20:15 and 20:36.

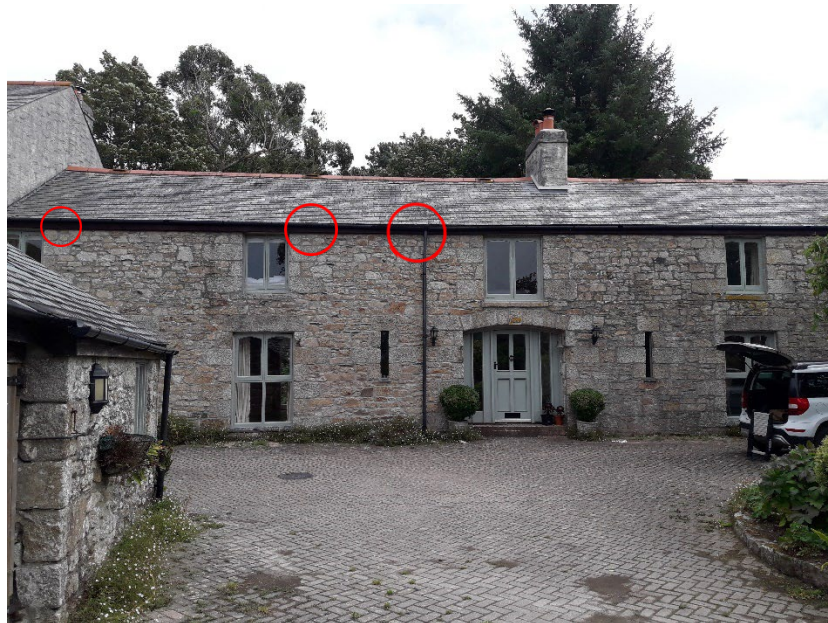
**Figure 6. Western Elevation. Bat emergence points**

The surveyor located at the western elevation (Fig. 6) recorded a common pipistrelle bat emerging from beneath a fascia board fitted to the building at 20:16 and was followed by a further four common pipistrelle bats between 20:17- 20:20. Three common pipistrelle bats were recorded emerging from a separate location close to a downpipe at 20:22 and a further common pipistrelle bat was recorded to emerge at 20:26 close to the southern elevation of the roof.

The survey commenced at 19:35, sunset was 19:57 and the initial bat recorded by the surveyor located on the western elevation (Fig. 6) was a common pipistrelle bat which emerged from a gap beneath the southern fascia, next to a down pipe at 20:11. A further three common pipistrelle bats were recorded to emerge from the same location between 20:16- 20:18.

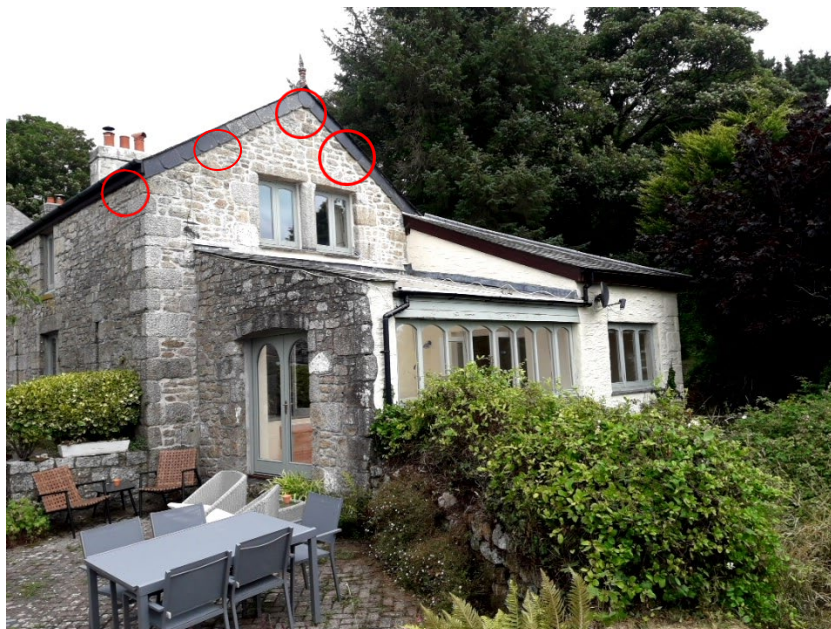
**Figure 7. Southern elevation. Bat emergence points.**

The surveyor located on the southern elevation (Fig.7) recorded six common pipistrelle bats emerging at 20:15 from beneath a section of slate verge, close to the roof apex. A seventh common pipistrelle bat emerged from beneath the slate verge, but slightly further down the roof slope.

The surveyor on the southern elevation (Fig. 7) recorded four common pipistrelle bats emerge at 20:13 – 20:14, from a gap beneath the slate verge. At 20:30, two common pipistrelle bats returned to the building and re-entered and then re-emerged at 20:34.

The Grange and Outbuilding are in use by common pipistrelle bats, the number of bats recorded emerging from the slate verge on the southern apex is indicative of this area being used as a nursery roost and the other roosting locations around The Grange and Outbuilding are in use as roosts by a lower number of common pipistrelle bats as day roosts.

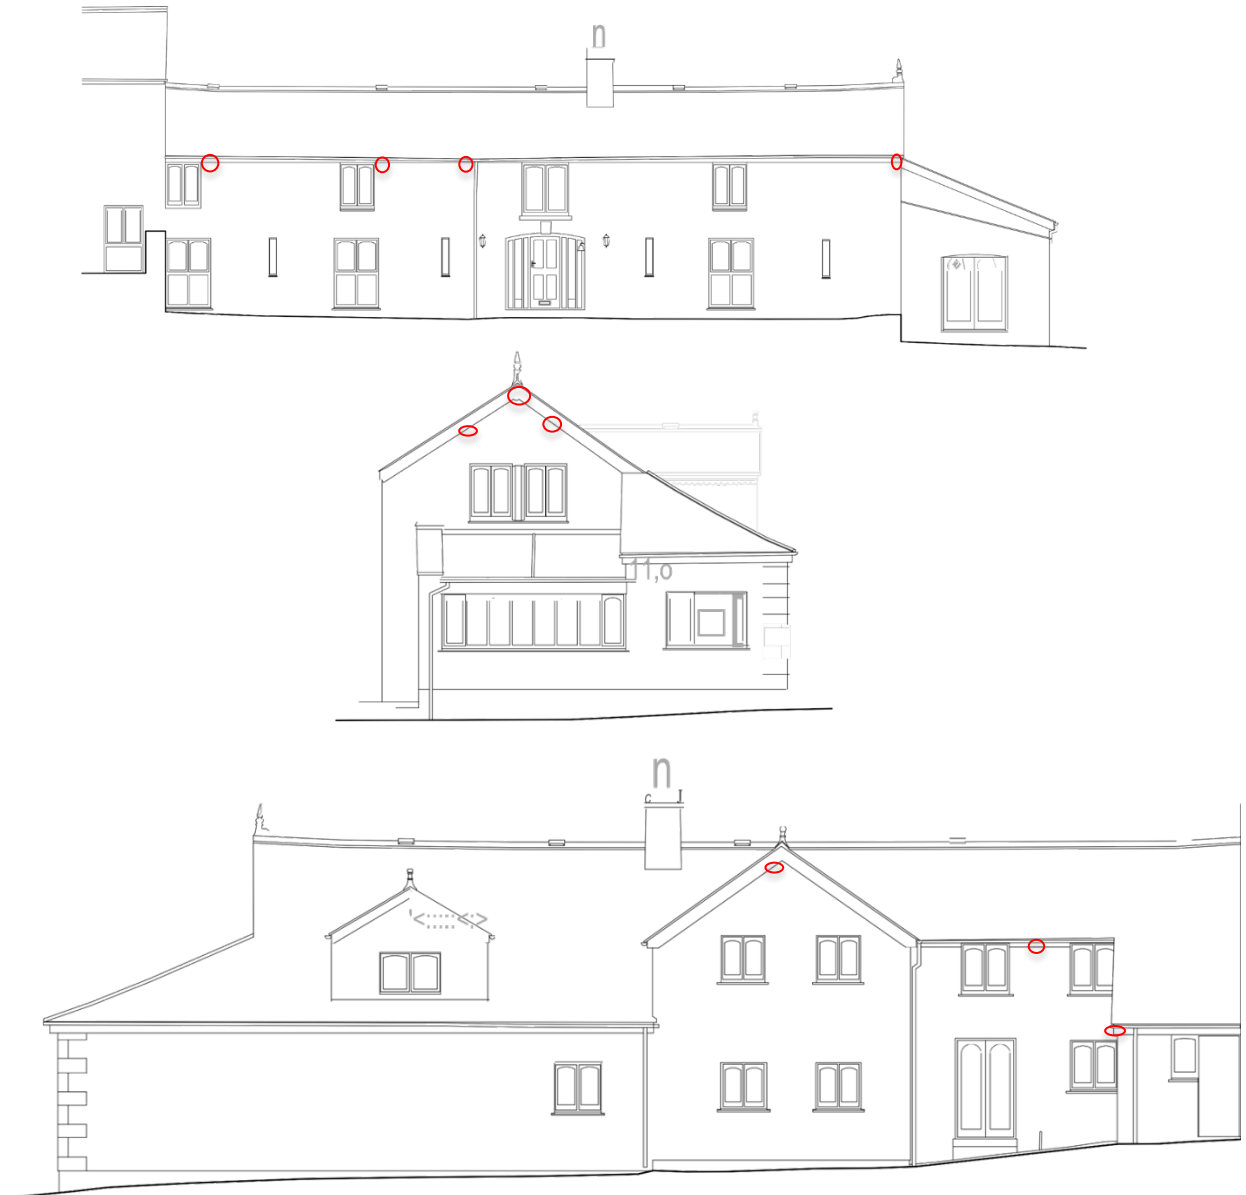
**Figure 9. Existing elevations & bat emergence points**

The initial visual assessment of the buildings concluded that The Grange had evidence of use by roosting bats and that further surveys should be undertaken to confirm species and use by bats. The subsequent emergence surveys recorded common pipistrelle bats emerging from various locations within the roof on all aspects.

The proposed works will include the addition of a roof extension, and conservation roof lights to be set into the roof. Although the proposed works are away from the entry/exit points the works if not appropriately mitigated may result in disturbance and the loss of roosting opportunities.

In order to allow for the proposal to be legally undertaken and based on the number of common pipistrelle bats and roosts found, the works will require a Natural England bat mitigation licence (A13) to be in place before any works are undertaken.
