**BAT AND BARN OWL SURVEY OF  
BUILDINGS AT SEA VIEW FARM, OLD PORTREATH ROAD,  
REDRUTH, CORNWALL TR16 4JA**

**June 2023**

**Spalding Associates (Environmental) Ltd.  
10 Walsingham Place  
Truro  
Cornwall  
TR1 2RP**

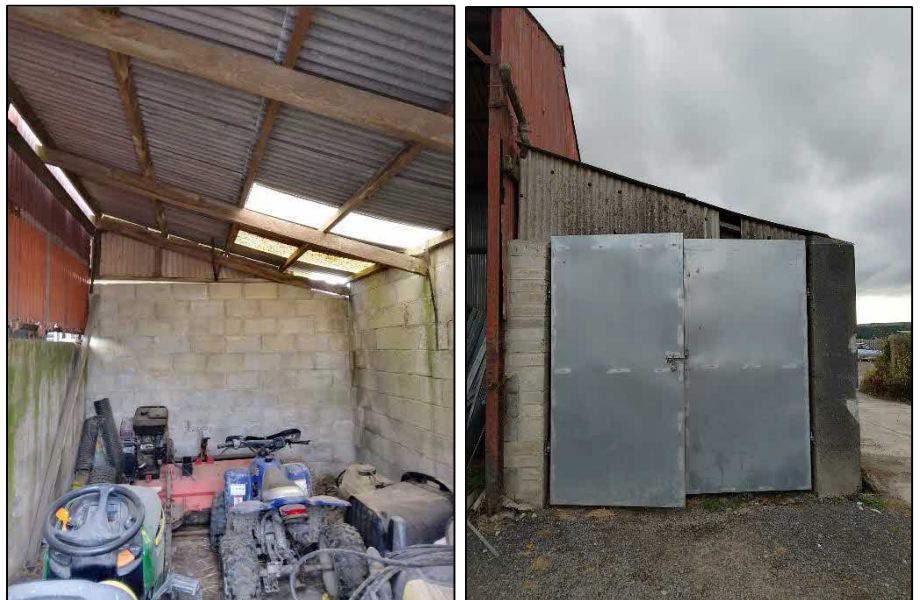
The main building on site is a pole barn, fully open to the east with the lean-to extension connecting to the north face of the barn. This mono-pitched extension is composed of concrete blockwork walling for the north and west walls and with the south side open to the external north face of the main barn building. Access into this lean-to extension is through a large metal double door on the east face. Internally, the space is currently in use for storage of machinery and small vehicles. The roof of the lean-to is composed of a mix of metal corrugated sheeting and a translucent composite material sheeting supported by a timber frame. The space is bright internally being lit with natural light.

**Photos 1 and 2:**  
**Internal view of the lean-to extension (left); east face of the extension showing metal double doors (right).**

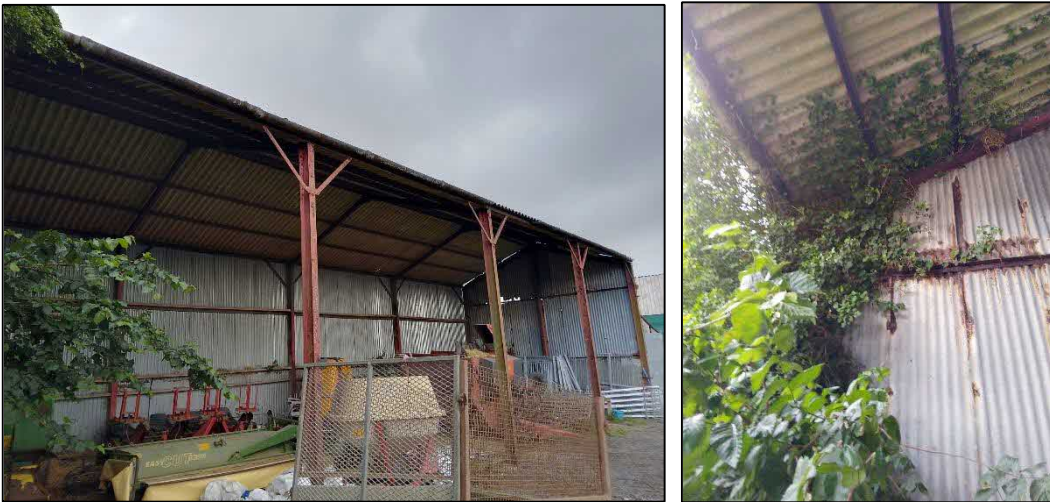
The main barn building walling is composed of corrugated metal sheeting for the south and west walls with the northern wall composed of rendered concrete blockwork to approximately 2 metres high with corrugated metal sheeting composing the top half of this wall. This barn is open to the elements and is light and draughty internally, with no enclosed roof void space. At the time of survey it was currently in use for storage of machinery and fencing materials.

A metal frame supports corrugated metal sheeting roofing and ridge tiles of a composite material which are loose and ill-fitted. There is a missing corrugated panel on the western aspect of the roof at the south end which allows in additional light. Ivy *Hedera helix* densely covers the southern external wall of the barn and is encroaching internally onto the south wall.

**Photos 3 and 4: East face of the main barn; internal south face of the barn.**

There is a disused bird nest (possibly Blackbird *Turdus merula* or Song Thrush *Turdus philomelos*) located on a wooden beam that extends along the western wall. A further two old bird nests (possibly Blackbird or Song Thrush) are present within the Ivy on the internal south wall supported by the metal frame and at the intersection between the corrugated metal roofing and walling, supported by a metal frame. The heavy Ivy on the southern wall of the pole barn and on the north, south and west faces of the stable block also has potential to be used by birds for nesting (1<sup>st</sup> March to end of August).

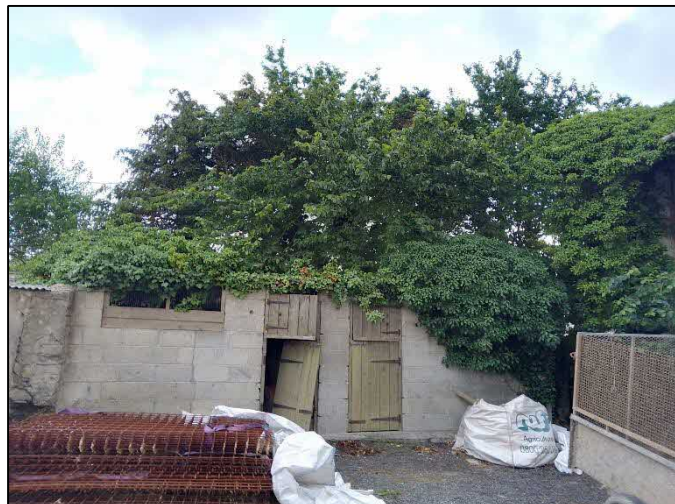
There is an old single-storey stable building located adjacent to the main barn building which is not currently included within the proposal to demolish. A brief internal and external inspection was conducted to assess if this building in close proximity could support a bat roost. The old stable building is relatively dark internally with some natural light entering through the stable doors and a metal mesh on the northern face. Walling is comprised of breeze blocks here and internally a timber frame supports corrugated metal sheeting. Dense Ivy covers the north, south and west faces of this building.

**Photo 5: North face of the adjacent stable building.**

Externally, gaps behind dense Ivy coverage on the stable-block and open pole barn offer low potential for roosting bats.

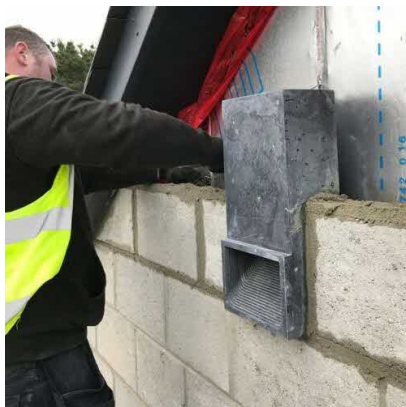
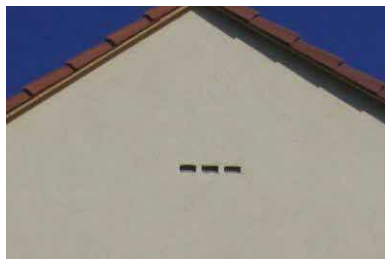
**Examples of Integrated Bat Blocks which can be incorporated into new buildings.**

However, if the owners wished to do so, new roosting opportunities for bats could be incorporated into the new buildings. This could be accomplished by installing purpose-built bat boxes onto/into the walls of the new buildings or by spacing off the fascia boards to create a cavity behind with access to the wall tops. If mitigation is carried out, care should be taken that no light sources reach the roost entrances. This would help to increase the biodiversity value of the site. If access to internal areas of the roof is provided, traditional Type 1F bitumen felting or a certified ‘bat-safe’ alternative should be used on new roofing as bats can become entangled within modern breathable roof membranes.

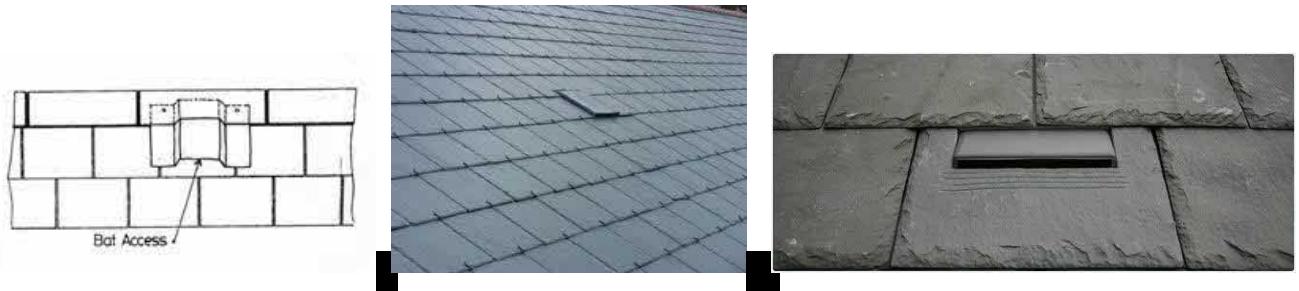
Bat slates could be incorporated into the design of the new roofing. These can be built by making the appropriate shape with an off-cut of lead. The opening should be 15-25mm wide by at least 50mm long. This allows bats to land on the roof and crawl into the roof void or area behind the tiles. Alternatively, a Bat Vent can be purchased and are available in a number of slate finishes and sizes. The bat slates or vents will be installed approximately one third of the way down the roof slope. A small hole (25mm x 50mm) will be cut into the roof lining/membrane under the bat slate to allow bats to access the roof void.

**Examples of bat slate designs, and bat vents.**

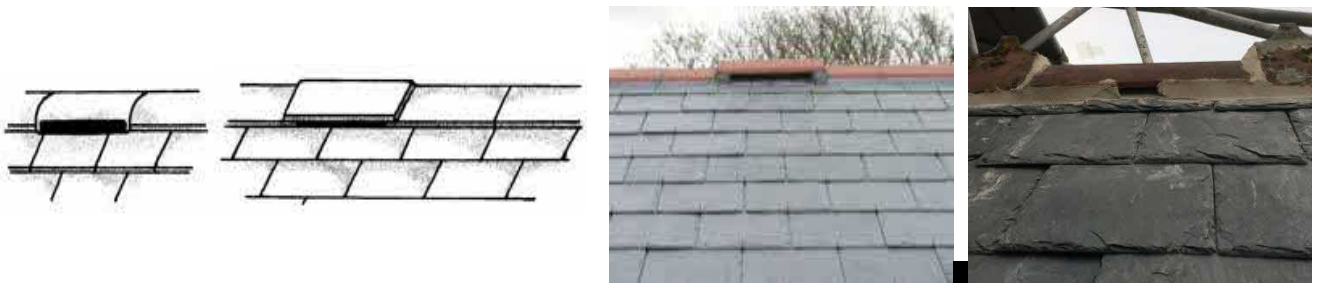
Modified ridge tile bat accesses can be created by overlapping one ridge tile over its neighbours. The gap created should be 15-25mm wide by at least 50mm long. Mortar should be applied sparingly on nearby ridge tiles so that a tunnel-like void is created through several ridge tiles. A small hole (25mm x 50mm) should be cut into the roof lining/membrane under the ridge tile to ensure bats can crawl into the roof void, for example ridge tile designs.

**Examples of modified ridge tiles.**
