cornwall
environmental
consultants LTD

Bat and Barn Owl Assessment
4 Treganoon Road
Mount Ambrose
Redruth
TR15 1NN

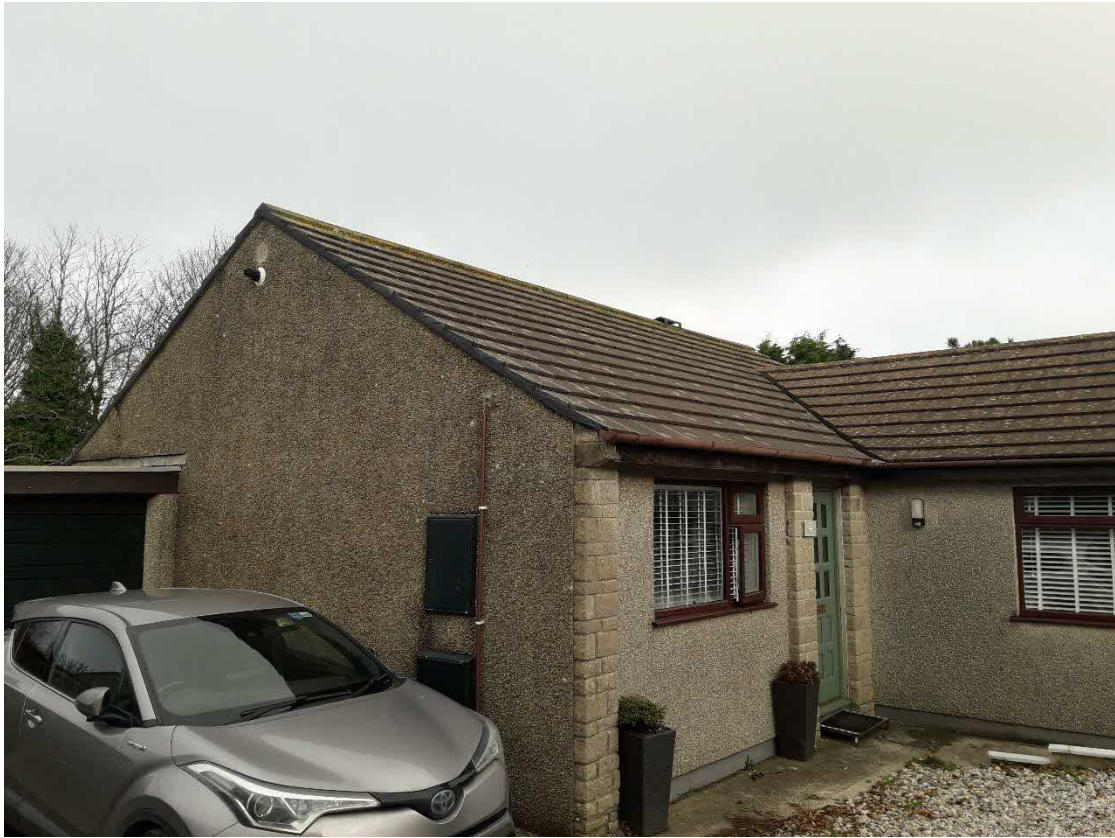
Figure 1. Building assessed.

The garage is built from single row concrete block and is covered with a felt covered flat roof. The main bungalow is built from rendered, cavity walled concrete block walls and is covered with a tiled roof which is underlined with bitumen felt. As well as assessing the garage, as the proposal will require the new extension to join into the main bungalow, a search of the interior of the bungalow roof void and the exterior of both was undertaken. The garage and roof void were searched for signs of use by roosting bats and was followed by a search of the exterior. The roofs of both sections are tightly fitted with no features suitable for use by roosting bats. The fascia and soffit boards are tightly fitted but there was a gap within the north-eastern aspect that has potential for use by bats. This gap was searched by means of an endoscope, no evidence of use by bats was noted but a previously occupied house sparrow (*Passer domesticus*) nest was noted. A search of all areas considered to have some potential for use by bats, including the exterior and interior of the garage and bungalow was undertaken; no evidence of use by bats was noted.

Although no evidence of use by roosting bats was found, roosting opportunities change, and bats may move between roosts, therefore it cannot be assumed that bats are not present when works commence. Care should, therefore, be taken during the work as bats could roost unseen deep within crevices in the structure. If any bats are discovered during the work, they must not be handled: works must stop immediately, and advice sought from CEC (tel 01872 245510).

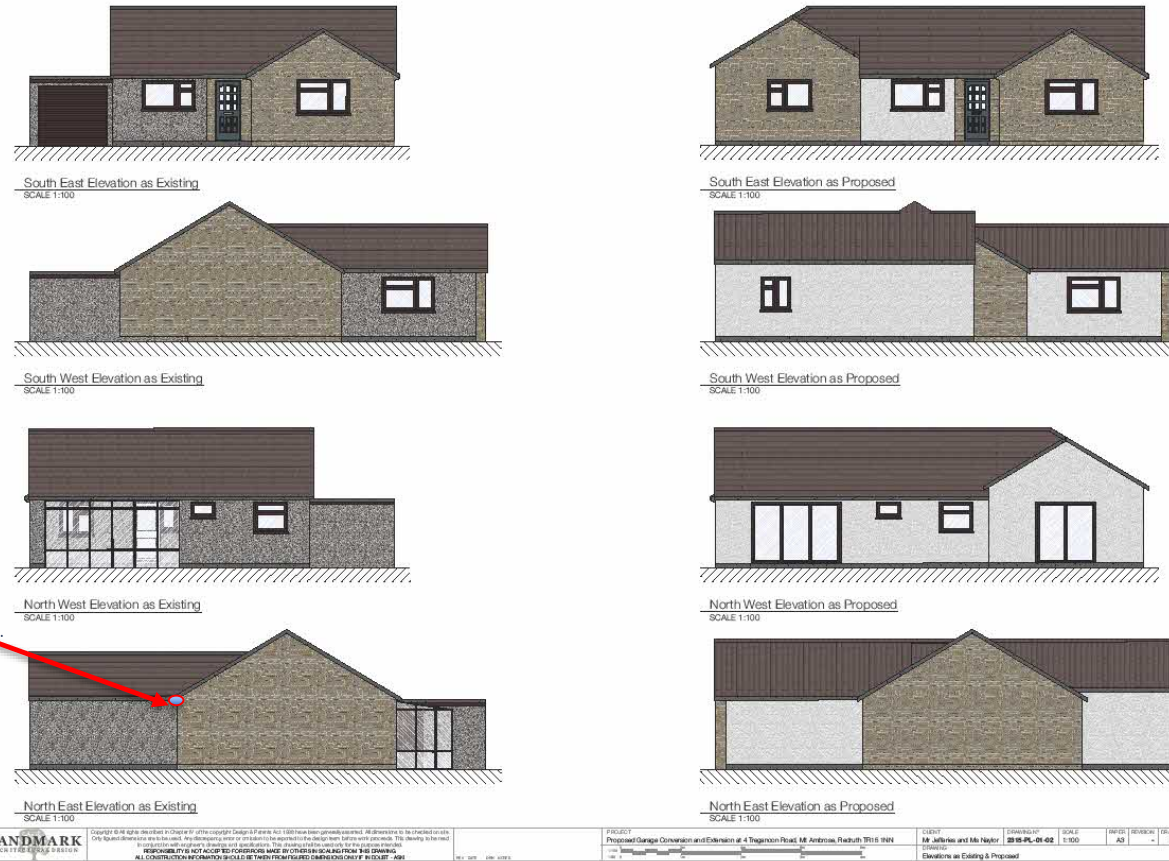
Figure 2. Proposed conversion.

If you wish to promote wildlife, it is possible to provide roosting opportunities for bats within the completed building. Access for bats can be provided into the roof space (or into the space beneath the roofing slates if the development is to have vaulted ceilings) by leaving small gaps 15-20mm wide by at least 50mm long in suitable places. Suitable places would include behind soffits, fascia and barge boards or at the gable apex. The access points would need to be next to the walls (to allow bats to land on the wall then crawl up through the access point) and not inadvertently blocked by insulation (see enclosed leaflet for additional information).
