Design and Access Statement

Marsland Manor, Morwenstow
Bude, Cornwall
EX23 9ST

August 2023

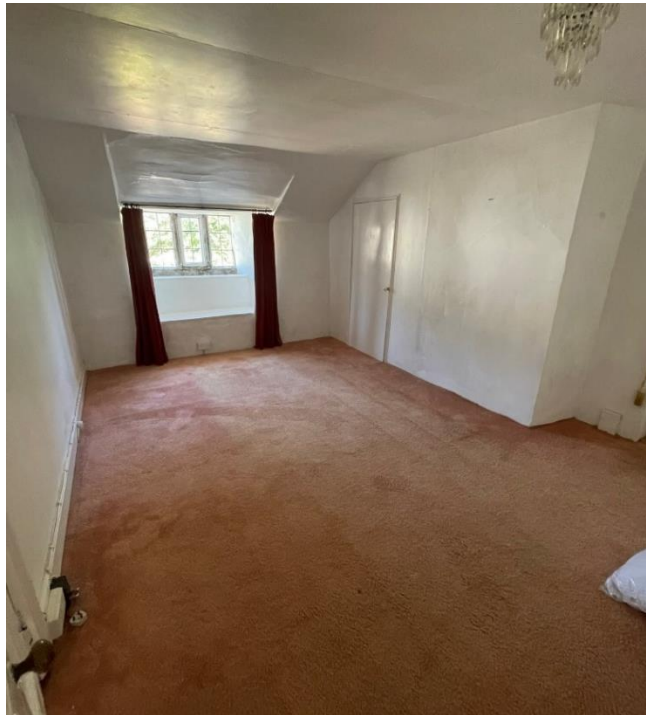
Figure 1 – Existing Bedroom 5 to be converted into a ‘Jack and Jill’ bathroom, retaining the through-passage layout. Pipework to be boxed in at low level and soil pipes to be located within existing cupboard, dropping down into the utility below.

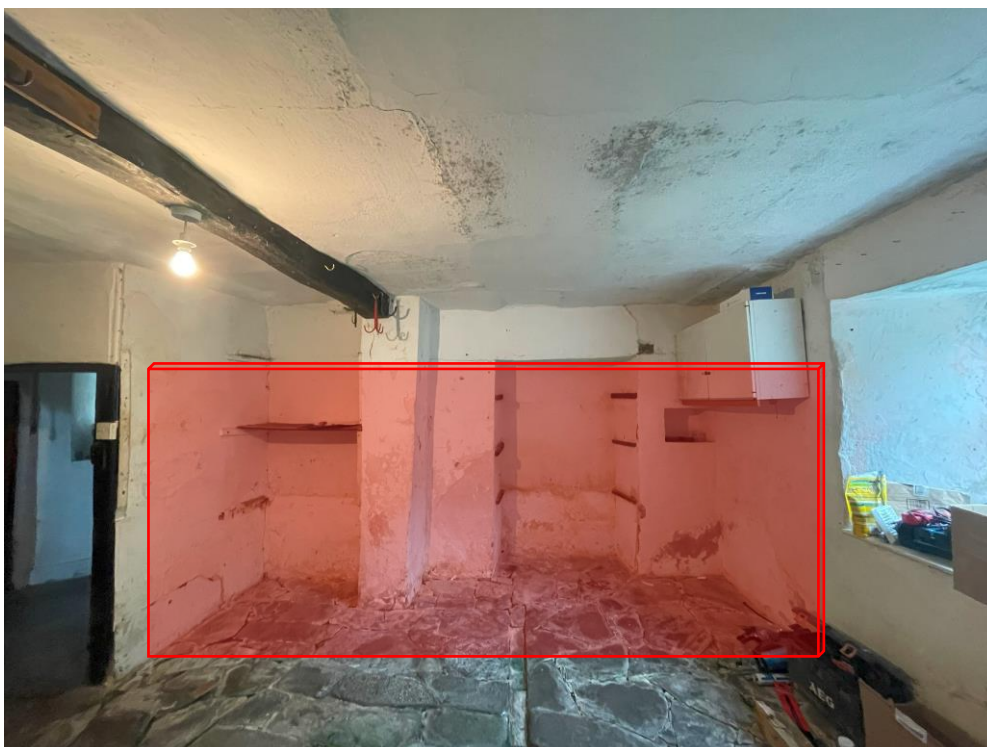
Figure 2 – Existing utility room. New shower and WC to be installed behind bespoke three-quarter timber stall partition on raised floor. Final joinery details to be submitted for approval.

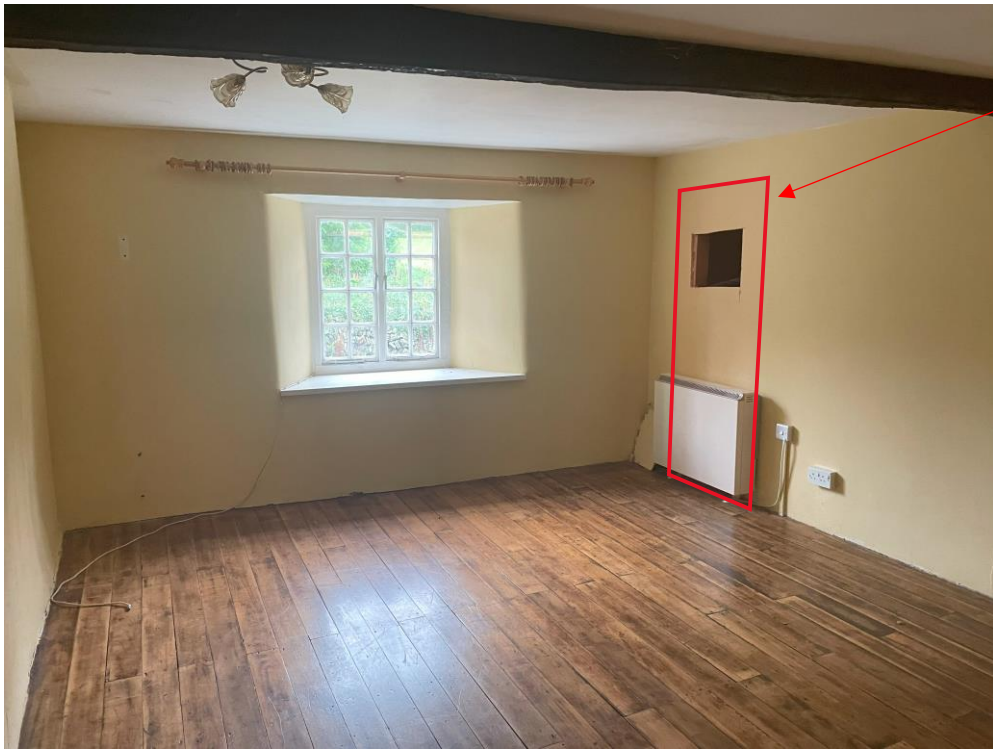
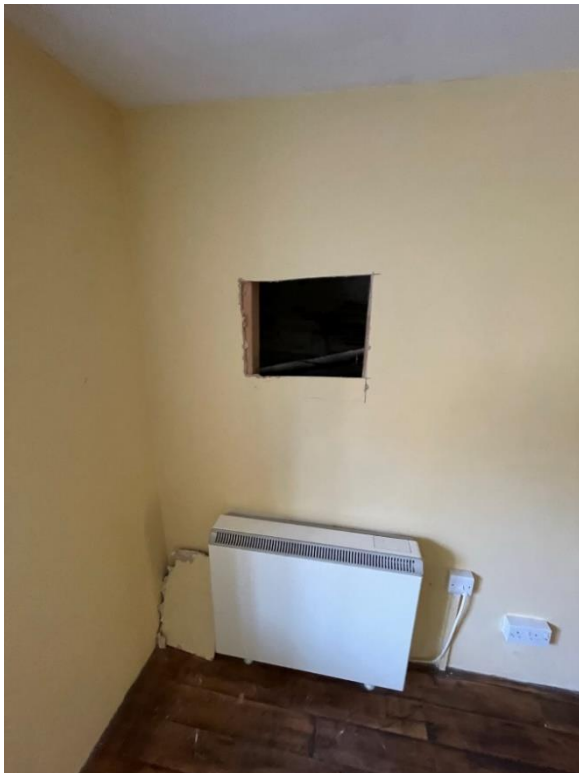
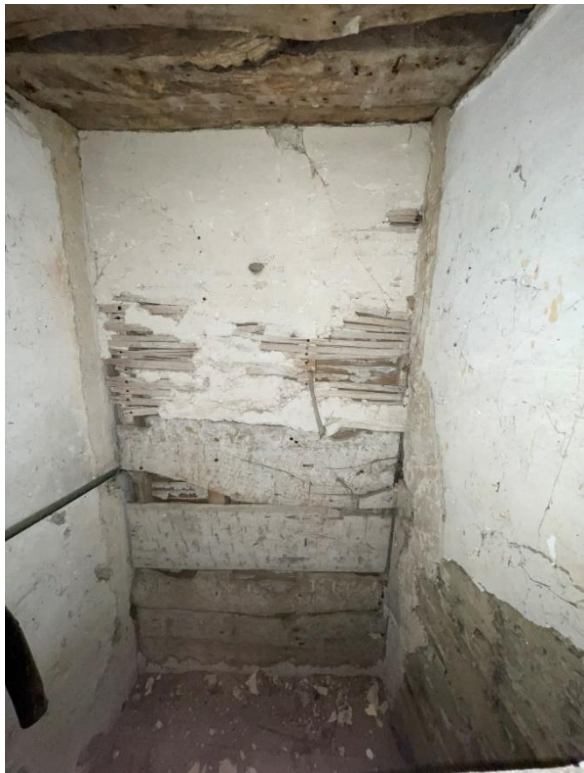
Historic opening reinstated

Figures 3-5 - Existing annexe bedroom to be converted into bathroom and opening to main Bedroom 1 to be reinstated. Photos showing timber plank and lath and plaster in-fill, timber lintels and plastered wall reveals, indicating historic opening, understood to have been blocked up in the 20th Century.

Pipework to be boxed in at low level, exiting through new opening in the external wall and connecting into existing external soil pipe.

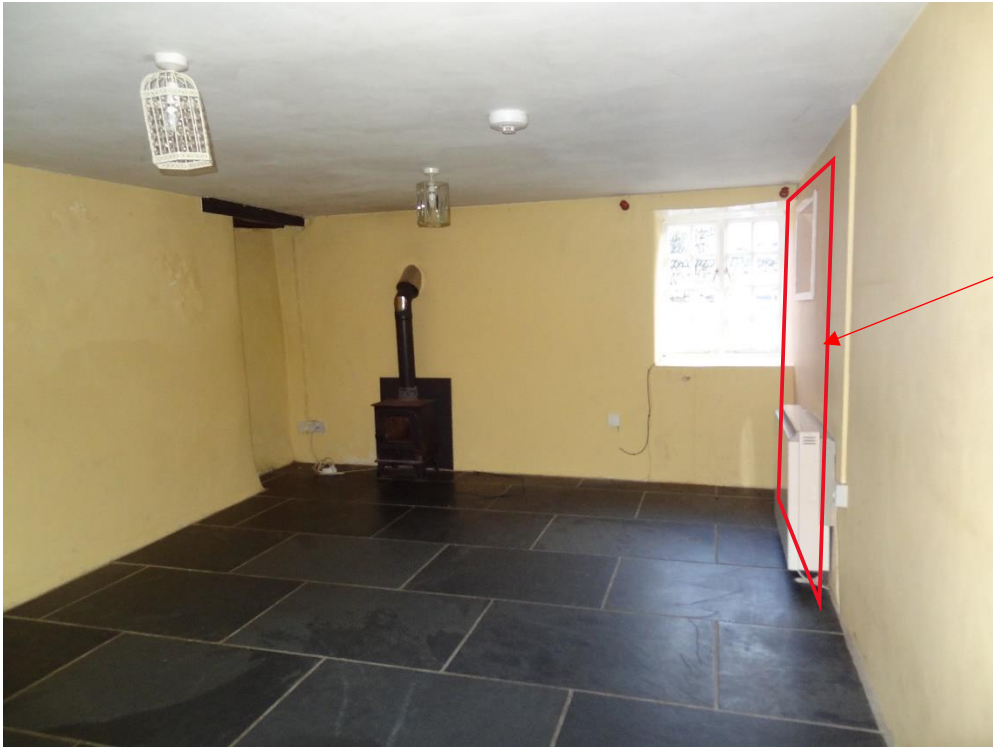
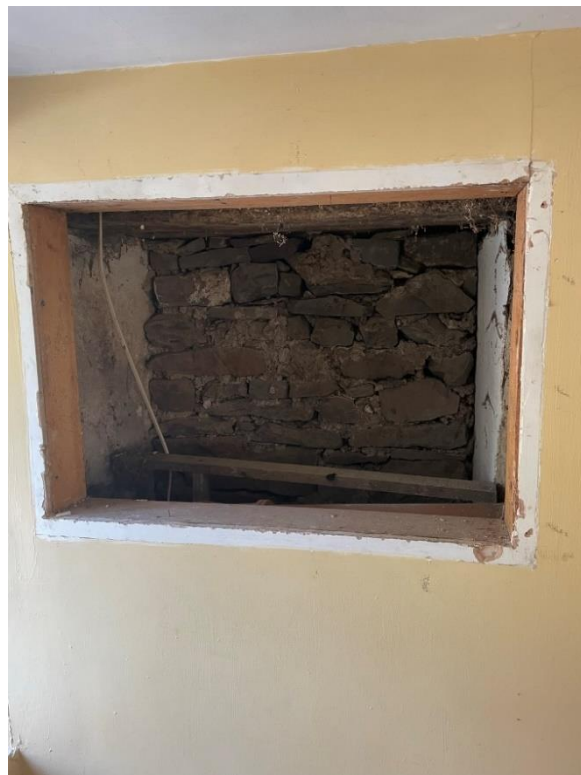
Historic opening reinstated

Figures 6-7 – Existing annexe dining room, opening to main sitting room to be reinstated. Photos showing stone in-fill, timber lintels and plastered wall reveals, indicating historic opening, understood to have been blocked up in the 20th Century.

Pipework from new boiler to enter via blocked up door opening to rear wall, shown at the far left of the photograph.

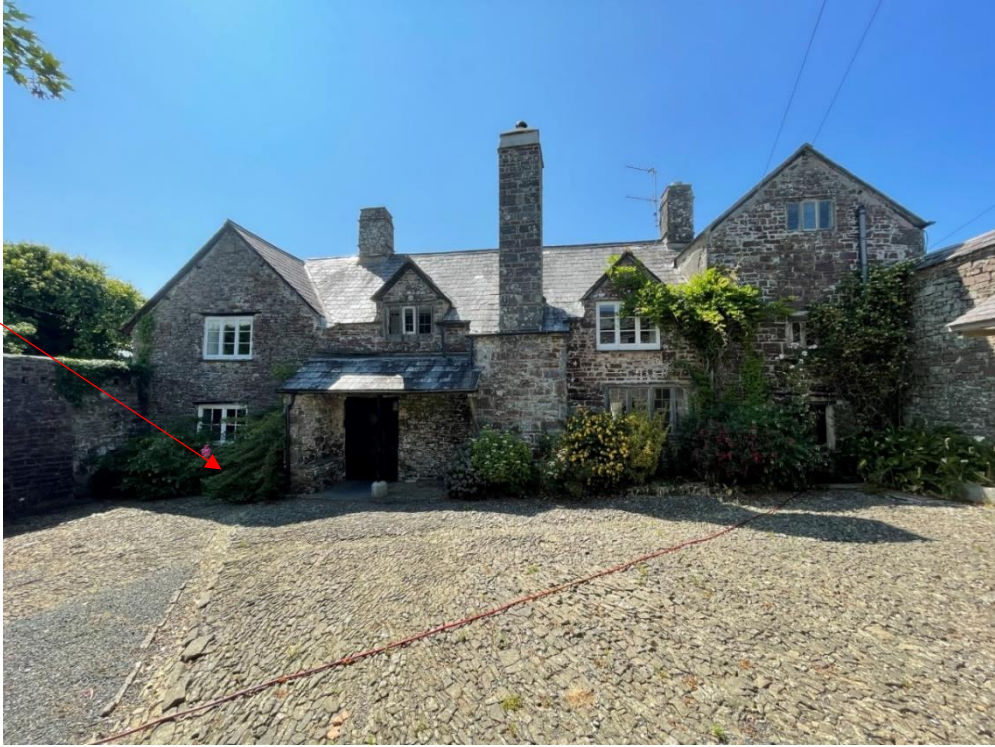
Soil pipe to exit at low level and connecting into existing underground soil pipe

Figure 8 – East elevation. New soil pipe to exit at very low level to connect into existing underground soil pipe. Localised lifting of cobbles to enable installation of pipe branch, cobbles to be reset as existing.

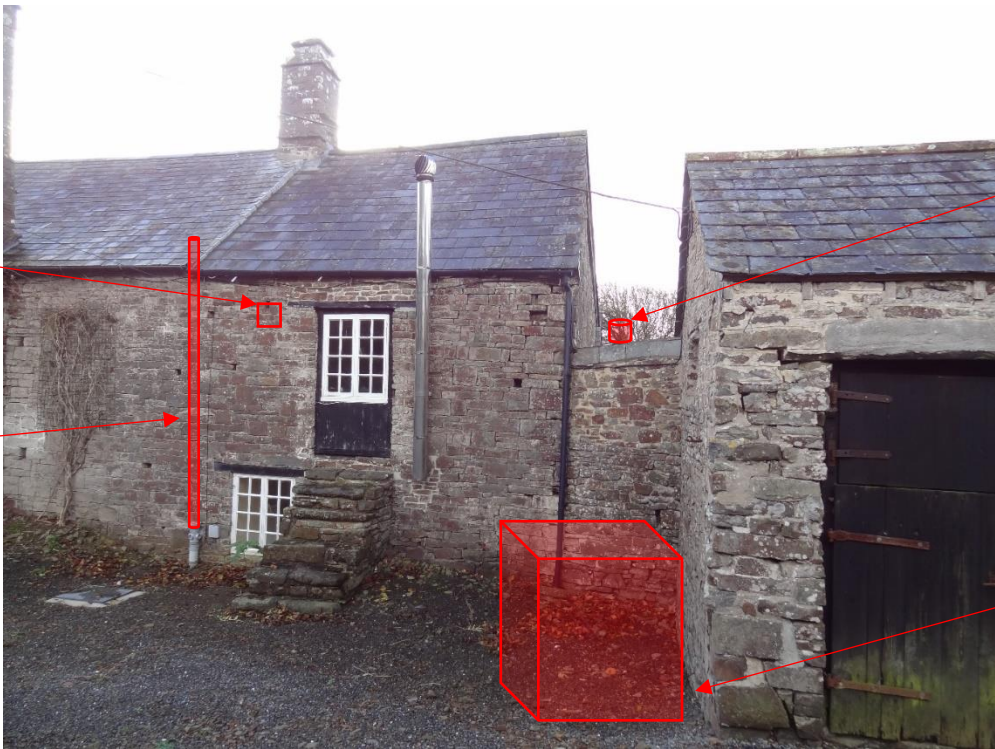
Conservation vent grille serving extractor fan.

Soil pipe connecting into existing stack. Replaced with cast iron pipe.

Boiler flue outlet through lean-to store roof

Location of new bundled oil tank serving boiler

Figure 9 – North elevation. Conservation vent grille with insect mesh to be installed. New soil pipe connecting into existing stack and pipe replaced with cast iron pipework. Localised making good of stonework in lime putty mortar.

The new oil tank will be a bunded tank, located at the north west of the property externally, sited in line with the requirements of Building Regulations Approved Document J including the incorporation of a protective fire guard. There is evidence of an oil tank having been sited in this location previously. The oil fired boiler is to be located within the adjacent lean-to store with flue terminating through the Delabole slate roof incorporating a pitched roof lead slate flashing detail. The pipework from the boiler into the property will be via minimal penetrations through a blocked up opening between the lean-to store and annexe sitting room. Circulation pipework will be surface mounted copper pipework to minimise disturbance of the historic fabric and enable the works to be reversible.

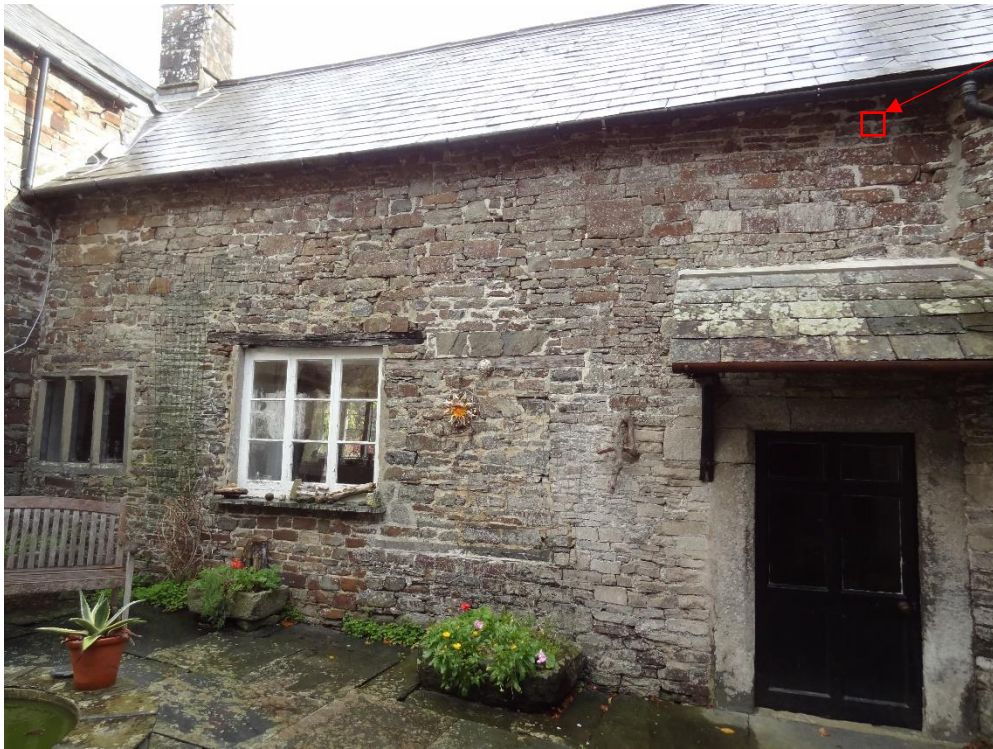
Conservation vent grille serving extractor fan, localised making good with lime putty mortar.

Figure 10 – Internal courtyard west elevation. Conservation vent grille with insect mesh to be installed and localised making good of stonework in lime putty mortar.

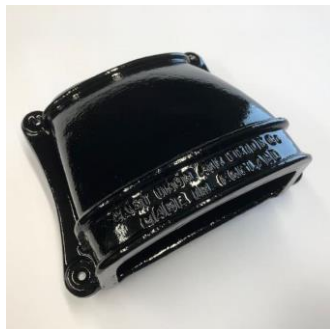
Figure 11 – Proposed conservation vent grilles (sourced from Cast Iron Brickwork Company).

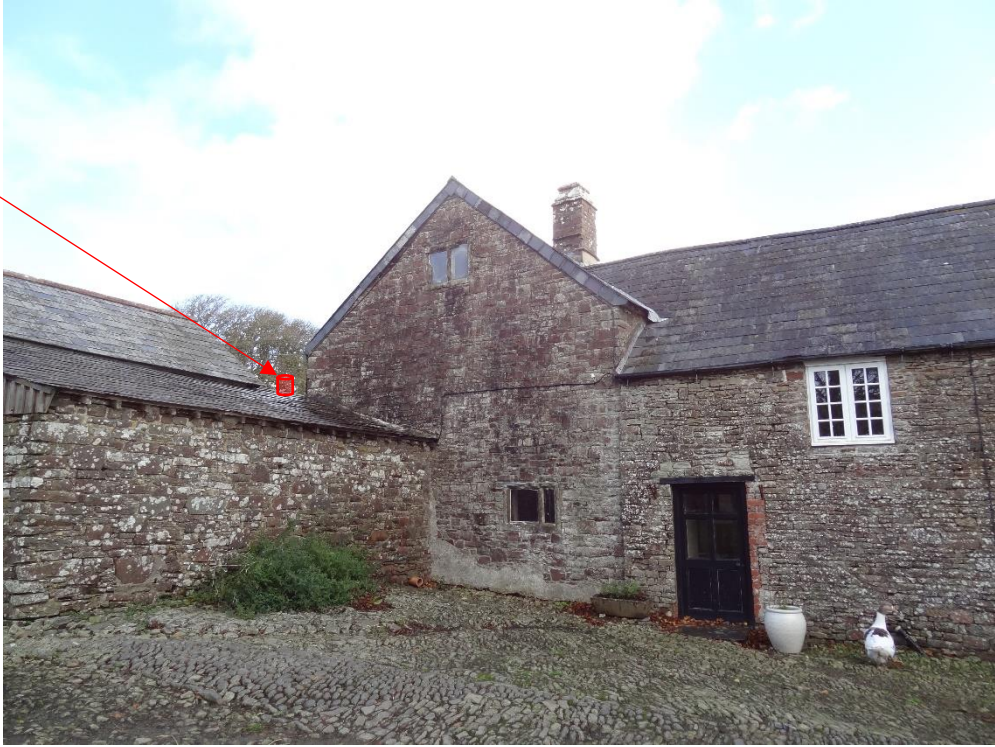
Boiler flue outlet through lean-to store roof

Figure 12 - West elevation. Boiler flue to terminate through roof of lean-to store.

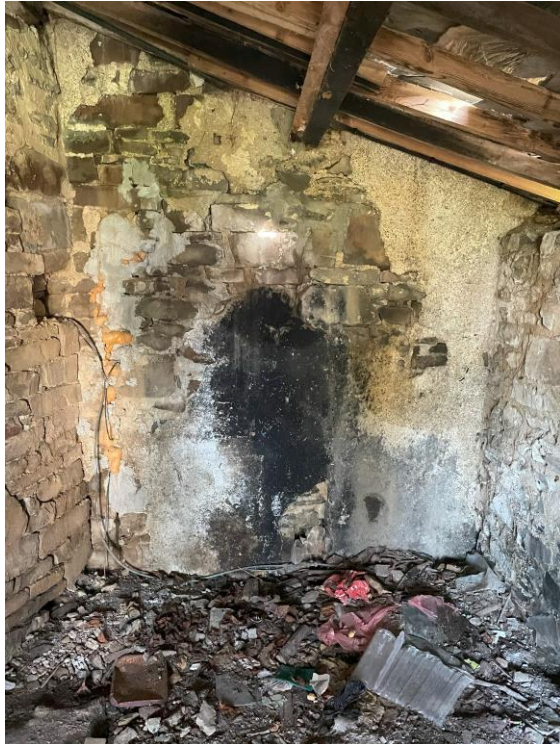
Figure 13 - Interior of lean-to store and location of proposed oil boiler, to be set on concrete plinth. Flue to terminate through rag slate roof. Service pipes to enter main house through blocked up opening (area of blackened render).

The application seeks to convert two first floor bedrooms into 'Jack-and-Jill' bathrooms, forming a ground floor shower room within the existing utility room, reinstating previous door openings and installing a wet central heating system with oil-fired boiler located in the lean-to store to the west.

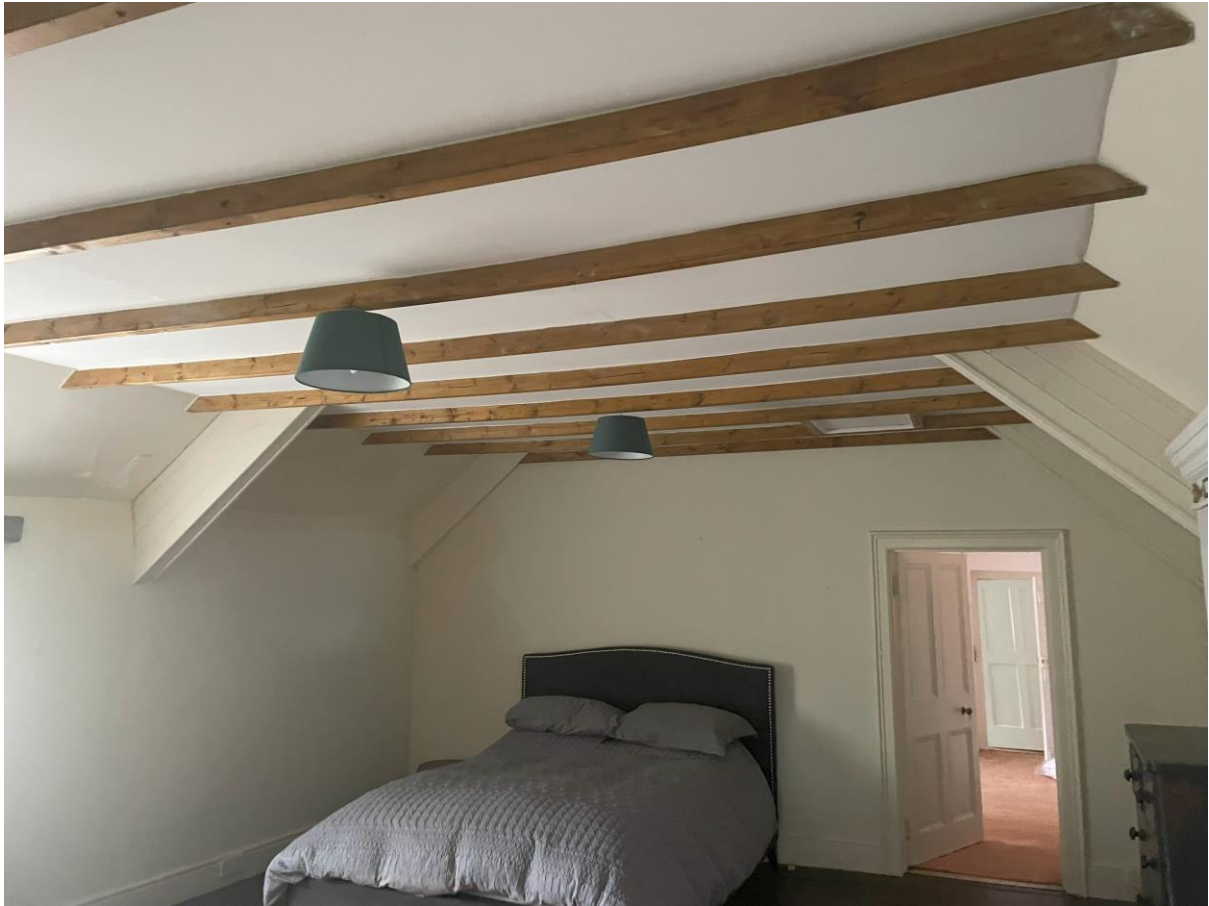
Figure 14 – Bedroom 2 ceiling – plasterboard to be fixed to underside of 20th Century timber beams, skimmed and painted, to provide ceiling of height and finish consistent with adjacent rooms.

The applicant also seeks to 'reverse' some of the modern interventions within the property to provide finishes that are more in keeping with the style and architectural values of the house. These include the replacement of the contemporary floorboards within the south range bedroom, fitted due to previous decay, with timber floorboards sourced to match the dimensions and colour of historic boards elsewhere in the property. The applicant also intends to board and skim the underside of the exposed contemporary ceiling beams within the east range central bedroom to provide a finish and ceiling height that is consistent with the ceiling of the adjacent bedroom.
