**Ecological Survey for
The Piggeries, Dusthouse Lane, Finstall,
Bromsgrove
B60 3AE
SO 98390 69443**

Survey Objectives

Planning permission is being applied for to convert an existing agricultural building to living accommodation. An ecological survey has been requested to ensure that no European Protected Species (EPS) are likely to be disturbed by this work.

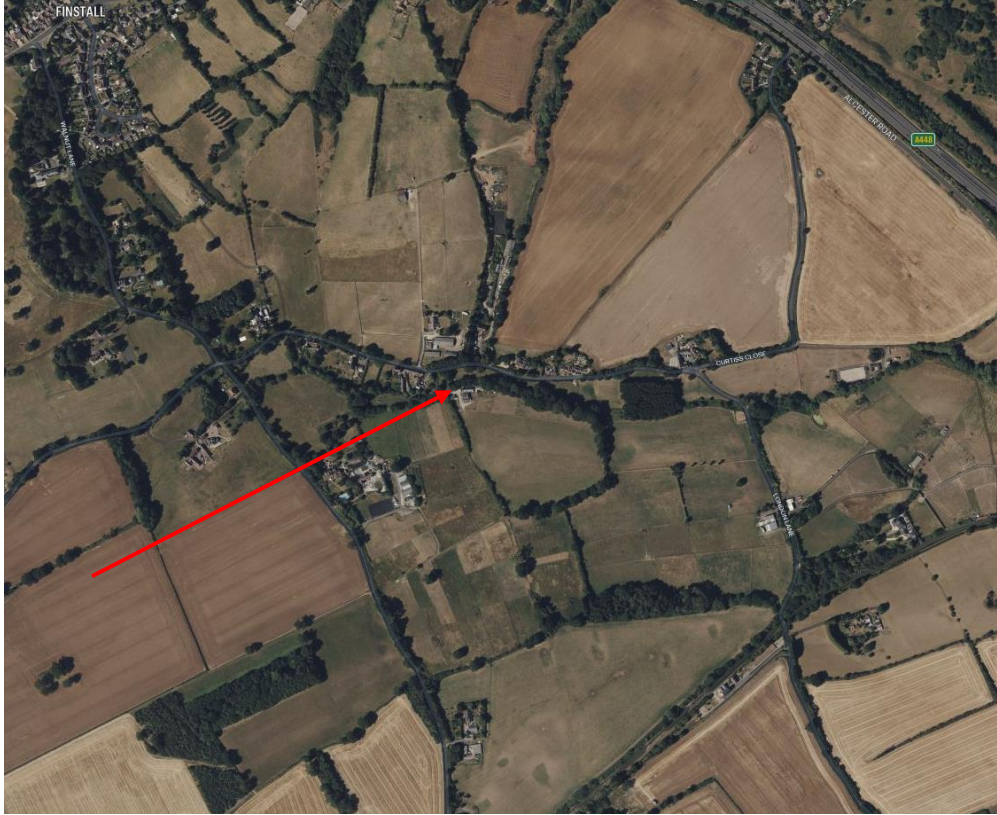
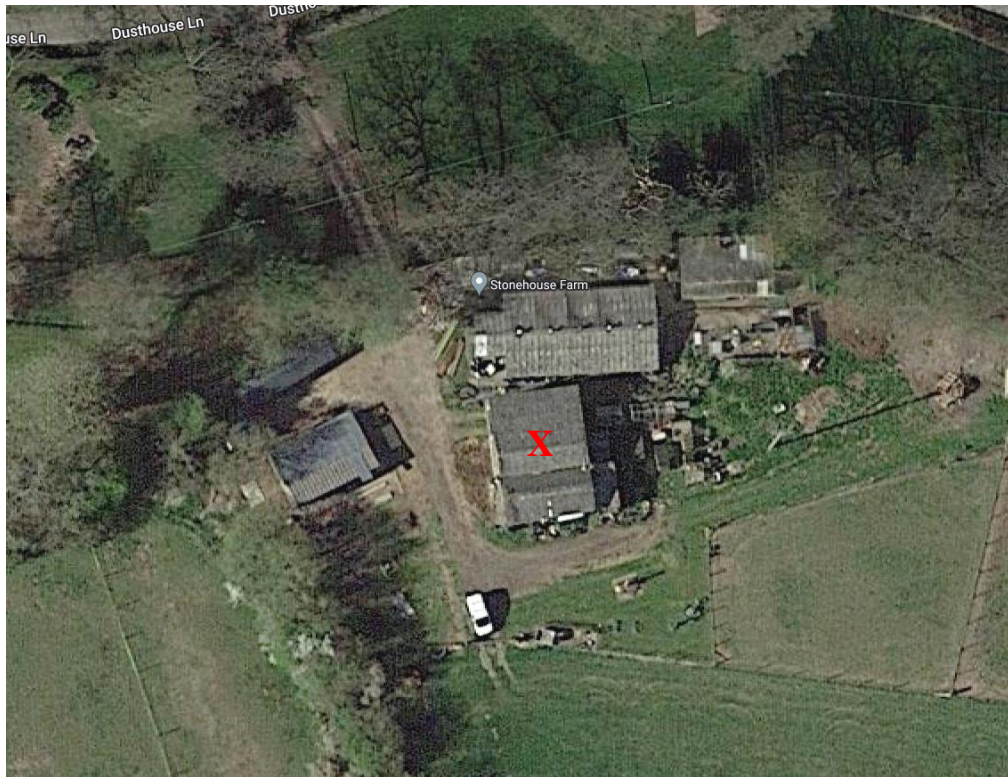
X marks building for conversion.

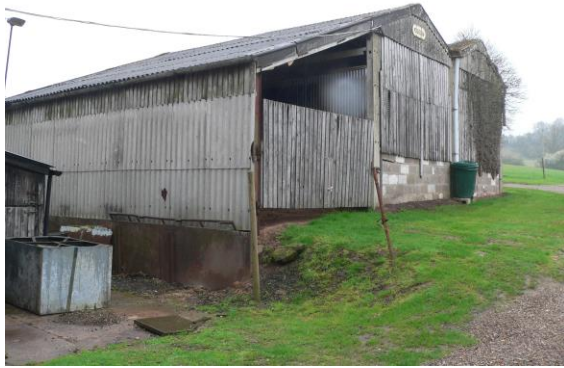
North west corner

The building was of a mostly tin construction with a corrugated fibre cement roof. Entry for bats or birds possible via open frontage. Most internal beams were concrete, although some wood. The construction offers little in the way of cosy roosting spaces for bats.

No birds nests were found on the outsides of the building although one section was sparsely covered with Ivy which if left to grow could provide nesting area for birds.

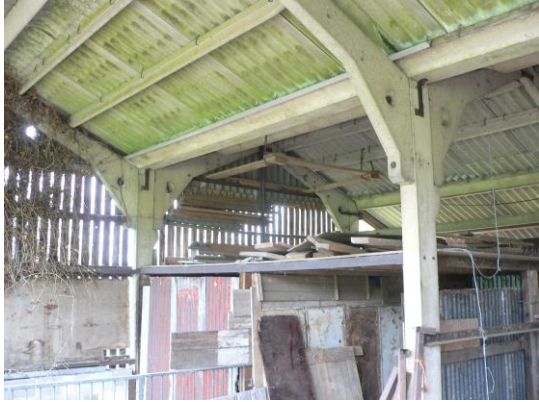
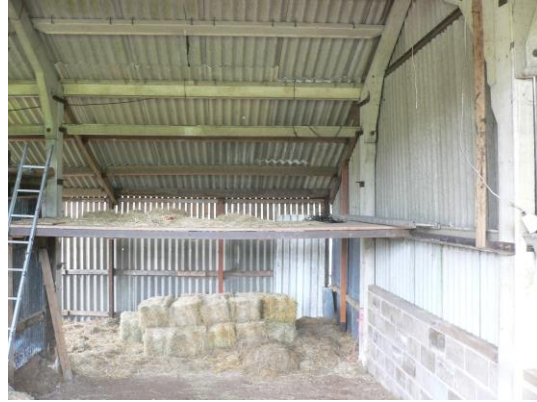
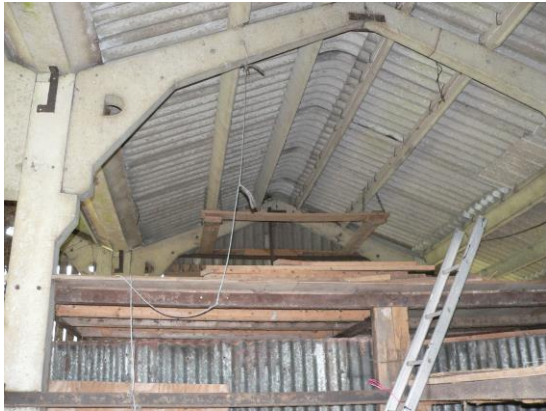
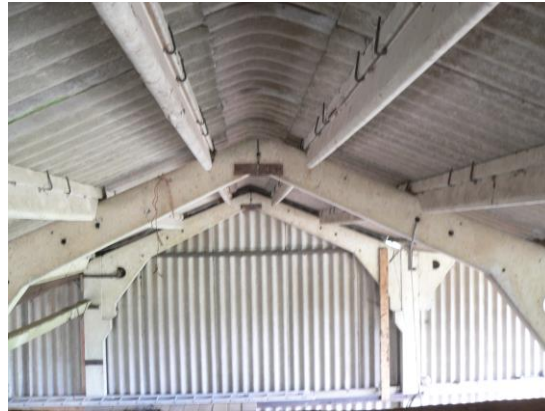
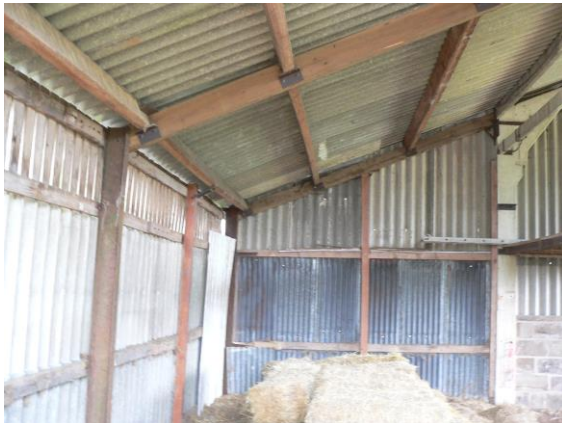
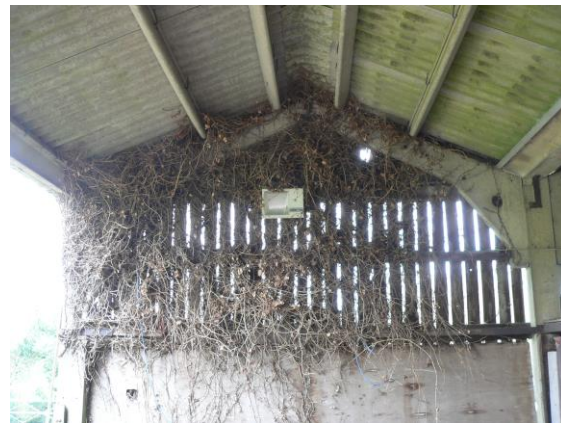
A thorough internal search was made for signs of bat or bird use. No bats or bat droppings were found following a close search of the entire area. The construction has little in the way of dark roosting spots, it is not likely to be used by bats.

No evidence of nesting birds was found although there was a patch of dead ivy inside the front area.

Dead ivy inside

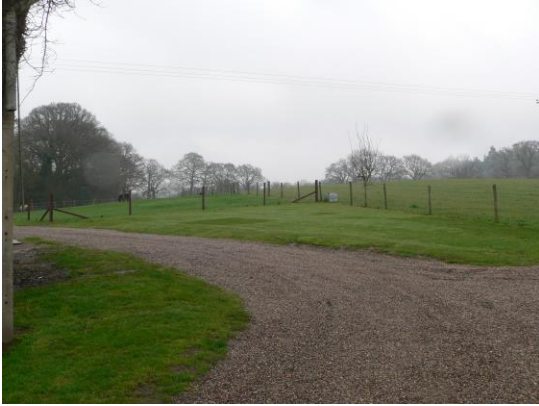
Grass pasture fields to the south.

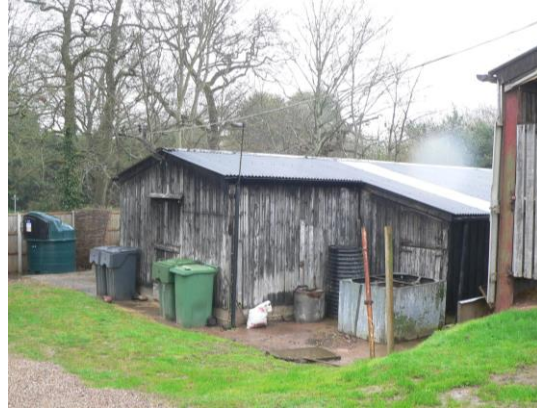
Barn on north side which will remain

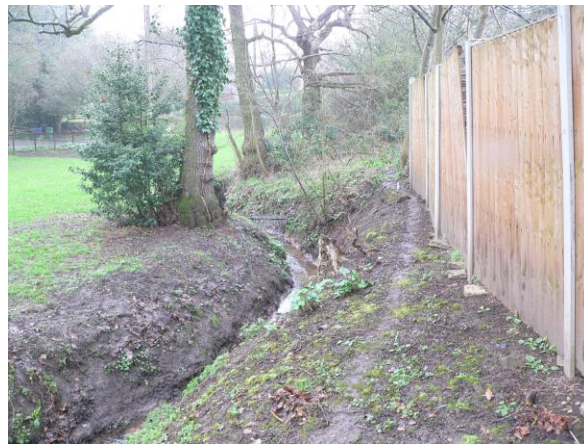
A search of the surrounding area was made, looking for places which could be used as a hibernaculum for reptiles, hedgehog, etc. No likely place was found. The area was also searched for signs of badger activity, nothing was present. The stream on the north side was viewed although this is separated from the building due for conversion by fencing and another existing barn structure which will remain. Nothing was found in this area.

Small stream on north side.

3. Should any active bird nests be found, construction must be halted until young birds have fledged.
4. It is always good policy to try to increase the general biodiversity of a site to attract future wildlife. It is recommended that one bat box be erected in the area, preferably

on a mature tree near the stream area. One or two bird nesting boxes could also be erected.
