### **Brief Letter Report for the Enhancement Measures at Pad End Barn**

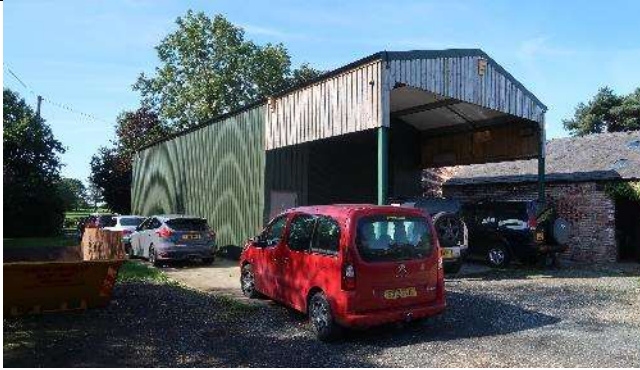
It was noted during the site visit, that a number of bat and bird boxes, including two owl boxes were already in situ on the 'new' building. These were not inspected further owing to the height of the boxes but were observed from ground level. A barn owl was also heard in one of the boxes and fresh barn owl pellets were found on the ground. In addition to this, sparrow terrace boxes were also noted on the building. Bat droppings indicative of pipistrelle species were also found on a parked car beneath the north facing canopy and indicate possible use of the bat boxes or foraging activity in that area.

'New' building as noted during the site visit 13.09.2023	Front canopy with bat and bird boxes

<p>Owl boxes within the canopy of the 'new' building.</p>	<p>Barn owl pellet on the floor beneath the canopy of the 'new' building.</p>

<p>Owl box and bat boxes beneath the canopy of the 'new' building.</p>	<p>Bat droppings on the bonnet of car parked beneath the canopy of the 'new' building.</p>

If in use, the bat boxes would be afforded full protection under the relevant legislation and a licence obtainable from Natural England would be needed should they need to be removed or if they are to be disturbed for any reason. Similarly, barn owls receive full protection whilst at or near to an active nest. See below photographs showing the bat and bird box locations.

In addition to the above, one of the pre-existing timber bat boxes shall be relocated to a less cluttered location on the 'new' building, currently on the west elevation. Prior to relocation, the box shall be inspected by a bat licenced ecologist for bats or any signs of bat presence that would indicate that this is a roost. In the unlikely event that it is found to be in use then the bat box will be protected under relevant legislation and must remain in situ to ensure that legislation protecting bats and their roosts is adhered to.

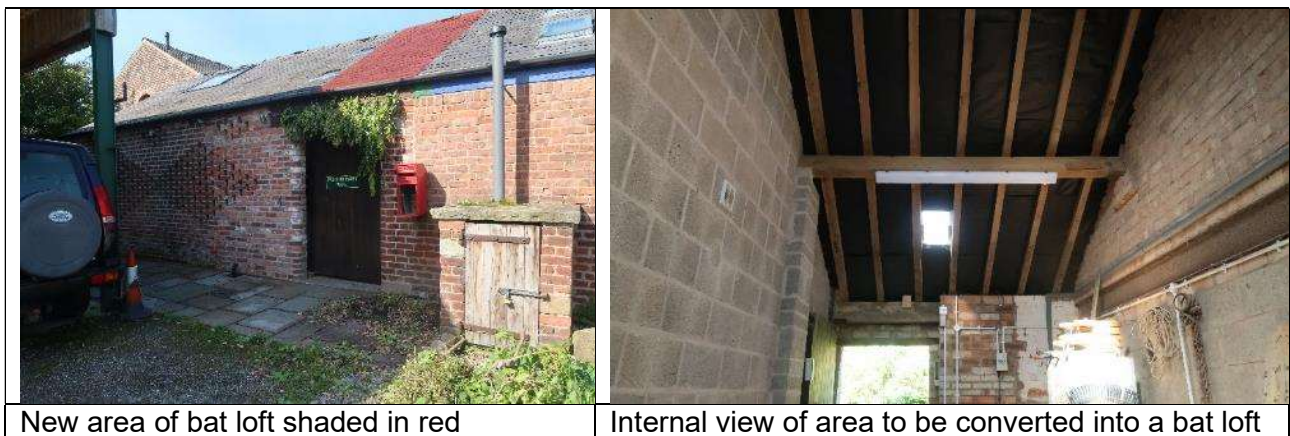
On the north western side of the building is a single storey former stable block. This building is brick built with a pitched Welsh slate covered roof. In the central part of this building there is a passageway with external doors at either side and internally the space is vaulted and open to the roof. The roof

New area of bat loft shaded in red

Internal view of area to be converted into a bat loft

space shall be converted into a bat loft with a height of no less than 1.5m at centre<sup>1</sup>. To facilitate this, rough sawn sarking boards shall be fitted beneath the rafters to allow bats to grip. A bat access point in the form of a bat tile will be installed in the roof to allow full access to the loft for species such as brown-long eared bats and also crevice dwelling bats. Gaps will also be made available at the eaves above the wall plate to allow access above the sarking boards and beneath the roof slates. Lighting shall be removed from the roof space and skylights will be covered to ensure no light spill enters the space. The breathable roofing membrane currently installed shall be removed entirely along with the wisteria over the door way. At present, the area is highly unsuitable for roosting bats being light filled, draughty and containing a non-bitumen coated roofing membrane, the latter of which poses a high degree of risk to bat species over time due to the spun bond filaments becoming loose and causing entanglement issues. A thorough search of this area was undertaken for signs of bat presence and no evidence of bats was found in this area. See photographs of loft below.

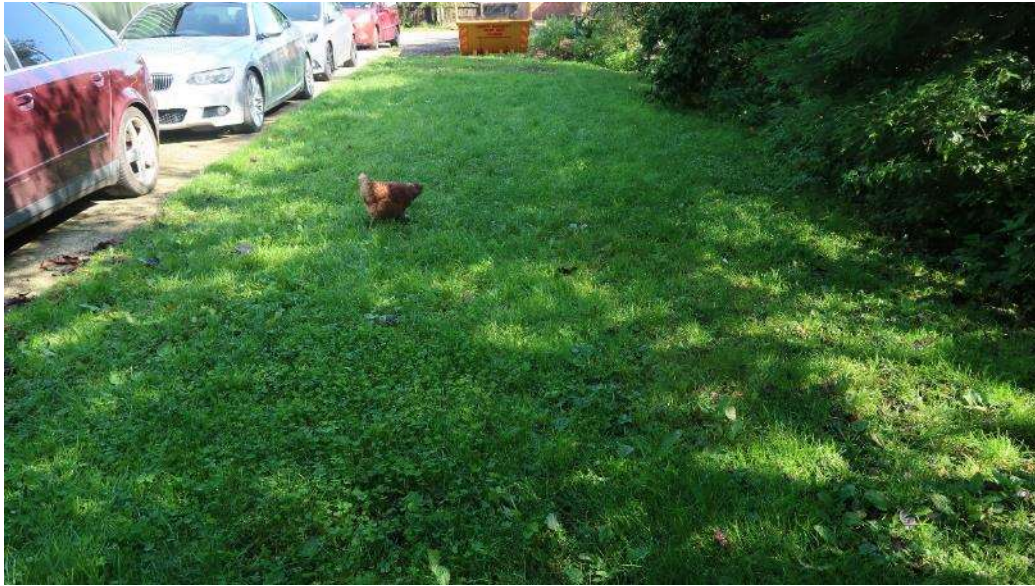
On the south eastern side of the building is a strip of shady grassland which lies between the new building and an area of outgrown scrub. It is proposed that this grassland be plug planted with shade tolerant species which are commonly found along woodland edge or hedgerows. See below list. Currently chickens have access to forage in this area but they will be excluded post planting.

Primrose	<i>Primula vulgaris</i>
Bluebell	<i>Hyacinthoides non-scripta</i>
Garlic mustard	<i>Alliaria petiolata</i>
Wavy bitter-cress	<i>Cardamine flexuosa</i>
Betony	<i>Stachys officinalis</i>
Hedge bedstraw	<i>Galium mollugo</i>
Ramson	<i>Allium ursinum</i>
Hedge woundwort	<i>Stachys sylvatica</i>
Wood aven	<i>Geum rivale</i>
Nettle-leaved bellflower	<i>Campanula trachelium</i>
Ragged Robin	<i>Lychnis flos-cuculi</i>
Red campion	<i>Silene dioica</i>

Selfheal	<i>Prunella vulgaris</i>
Sweet cicely	<i>Myrrhis odorata</i>
Foxglove	<i>Digitalis purpurea</i>

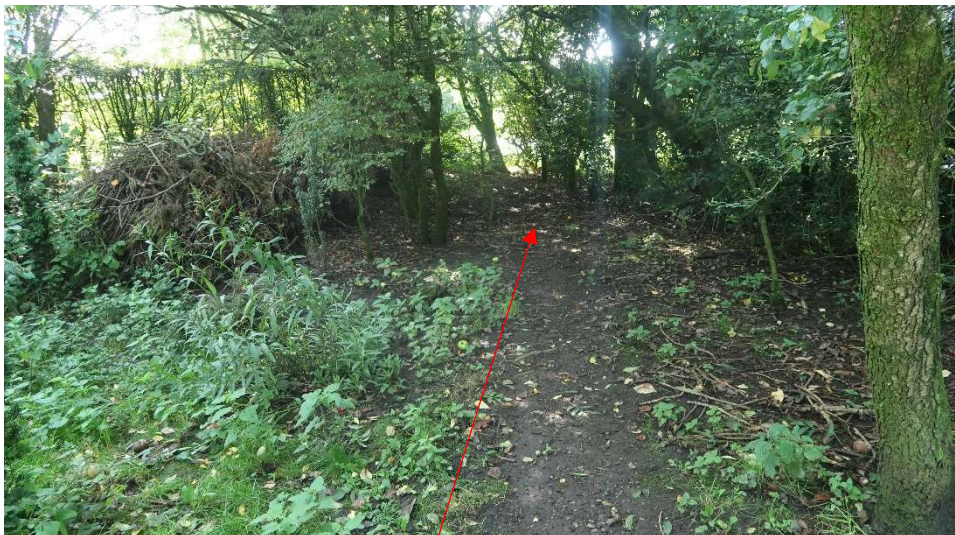
Pathway towards the site entrance on Pinfold Lane

On the south eastern side of the 'new' building, beyond the strip of grassland is an area of outgrown scrub. Part of the scrub will be managed by pruning the back canopy to open up the small pathway that runs through it to the entrance to the site on Pinfold Lane to provide a small ride. Scrub along the edges of the path will be cut back with some species locally coppiced to allow for a thicker growth and provide improved breeding bird habitat. The side of the path will be plug planted using the species listed above. This area will also provide a sheltered space in which insect species will cluster thereby providing increased foraging potential for birds and bats.

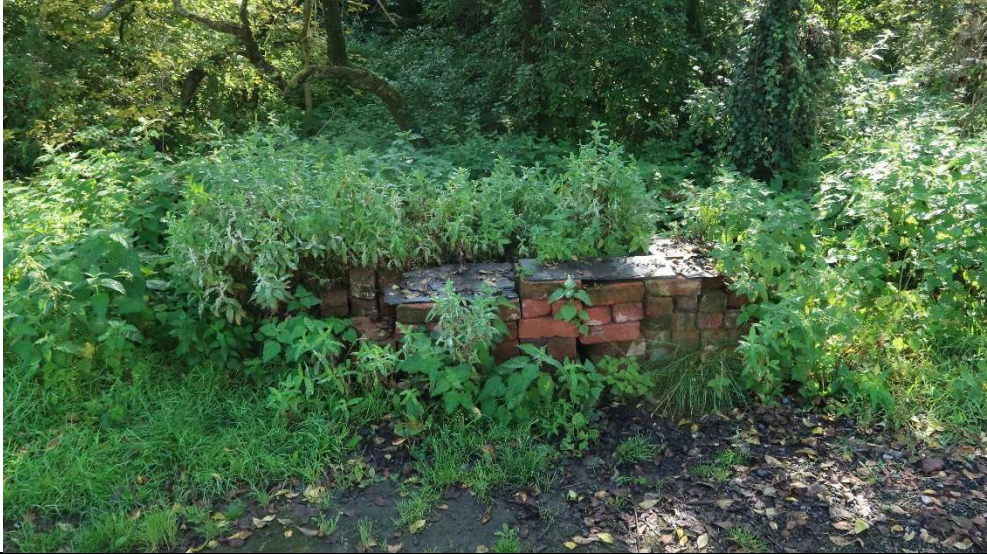
Also within the area of outgrown scrub are a number stacked of brick piles which appear to have been in situ for a number of years. Ideally these could be utilised in a more effective way and it is proposed that these will be re-used to construct a number of hedgehog houses. Hedgehogs are

Stacked brick piles to be re-used to construct hedgehog houses

likely to be present in the area and would benefit hugely by the addition of well-constructed refuge/hibernation habitat.
