# 1 West Halkin Street - Method Statements

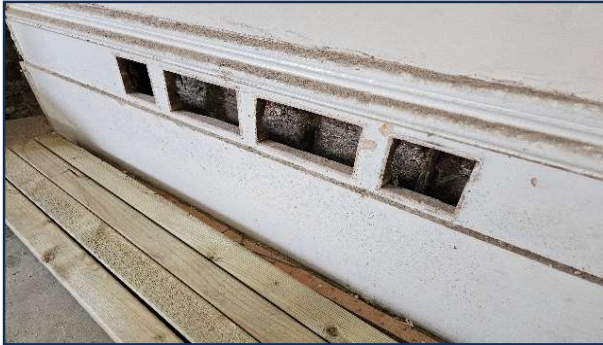
Note: Photograph shows typical example of original skirting boards.

The original skirting boards are located within the first floor principal room.

Strip all paintwork from the existing skirting boards.

Prepare a 'Dutchman' block for each cut-out section of skirting board using reclaimed Pine wood.

Block should be slightly bigger than the hole in the skirting board.

Prepare each existing cut-out section of skirting board by creating a ¼ " rebate to support the 'Dutchman' block.

Apply adhesive to the 'Dutchman' block and press in position.

Using a belt sander or hand planer, sand down the face of the 'Dutchman' block to make it flush with the existing skirting board.

Fill all small holes and cracks using wood putty. Coloured putty can be applied if using varnish as finished product .

Paint or varnish all skirting boards to achieve matching design colour.

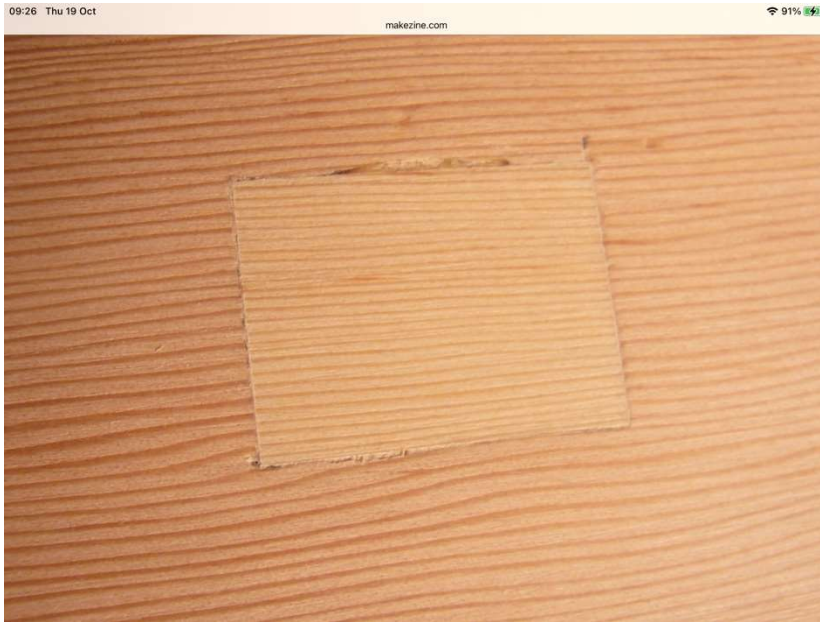
Note: Typical Example of finished 'Dutchman' block.

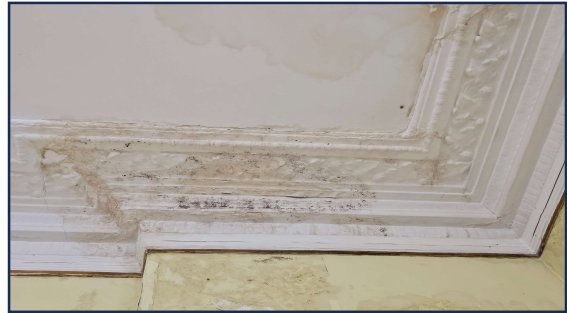
Note: Photographs show typical examples of the original cornices.

The original cornices are located within the first floor principal room.

Strip off all layers of existing paint work using 'Peelaway 1' paint and varnish remover.

Make good all damaged areas using 'Fine Casting Plus' plaster.

Sand down all imperfections by hand using fine sand paper.

Clean using a soft wet sponge.

Paint all skirting boards to achieve matching design colour.

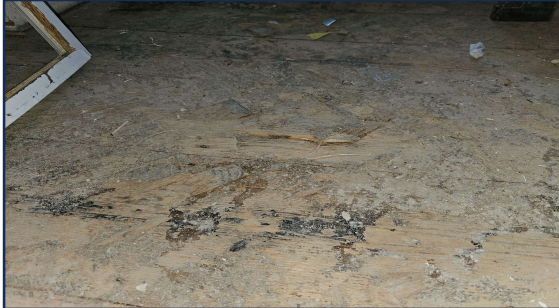
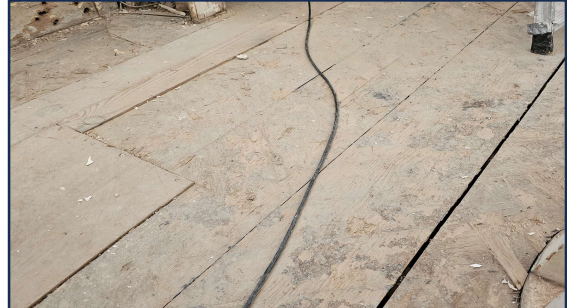
Note: Photographs show typical examples of original floor boards.

The original floor boards are located within the ground, first and second floor rooms however, they are only visible on the first floor.

There are no floorboards within the second floor master bedroom, master ensuite, and small storage room.

Remove all nails and unnecessary screws and vacuum throughout.

Reinstate all missing floorboards with reclaimed traditional pine wood floorboards to match existing.

Replace all non-compliant floor coverings, such as ply wood and mdf boards, with reclaimed traditional reclaimed pine wood floor boards to match existing.

Clean all floor surfaces with a sander and buffer until the original wood finish is visible.

Apply 'Rustins Advanced Wood Preserver' throughout.

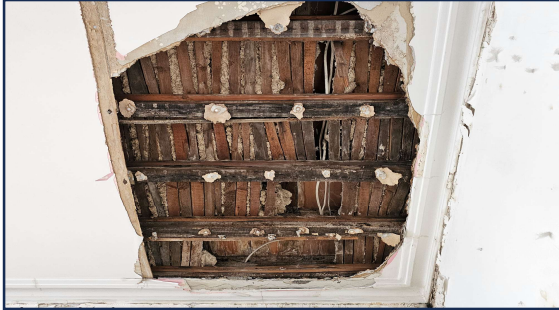
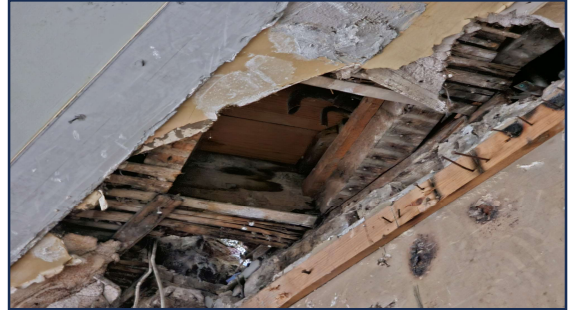
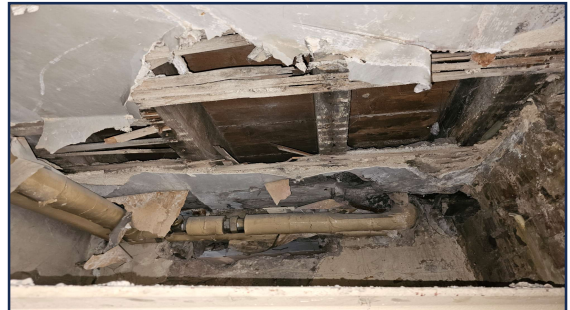
Note: Photographs show typical examples of original lath and plaster ceilings.

The original lath and plaster ceilings are located within the basement, ground, first and second floor rooms however, they are only visible in certain areas

Remove all severely damaged timber laths and surrounding loose material.

Fit new riven chestnut timber laths.

Apply 'Limelite Easy Bond Breathable Primer'

Apply two base coats of 'Limelite Renovating Plaster'.

Apply finishing coat using 'Limelite High Impact Finishing Plaster'.

Apply one coat of 'GCS Interior Premium'.
