**PROTECTED SPECIES SURVEYS –BUILDINGS AT MILL
FARM, SKERNE ROAD, WANSFORD, DRIFFIELD, YO25
8NQ**

August 2023

PROTECTED SPECIES SURVEYS – BUILDINGS AT MILL FARM, SKERNE ROAD, WANSFORD, DRIFFIELD, YO25 8NQ

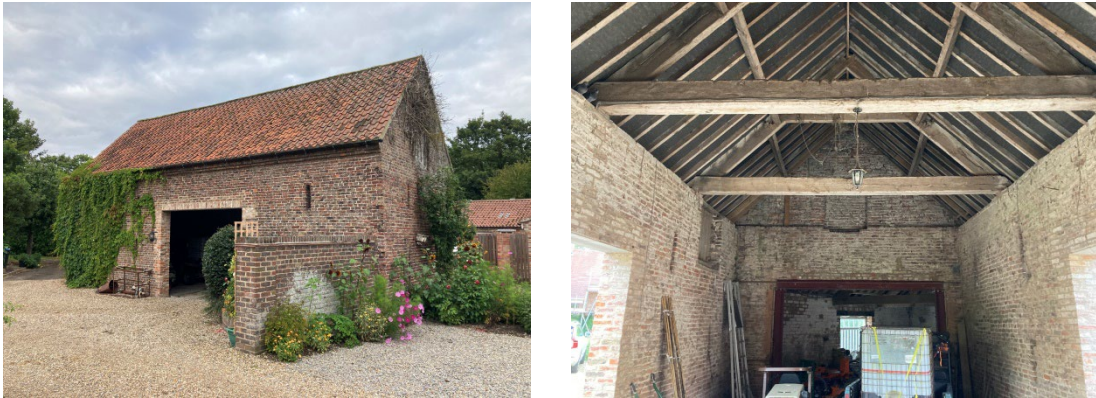
A tall but single storey, open plan, red brick barn, supporting a timber framed roof, covered by clay pantiles. The building is gable ended and the roof of equal pitch. The roof is in good condition, with only a single slipped tile present on the western aspect, having been re-roofed approximately 20 years ago including some new roof timbers. Internally the building is open to the apex, with no internal ceilings present and is underdrawn utilising a modern breathable membrane throughout. Both the eastern and western elevations contain opposing, tall vehicular openings. Elevated but timber shuttered window openings are also present. Integral air vents are present in the southern gable and western walls. A large pedestrian opening connects Building 1 to Building 2. Historic ivy *Hedera helix* and current Virginia creeper *Parthenocissus quinquefolia* growth is present externally. No cladding, hanging tiles, soffits, barge boards, fascias or eaves are present. Limited structural defects were noted, with only very minor settlement cracks present.

Ambient light, draught and detritus levels were recorded as high throughout the structure.

Photograph 1: Representative views of the Building 1, south eastern aspect (left) and internal (right)

- Three bat roosting units (Swhegler 1FR, **or similar**) will be incorporated within the redeveloped structures. An example image of these can be found in Appendix 5.
- The boxes are to be erected at as high as possible (a minimum height of 2m or greater) and be located where it will receive the maximum amount of sunlight. In the northern hemisphere this will be the southerly aspects/orientation (south, south-west and south-east).
- Installation should take place during the construction phase.

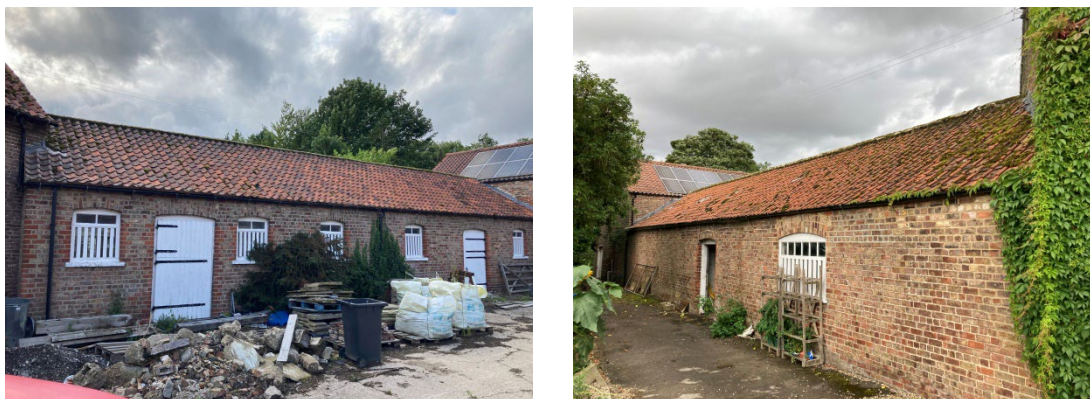
A low, single storey, red brick, former stable block, supporting a timber framed roof, covered by clay and occasional translucent pantiles of equal pitch. The roof is in good condition, again having been in receipt of maintenance in recent decades including some new roof timbers. Only two raised/slipped tiles were present at the time of survey on the western aspect. Any lead flashing work adjacent to Buildings 1 and 3 is tight and contains only very minor gaps. Internally the building is open to the apex throughout, with no internal ceilings present and is underdrawn utilising both a modern breathable membrane whilst retaining some areas of original wooden lathe, (no plaster). The building is subdivided by solid brick walls which extend into the apex, into three adjoining compartments. A number of glazed windows and tightly fitted timber pedestrian doorways are present. External and internal pointing is good, with significant internal elements being whitewashed. Virginia creeper *Parthenocissus quinquefolia* growth is present externally and has ingressed internally on the eastern aspect. No cladding, hanging tiles, soffits, barge boards, fascias or eaves are present.

Ambient light levels were recorded as high throughout the structure, detritus levels moderate and ambient draught levels low.

Photograph 2: Representative external views of the Building 2, eastern aspect (left) and western aspect (right).

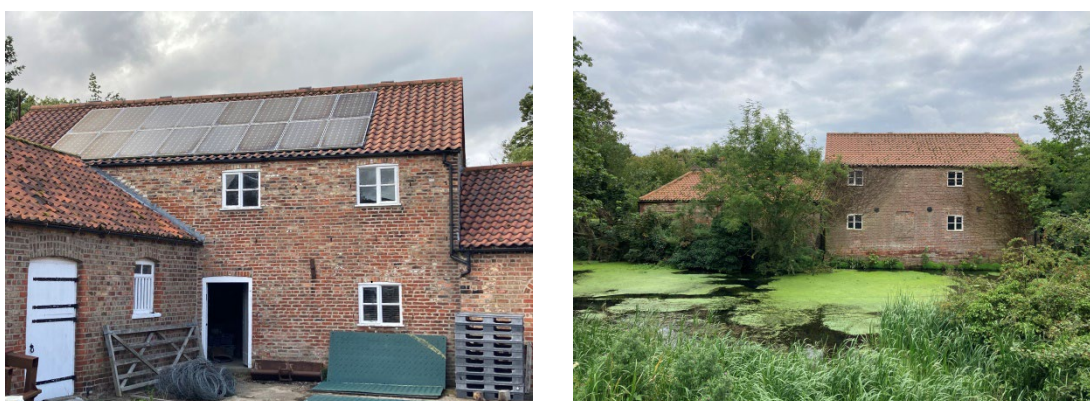
A tall, two storey, red brick barn, supporting a timber framed roof, covered by clay pantiles and a solar panel arrangement on the southern elevation. The building is gable ended and the roof of equal pitch. The roof is in good condition, with no slipped, lifted or absent tiles present having been re-roofed approximately 20 years ago including timbers. Internally the building is open to the apex, above the first floor, (a single board on beam, exposed beneath), with no internal ceilings present and is underdrawn utilising a modern breathable membrane throughout. It is open plan throughout. Any timber doors are tightly fitting and windows glazed with the exception of a pair of elevated timber granary hatch doors in the apex of the western gable end which contained significant gaps. An exterior recessed door is built into the western gable end wall. The recess is covered by small gauge wire mesh. No cladding, hanging tiles, soffits, barge boards, fascias or eaves are present. Limited structural defects were noted, with only very minor settlement cracks and occasional gaps between door frames and brickwork present. The building is currently used for domestic storage. Both ambient light and detritus levels were recorded as moderate on the ground floor and high on the first floor. Draught levels were recorded as low throughout the structure with extensive fine cobwebbing present on the ground floor.

Photograph 3: Representative external views of Building 3 southern aspect (left) and northern aspect beyond Driffield Canal (right).

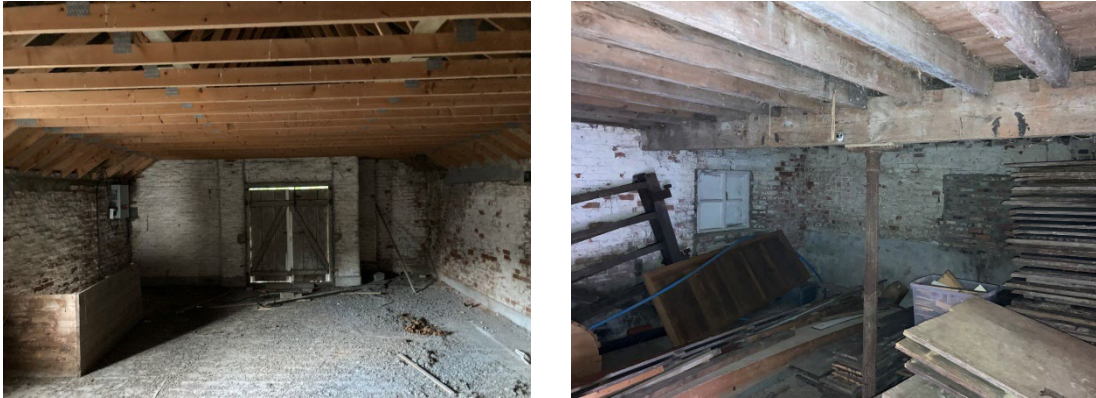
Photograph 4: Representative internal views of Building 3 first floor (left) and ground floor (right).

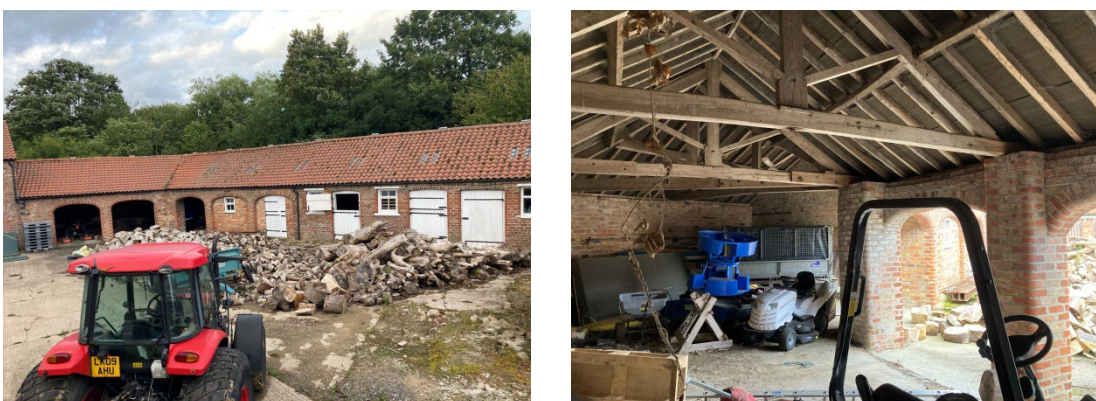
A single storey, 'L' shaped red brick barn, supporting a timber framed roof, covered by clay and translucent pantiles which adjoins Building 3 to the west. It has a gable ended and the roof of equal pitch. The roof is in good condition, with no slipped, lifted or absent tiles present having been re-roofed approximately 20 years ago including many new timbers. Internally the building is open to the apex throughout and is underdrawn utilising bitumen felt throughout. The building is subdivided internally by solid brick walls which extend to the apex. The northern element of the building is open sided and exposed to the elements having three south facing former waggon bays. The eastern/southern element is comprised of a series of former stables. Any timber doors are tightly fitting and windows glazed. No cladding, hanging tiles, soffits, barge boards, fascias or eaves are present. Limited structural defects were noted, again, with only very minor defects noted. The building is currently used for domestic storage. Ambient light, detritus and draught levels were recorded as high throughout the open sided northern element and low draught levels and moderate detritus and light levels were recorded in the eastern/southern element.

Photograph 5: Representative external view of Building 4 southern aspect (left) and internal view adjacent open waggon bays (right).

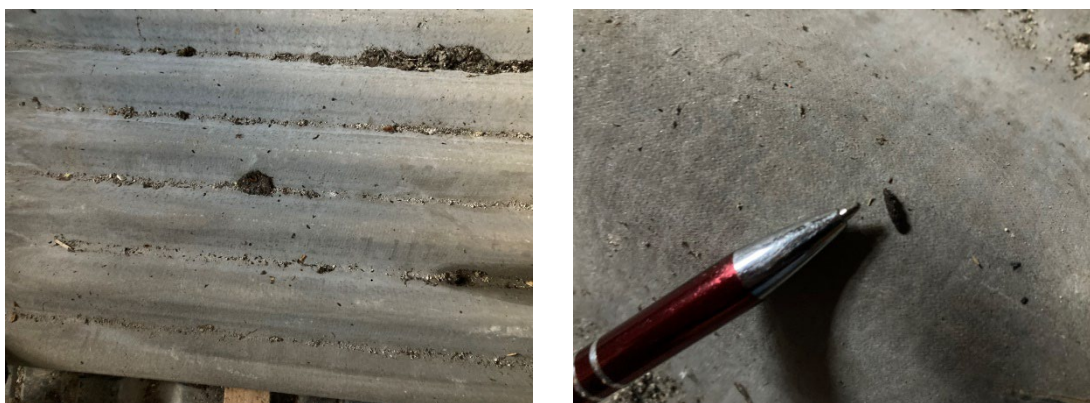
- Building 1: No bats or associated bat roost field signs were recorded.
- Building 2: Circa 15 mixed age bat droppings and occasional small tortoiseshell *Aglais urticae* and peacock *Aglais io* butterfly wings were located in the northern element of Building 2, deposited over an approximately 1 m² area beneath the central ridge beam. This is thought to indicate the presence of either a 'Day Roost' or 'Feeding Roost'.

Photograph 6: Representative views of bat droppings in Building 2 (left) and close up (right).

Following implementation of post planning surveys on Building 2, it is likely that the site is found to meet the criteria for a Natural England Bat Mitigation Class Licence, (previously a Bat Low Impact Licence), whereby low impact and low numbers of roosting bats, (i.e. not hibernation or maternity roosts), not more than three separate roosts of the seven most common and wide spread bat species. This will reduce application paperwork, scrutiny of the 'three tests' prior to the licence being granted and reduce licence application determination time from the statutory 6 – 10 week period down to 5 – 15 working days.

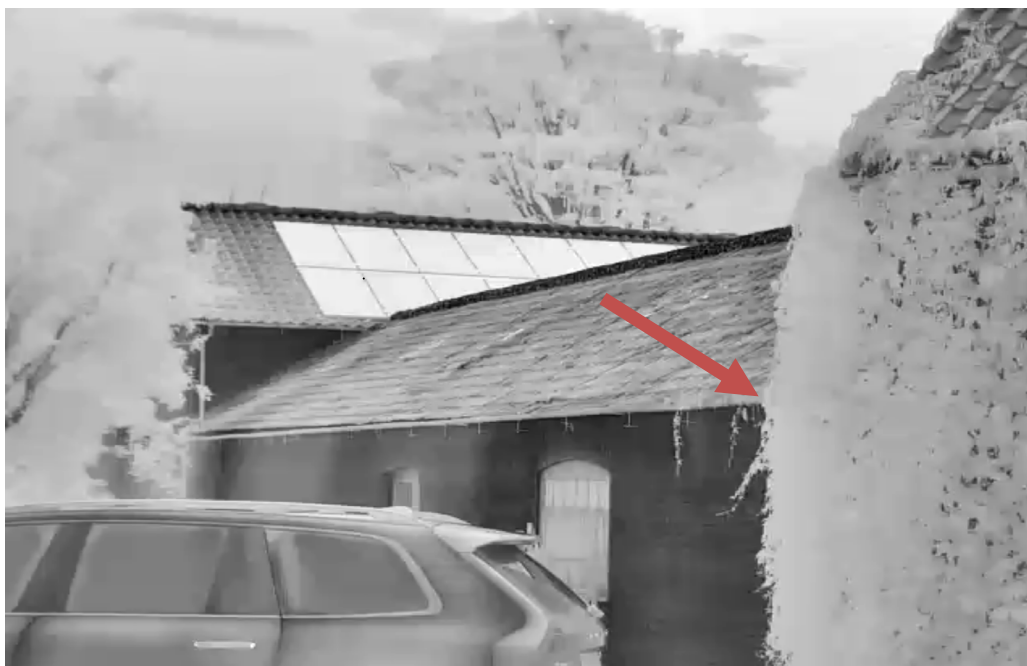
A single brown long-eared bat was observed emerging from the west side of Building 2 at 21.45hrs adjacent to Building 1 – See thermal camera photograph 7 below:

Photograph 7: Representative external view of Building 2 showing approximate bat emergence point

A single brown long-eared bat was observed for the second time emerging from the west side of Building 2 at 21.14hrs adjacent to Building 1 – See thermal camera photograph 7 above.

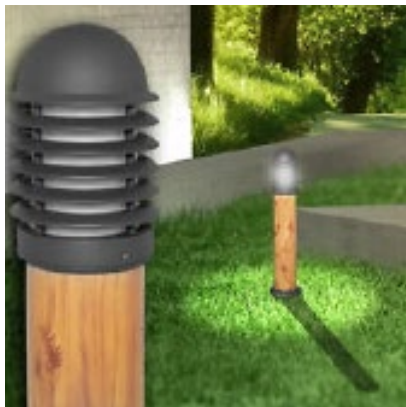
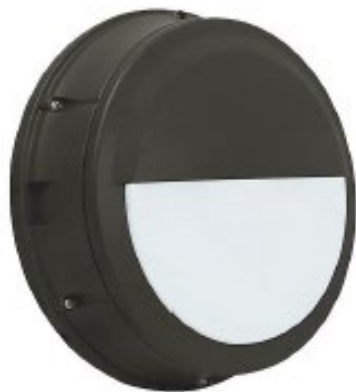
Figure 4: Appropriate lighting examples

2. Lighting units chosen, (suitable examples are shown below in Figure 4), must be fitted with a 'dimming' mechanism and be set at the lowest light level practicable. This should be below 3 lux at ground level where possible. The selected units are considered appropriate due to the 'down lighting' nature of the products and the low level of the chosen lighting bollards.
3. Accessories such as hoods, cowls, louvres and shields to direct the light to the intended area only can be utilised on surface mounted chalet lights. Planting can also be used as a barrier or manmade features that are required within the build can be positioned so as to form a barrier.
4. The times during which the lighting is on should be limited to provide some dark periods. Sensors should be used where possible.

Image 1: MIA Worldlight 'Ship Bollard'

Image 2: Apollo 'Roman' LED surface mounted

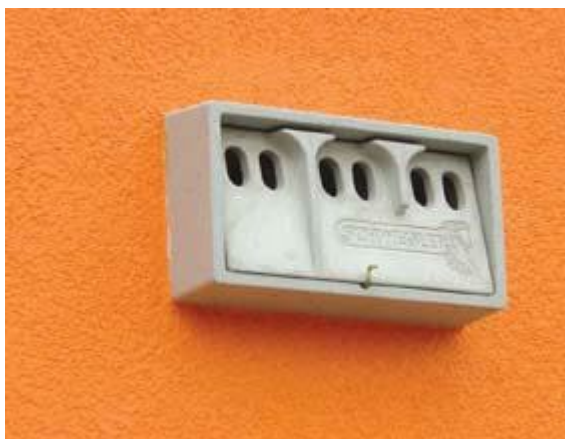
Photograph 8: Schwegler 1SP Bird Box
Measures 245mm x 430mm x 200mm and
weighs 13kgs.

House sparrows have been noted within the locality of the survey site. This species is included on the UK Biodiversity Action Plan and on the Red List under the criteria set out in Birds of Conservation Concern 3: (Eaton M A et al, 2009), as their breeding population has suffered declines of over 50% in the last 25 years. As a conservation measure, it is recommended that a minimum of 2 artificial nest places will be provided, within (or adjacent on neighbouring agricultural buildings under the ownership/control of the applicant), the new redevelopment: **Schwegler 1SP** (245mm x 430mm x 200mm) are recommended. See Photograph 6:
