Phase I Geoenvironmental Assessment

Land at The Common

Little Blakenham

2240 R01: Issue 1

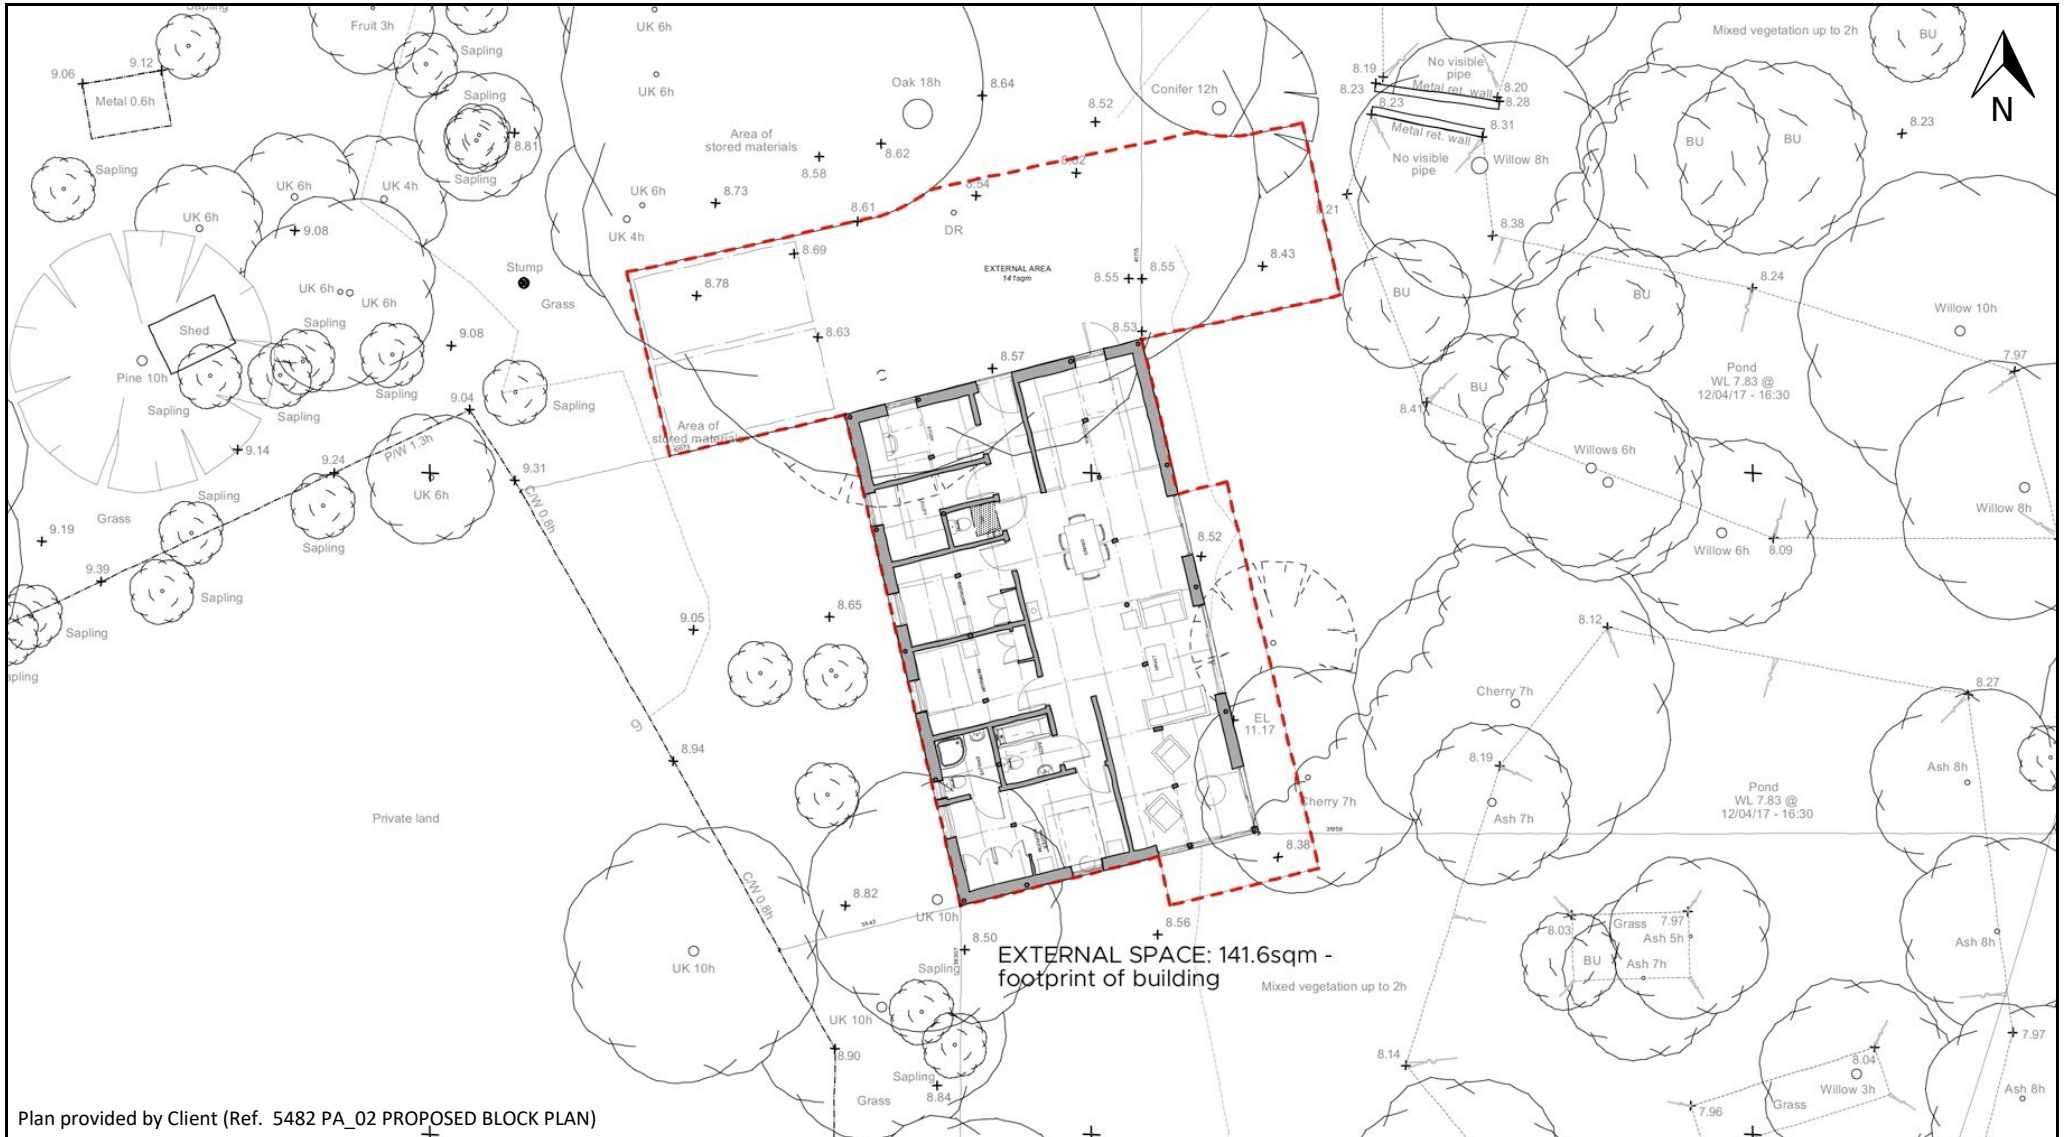
Figure 2

Proposed Development Plan

Plan provided by Client (Ref. 5482_PA_02 PROPOSED BLOCK PLAN)

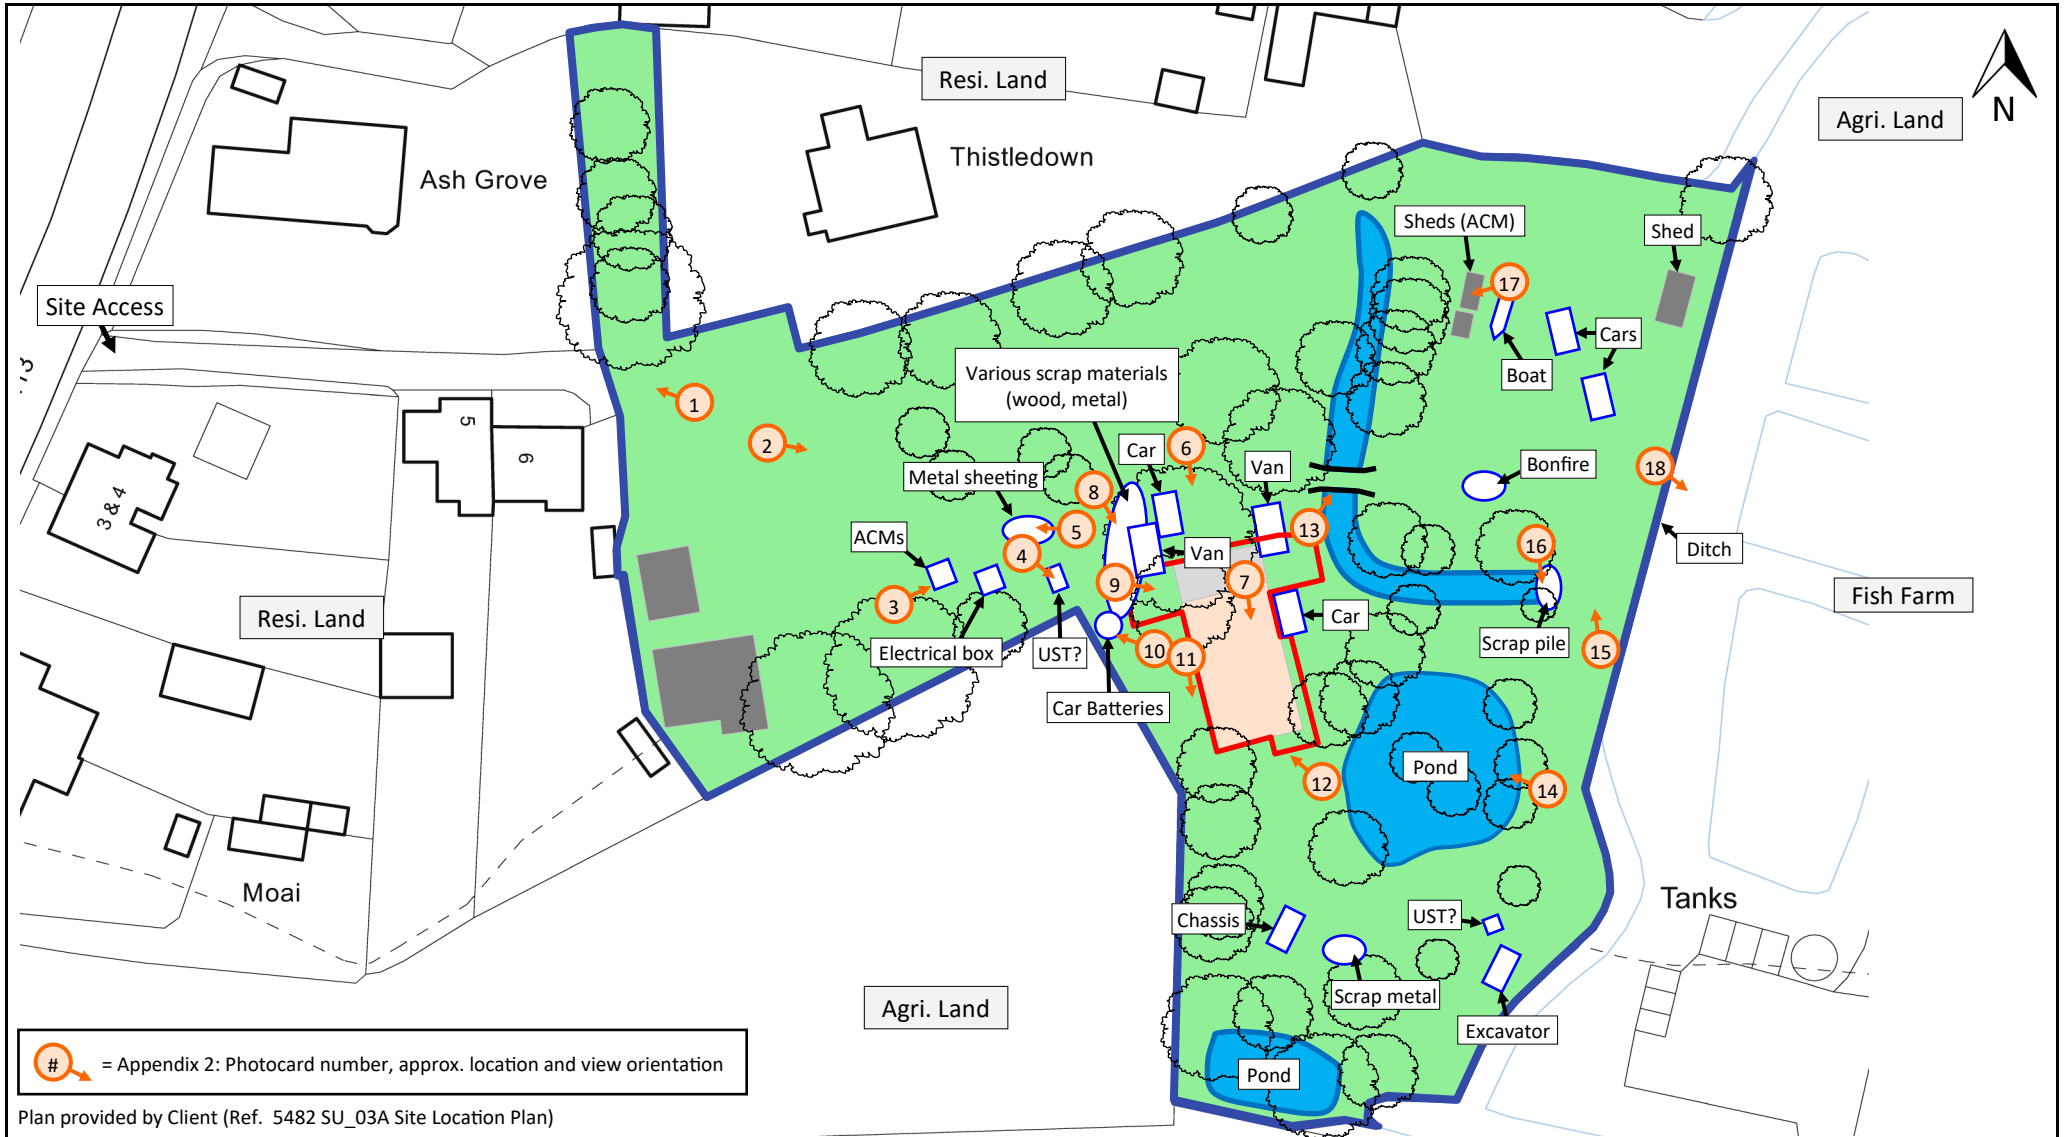
Figure 3

GEMCO undertook a Site Walkover survey on the 4th May 2023 to inspect the Site and immediate surroundings. A selection of photographs taken during the visit are presented at Appendix 2, and the layout as encountered at the time, plus the locations of photos, are shown at Figure 3.

Site Layout Plan

= Appendix 2: Photocard number, approx. location and view orientation
Plan provided by Client (Ref. 5482 SU_03A Site Location Plan)

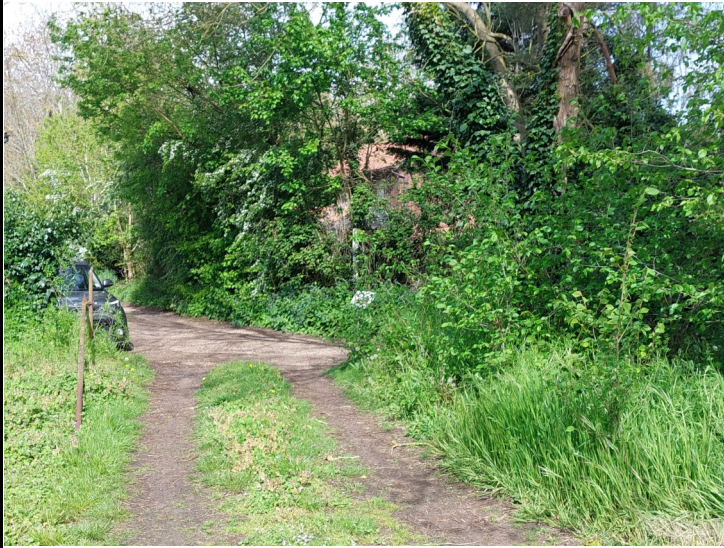
Picture 01

- Pic 01:** View of access track from Bramford Road into the northwest of the parcel.
- Pic 02:** View towards the Site from the entrance, facing southeast.
- Pic 03:** Example of potential ACM sheeting used around the site as boarding.
- Pic 04:** Potential UST cover found to West of Site.
- Pic 05:** Small allotment-type area segregated by metal sheeting.
- Pic 06:** View of the Site, facing south from the north.
