Cove Ecological Surveys was instructed by Chloe Pitt of Laurence Associates to carry out an update of a bat and nesting bird survey at a detached house in St Agnes, West Cornwall, on behalf of the owners, Peter and Rachael Coles. The survey was requested in preparation for a planning application to demolish the building and build a replacement dwelling in the footprint. An initial assessment was carried out on 11 October 2022, which identified the building as holding negligible potential for roosting bats using the national survey guidelines (Collin, 2016). An additional visit was carried out by Scott Barron on 27 November 2023 to update the findings.

### 1.2 Site description

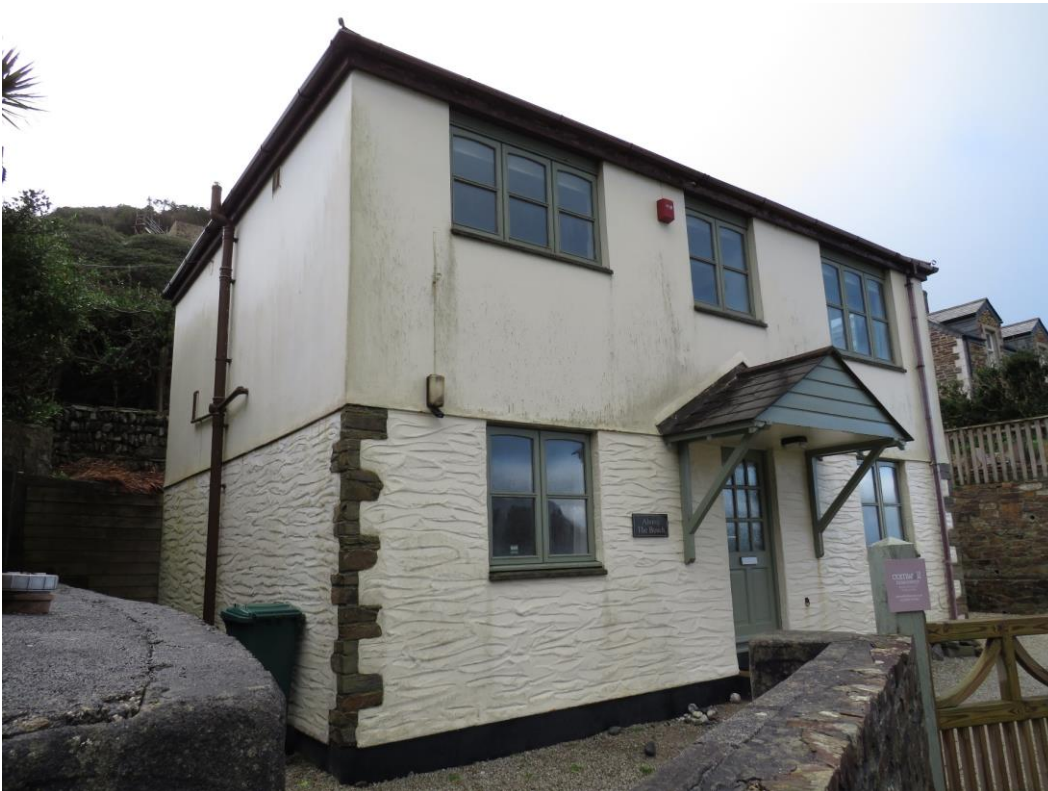
The survey site (SW721515) consisted of a detached two-storey building known as 'Above the Beach', with a built-on garage, located next to the beach in Trevaunance Cove, St Agnes, TR5 0RZ (Figures 1, 2 & 4). The structure was stone-built with smooth rendered walls and had a hipped roof made up of slates (Figure 3). The roof slates and the ridge were tightly fitted with no broken slates or suitable gaps for roosting bats. A wooden fascia was present on all sides of the building, which was tightly fitted and meshed at the bottom thus offering no potential for roosting bats.

**Figure 1.** Southern and eastern elevations of the building, November 2023.

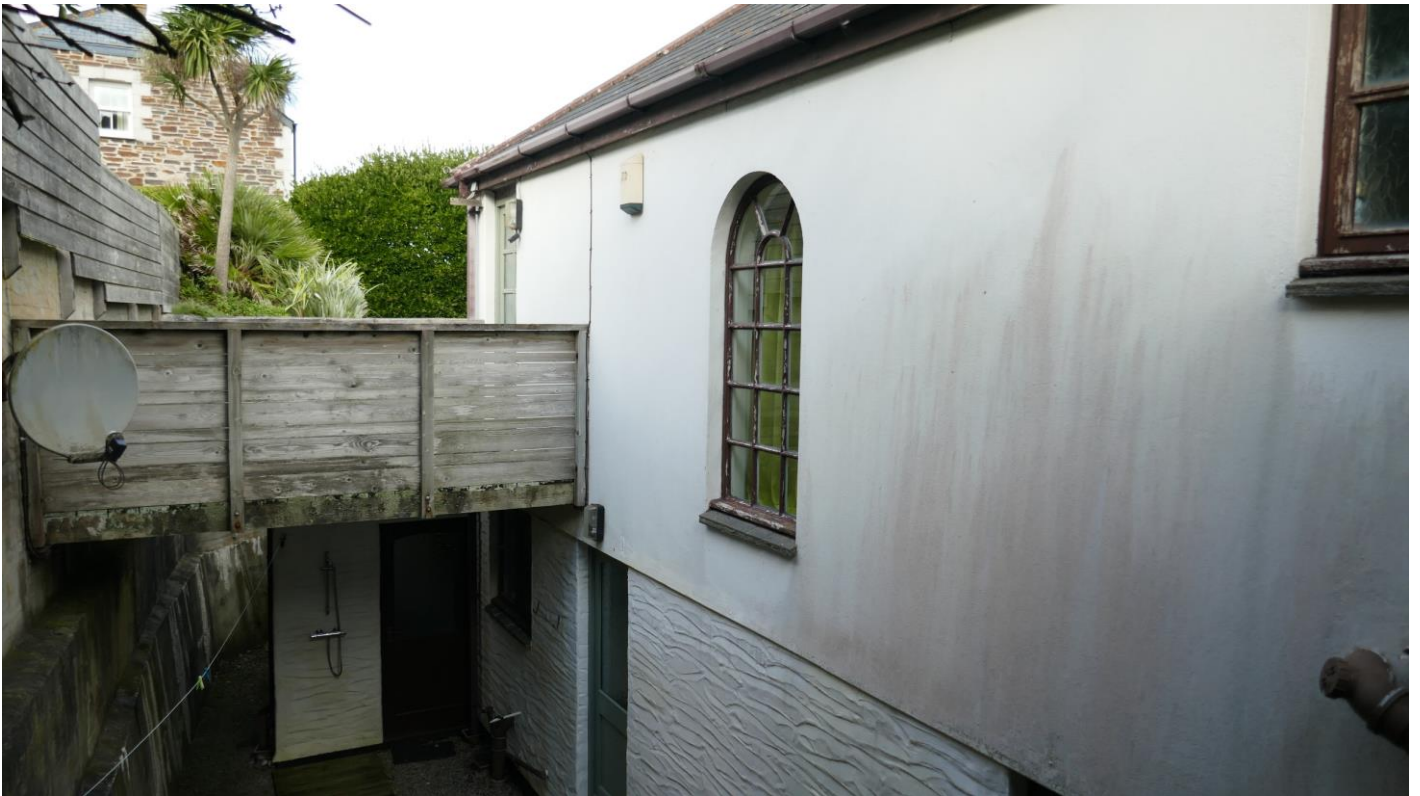
The western side of the property faced a wall at the bottom of a steep bank above, creating a sheltered area at the back of the house. An outside shower was located here (Figure 2), accessed by a wooden door beside the garage (Figure 7).

**Figure 2.** Western aspect of the property, including outside shower (October 2022).

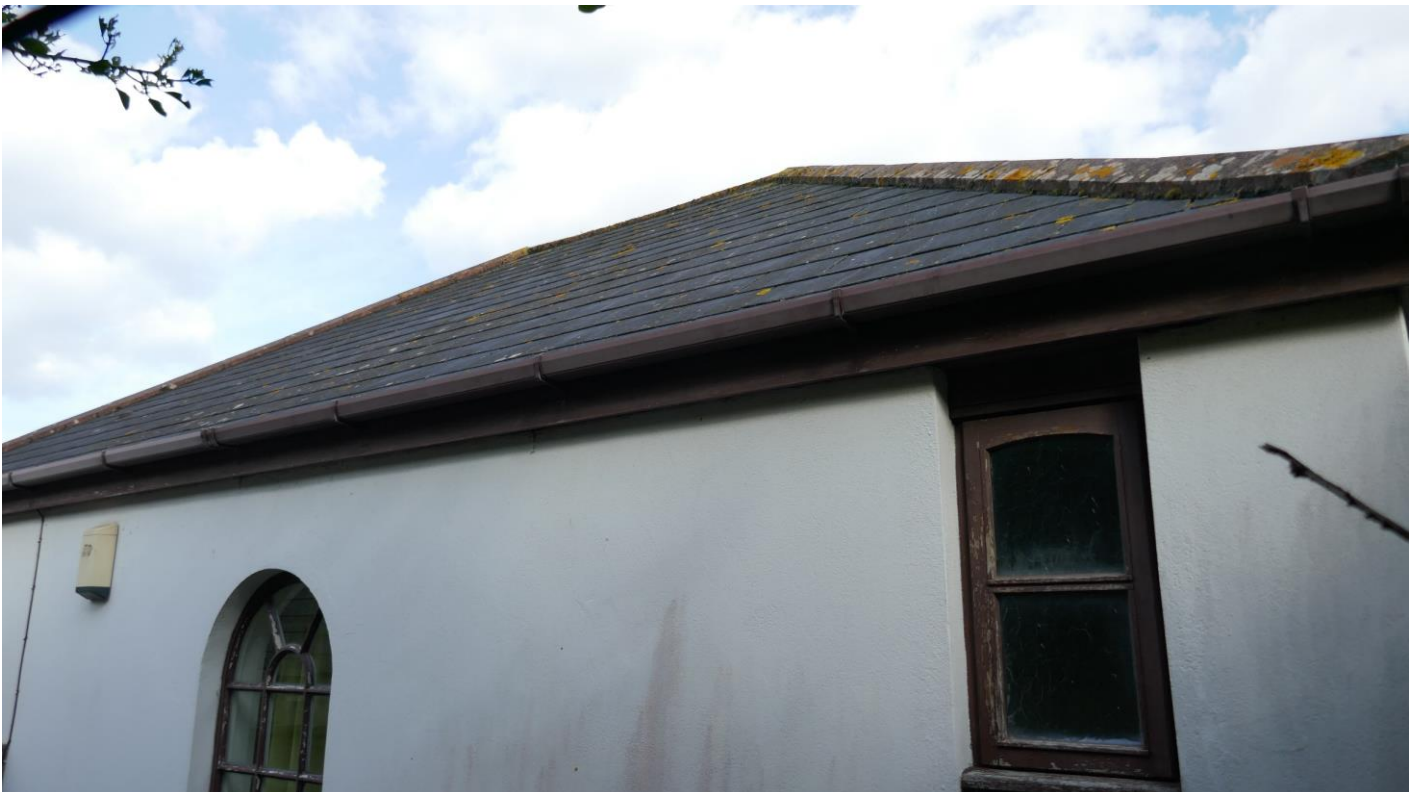
**Figure 3.** Roof on western aspect of the building (October 2022).

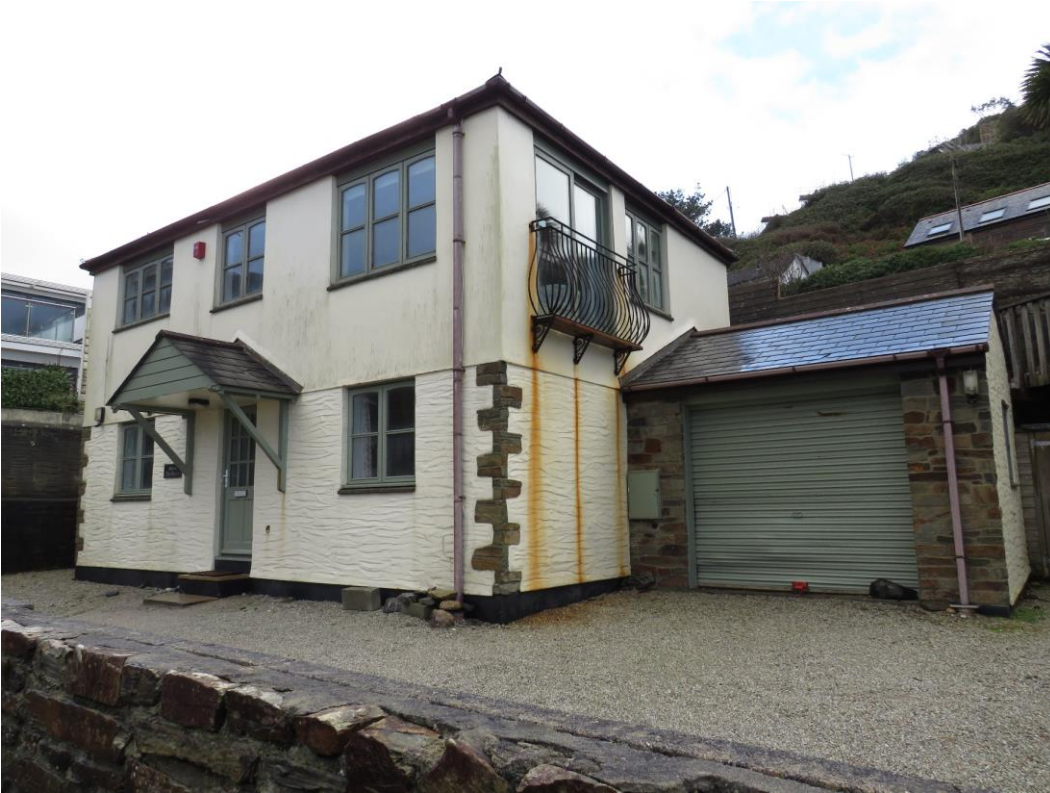
**Figure 4.** Northern and eastern aspect of the building with built-on garage (November 2023).

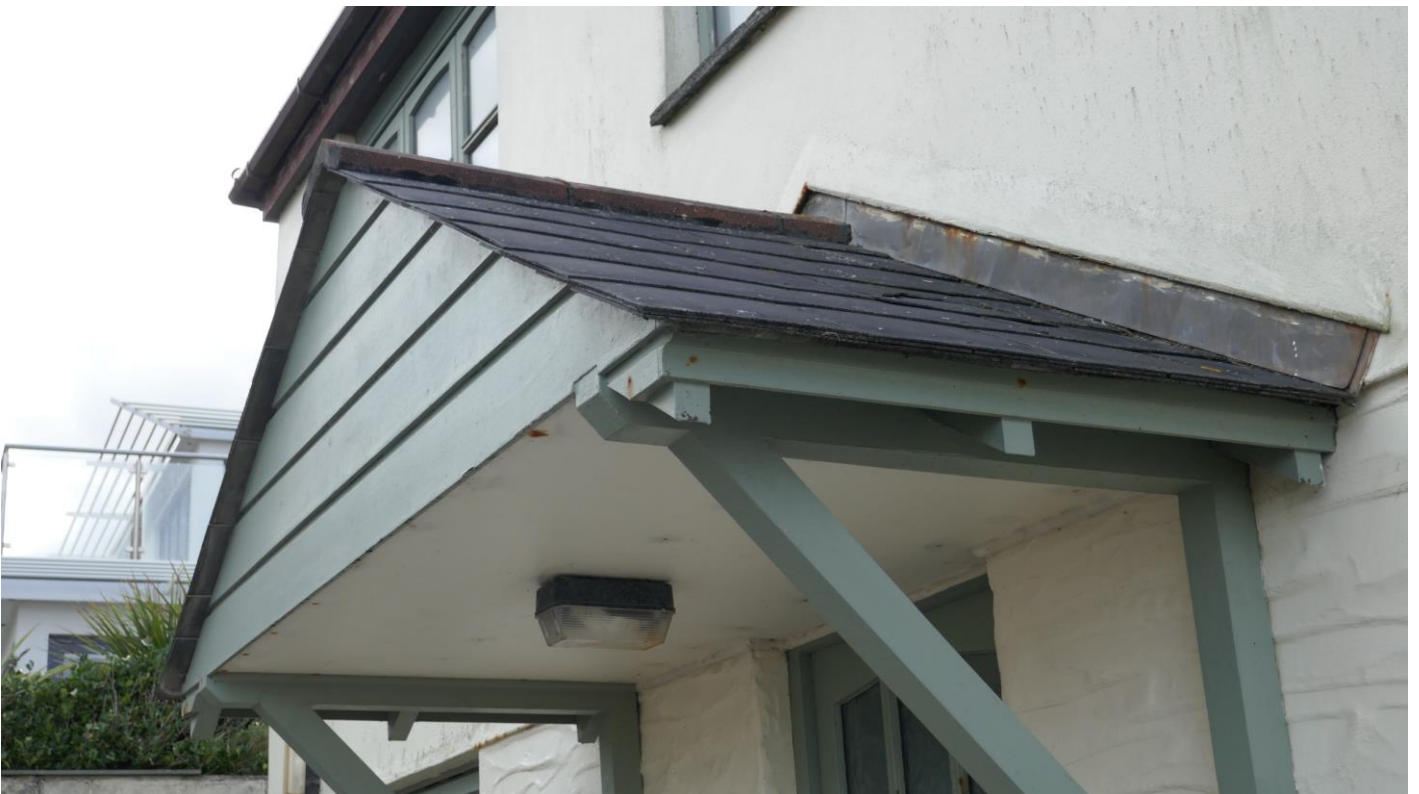
Above the main entrance to the building on the east side of the property was a pitched porch (Figure 1 & 5) with a slate roof and boxed area in the roof of the porch but there were no visible features that may have given bats access to any void present within the porch.

**Figure 5.** Porch above entrance door on eastern aspect of the building (October 2022).

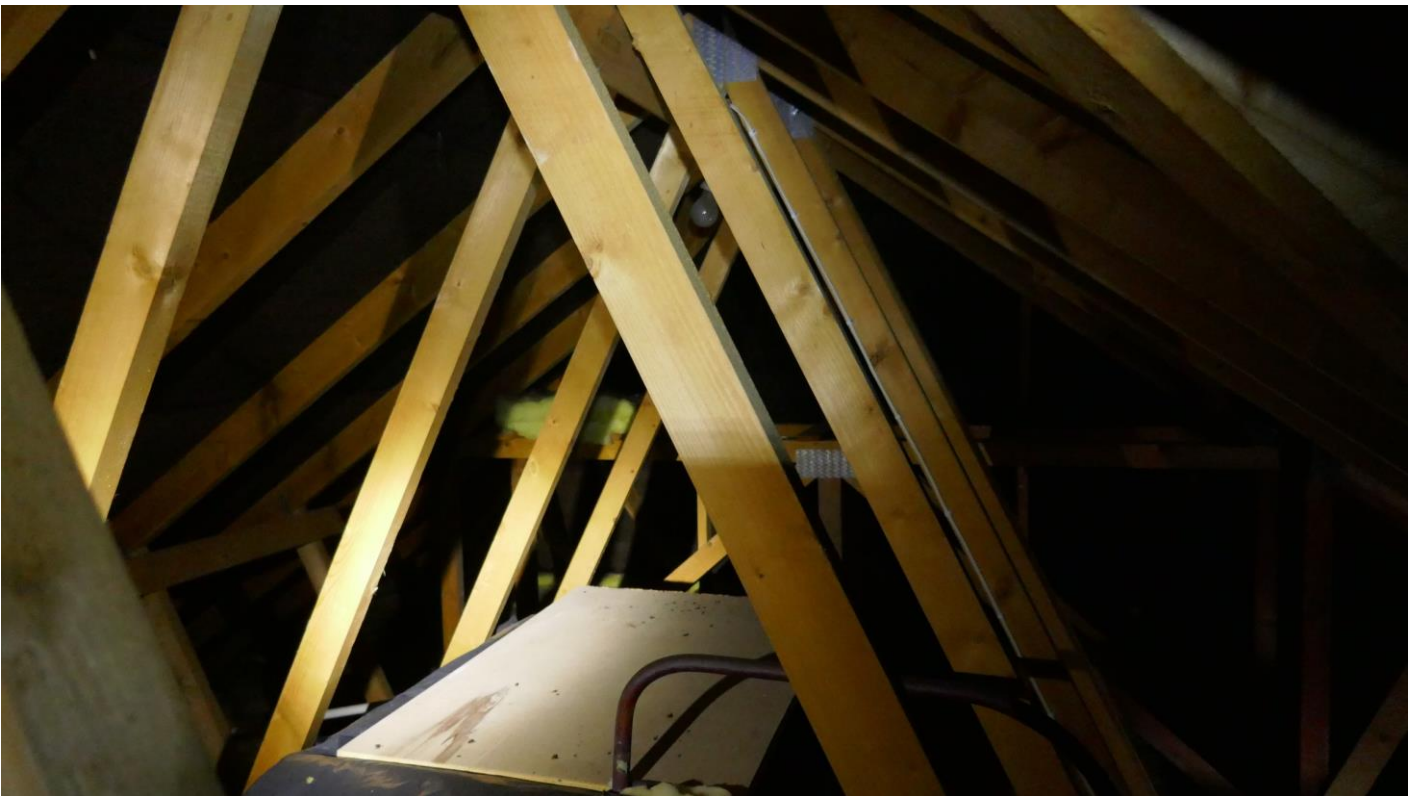
A substantial roof void was present in the property, accessed via a hatch on the first-floor balcony. The void was approximately 2.5m high with a layer of fiberglass insulation on the floor and bitumen felt on the roof. A

covered water tank was present and the network of trusses created a cluttered environment, which would not be naturally attractive to bats.

**Figure 6.** Roof void (October 2022).

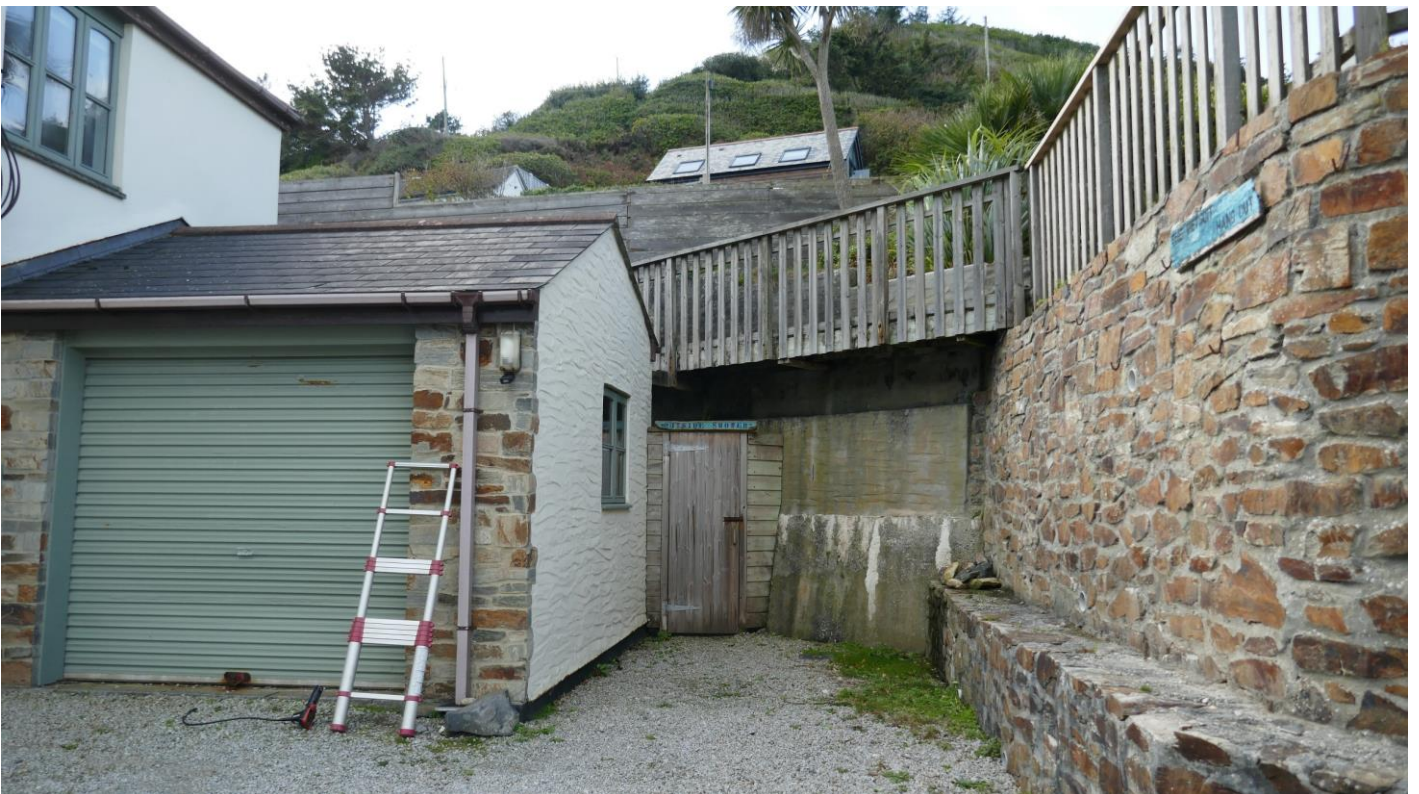
**Figure 7.** Garage (October 2022).

A built-on garage was present on the north side of the building with an ‘up and over’ door allowing access within. The building had a pitched slate roof and partially rendered walls. A single broken slate was present on the eastern pitch of the roof which could potentially have allowed bats access to the space below but the rest of the roof and ridge was tightly fitted with no suitable gaps for roosting bats. A window was present on the north side of the building which allowed light penetration within. A wooden fascia was present, which was grilled at the bottom and did not provide any suitable roost features. On the north-east corner of the building, beside the door, a small gap was present between the soffit and the top of the wall where mortar was missing. This was approximately 6cm x 2cm in size and was large enough to allow bats access to the interior of the building. The interior of the garage was open to the rafters, the roof lined with bitumen felt and no roof void was present. This would have made any bats or evidence of their presence easy to find.

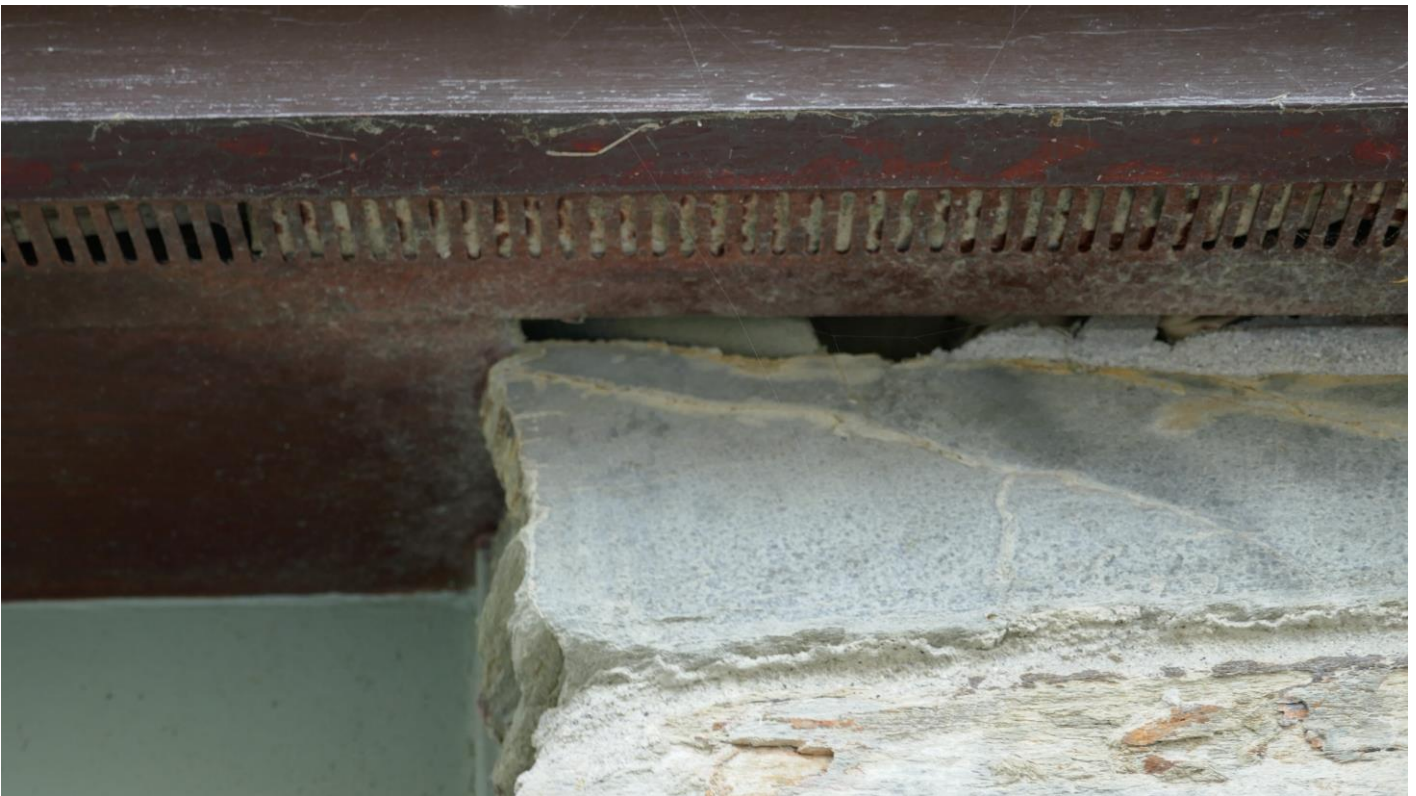
**Figure 8.** Gap present at the wall top of the garage.
