Listed Building Consent

Client
R White
Site Address
8 Brook Street

Drawing Title
Existing Elevations

Job No. 2320	Drawing No. 1001	Rev.
------------------------	----------------------------	------

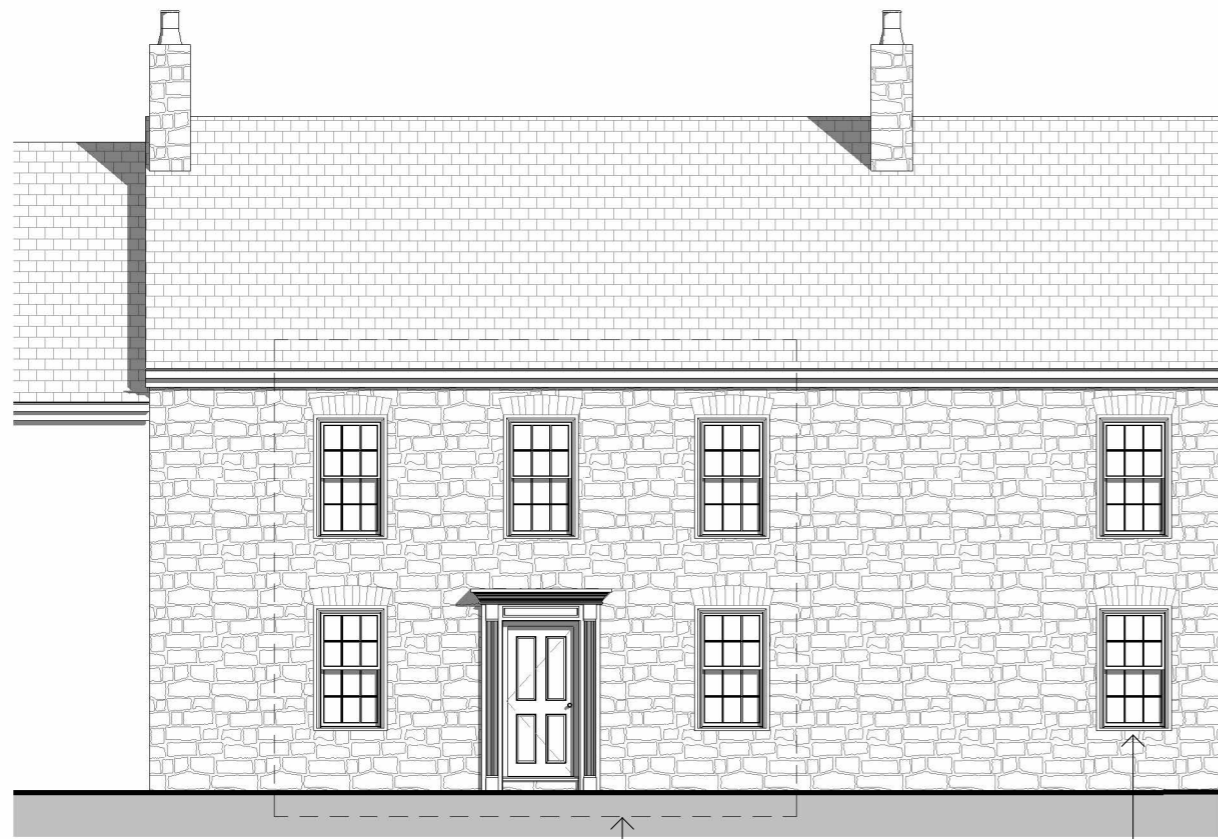
1 Existing East Elevation
1 : 100

All sash windows are in poor condition from a combination of neglect and damp. There is internal secondary glazing which has been poorly fitted due to the narrow reveal and is impossible to use if someone has limited dexterity such as the current owner. The secondary glazing detracts a huge amount from the character of the windows. This proposal seeks to replace the windows and secondary glazing with new slim double glazed timber sash windows.

Adjacent matching windows in no. 6 Brook Street

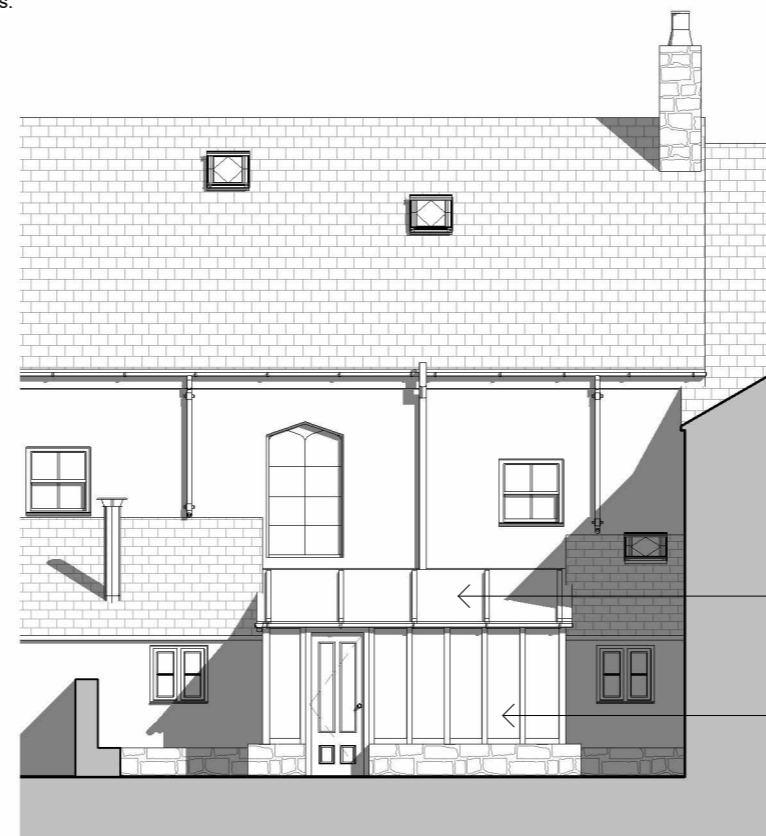
4 Existing West Elevation
1 : 100

Poor quality polycarbonate roof

Glazed garden room on stone plinth
