Broad Lane Business Centre, Westfield Lane, South Elmsall  
Garden Soils Validation – Apartment Block and front gardens of plots 14 and 26.

**Project**  
 BROAD LANE BUSINESS CENTRE,  
 WESTFIELD LANE, SOUTH ELMSALL

**Title** SOILS VALIDATION PLAN  
 (APARTMENT BLOCK AND  
 FRONT GARDENS)

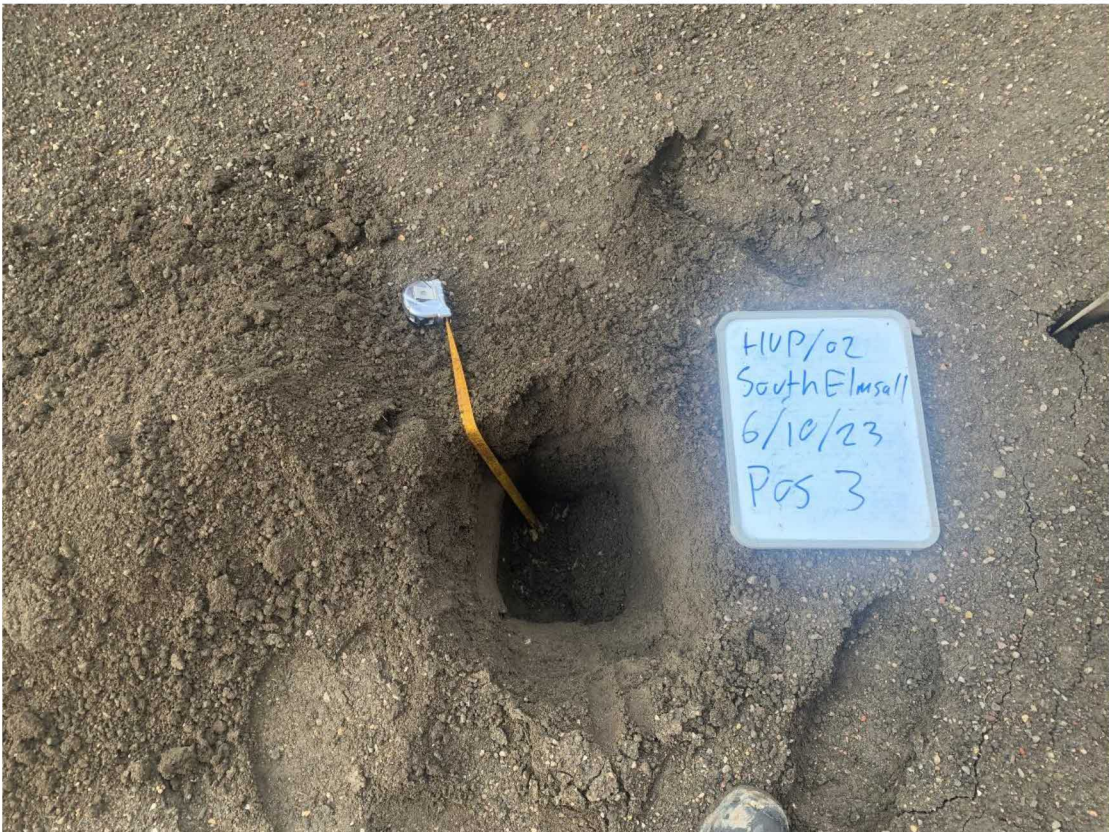
GL -0.6      Brown slightly gravelly slightly sandy clayey TOPSOIL. Sand is fine to coarse. Gravel is subangular to subrounded, fine to coarse of mixed lithology including sandstone and mudstone.

0.6            Firm light yellowish brown mottled orangish brown slightly sandy gravelly CLAY.  
Gravel is subangular to subrounded, fine to coarse, of sandstone and siltstone.

**Photo 2: View of the pit dug for POS3.**
