The Coach House, Spring Hill,
Nailsworth, Stroud,
Gloucestershire, GL6 0LX

BAT SURVEY REPORT

November 2023

5281 V2.1

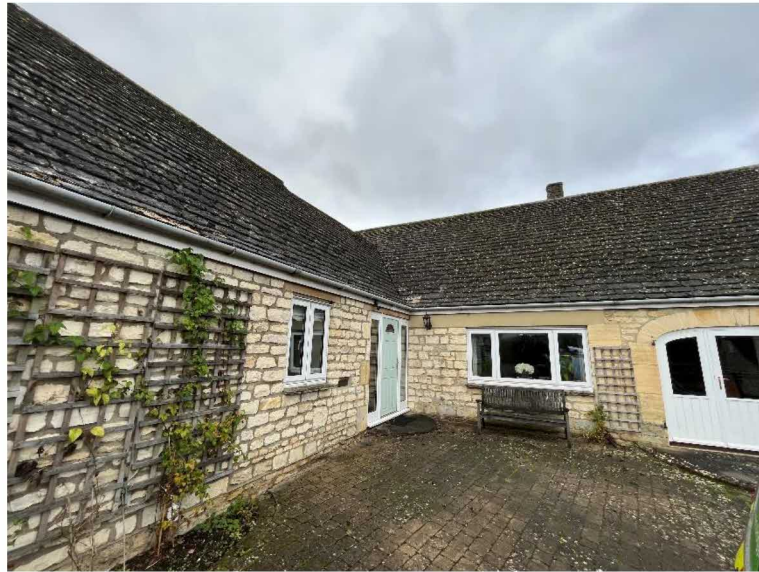
Plate 1. The northern façade.

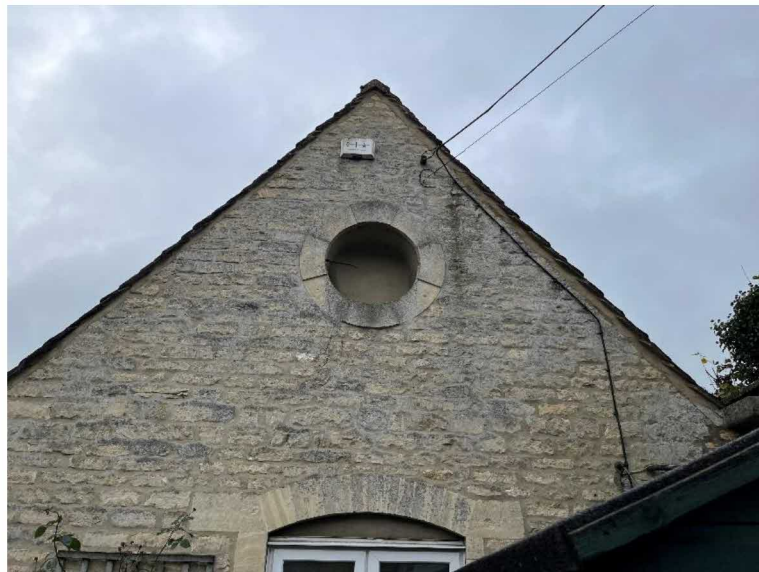
Constructed of squared Cotswold limestone, stonework and pointing are in good condition all round with some repointing evident. Windows and doors are a mixture of modern PVCu and timber framed all in good condition and tight to apertures with stone lintels and slate sills, timber doors on the façade are set within gauged stone surrounds indicating the original coach entrance. Timber facia are tight to stonework and moderately cobwebbed. A circular encasement with gauged stone surround is present in the northern gable.

Plate 2. Northern gable.

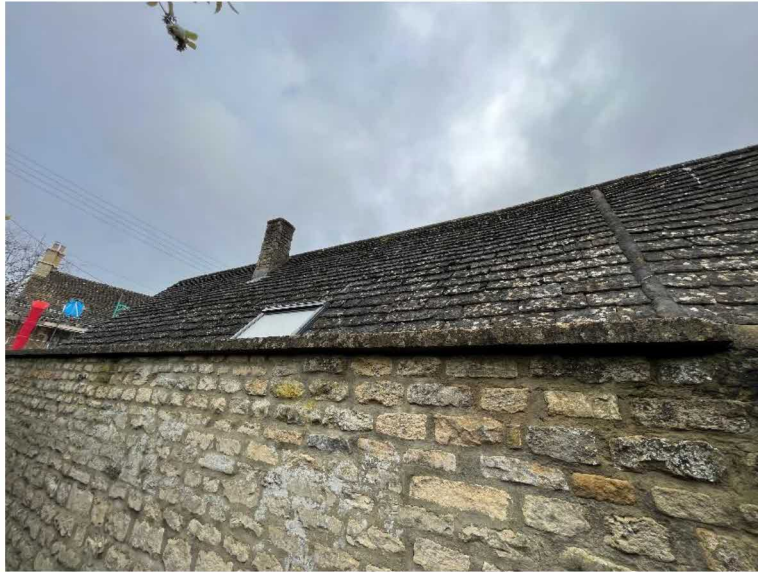
The property features a gable and valley roof with rustic Cotswold stone covering, tiles are in largely good condition and well seated, however due to their rustic nature there are multiple potential access points between and beneath stone tiles on eastern and western aspects. A gable dormer is present on the southern aspect, featuring rendered sides and hanging stone tiles to the apex. Individual 'Velux' style windows are located on the western, northern, and southern aspects including southern aspect of the garage.

Plate 3. Western aspect roof.

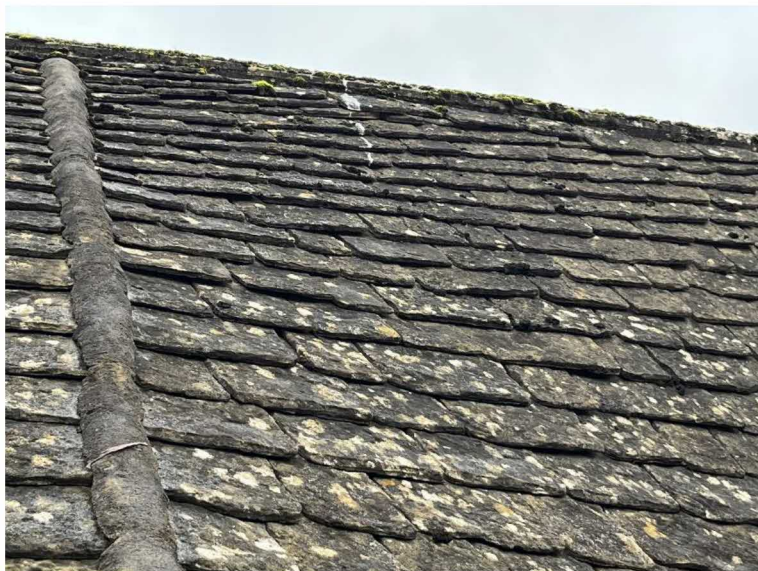
Endoscopic inspection of some access points identified between / beneath tiles found the cavities between tiles and sarking membrane to be dry and sufficiently large as to provide roosting opportunity. While no endoscopic inspection of select crevices identified no evidence of bat roosting the roof offers too many opportunities to inspect fully.

Plate 4. Lifting and parting of Cotswold stone tiles.

- As a precaution a soft-demolition approach is recommended toward the removal of roofing materials.
- In the unlikely event that bats are found during works, all work must halt immediately, and the project ecologist consulted on how to proceed.

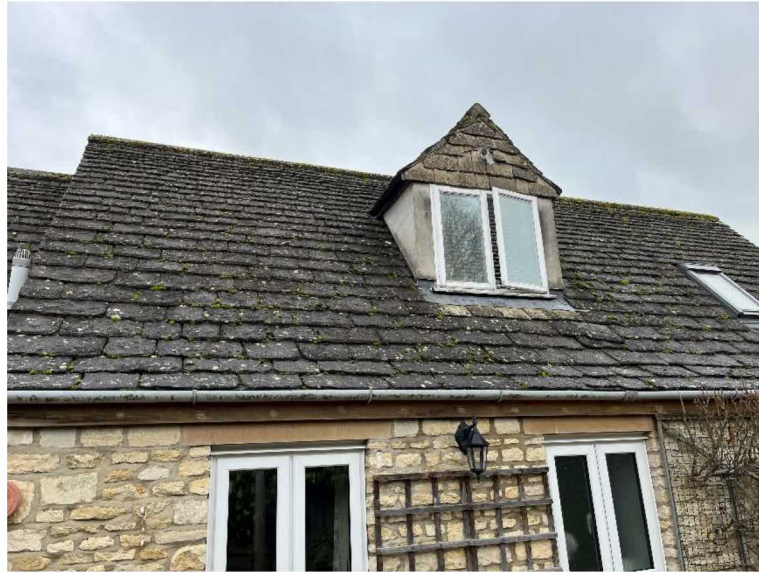
Plate 5. Southern rear aspect with dormer.

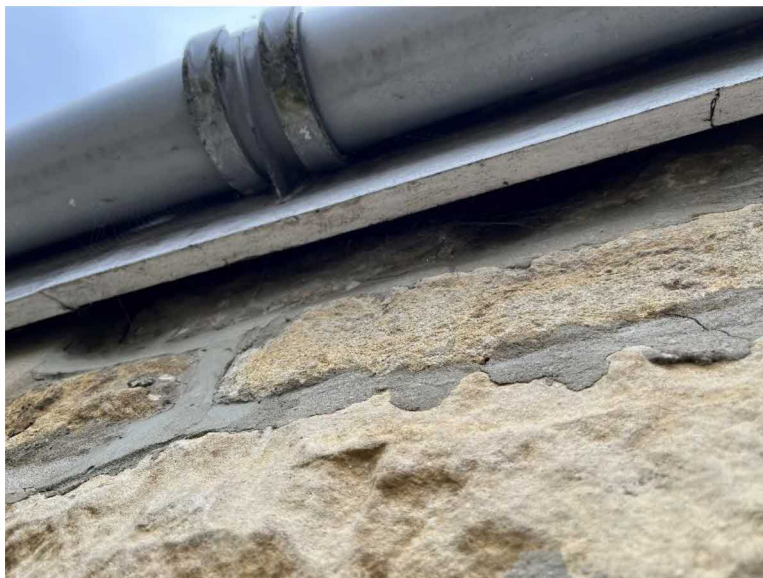
Plate 8. Crevice between fascia board and stonework.

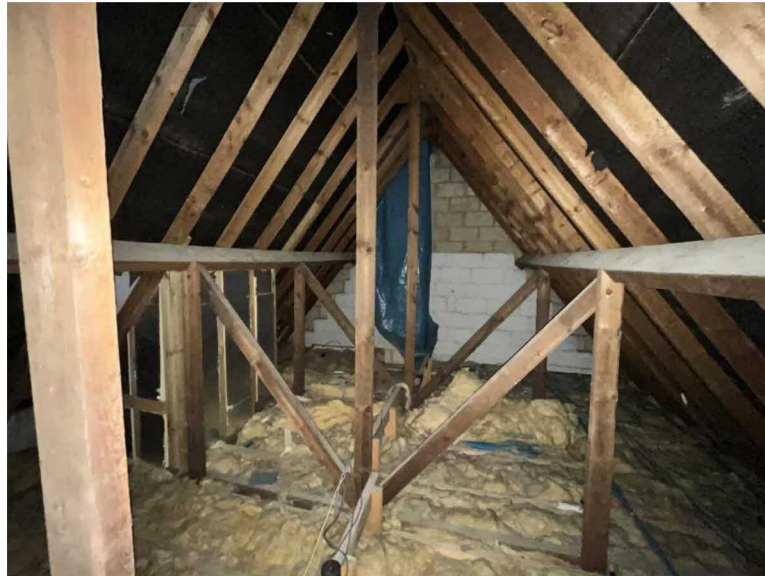
Internally the western part of the property features a partially divided roof void. Timbers are modern machine-cut rough-sawn with moderate to heavy cobwebbing. Tiles are lined with a mixture of Type 1F bituminous felt and a string-reinforced polythene sarking material. Floors are fully insulated with glass-fibre roll with minimal boarding. Eastern part of the property features vaulted ceilings with no void.

Plate 9. General view of interior roof void, northern end.

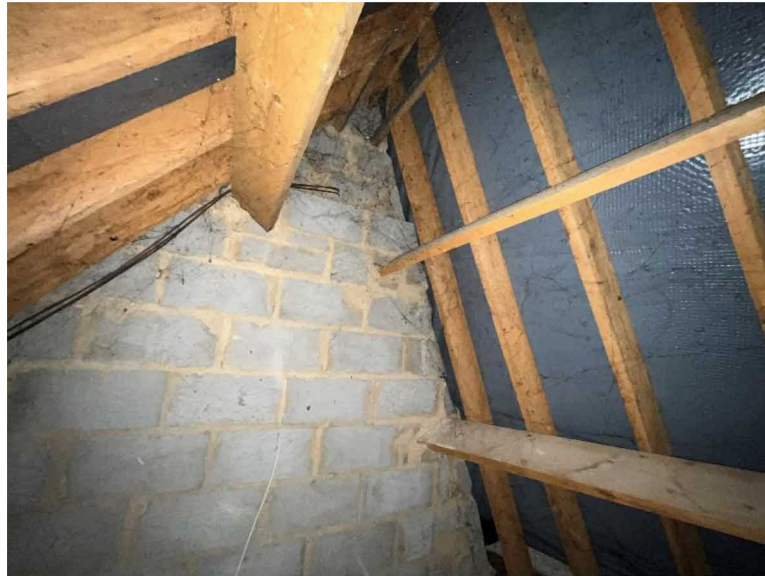
Plate 11. General view of interior roof void, southern end.
