Heritage Impact Assessment

Alterations to include the removal of existing WC and shed attached to rear of property, construction of a retaining garden wall with alterations to existing external ground levels at the rear of the dwelling and underpinning works to basement

Thatched Cottage, Church Street, Bampton, Oxfordshire

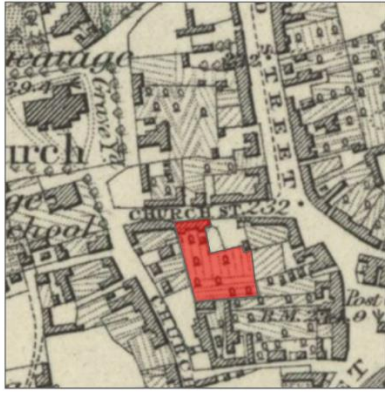
Figure 5. Map regression of the Site

OS 1:6 Oxfordshire Sheet
XXXVII 1876-1880

OS 1:6 Oxfordshire
Sheet XXXVII.NE 1898

OS 1:6 Berkshire Sheet IV.
1922

evidence although not completely reliable does suggest that in 1880 the building was adjoined at its western end to the terrace of properties leading to the end of Church Street. By 1898 the site is depicted as detached from the terrace.

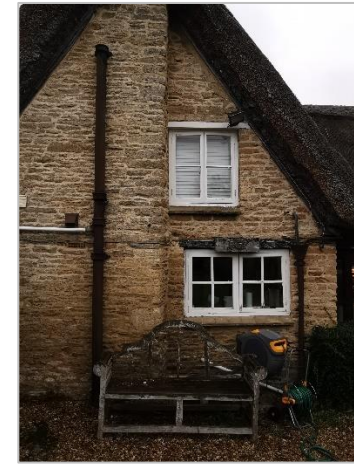
6. Mid 18th century rear extension at time of report

6.4. The rear gable and stack extension increased the Site footprint and internal proportions significantly, the structure exhibiting mid-18th century detailing (casements with leaded panes, Stonesfield slate stones, slim timber lintels) inferring an improvement in the residences economic position. These contribute to the overall architectural interest of the Site as well as contributing to understanding the history and phasing of the building.

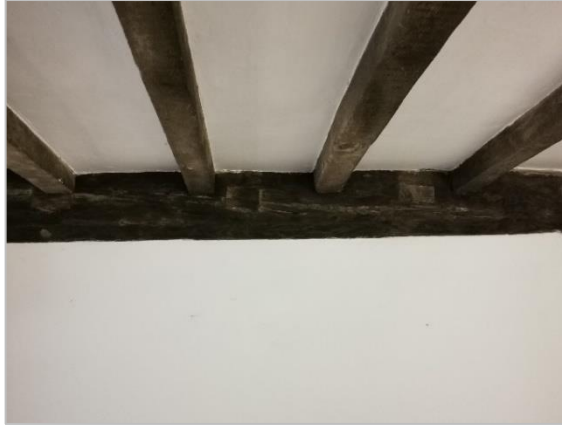
8. Evidence of removal of historic joists and replacement and re-notching of new timber

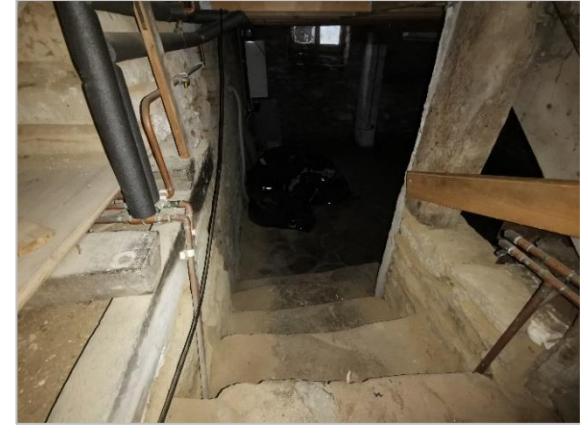
9. Basement stairwell. The vertical timber support to the partition wall above is anachronistic and purportedly supports only the broom cupboard above.

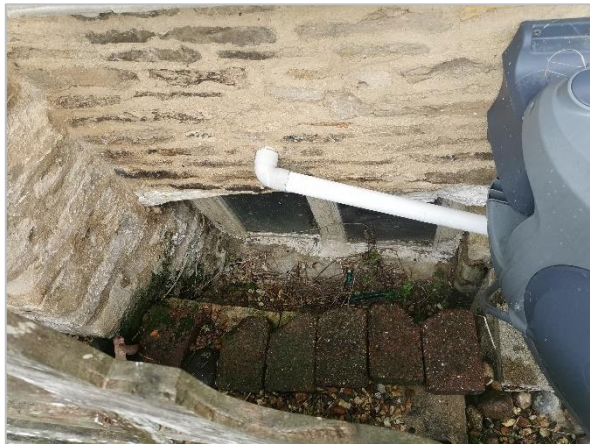
10. Viewing window to cellar. It is unlikely that the cellar was designed to be accessed from the rear of the property, indicating the internal stairwell is contemporary to the cellar as the main access.

- 5.10. The cellar post-dates the original construction and was likely developed at the time of the rear extension in the early 19th century owing to the alignment of the cellar retaining walls aligned to the kitchen rear extension footprint.

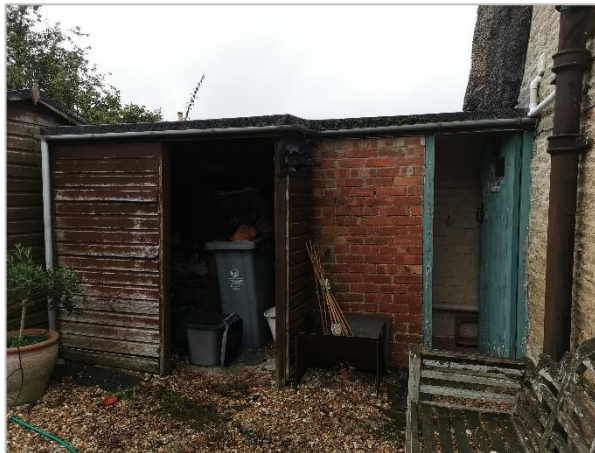
11. Current facilities at ground level – a 1950s outhouse and adjoining shed.

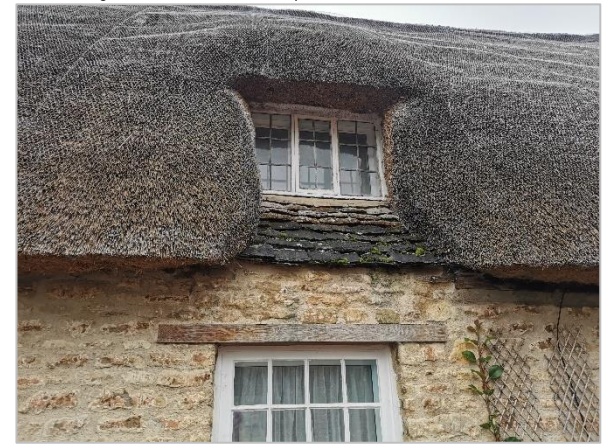
12. Example of Stonesfield slates built into historic sill at front of the Site.
