## Proposed Alterations at Nelsons

2304.1400.P3 - Planning & Heritage Statement

Theo Arch Tech  
3 House Martin Way  
Stowmarket  
Suffolk  
IP14 5JB

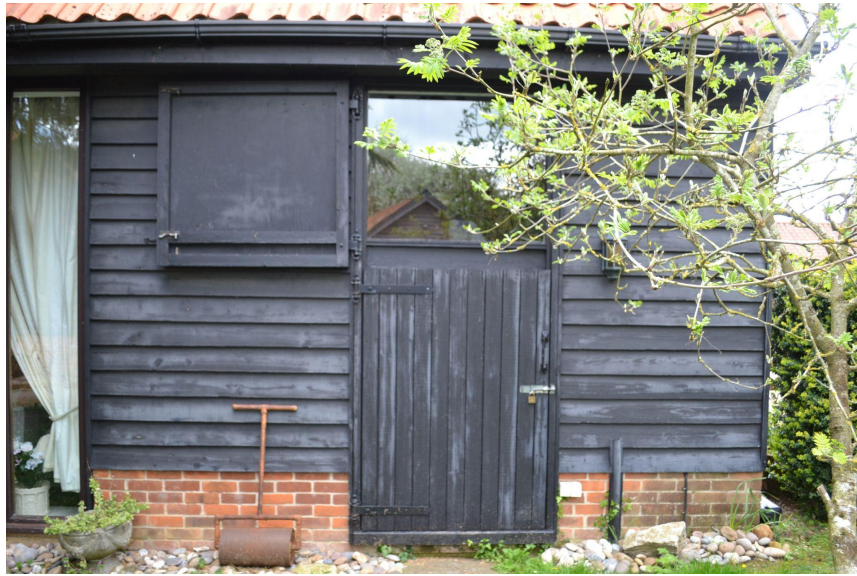
Plate 3 - Glazed panel to be replaced.  
Outer frame including upper and lower stable doors retained.

It is proposed to replace the existing single glazed panel within the stable door. The primary reason for this alteration is to enable the window to be used for emergency egress, addressing the current deficiency in the room, which lacks a suitably sized window for this crucial purpose. The alterations will also serve to improve ventilation within the room, a measure that will aid in controlling humidity and moisture, in turn safeguarding the timber frame in the heritage asset. Our approach will involve a precise removal of the single glazed panel, including the careful extraction of the softwood batten that is currently fixed to the more substantial outer frame of the stable door.

The replacement joinery has been thoughtfully designed to seamlessly fit within the existing aperture, eliminating the need for alterations to the surrounding fabric.

In the interest of long-term protection and reduced future maintenance demands, the replacement joinery will be expertly crafted from hardwood—a choice known for its durability and longevity. This selection of high-quality materials not only safeguards the building's integrity but also contributes to the long-term preservation of the heritage asset.

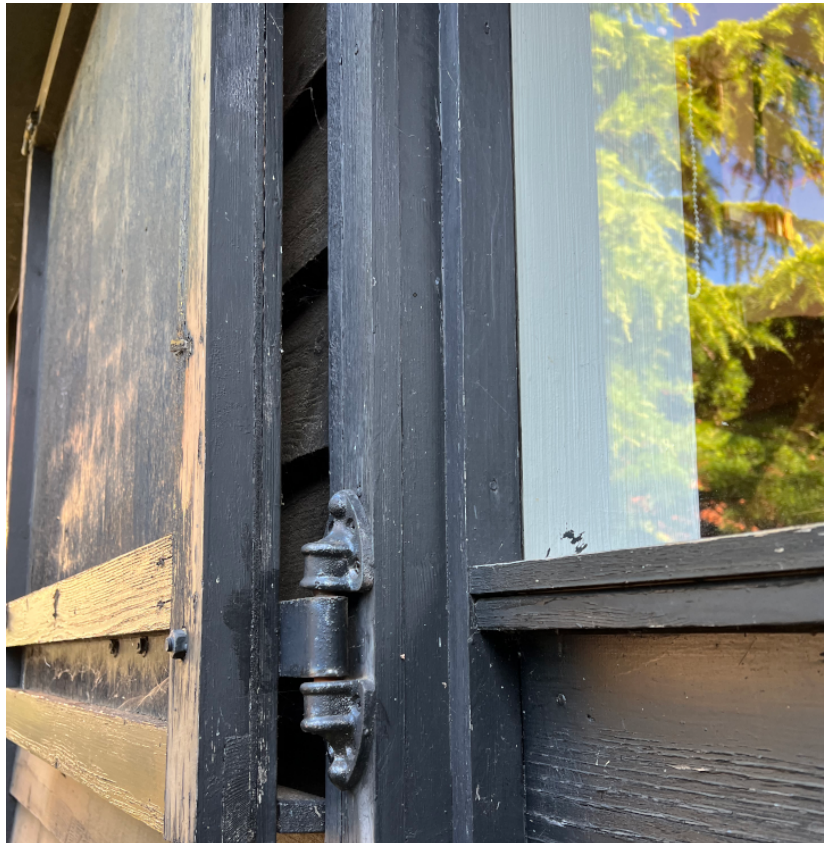
Plate 4 - Upon close visual inspection of the existing glazing, it is evident that a single glazing panel is affixed against a softwood batten, which, in turn, is securely attached to the 'principal' joinery frame. In the proposed alterations, the single glazed panel will be methodically removed, and the softwood batten will be meticulously trimmed to accommodate the installation of a new unit within this defined aperture.

Furthermore, it is crucial to note that the elements slated for replacement, namely the glazing panel and softwood batten, do not constitute historic fabric of significant heritage value. This fact, combined with the reversible nature of the proposed alterations, underscores the appropriateness of these changes from a conservation perspective.

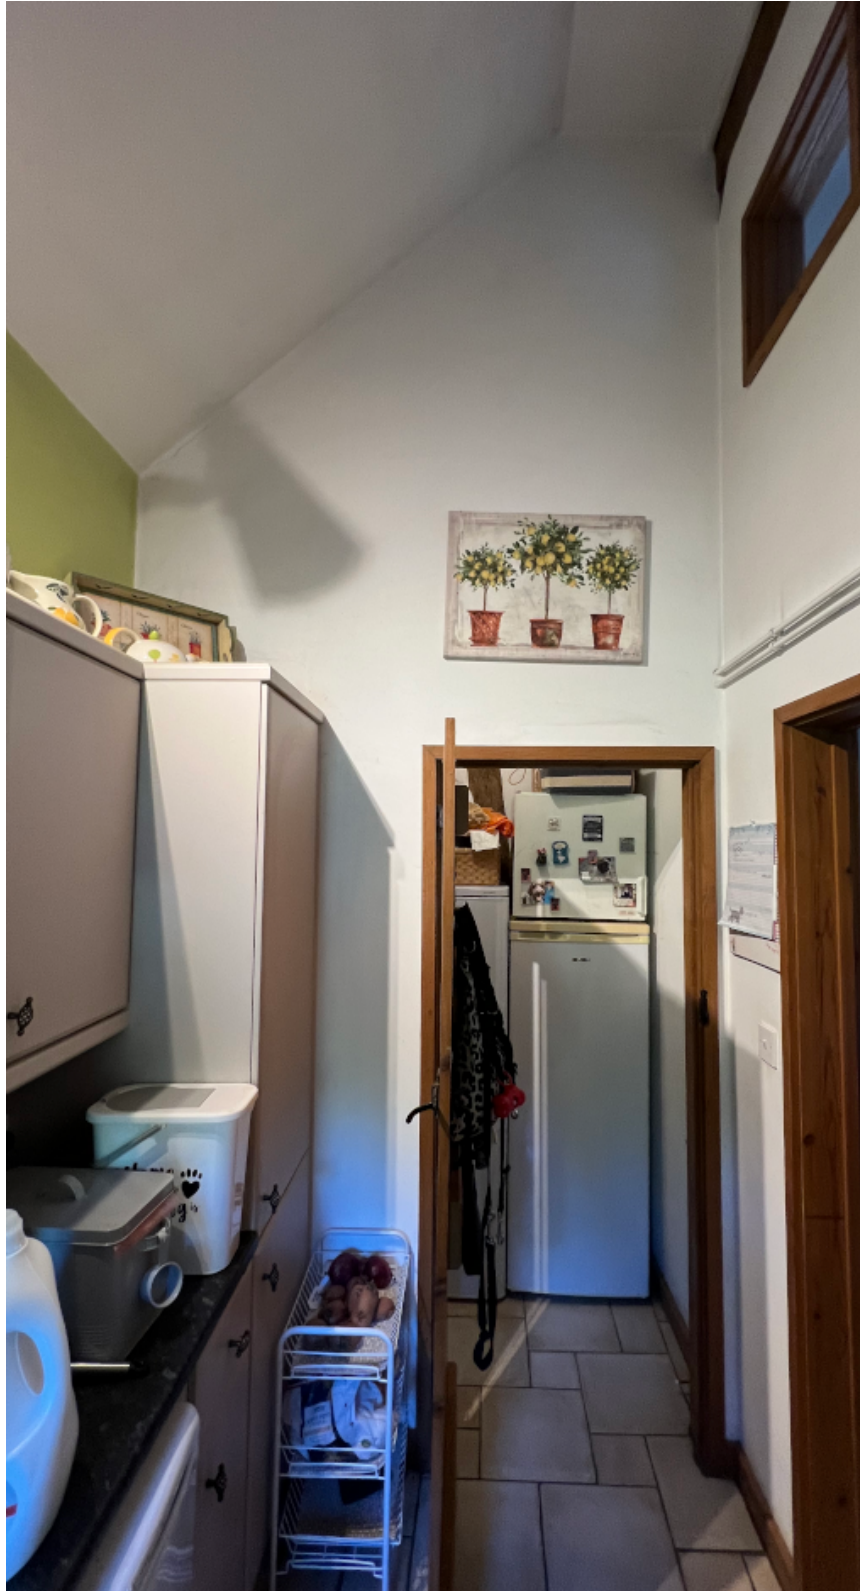
Plate 5 - Partition between R007 & R008 to be removed

It is proposed to remove the modern partition separating R007 and R008 to enhance the utility of these spaces. R007, being a relatively small, and particularly slim space, would benefit significantly from the removal of this partition. Moreover, this action would reveal more of the existing timber frame, currently concealed within R008 as part of a larder, allowing its visual appreciation and enjoyment.

The proposed removal of the partition separating rooms R007 and R008 has a negligible impact on the heritage asset. This partition is situated within an extension to the original barn, with a historic wall interface on one side. Its removal will result in the exposure of more historical fabric to the habitable rooms, notably the original timber framing visible in R008.

It's important to note that the partition slated for removal consists of modern plasterboard cladding on both faces, making it a non-historic addition to the structure. Its thickness would indicate that its structure is made up of sawn softwood.

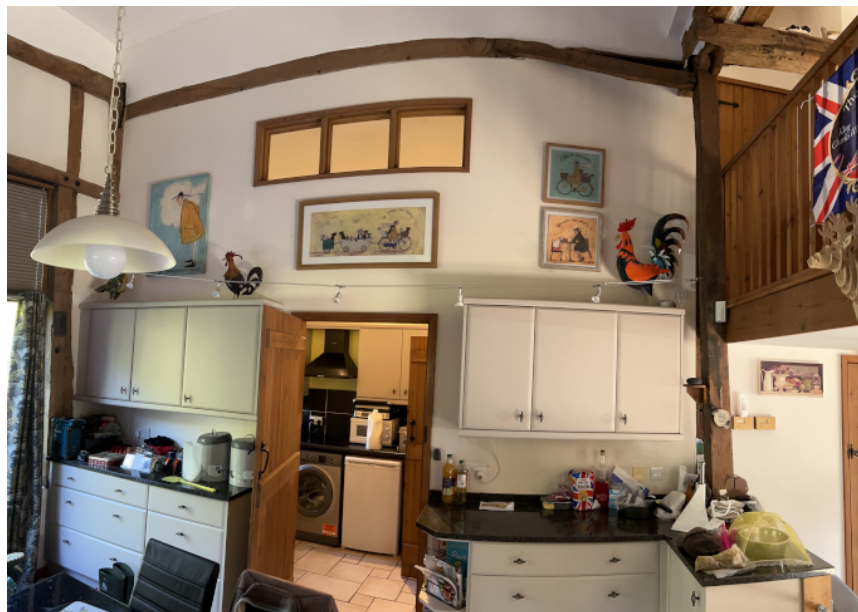
Plate 6 - Wall between R002 & R007/R008. R007 & R008 are formed within an extension to the original barn with historic framing visible in all other partitions except that which is proposed to be removed.

There is potential for impacting the adjoining historic fabric if the work is not carefully undertaken. Particularly at the interface with the wall shown in plate 6. This would need to be mitigated against with careful and methodical working methods.

In particular, work at the interface with the historic wall will be executed with a deliberate and methodical approach. This careful process aims to mitigate any potential unintended damage to the surrounding fabric, ensuring the heritage asset's integrity remains intact.

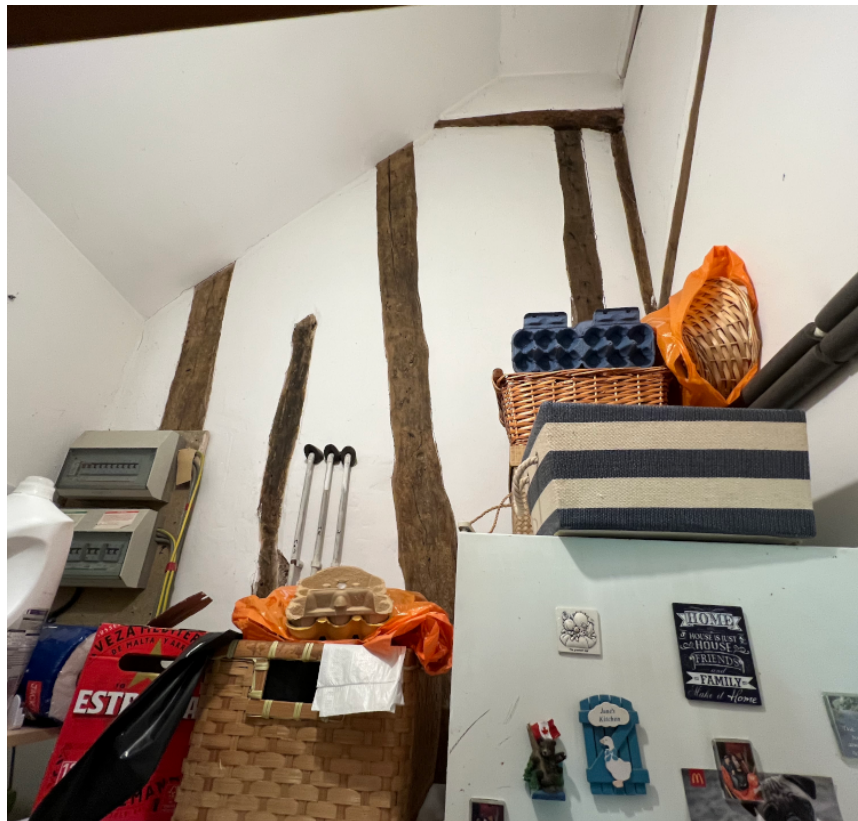
Plate 7 - Existing timber framing, visible within R008. (Wall between R004 & R008)
