# Ivy House, Castle Caereinion Bat Report

Title Ivy House, Castle Caereinion

Document Number R01-Bat Report-Rev01

Client Chrysalis Architectural Design

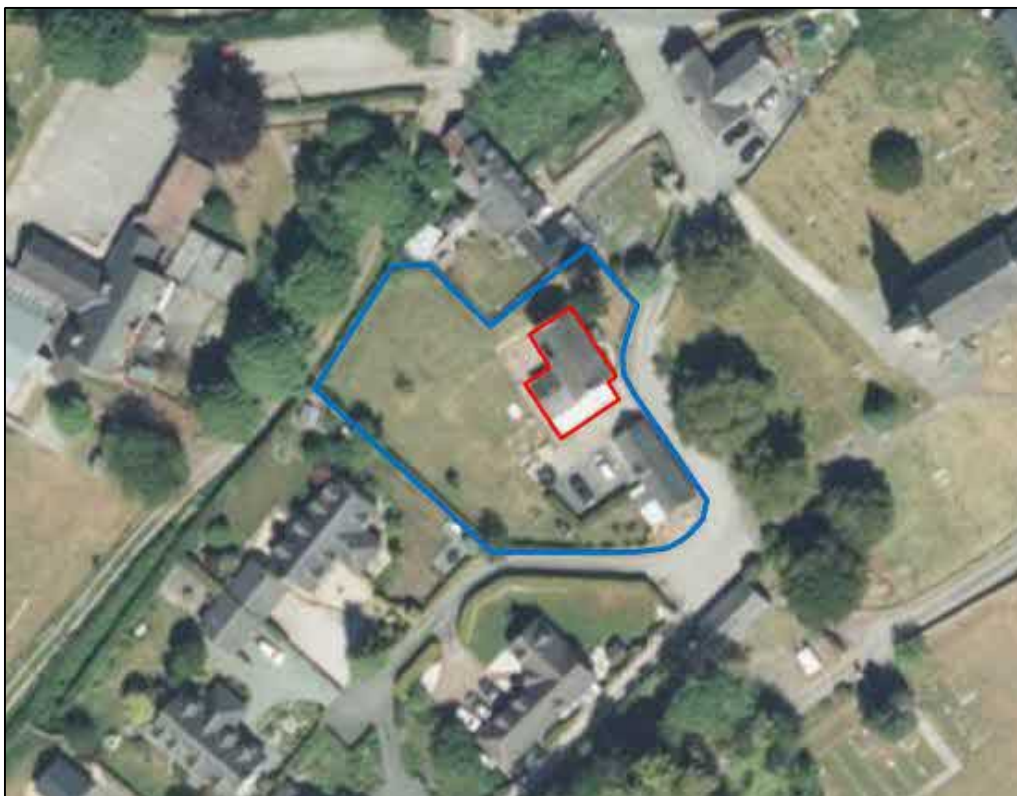
The proposed development site is located in Castle Caereinion, approximately 5 km south-west of Welshpool (*Figure 1*). The site comprises a detached two-storey Farmhouse, detached brick barn and associated gardens and driveway (*Figure 2*). The proposals involve the replacement of the existing conservatory with a single-storey aluminium-framed extension along the south-eastern extension, the construction of a single-storey aluminium-framed extension along the south-western elevation, re-roofing of the Farmhouse, installation of two dormer windows and a Velux window along the north-eastern elevation, installation of a first-floor window along the south-western elevation and conversion of the attic into bedrooms.

*Figure 2. Proposed development site (affected building outlined in red, ownership boundary outlined in blue) (www.bing.com/maps accessed 12.09.2023)*

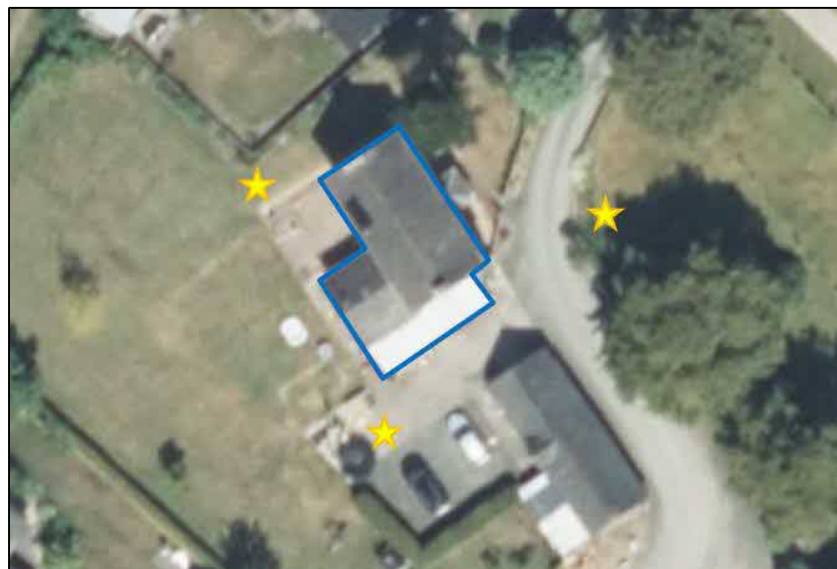
Surveyors were able to position themselves so any activity could be clearly observed and general activity around the site could also be recorded from the surveyor's location. Three surveyors were used which allowed for all parts of the building to be surveyed (*Figure 3*).

Figure 3. Surveyor locations (yellow stars) and affected building outlined in blue ([www.bing.com/maps](http://www.bing.com/maps) accessed 30.08.2023)

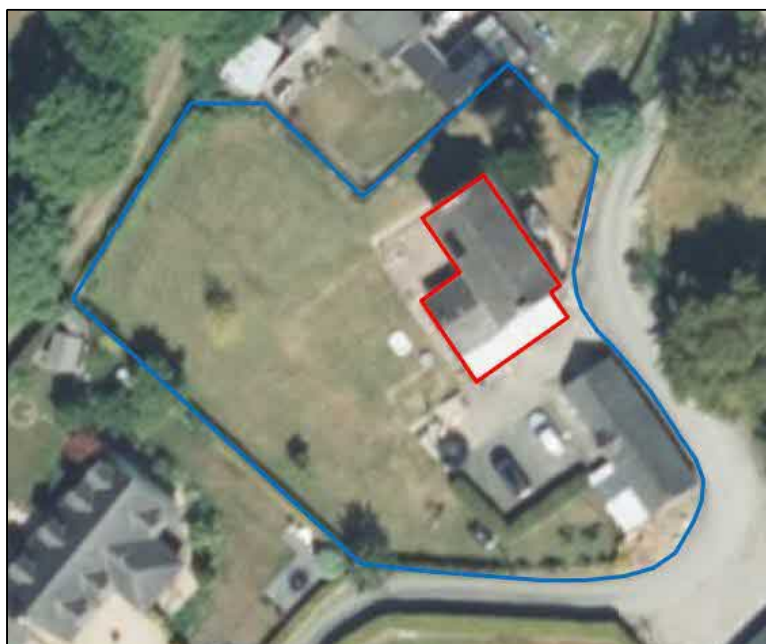
The proposed development site comprises a two-storey detached Farmhouse, with a patio and amenity grassland located to the north-west, west and south-west, further amenity grassland located to the north and east and a driveway located to the south. A minor road is located to the east. A detached barn is located south-east of the Farmhouse and will not be affected by the proposals. The existing layout of the site is shown in *Figure 4* and existing elevations and floorplans are shown in *Figures 5 and 6*.

*Figure 4. Existing site boundary (outlined in blue) and affected building (outlined in red)*

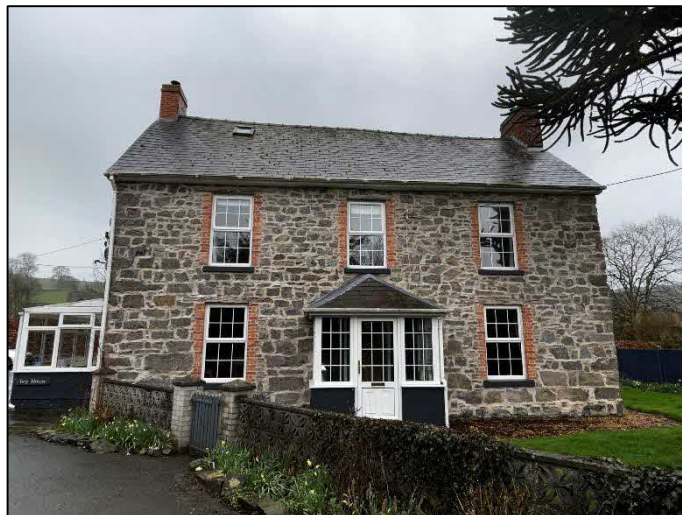
The affected building comprises a two-storey, detached stone and brick Farmhouse with a two-storey extension adjoining the south-western elevation and a lean-to conservatory adjoining the south-eastern elevation. The Farmhouse has a pitched, slate tiled roof with a Velux window and two solar panels on the south-western aspect and a Velux window on the north-eastern aspect. Brick chimneys are located at the northern and southern extents of the roof.

*Plate 1. North-eastern elevation (looking south-west)*

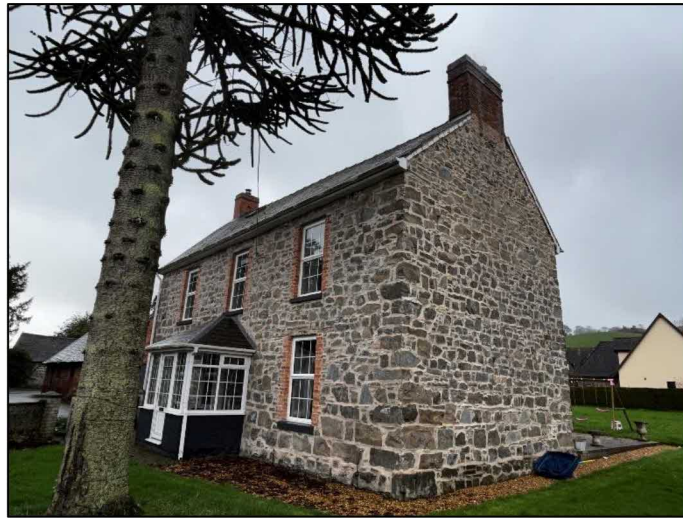
*Plate 2. North-eastern and north-western elevations (looking south)*

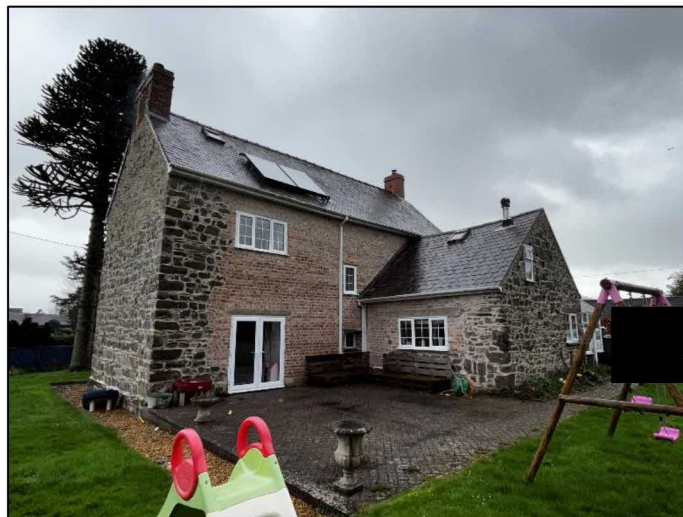
The two-storey extension has stone walls and a pitched, slate tiled roof with a Velux window and metal flue along the north-western aspect and uPVC windows along the south-western and north-western elevations. The conservatory adjoins the south-eastern elevation of the farmhouse and two-storey extension and has a brick, rendered base with uPVC windows along the north-eastern, south-eastern and south-western elevations. The roof is formed by gently sloping plastic roof sheets. A porch is located at the centre of the north-eastern elevation of the Farmhouse and has a pitched, slate roof with wrap-around uPVC windows (*Plates 1 to 4*).

*Plate 3. North-western and south-western elevations (looking south-east)*

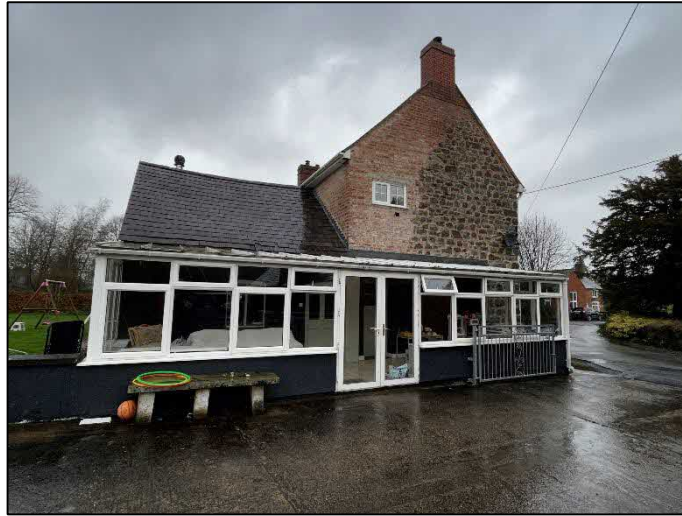
*Plate 4. South-eastern elevation (looking north)*

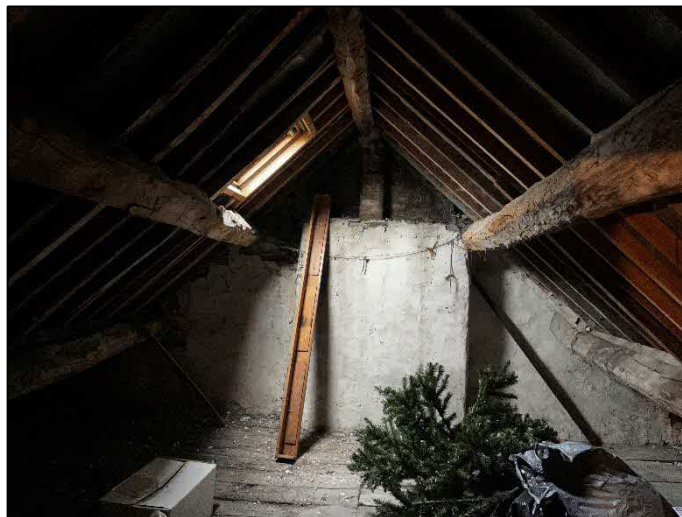
The ground and first floor of the Farmhouse comprise light and well-sealed living accommodation. The attic on the second floor comprises two rooms and a landing area currently used for storage. The roof has exposed timber frame and is lined with a plastic liner (*Plates 5 to 7*). A single Velux window is located in the roof of each of the rooms.

*Plate 5. Attic room at northern end of second floor*

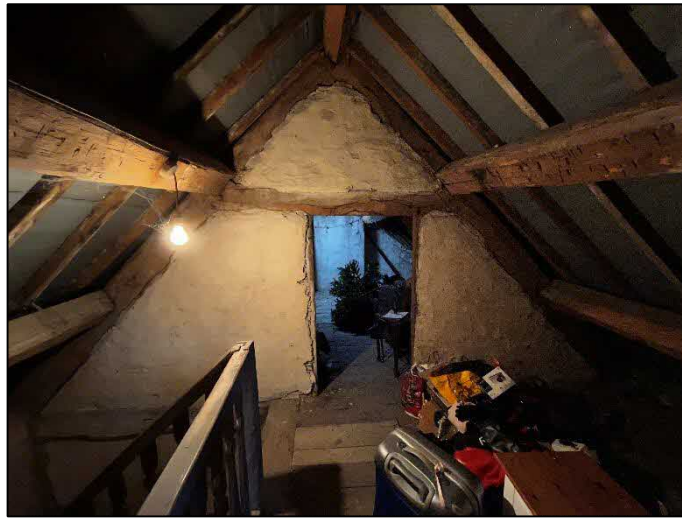
*Plate 6. Landing area on second floor*

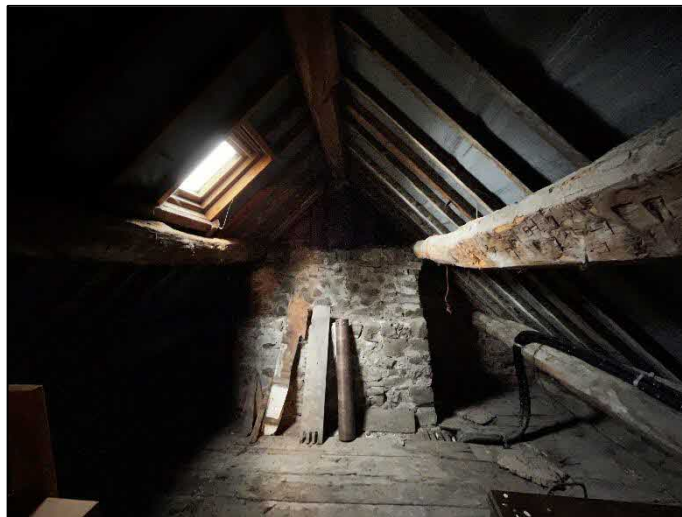
*Plate 7. Attic room at southern end of second floor*

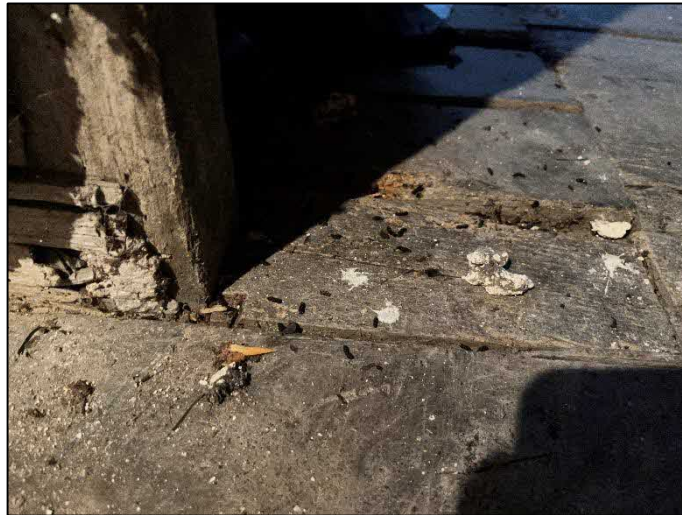
Evidence of roosting bats was recorded within the attic with approximately thirty small bat droppings (characteristic of a *Pipistrelle* species) noted on the floor around a doorframe (*Plate 8*). Gaps are present above the door frame and around the timber roof frame where bats are likely to roost, with internal access likely gained through gaps around the chimney and ridge tiles (*Plate 9*).

*Plate 8. Bat droppings around door frame in attic*

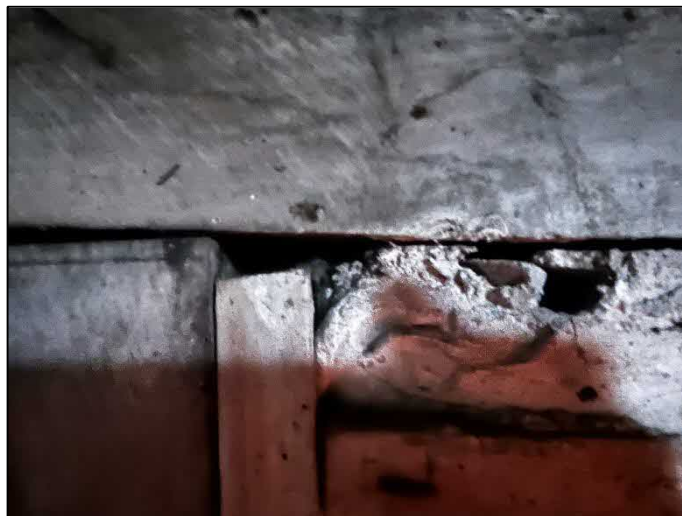
*Plate 9. Gaps around door frame in attic*

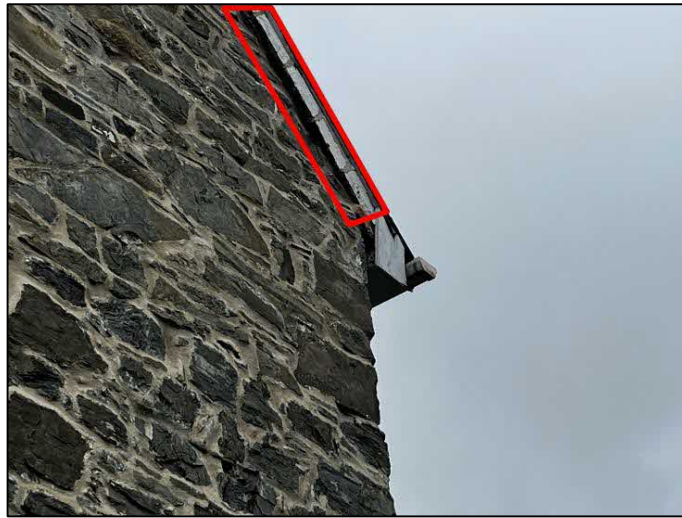
Suitable roosting access features around the Farmhouse include gaps at wall tops (*Plates 10 and 11*), gaps under ridge tiles (*Plate 12*), gaps around the chimneys (*Plate 12*) and gaps into the soffits (*Plate 13*). The mortar is in good condition, with no cracks or holes visible.

*Plate 10. Gaps at wall tops*

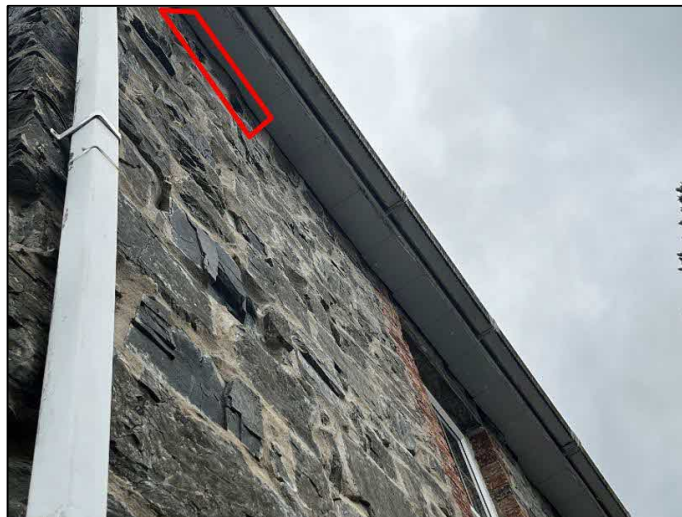
*Plate 11. Gaps into wall top*

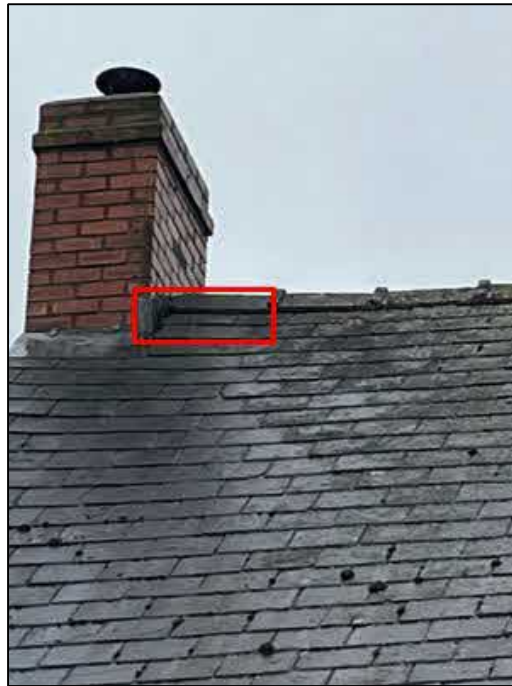
*Plate 12. Gaps under ridge tile and around chimney*

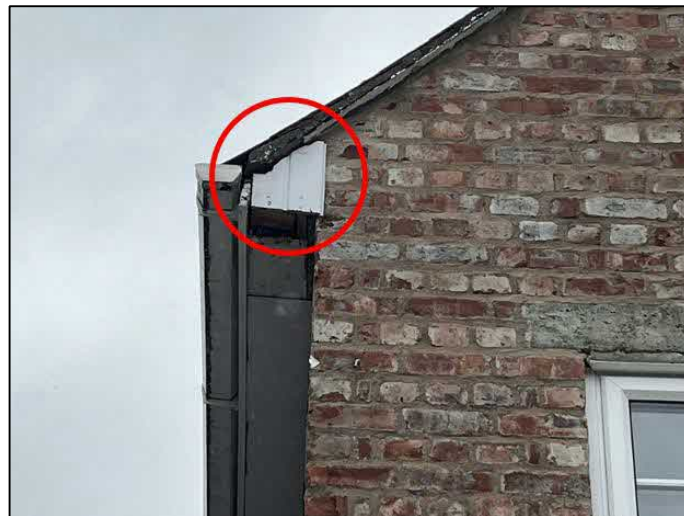
*Plate 13. Holes into soffit*

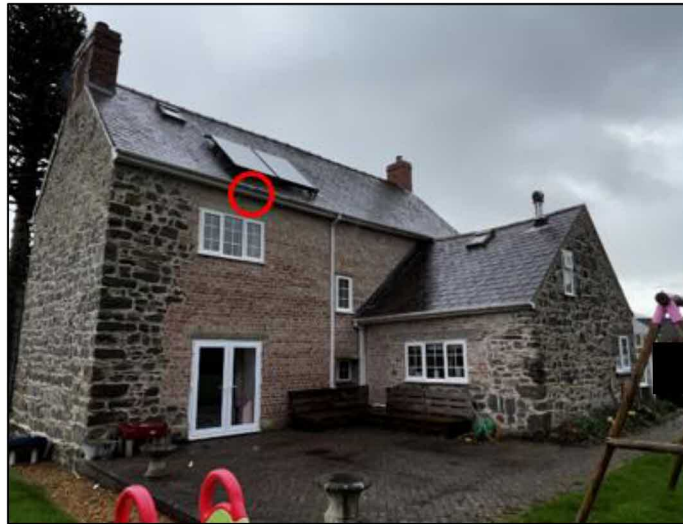
- 21:25 Individual Common Pipistrelle (*Pipistrellus pipistrellus*) emerged from gap in soffit on the south-eastern elevation (*Plate 14*).
- 21:32 Individual Common Pipistrelle emerged from gable end of barn to south of Farmhouse (*Plate 15*).
- 22:20 Individual Brown Long-eared Bat (*Plecotus auritus*) possible emergence from south-western elevation of barn to south of Farmhouse (*Plate 15*).

*Plate 14. Location of emerging individual Common Pipistrelle from gap in soffit during May dusk survey (red circle)*

- An individual Common Pipistrelle roosting in the soffit on the south-eastern elevation;

A gap will be created into the replacement soffit along the south-western elevation at the same location as the existing Common Pipistrelle day roost (*Figure 11*);

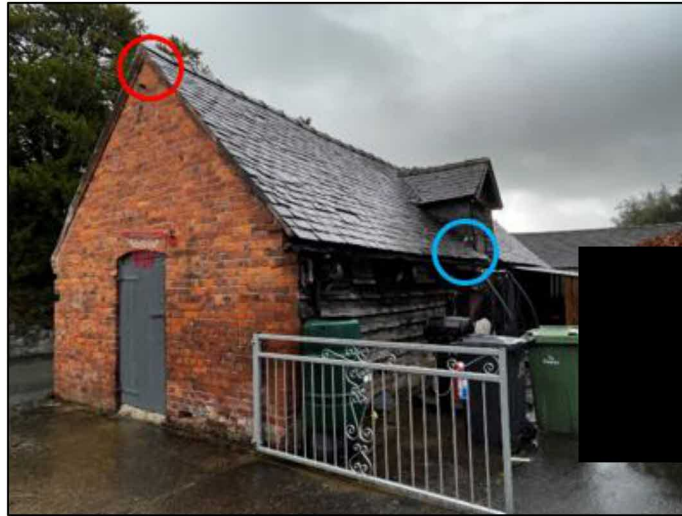
Plate 15. Emergence location of individual Common Pipistrelle (red circle) on north-western gable end of barn and possible emergence location of Brown Long-eared Bat (blue circle) on south-western elevation of barn

- An individual Common Pipistrelle roosting in a gap at the wall top of the north-western gable end of the barn;

- An individual Brown Long-eared Bat possibly roosting in a gap at the wall top of the south-western elevation of the barn.

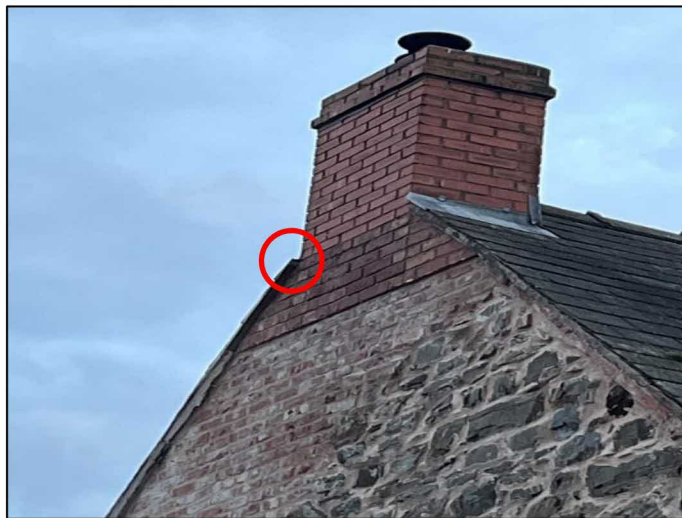
- 04:28 Individual Common Pipistrelle re-entered into roof verge/lead flashing of chimney on south-eastern gable end (*Plate 16*).

Plate 16. Location of individual re-entering Common Pipistrelle during July dawn survey (red circle)

- An individual Common Pipistrelle roosting in a gap at the roof verge on the south-eastern gable end. This roost location is considered likely to provide internal access to the attic and be associated with the droppings recorded within the attic.

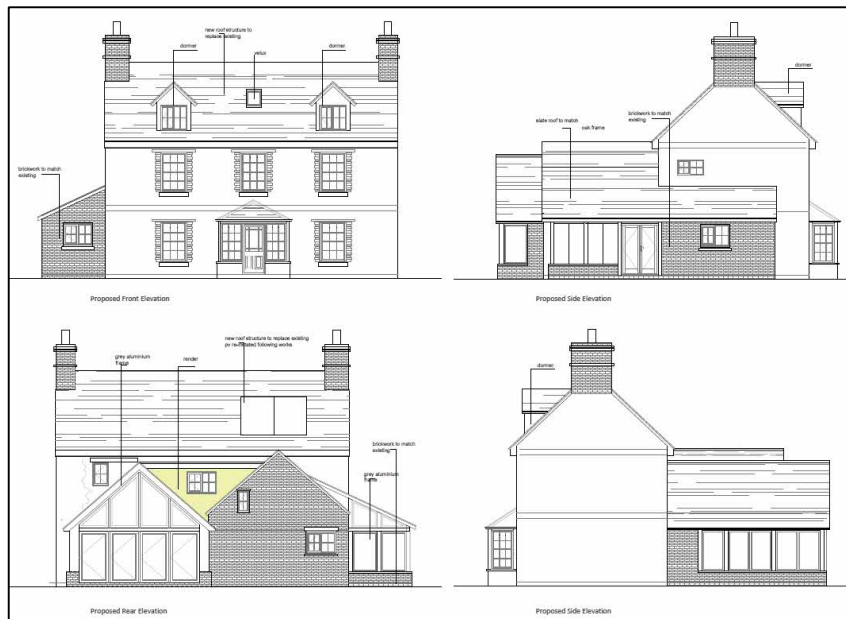
Figure 7. Proposed elevations

The proposals involve the replacement of the existing conservatory with a single-storey aluminium-framed extension along the south-eastern extension, the construction of a single-storey aluminium-framed extension along the south-western elevation, re-roofing of the Farmhouse, installation of two dormer windows and a Velux window along the north-eastern elevation, installation of a first-floor window along the south-western elevation and conversion of the attic into bedrooms (Figures 7 and 8).

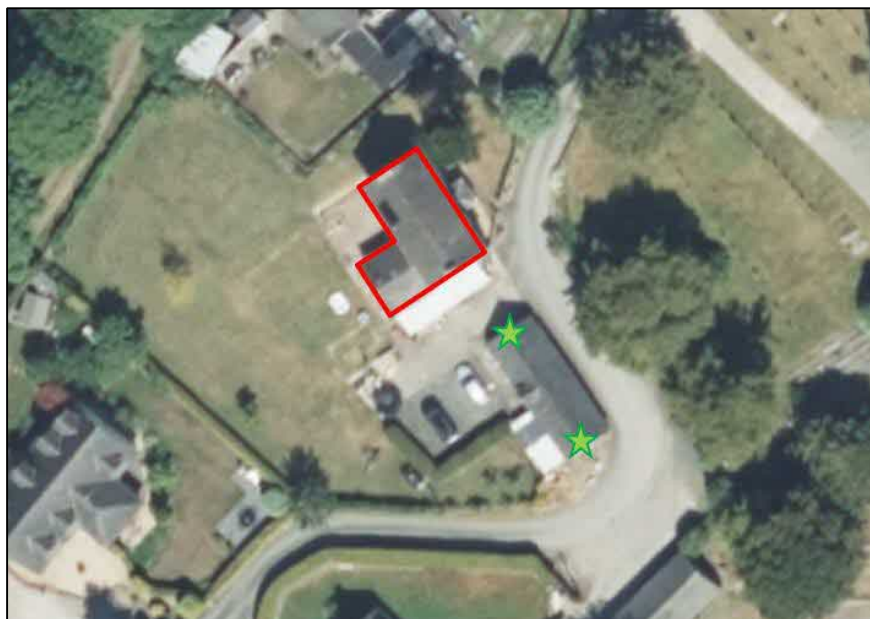
*Figure 9. Proposed bat and bird box locations on barn (green star =Schwegler 2F, or equivalent and hole-fronted nest box)*

Provision of roosting locations for the duration of works with two Schwegler 2F bat boxes, or equivalent, erected on the barn at the south-eastern end of site (*Figure 9*). These boxes will be retained and maintained for the lifetime of the development.

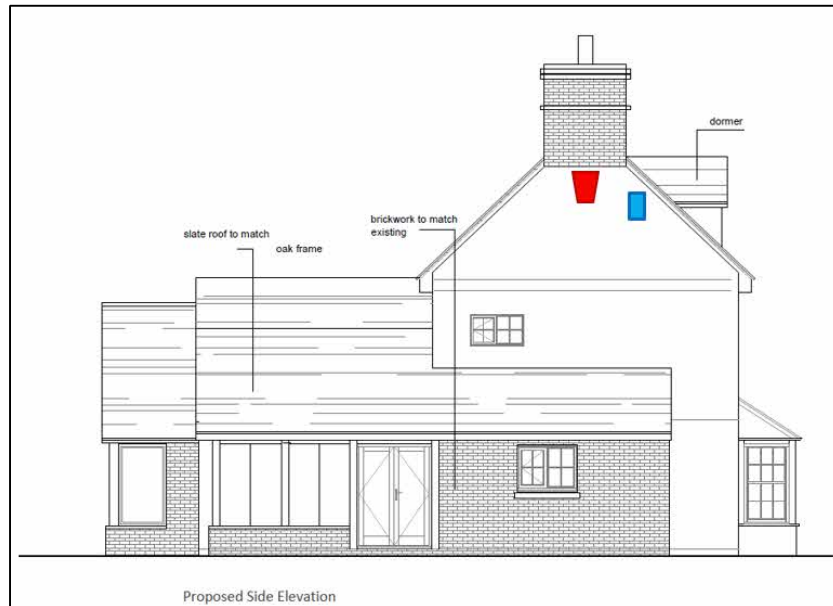
Figure 10. Proposed bat and bird box locations on south-eastern aspect of Farmhouse (red box = *Beaumaris maxi* bat box, or equivalent; blue box = Sparrow terrace box)

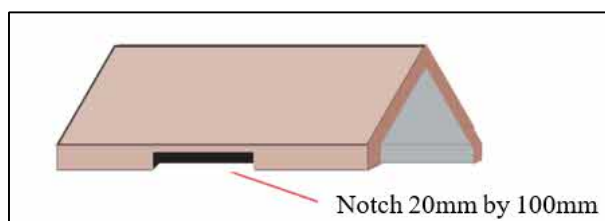
Figure 12. Creation of access and roosting opportunities under lifted ridge tiles in new roof

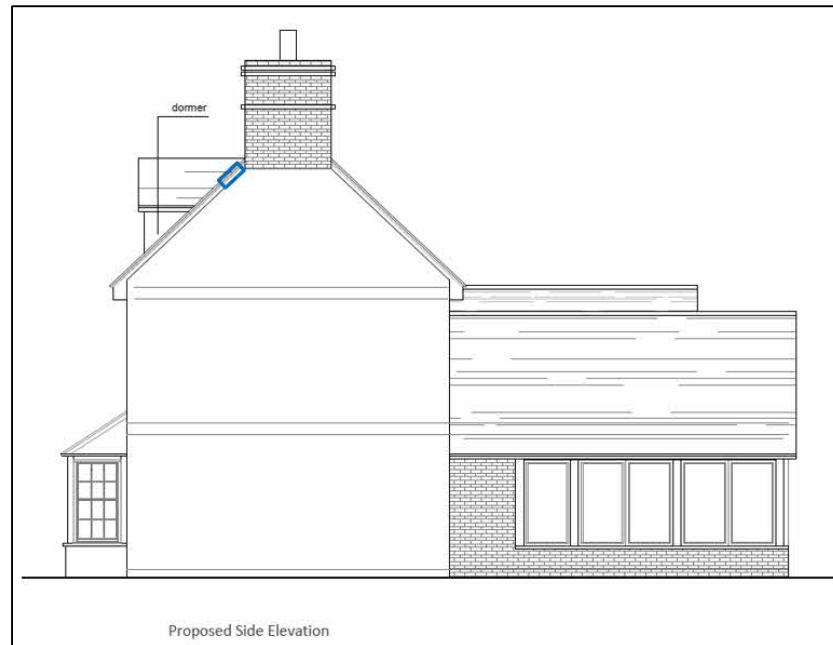
Figure 13. Location of re-created bat access gap at verge on north-western gable end
