## PRELIMINARY SITE RISK ASSESSMENT TIER 1

**SITE:** 13 MARKET SQUARE  
ST JUST  
PENZANCE  
CORNWALL  
TR19 7HE

**CLIENT:** MR D MENEAR  
BOSTRAZE RECYCLING  
10 CHYWOONE WORKSHOPS  
ST JUST  
PENZANCE  
CORNWALL  
TR19 7RZ

**End-use:** Conversion of existing redundant first & second floor (including attic space) residential flats & storage area to apartments & associated works.

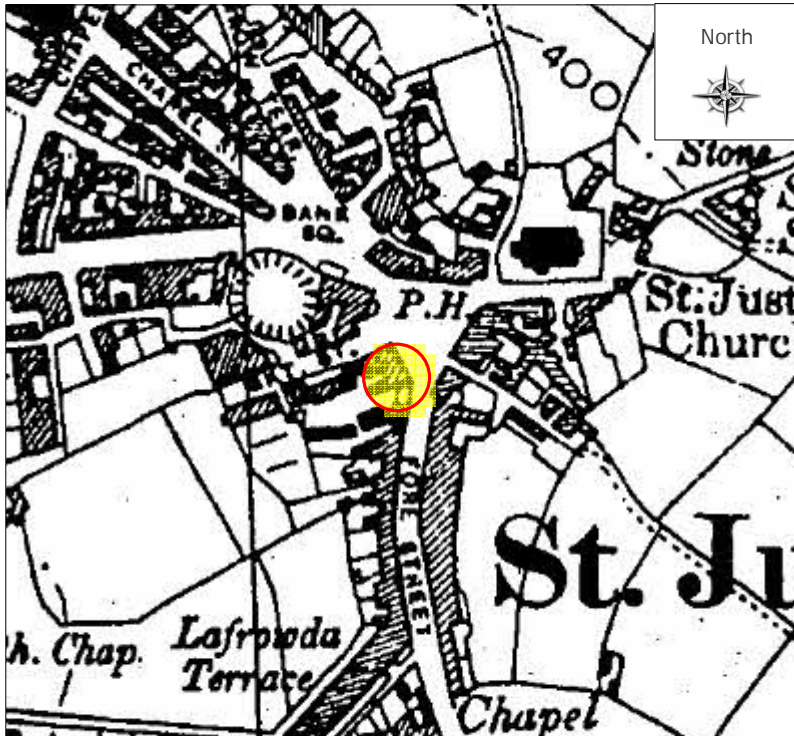
Historical OS Map of 1938

The historical OS map of 1938 shows the site as an existing building located beside the town square.

The site is surrounded by a mix of residential and commercial buildings forming the town of St Just. Outside of the town, the surrounding area comprises of rural agricultural fields.

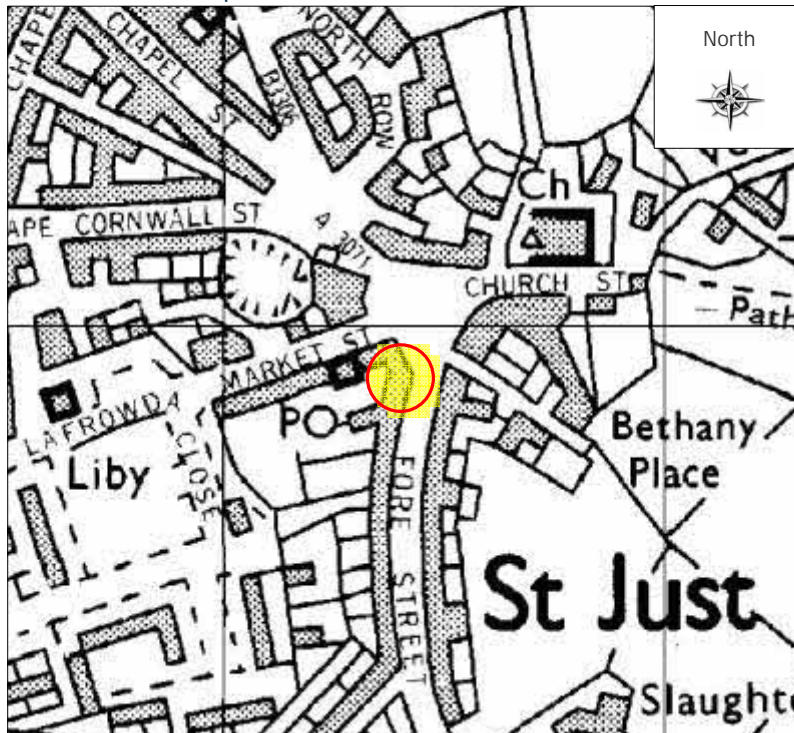
Historical OS Map of 1981

The historic OS map of 1981 shows the site remains unchanged.

A residential housing estate has been developed to the southwest, replacing former fields. A slaughterhouse is indicated to the southeast.

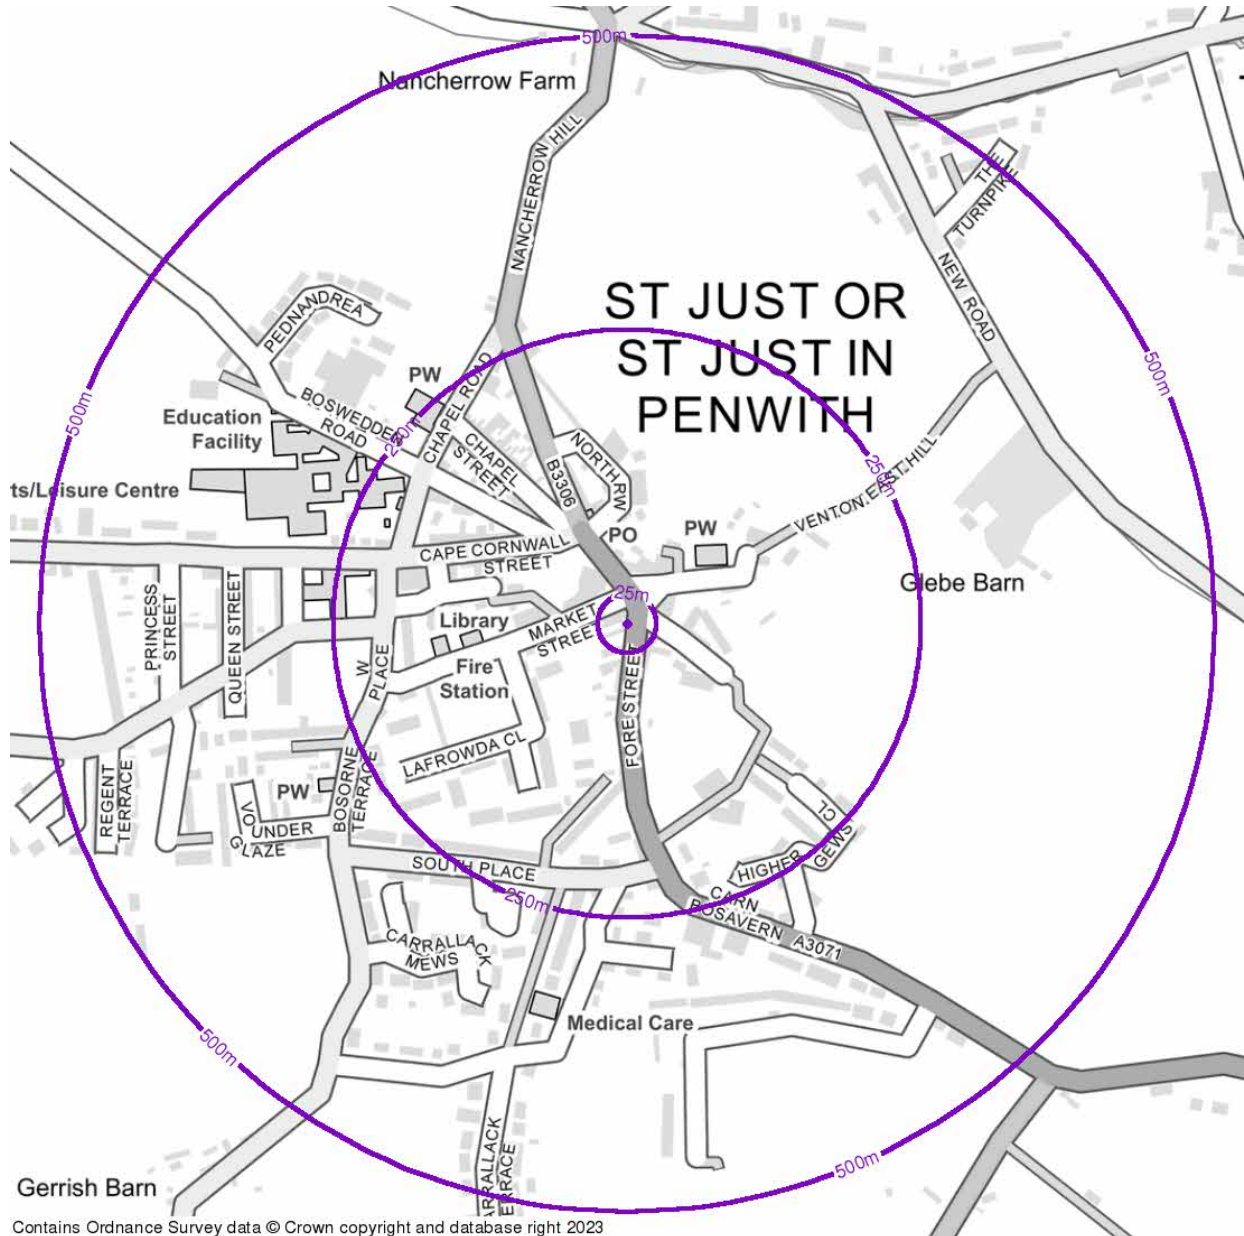
## Section 1a and 1b: Information Map

The map detailed below shows the location of the Designated Contaminated Land and Landfill and Waste features highlighted within sections 1a and 1b of this report.

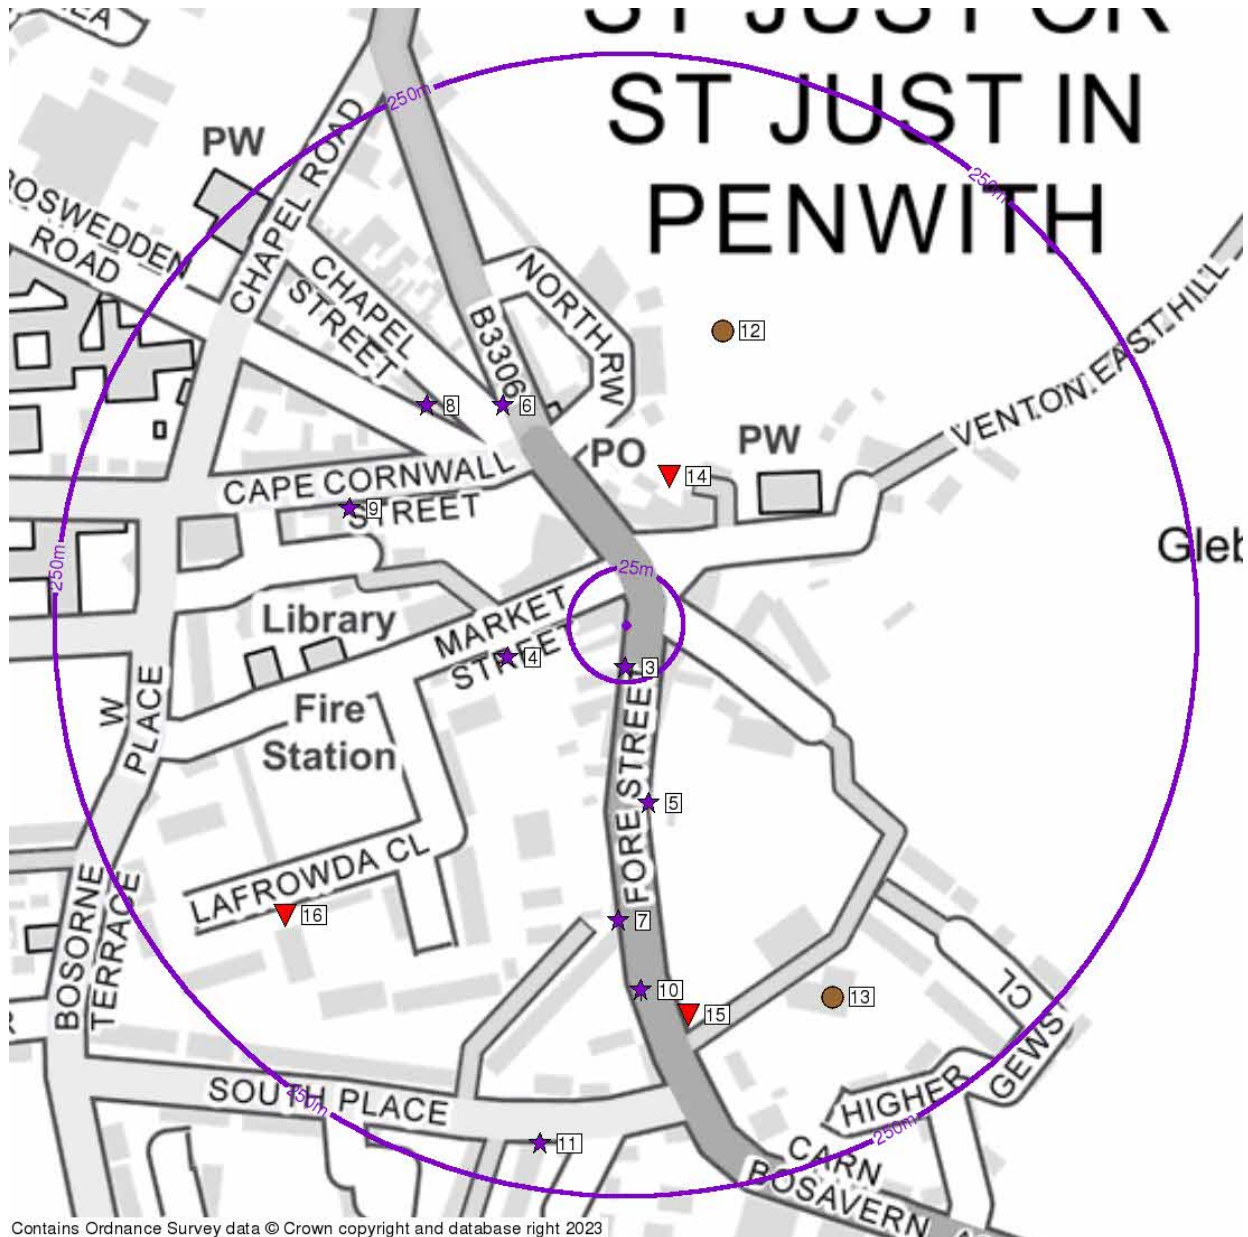
## Section 1e: Information Map

The map detailed below shows the location of the Other Potential Contaminative Land Uses features highlighted within section 1e of this report.

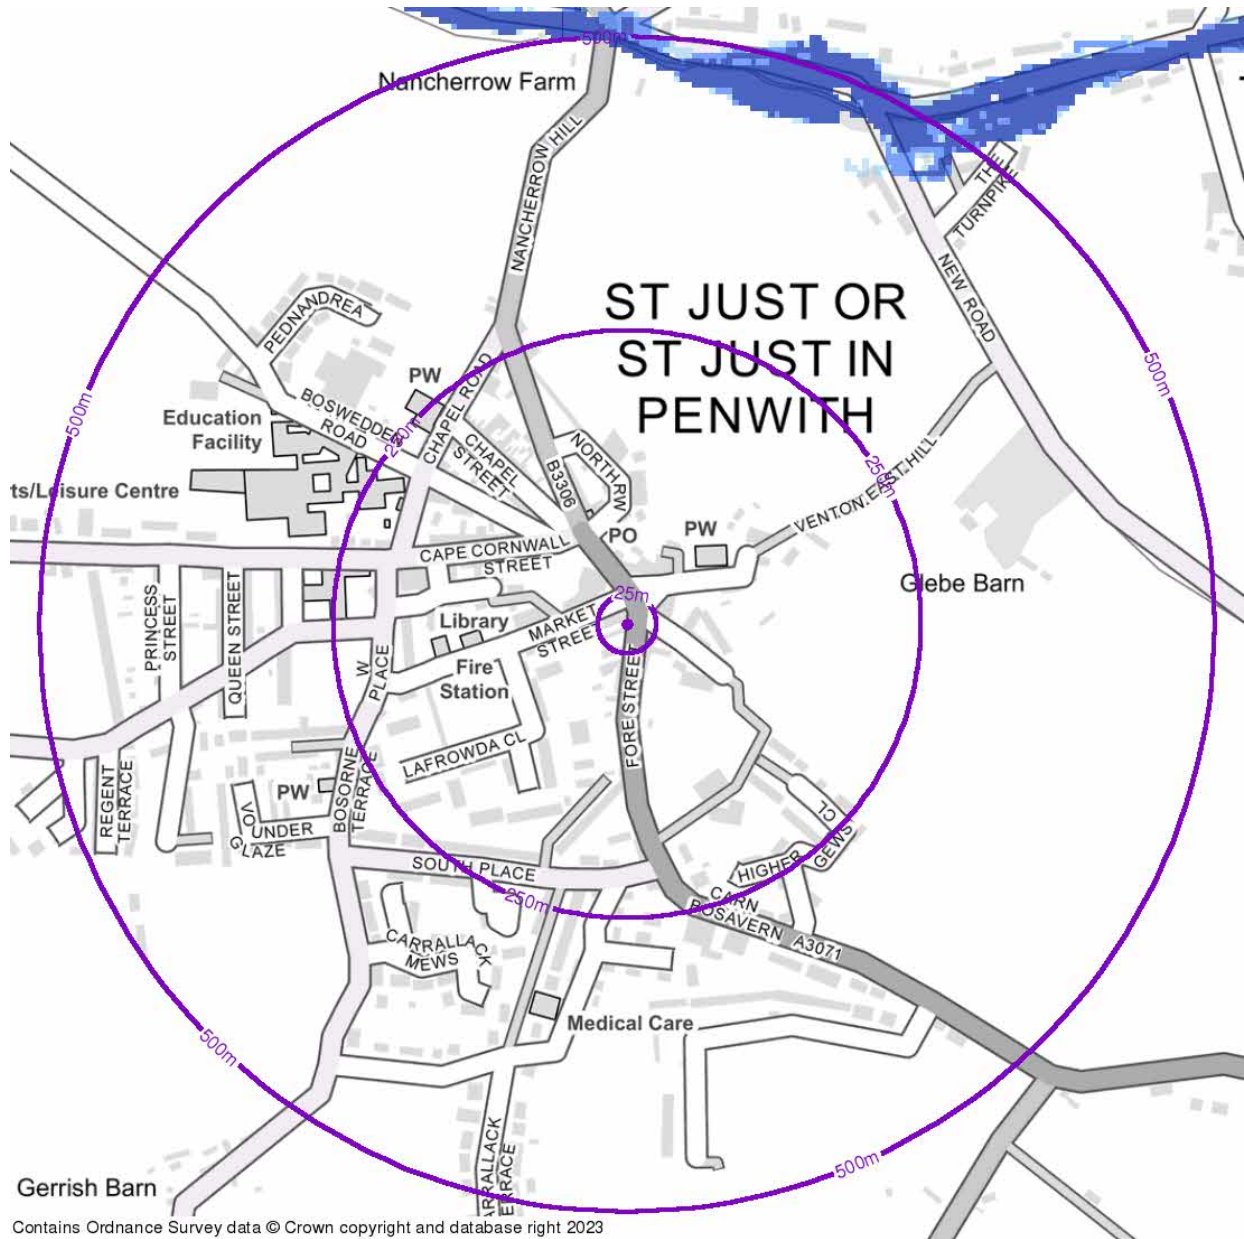
### Section 2a and 2b: River and Coastal Flood Map

The map detailed below shows the location of potential river and coastal flood risk. The potential risk has been modelled on the basis of an event occurring on average every 75, 200 or 1000 years.

<p>8.8 <u>Flooding</u> (reference pages 13 - 15)</p>	<p>The site is not indicated to be affected by any type of flooding within 25m of the site area.</p> <p>Further information relating to flood risk zones can be located on the Environment Agency web site.</p>
<p>8.9 <u>Radon Affected Zones</u> (reference page 16)</p>	<p>The site lies within a radon affected area, it is indicated that over 30% of homes are at or above the action level.</p> <p>Radon is a natural gas found in soil and rocks. It has no colour, taste or smell. Levels vary from country to country, region to region and from house to house in the same street. In open spaces, when radon mixes with air, it is quickly diluted into the atmosphere. When air containing radon gas rises from the soil and rocks beneath your property it is possible it may migrate internally, primarily through cracks in floors, walls and gaps around service pipes.</p> <p>Generally a membrane of 300 micrometre (1200 gauge) polyethylene sheet (correctly installed) will be adequate to stop radon migration. Possible prevention measures may require the installation of an active radon ventilation system. We would recommend that advice is obtained from the Local Authorities regarding monitoring &amp; protection.</p>

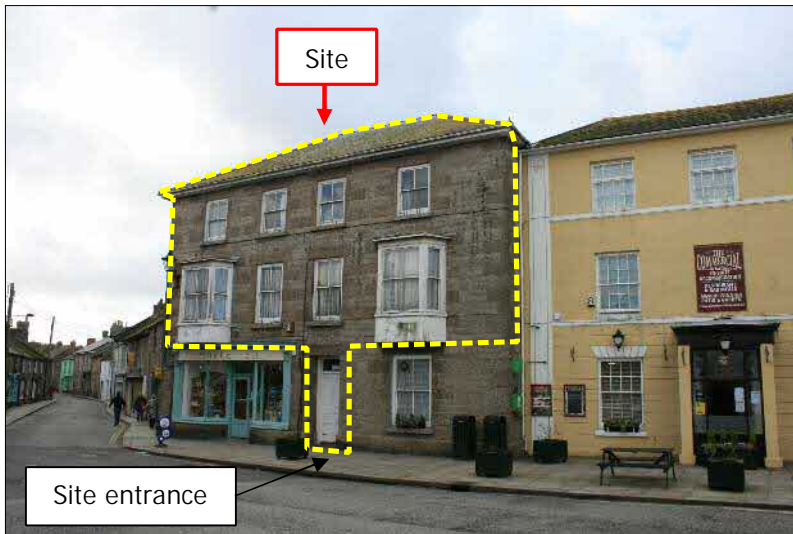
Photograph 1.

View: south

Looking towards the north-eastern elevation of the site building, as viewed from the adjacent public road, Market Square.

The yellow dashed line indicates the approximate site boundary.

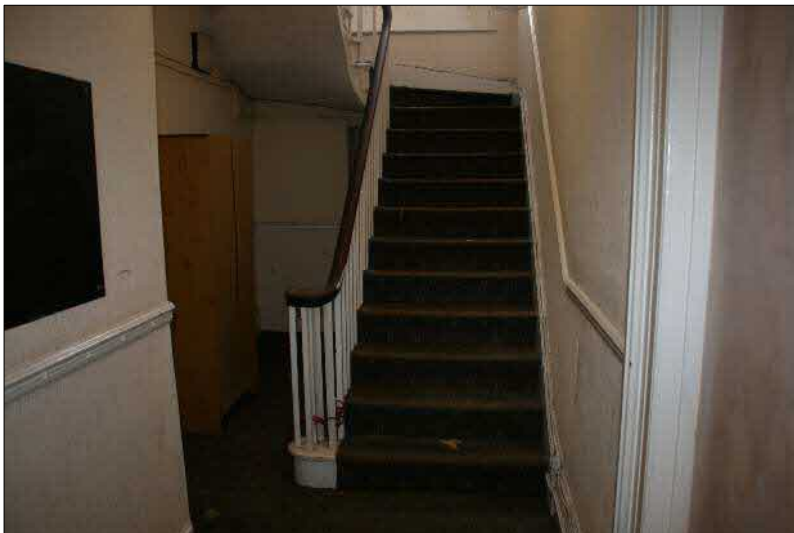
Photograph 2.

View: west-southwest

Looking towards the internal access stairs leading from the ground floor to the first floor of the proposed site.

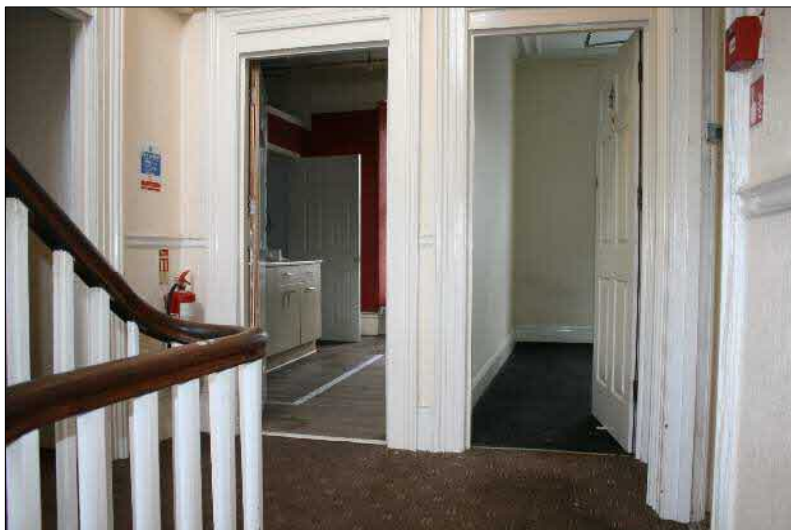
Photograph 3.

View: east-northeast

View of first floor landing which leads into three single-occupancy rooms. The doorway on the left is another hallway which leads into two more single-occupancy rooms.

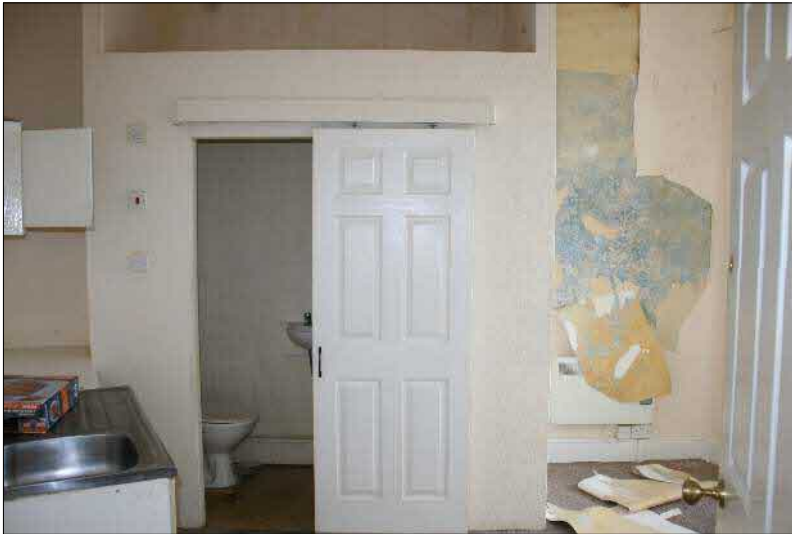
Photograph 4.

View: south

Interior view of a single-occupancy room and bathroom within the southern extent of the first floor.

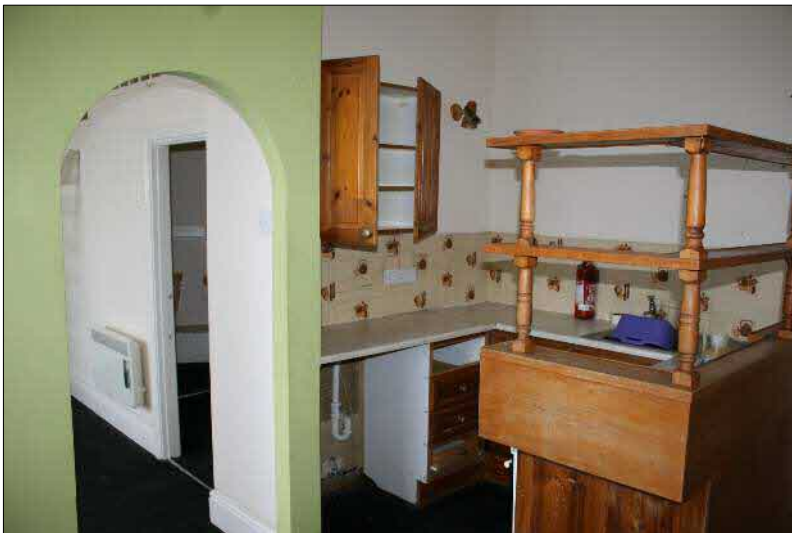
Photograph 5.

View: south

Interior view of the studio flat within the south-eastern extent of the first floor.

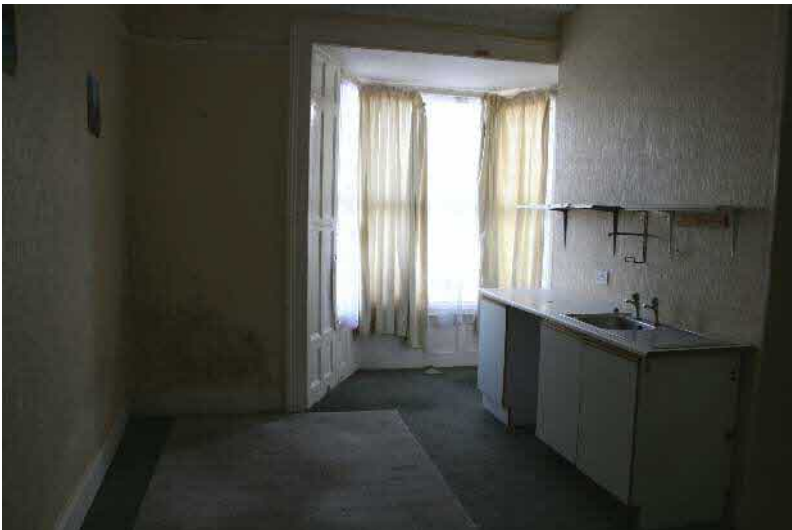
Photograph 6.

View: east-northeast

Interior view of a single-occupancy room and kitchenette within the northern extent of the first floor.

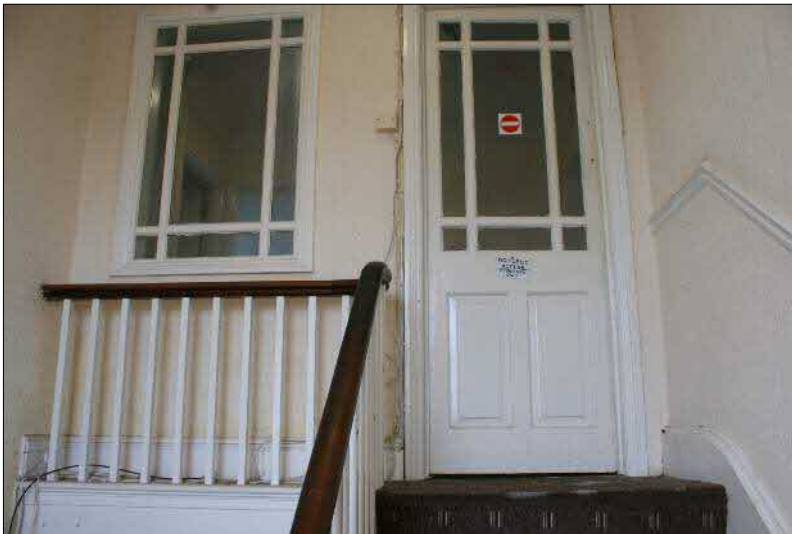
Photograph 7.

View: east-northeast

Looking up the stairs to the second floor entrance.

Although fitted for residential purposes we have been informed by the client that this floor, including the attic space, was utilised for storage purposes only.

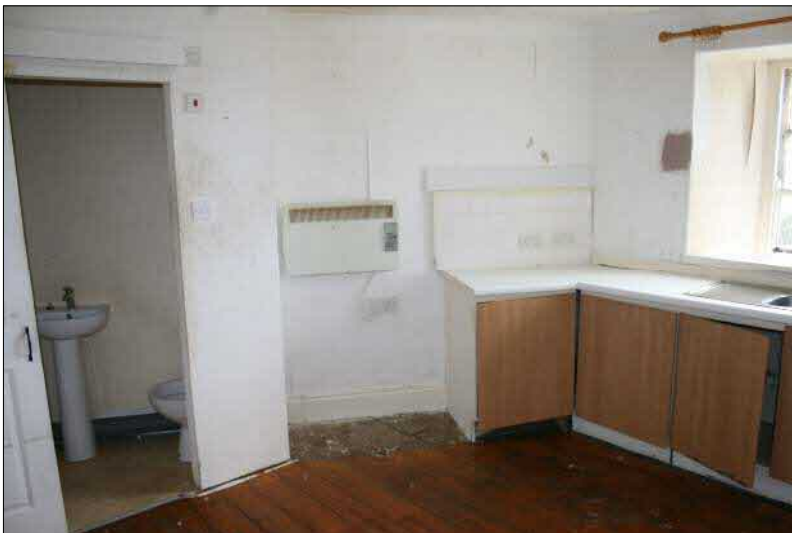
Photograph 8.

View: south

Interior view of a single storage room located at the southern extent of the second floor.

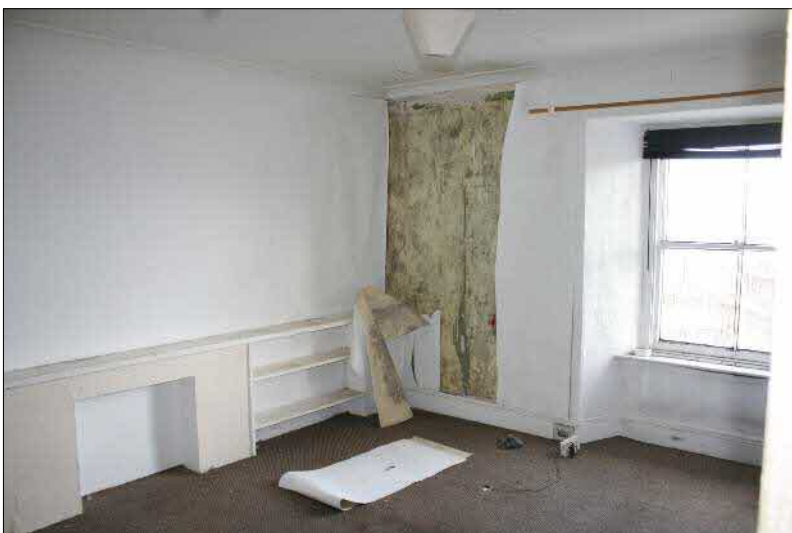
Photograph 9.

View: north

Interior view of a single storage room located within the northern extent of the second floor.

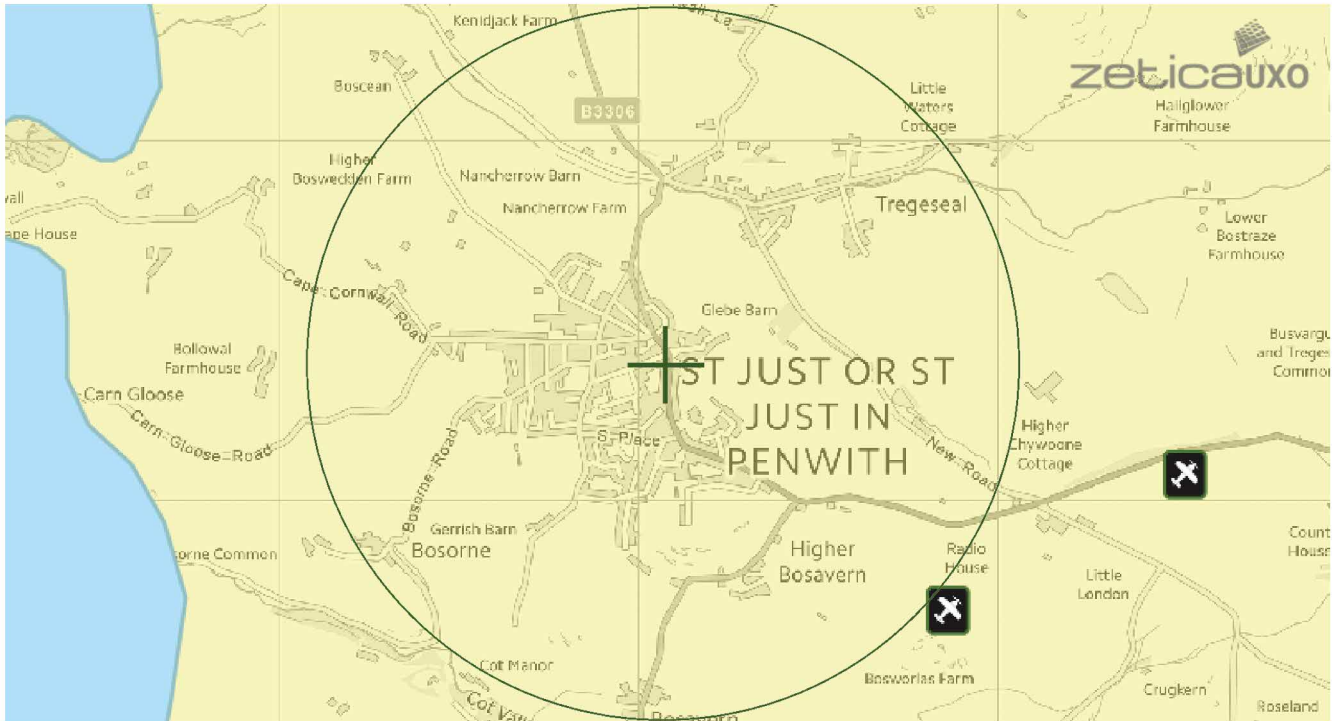
## SITE LOCATION

Location: TR19 7HE,  
Map Centre: 137080,31381

- High:** Areas indicated as having a bombing density of 50 bombs per 1000acre or higher.
- Moderate:** Areas indicated as having a bombing density of 15 to 49 bombs per 1000acre.
- Low:** Areas indicated as having 15 bombs per 1000acre or less.
