cornwall
environmental
consultants LTD

Bat and Barn Owl Assessment
13 Market Square
St Just
TR19 7HE

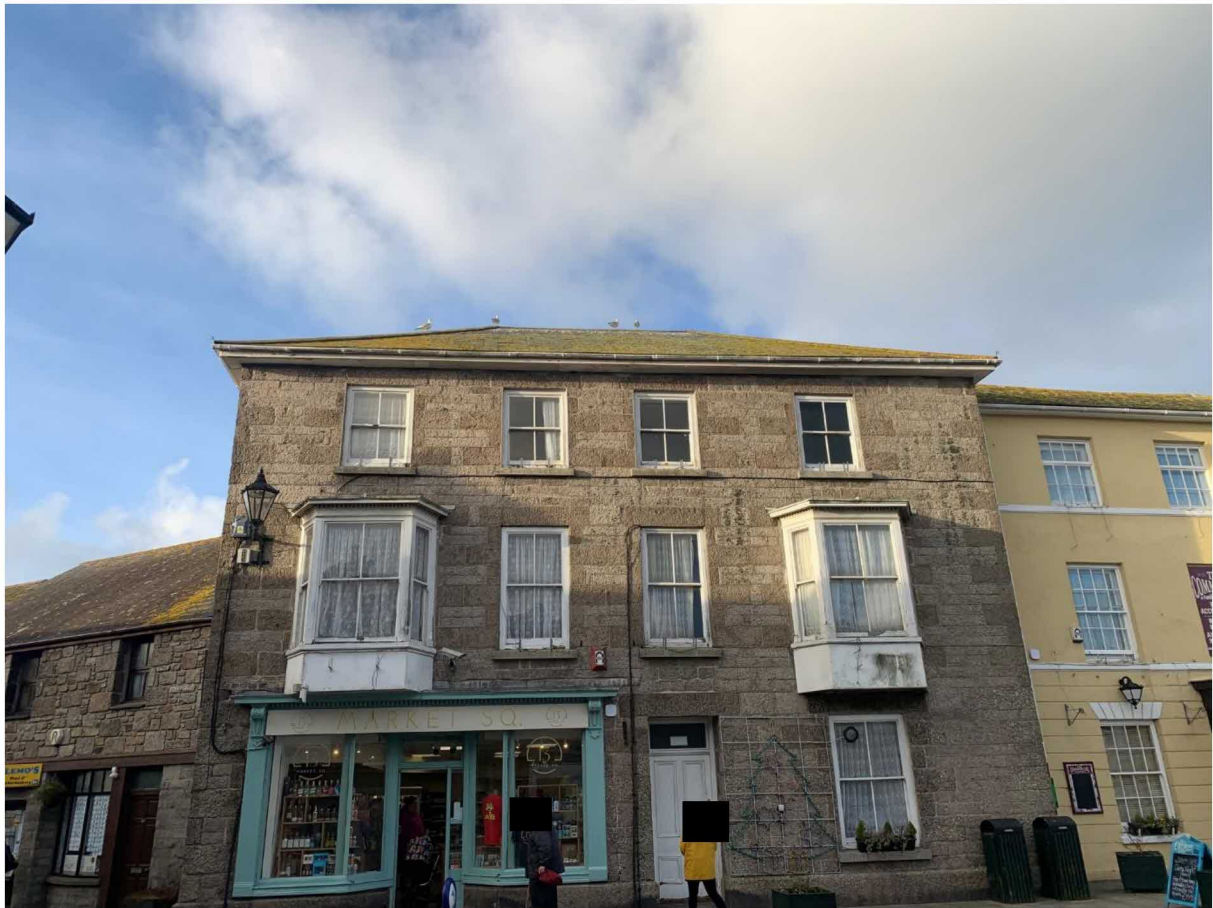
Figure 1: Building surveyed, north-eastern elevation

The property is a terraced building with a commercial shop on the ground floor, the building is constructed from stone walls, a pitched slate tiled roof underlined with bitumen felt and wooden soffits.

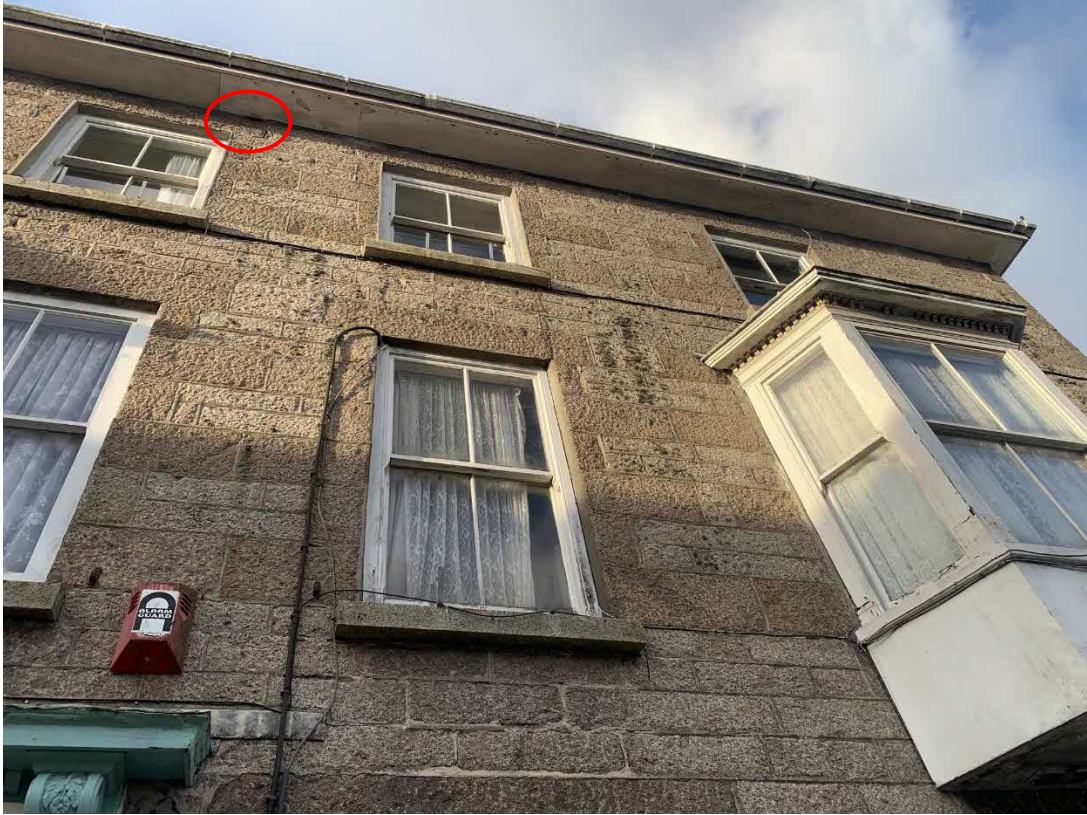
The exterior of the building shows several large gaps between the soffits and the walls on the north-eastern and north-western elevations (figure 2) and there is a gap in the tiles on the north-eastern elevation. The walls and windowsills were checked for signs of bats.

Figure 2: Gap in soffit

Although no current evidence of roosting bats was found it cannot be assumed that bats are not present when works commence. Care should therefore be taken during the work as bats could roost unseen deep within crevices in the structure, particularly under ridge tiles, beneath wall plates, or between or above lintels. If any bats are discovered during the work they must not be handled: works must stop immediately and advice sought from CEC (tel 01872 245510).

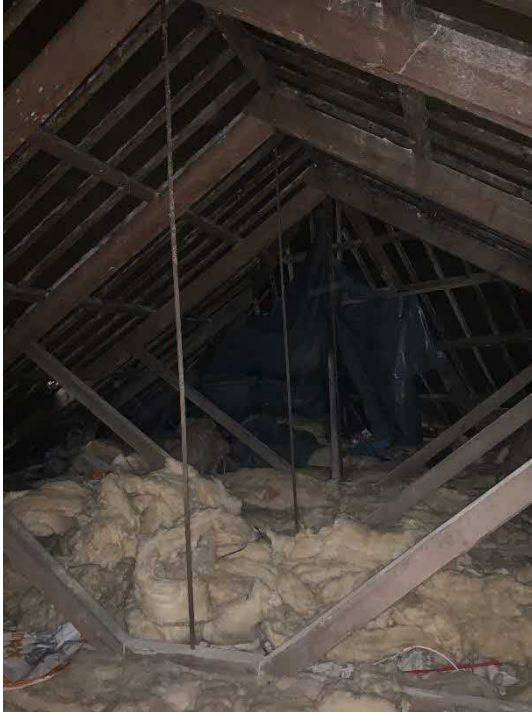
The interior of the loft space is approximately 3.2m high and has mineral wool insulation on the floor (figure 3). The bitumen felt was torn in sections, including behind the gap in the tiles on the north-eastern elevation, these tears were inspected with a high-power torch and no signs of bats were found. The rafters, insulation and eaves were also searched for signs of bats.

Figure 3: Loft interior

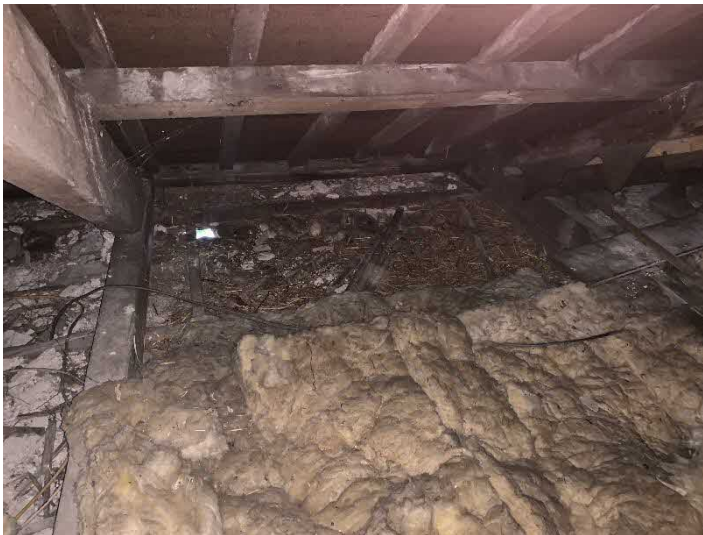
Figure 4: Jackdaw nest

A search of the loft contained several old jackdaw *Corvus monedula* nests (figure 4). No active signs of nesting birds were recorded within the building at the time of the survey. If the works are to be carried out within the bird breeding season (March to September) the building should be searched for nesting birds. If nesting birds are present, works should not commence and further advice sought from Cornwall Environmental Consultants (tel 01872 245510) or Natural England (tel 01872 245045) as the nests and eggs of all wild birds are protected against taking, damage or destruction under the Wildlife and Countryside Act 1981.
