QUINBURY FARM COTTAGE, HAY STREET, BRAUGHING, WARE, SG11 2RE

PRELIMINARY ROOST ASSESSMENT REPORT – 6th APRIL 2022

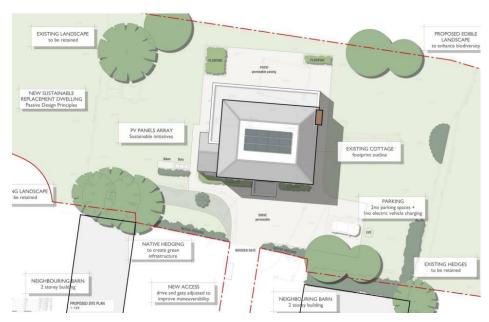
- 1.5 This application is for a new dwelling which will cover a smaller surface area and replace the existing dwelling (3/22/0138/FUL). The new dwelling will be built within the footprint of the existing dwelling. A proposed development plan is shown in Image 2.

Image 2: Proposed Development (Proposed by Kirby Cove Architects).

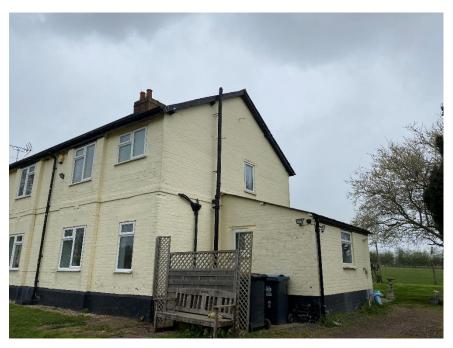
Photograph 1: Southeast corner of building.

- 3.3 Quinbury Farm Cottage is a two-storey residential property of brick construction with a pitched roof clad in slate tiles. The roof tiles are in good condition and are close fitting (Photographs 1 and 2).
- 3.4 An extension is present on the eastern side with a sloping roof clad in corrugated asbestos sheets.
- 3.5 Several gaps are present beneath the soffits, however inspection revealed that the gaps are blocked with no access available for bats.
- 3.6 The building which will be impacted by the proposed construction works was considered to have negligible suitability to support roosting bats due to a lack of available roosting features.
