Bramwell Cross (Roger Balmer Design)

Date: 27 November 2023

Ecological assessment of proposed alterations to Oak Tree House, Holton St Mary.

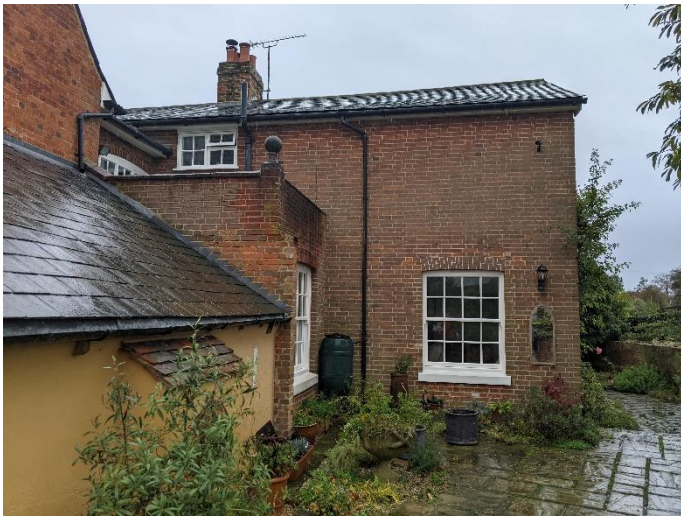
The existing lean-to slate roof does not contain any lifted slates or gaps behind the lead flashing which could support roosting bats and therefore, no impacts are predicted. Good practice building practices are identified for the soft demolition of the existing roof structure – see Section 4.2.3(b)(i).

Photo 1 current extension with lead flashing roof

The lead flashing should be lifted by hand and all the slates then removed by hand. In the unlikely event that a bat or evidence of bats is found then works should stop immediately with the bat (if found) left protected in the roof and advice should be sought from a licensed ecologist with regards to a way forward. This may require further surveys and the securing of a bat licence.

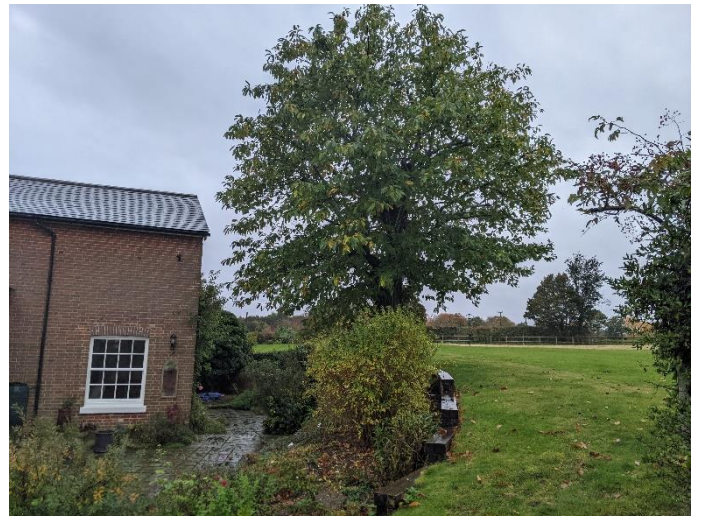
The proposed development site (Figure 1) comprises an existing lean-to extension with slates and some lead flashing, some hard standing and gravel, and some raised beds (e.g., herbs and shrubs) and sleeper retaining wall and a large pollarded sweet chestnut tree (*Castanea sativa*). At the time of surveying the well-maintained lawn northwest and south of the proposed extension support mostly grasses with some common forbs such as yarrow (*Achillea millefolium*) and ribwort plantain (*Plantago lanceolata*) (Photos 1 to 4).

Photo 2 Main roof of house, hard standing, raised beds and a large, sweet chestnut tree

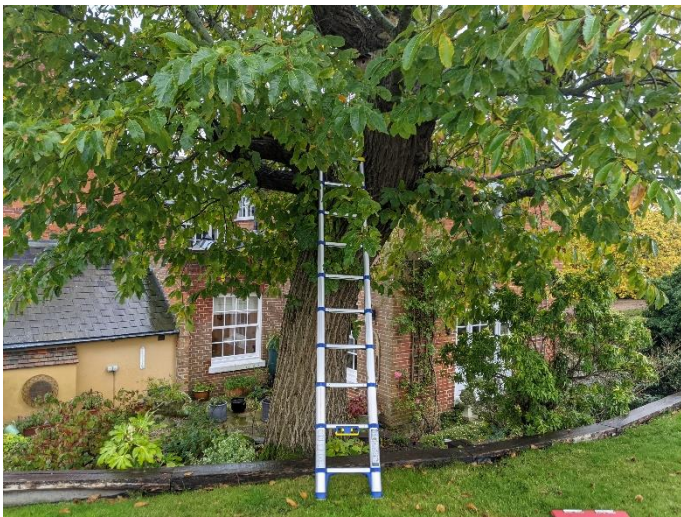
A physical inspection of two shallow splits on the mature sweet chestnut tree found no evidence of roosting bats.

The mature sweet chestnut tree provides nesting and song perch opportunities for a range of small passerines such as song thrush (*Turdus philomelos*) (Red List; S. 41 List) and stock dove (*Columba oenas*) (Amber Status).

Photo 3 Large pollarded Sweet Chestnut tree

The proposed development requires the removal of a large, sweet chestnut tree (*Castanea sativa*), ornamental shrubs and herb planting raised beds made of sleepers and potential lawn damage whilst construction occurs. Some native trees should be planted to offset the mature sweet chestnut proposed for removal.

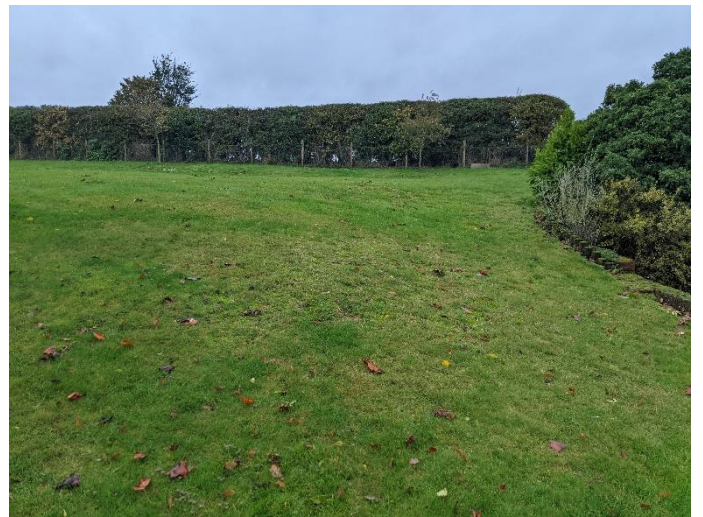
The lawn areas provide foraging habitat for hedgehogs. The mature sweet chestnut could support S. 41 list invertebrates, including Lepidoptera. No evidence of badgers was found on site.

Photo 4 Lawn area south of the dwelling

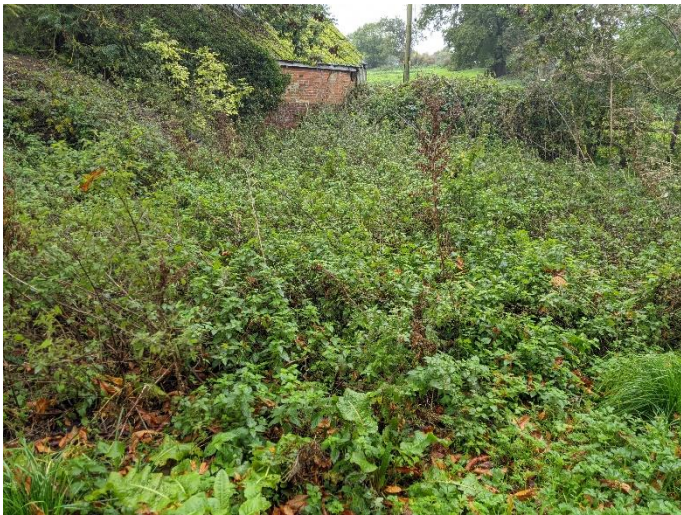
A potential breeding pond P1 (Photo 5, Figure 1) was shown on OS Maps within 250m of the application site boundary. An inspection of the pond found that it was choked with terrestrial plant species such as common nettle (*Urtica dioica*) which indicates the pond does not hold water and is not currently functioning as a pond.

Whilst the surrounding garden could provide a range of habitats including for overwintering for GCNs and common amphibians, due to the poor quality and lack of potential breeding ponds due to being heavily overgrown with vegetation the potential for GCNs being present on site was considered to be negligible.

Photo 5 Heavily overgrown and silted pond P1 east of the property.
