Penstrowed Quarry, Caersws, Powys, SY17 5SG

Proposed change of use and construction of holiday lodges

Bat Survey

06 July 2021

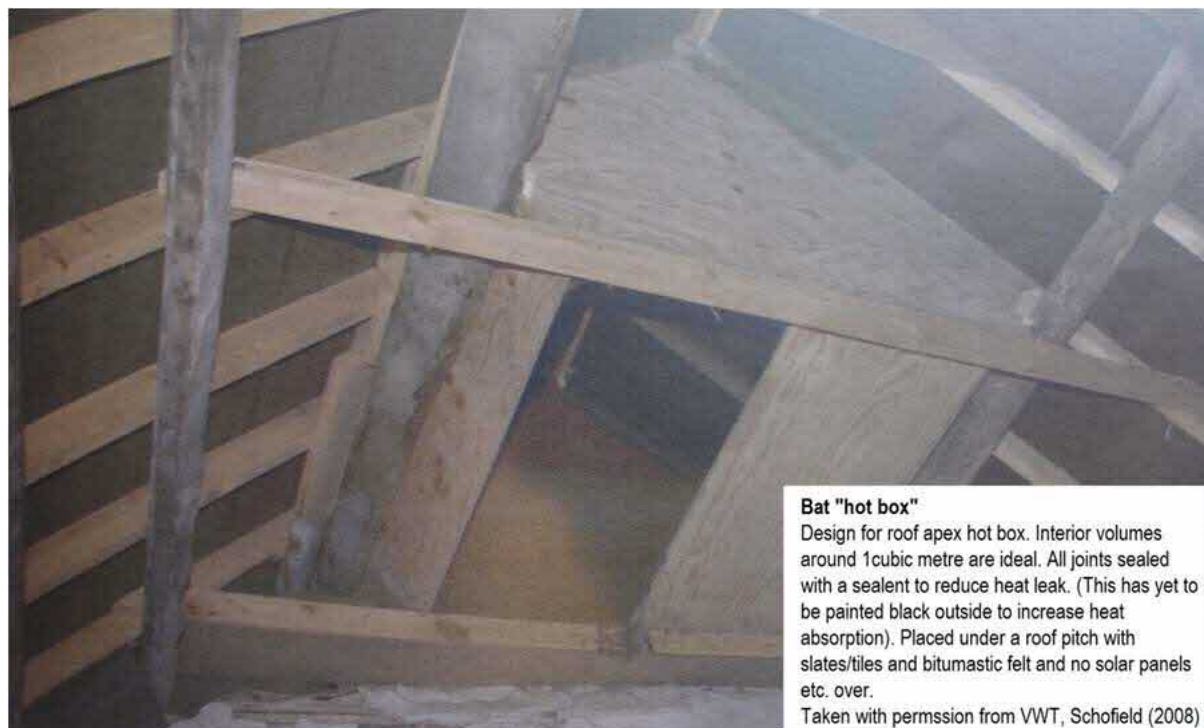
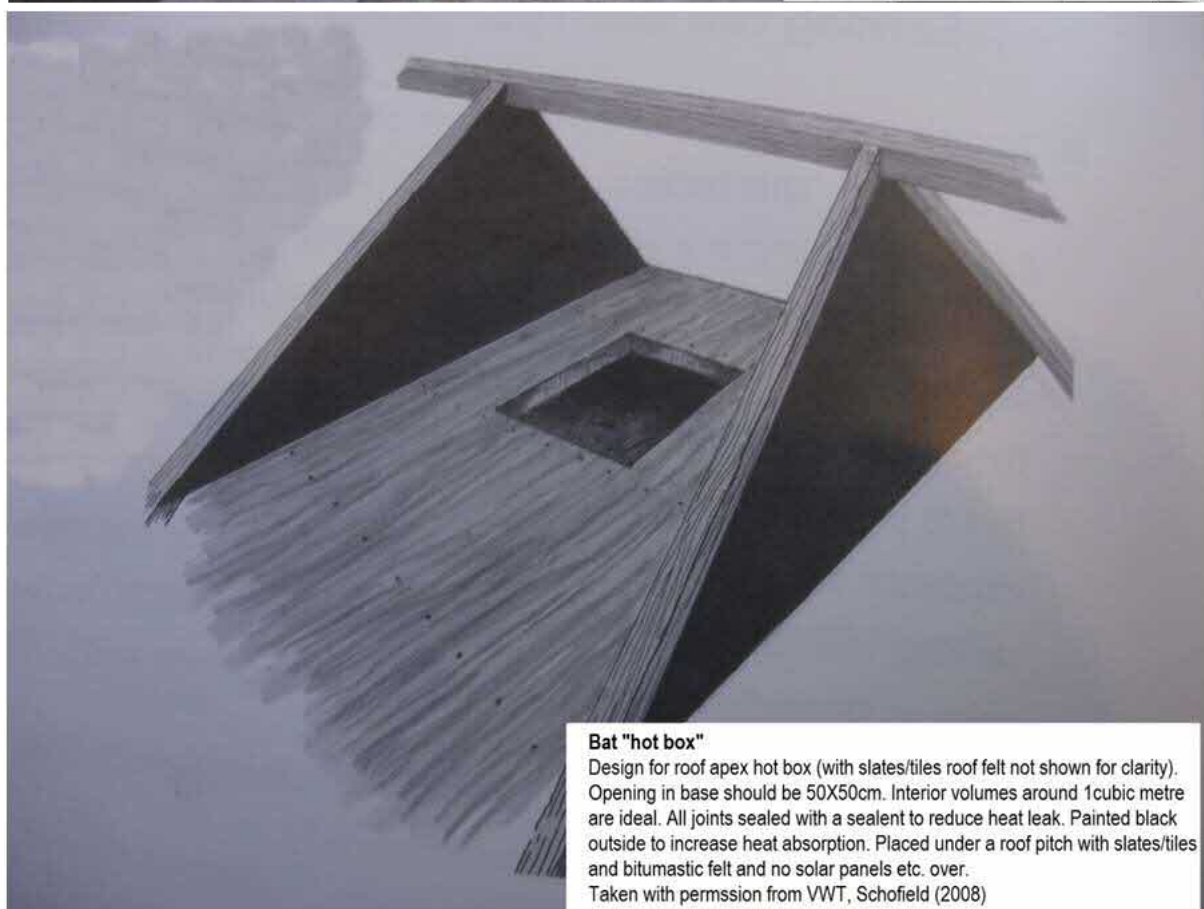
10. In the centre of the loft, a “hotbox” will be constructed of sterling/OSB and untreated timber, to be approximately 2m long and 1m deep, sealed with mastic at its joints, painted black on the outside with a bat access hatch through its “floor” of 45cm by 45cm. See illustrative photo of a “hotbox” installed and a drawing with roof and slates removed for clarity (below).

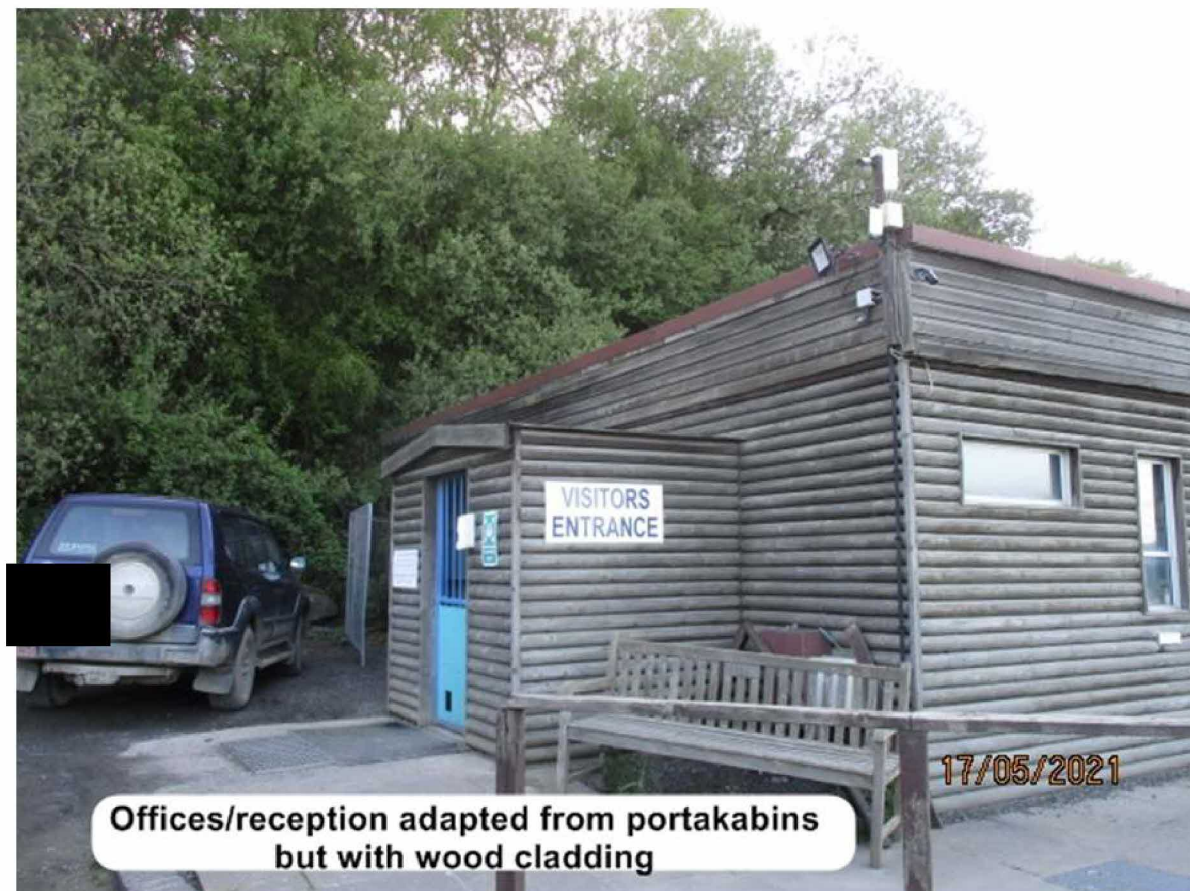
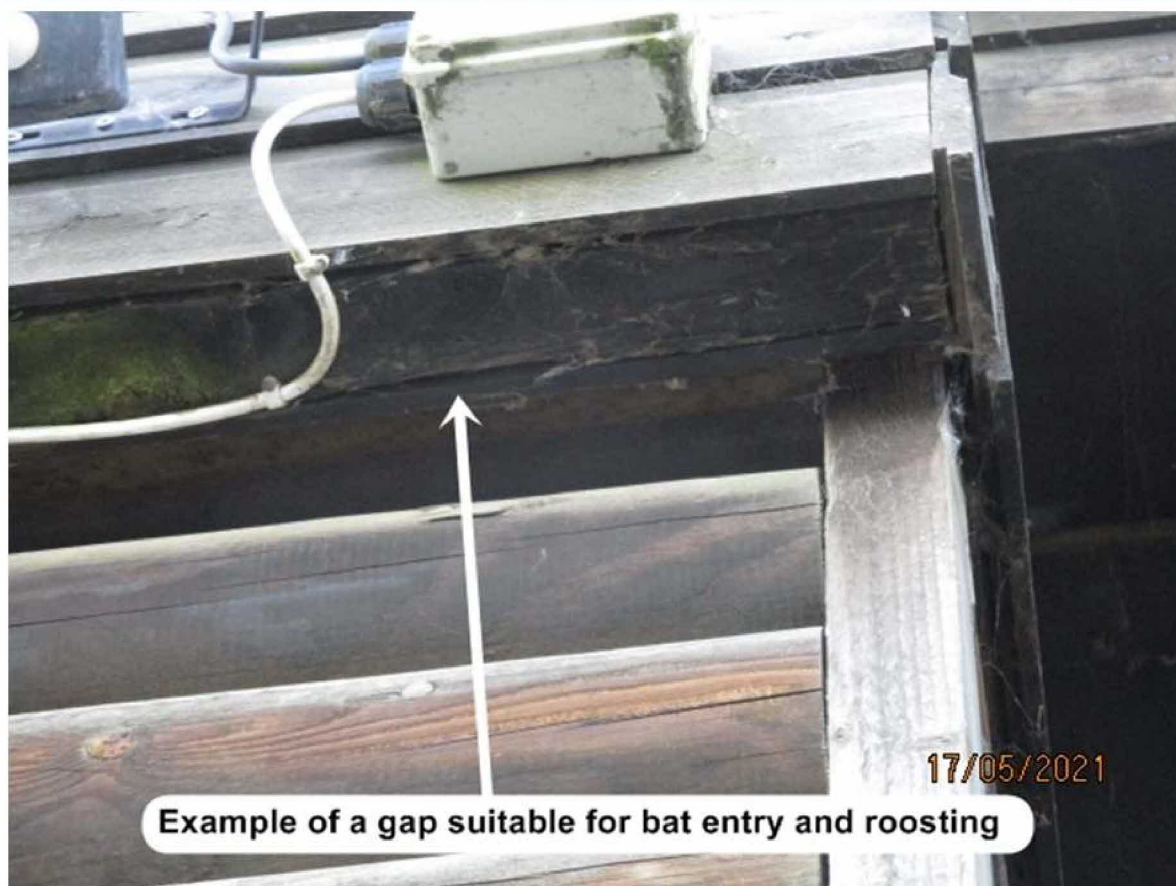
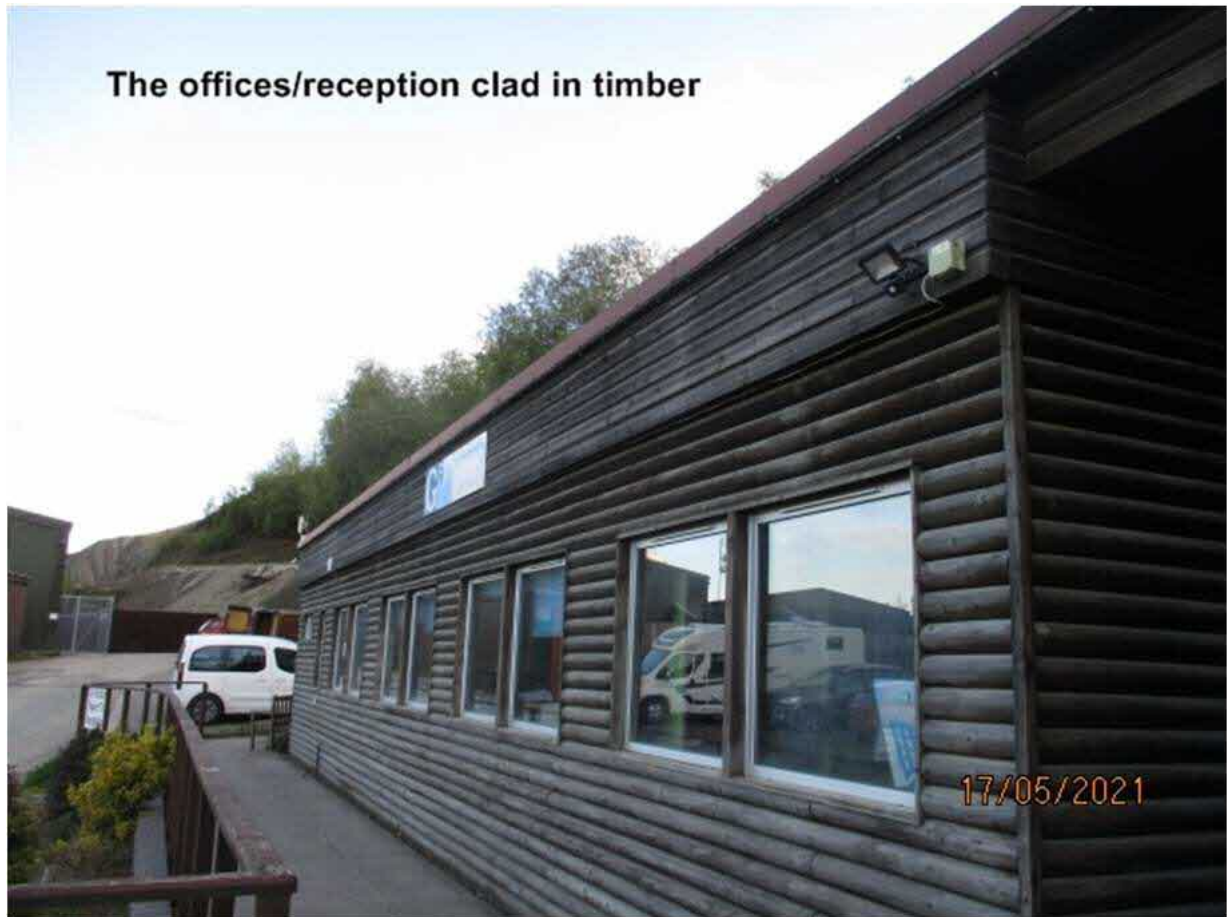
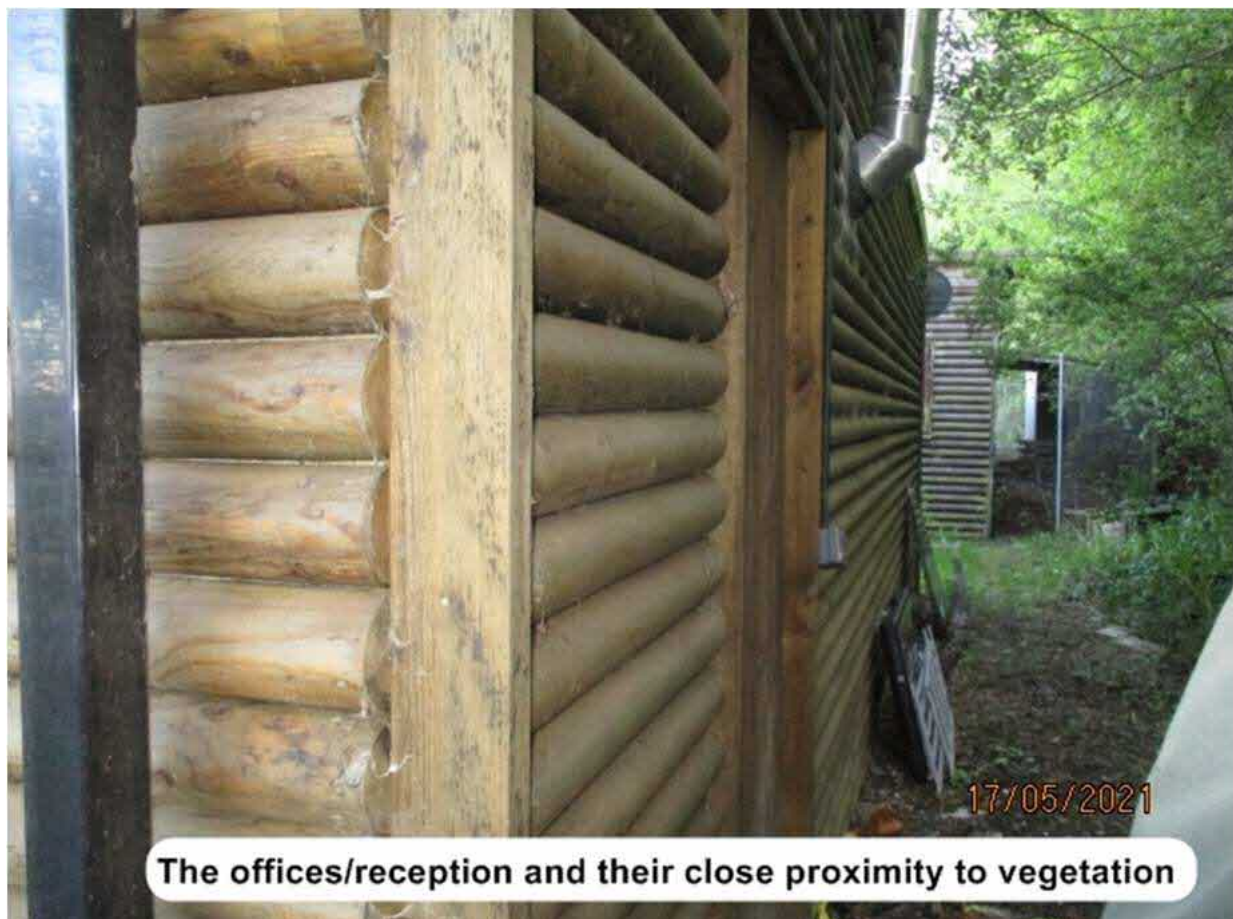
7.0 SITE PICTURES

There were three buildings (reception/offices); two of these were attached and one detached. They were Portakabin type buildings which had been clad in timber. The timber boarding was horizontally laid, giving potential access for bats via small gaps and cracks and providing some possible habitat for bat roosting under the cladding.

No bats or signs of bats were found on the outside of the buildings during the Preliminary Roost Assessment and it was the same in May 2021, just gaps and cracks in the timber cladding and excellent foraging habitat nearby. The buildings had no attics or other spaces away from the cladding bats could go to roost in as the buildings were flat roofed Portakabins.
