Phase 2 land quality assessment: Penstrowed Quarry, Caersws, Powys

Prepared for: GF Grigg Construction Ltd
Penstrowed Quarry
Caersws
Powys

Report reference: 4316R1

Prepared by
Ground First Ltd

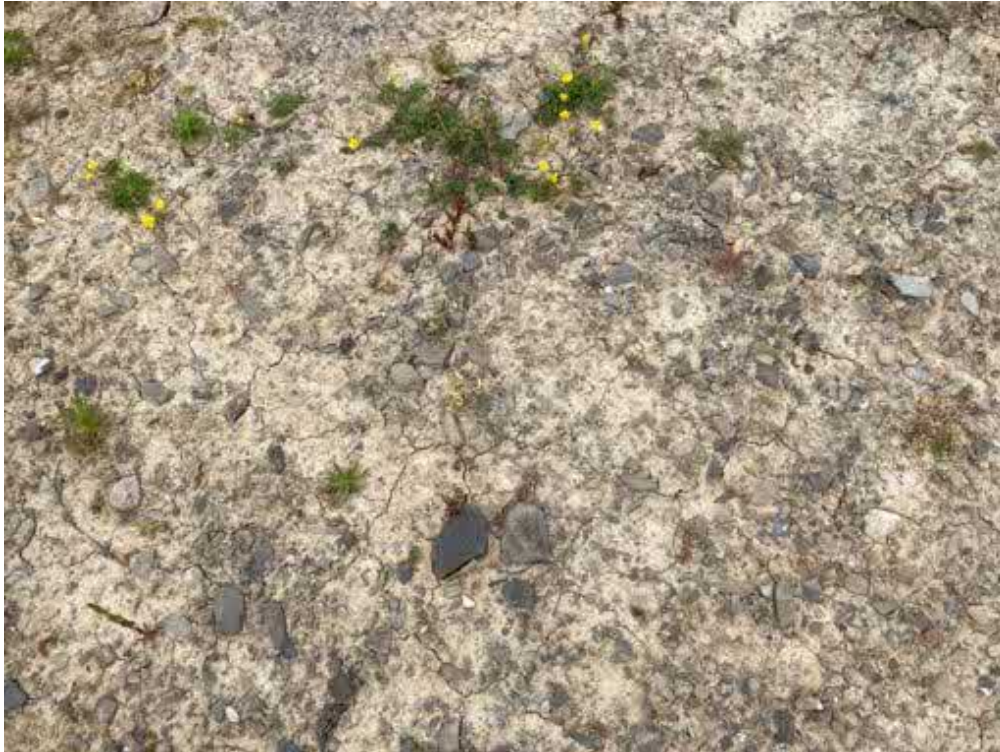
Photograph 3

Description: Typical ground surface across upper bench level

Location: South-western part of the Site

- The ground surface across the upper and middle quarry benches largely comprised of compacted gravelly silt (see Photographs 3 and 4 in Appendix C).
- A stockpile of imported aggregate was observed on the middle quarry bench (see Photograph 33 in Appendix C); this material comprised largely of stone with occasional brick remains (see Photograph 34 in Appendix C).

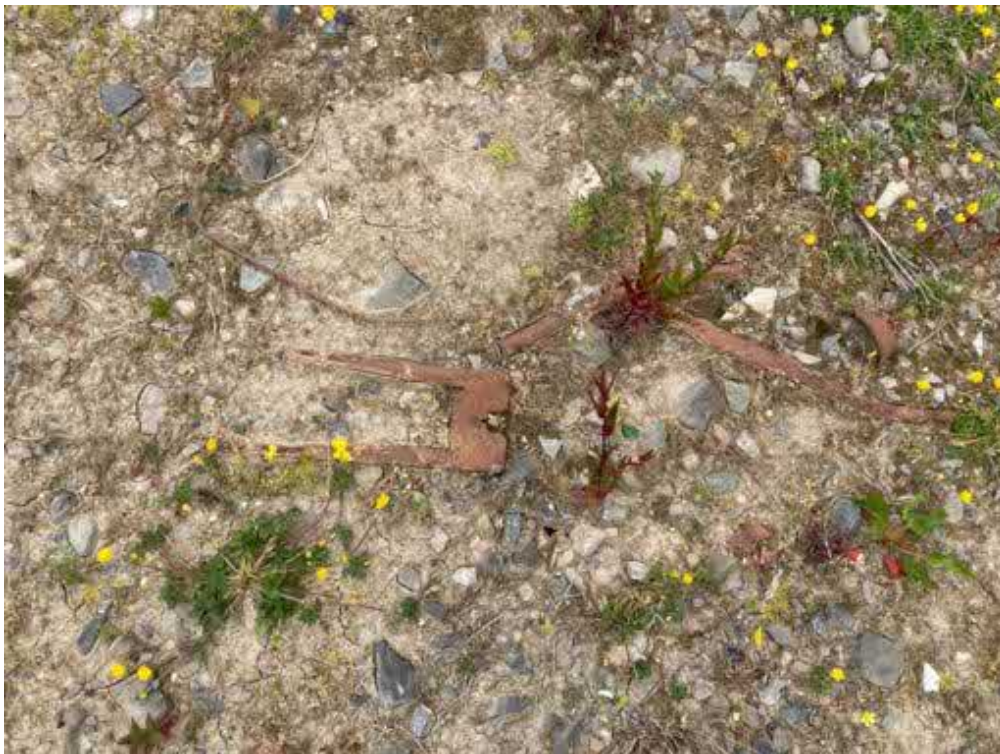
Photograph 4

Description: Ground surface across upper bench level (incl. some metal remains)

Location: South-western part of the Site

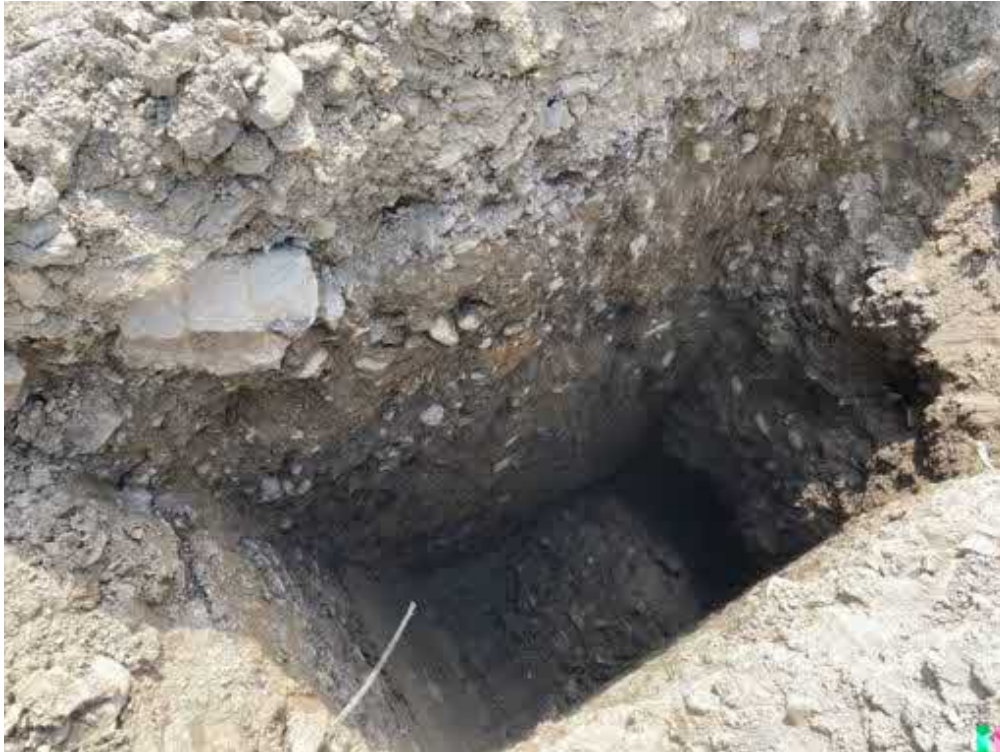
Photograph 18 Description: Trial pit TP03 (including perched water)
Date: 07/06/2023
Location: Upper quarry bench

No shallow groundwater was encountered (to a maximum excavation depth of 3.35 m bgl) during the recent ground investigations, although localised perched water was observed towards the base of trial pit TP03, at a depth of c. 1.4 m bgl (see Photograph 18 in Appendix C).

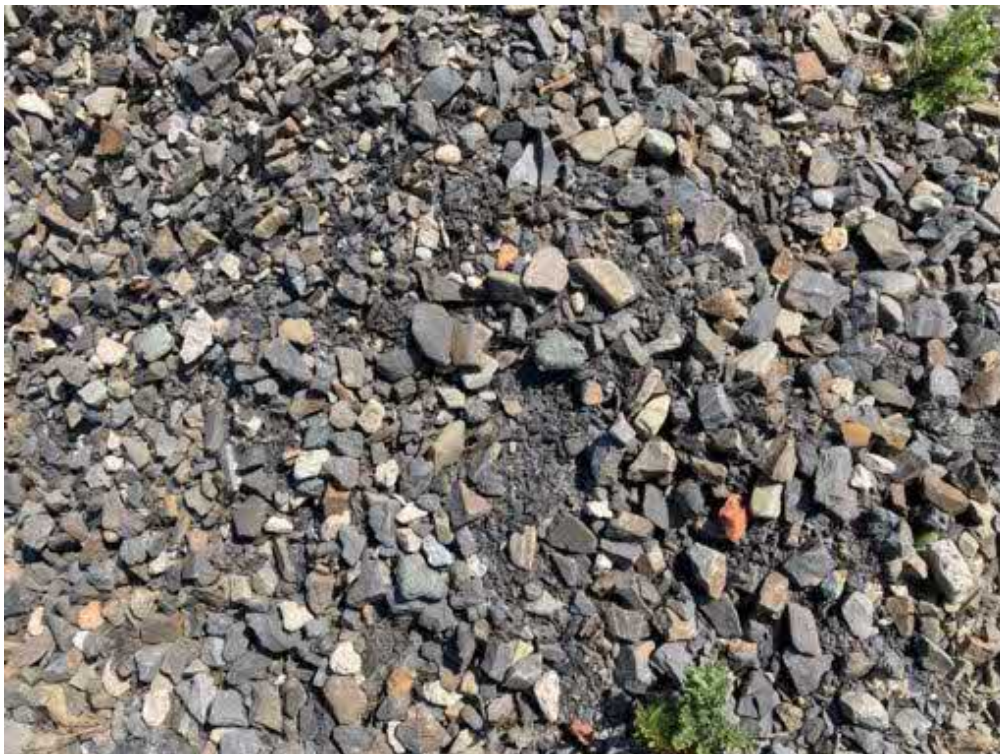
Photograph 34 Description: Stockpiled inert material on middle bench
Date: 07/06/2023
Location: Central part of middle bench

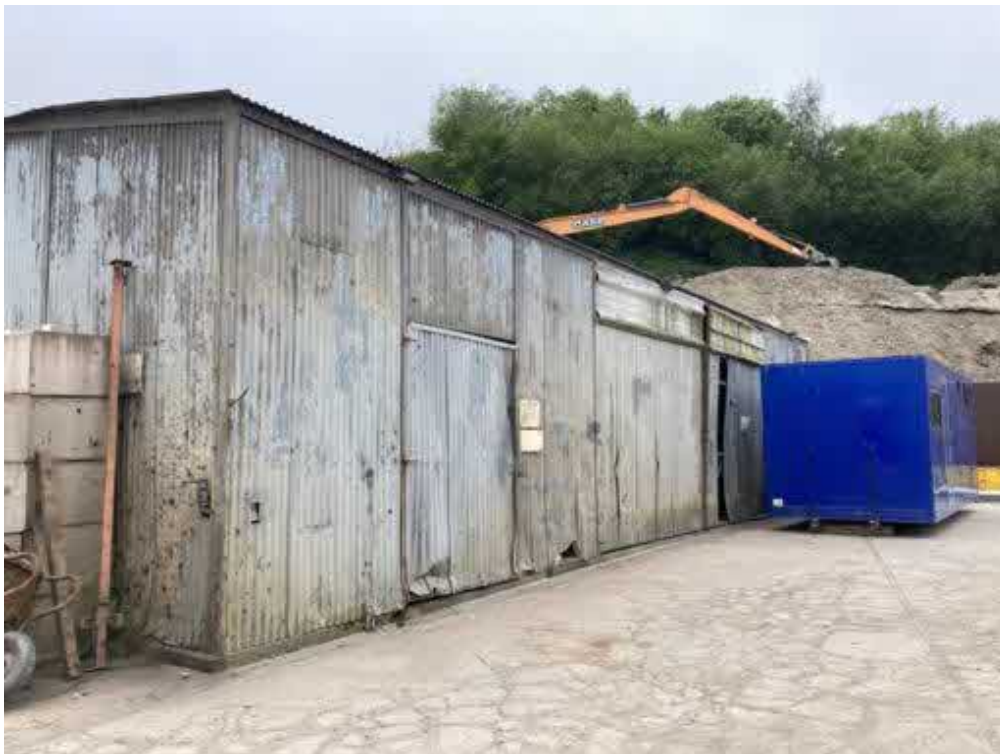
Photograph 74 Description: Unit containing banded diesel storage tanks
Date: 08/06/2023
Location: Central-western part of the lower bench

- A corrugated metal shed containing several above ground diesel storage tanks (all situated within concrete bunds); see Photograph 74 in Appendix C.
 - Several adjoining sheet metal clad units used for general storage plus a vehicle repair centre (see Photographs 75 to 78 in Appendix C).

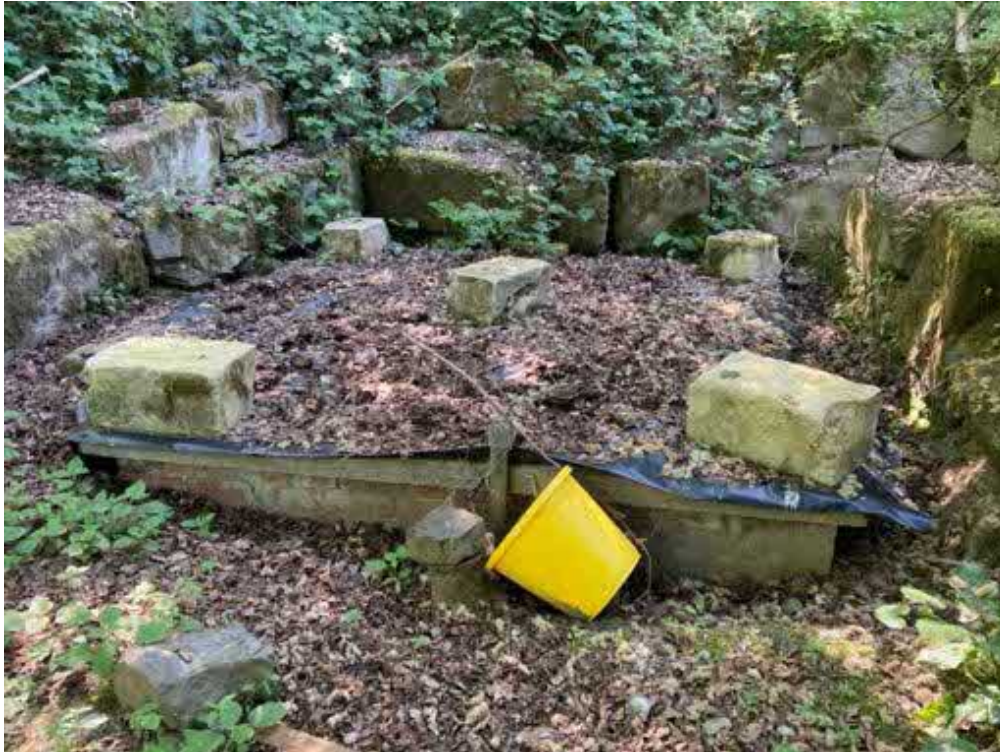
Description: Spring chamber

- A spring chamber was observed c. 70 m to the east of the Site (see Photograph 79 in Appendix C); the associated flow discharged into a minor stream (see Photograph 80 in Appendix C).
- The Client has indicated that a second spring is located c. 40 m to the south of the Site; this is understood to be piped into a nearby sub-surface water tank (see Photograph 81 in Appendix C).
- The water course located c. 135 m to the south-east of the Site was observed to be dry (see Photograph 82 in Appendix C – this image shows the stream channel at a location c. 300 m from the Site boundary).

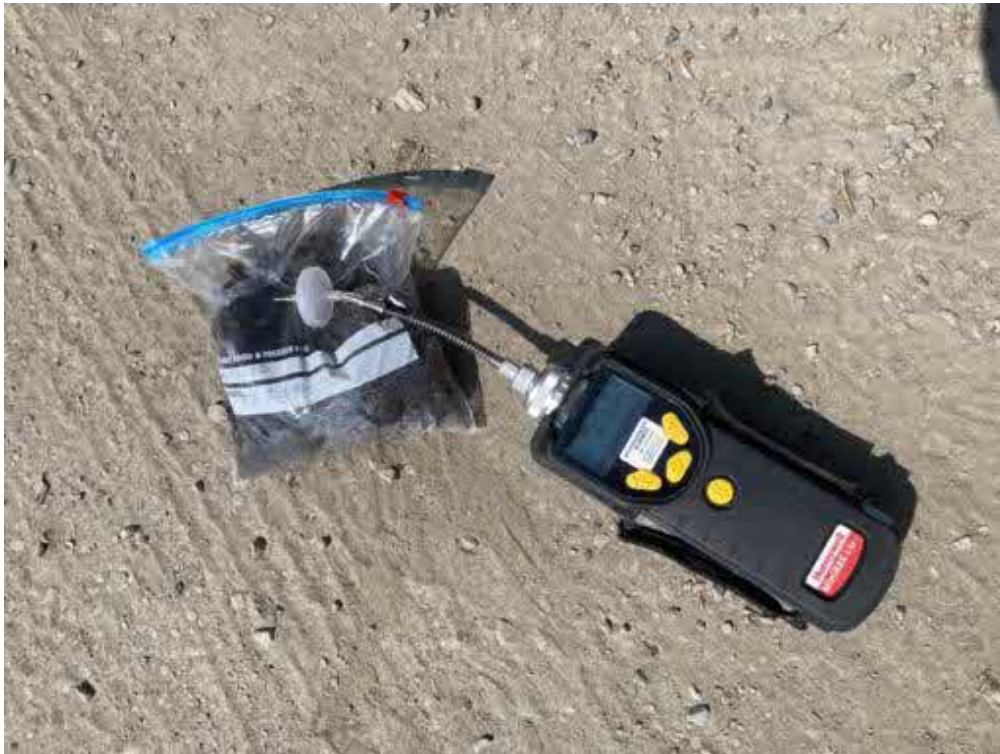
Photograph 111 Description: Example of PID headspace testing
Date: 08/06/2023
