Stabilisation of Penstrowed Quarry, Newtown
by Partial Backfilling
Report in Support of Planning Application Rev-B
G F Grigg Ltd

GroundSolve Ltd
Consulting Geotechnical, Engineering Geology and Environmental Engineers

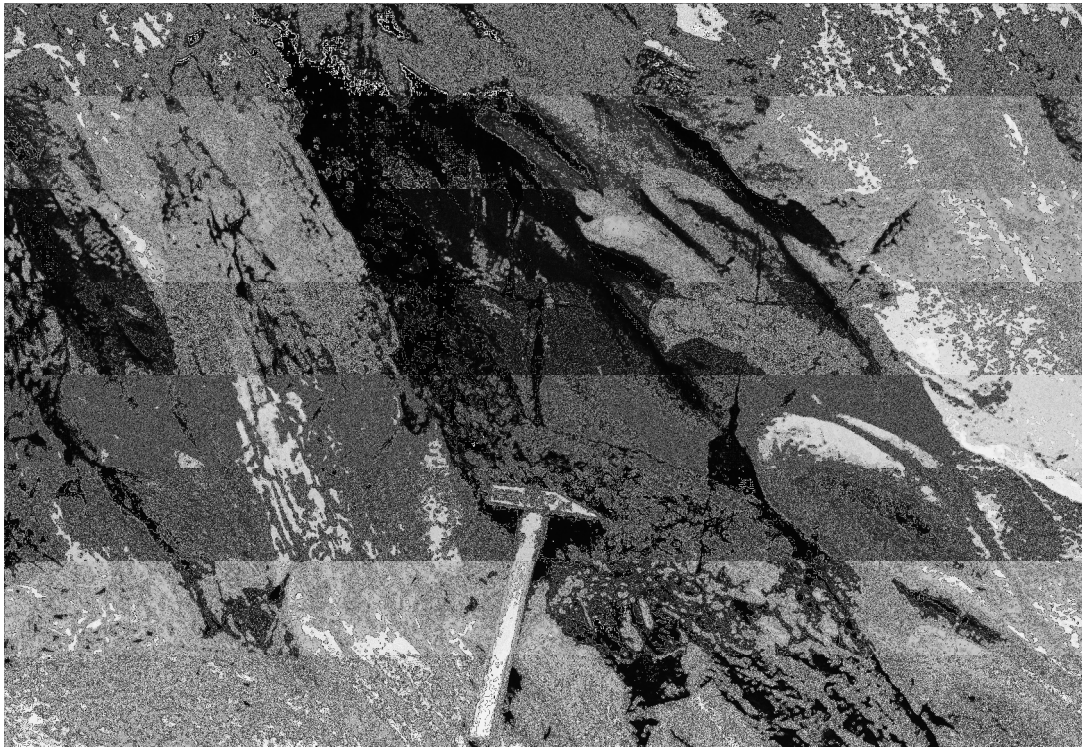
Photograph 1: Flute Casts

The geology of the site comprises the Penstrowed Grits, which are Silurian in age and are the youngest and most easterly sandstones deposited in the southern and central parts of the Welsh Basin. Most of this section comprises beds of sandstone reaching several metres in thickness, interlayered with thinner bedded siltstone and mudstone. The quarry is particularly well known for its Flute casts, see photograph 1 below.

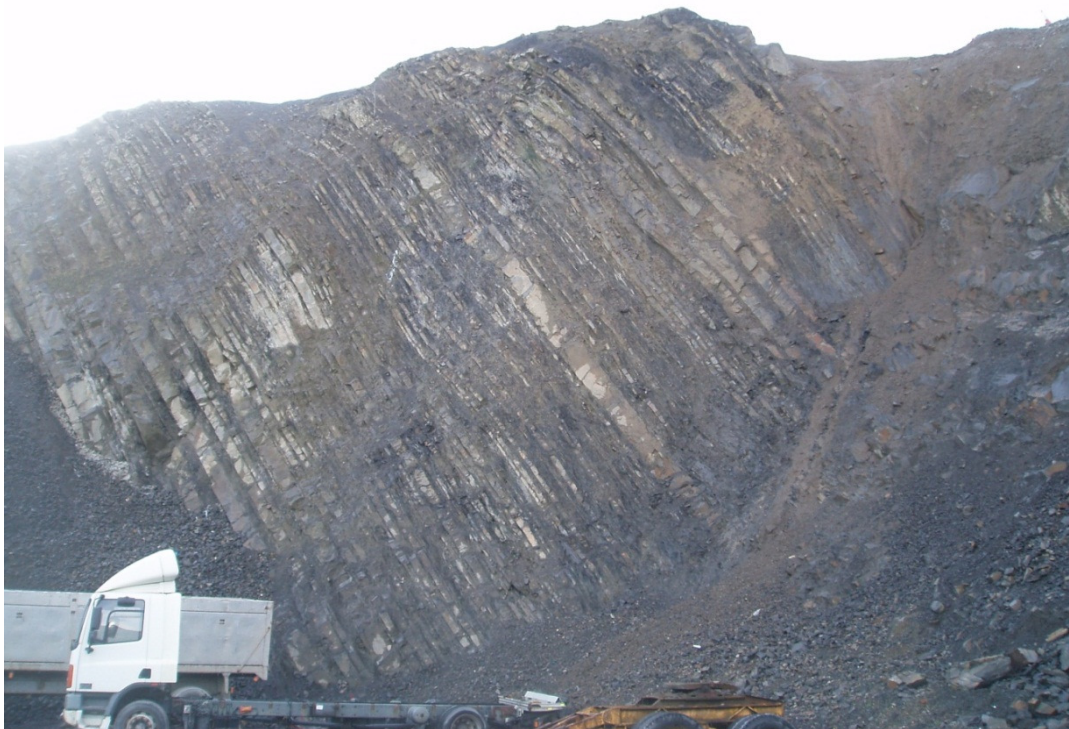
Photograph 3: Alternating sequence, lower quarry face

The Penstrowed Grits in the quarry consist of a rhythmic alternating sequence of cream coloured greywacke sandstones, and dark grey siltstones and shaley mudstones, see Photograph 3.

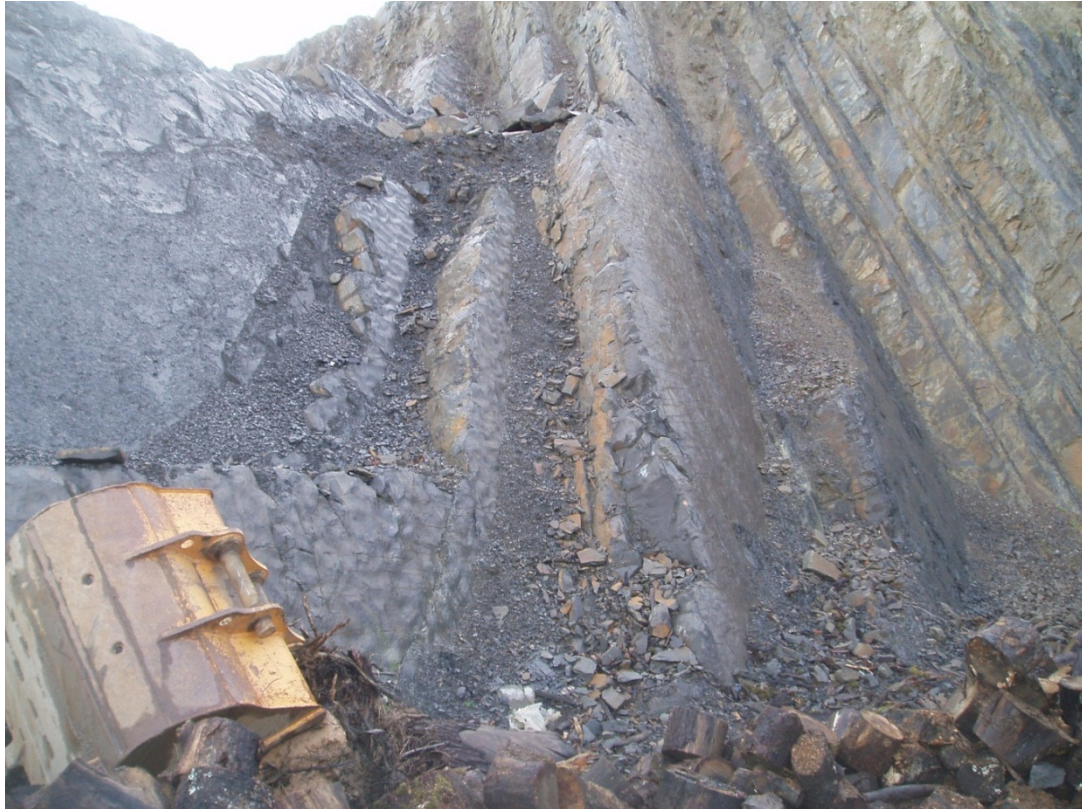
Photograph 4: sedimentary structures exposed on upper face

This exposure represents a combination of the clear rhythmic alterations, sedimentary deposition and the well developed sole markings.

According to Reference 1, the main objective at Penstrowed quarry is to maintain the integrity of, and access to the rock faces particularly those which are located on the upper level, since it is in this area that the best examples of sedimentary structures can be found, see Photograph 4.

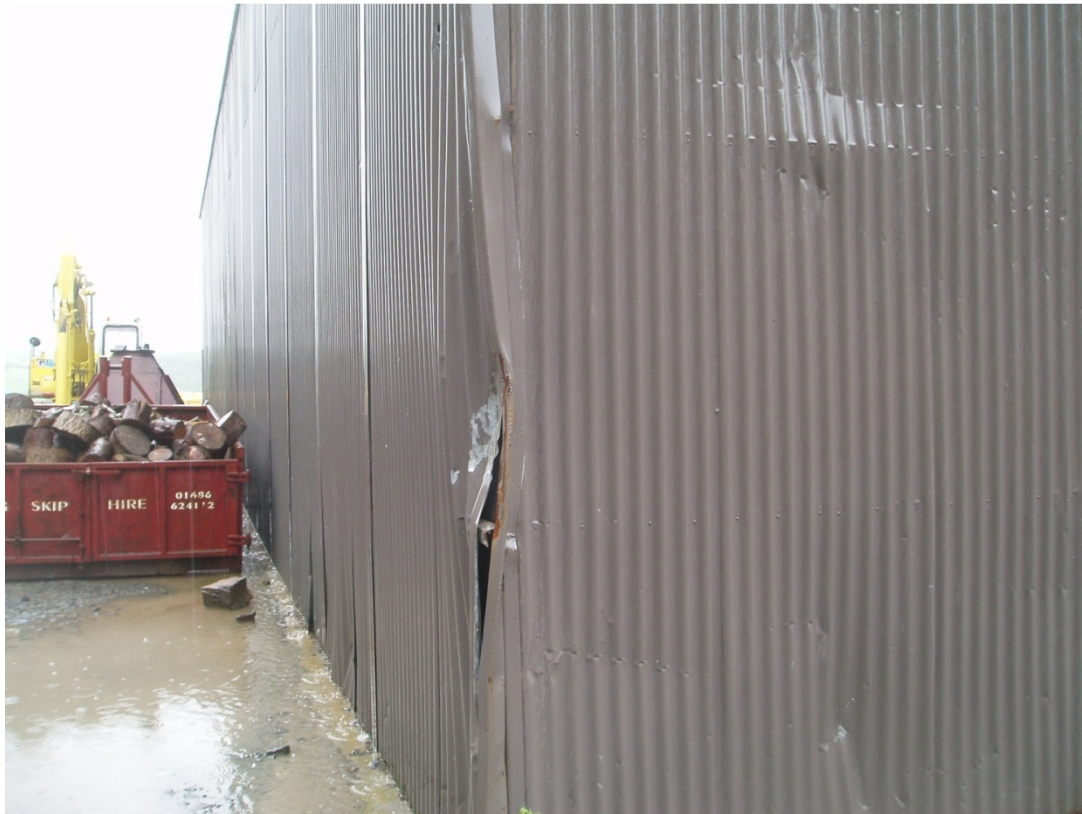
Photograph 5: Damage to existing building from rock fall

Reference 1 has already highlighted the dangerous nature of the rock faces for close inspection at the base of the cliffs. This is also shown by damage to one of the existing buildings on site; see Photograph 5, which also has a small fallen block nearby.

The main risk of failures were related to the potential for small to medium sized blocks of rock to fall from the slope and several examples of this mechanism can be observed on site, especially where one of the buildings has been slightly damaged by falling rocks.

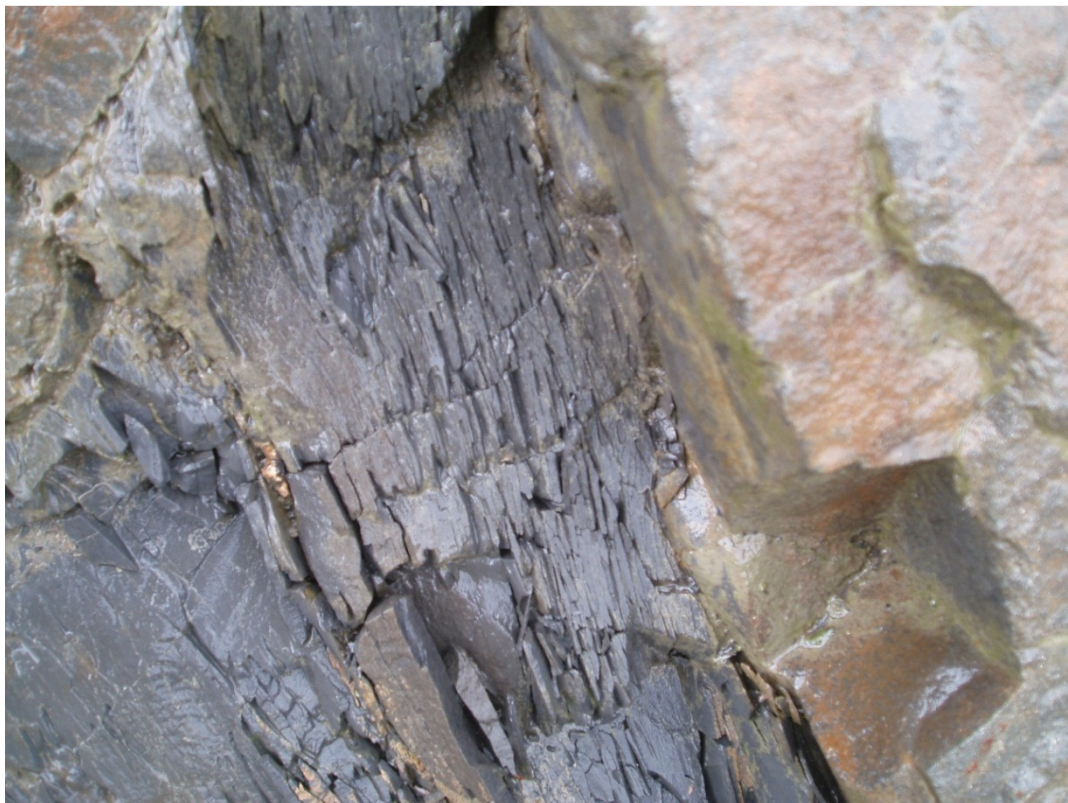
Photograph 6: Well developed cleavage in the mudstone

In addition, the cleavage was observed to be very well developed in the mudstone bands, see Photograph 6.

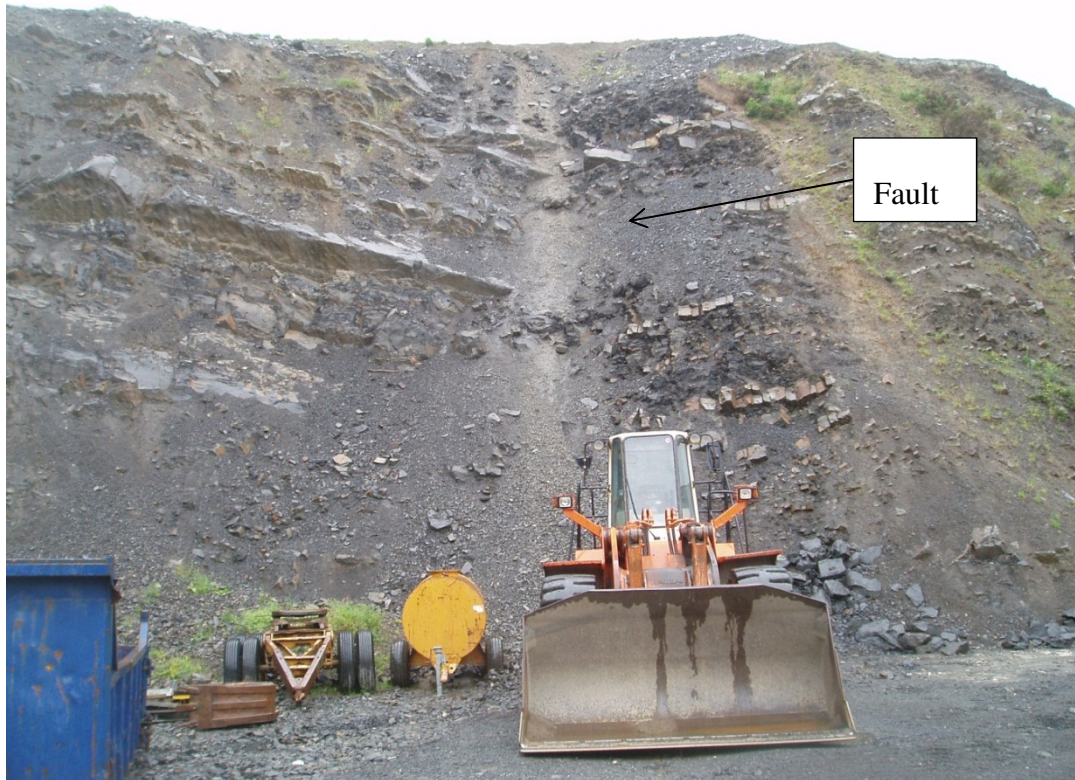
Photograph 7: Fault in quarry face showing change in geology across the fault

A large fault was also observed in the quarry face on the lower section which trends in a south west to north east direction, see Photograph 7.

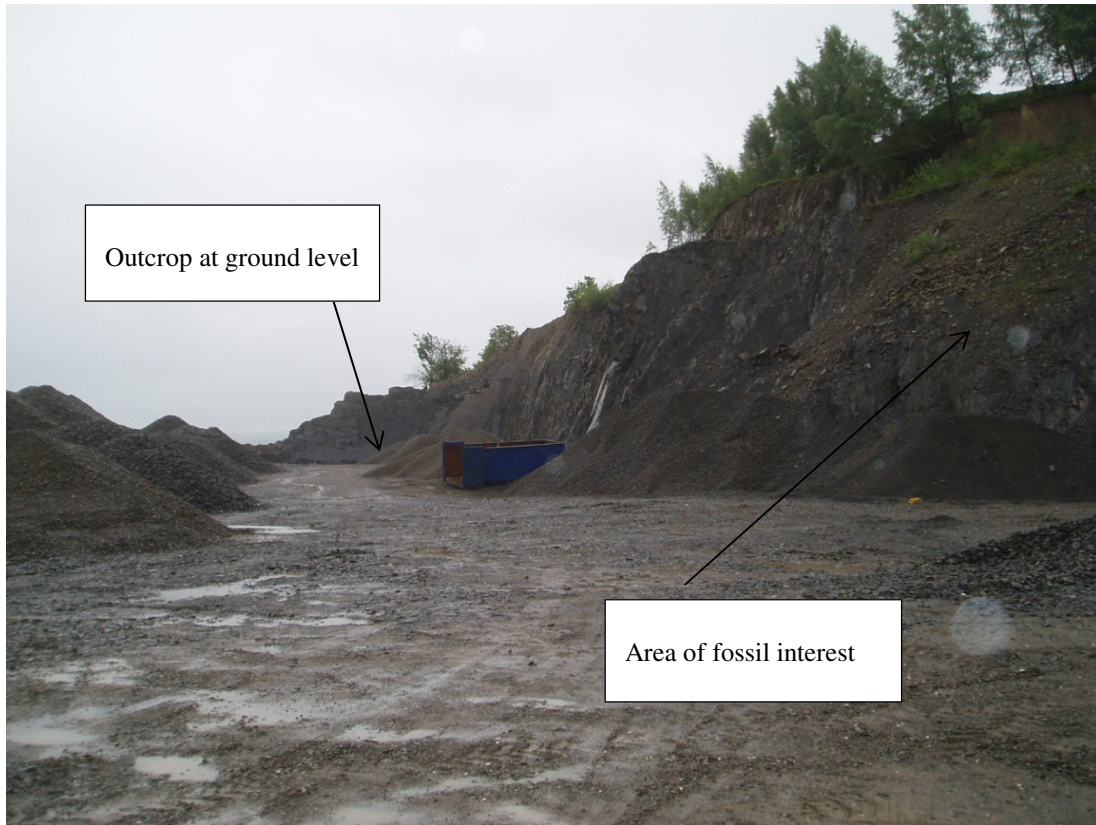
Photograph 8: Upper quarry face

CCW have requested that the top 6m of the upper face be left exposed, along with the outcrops at ground level at the southern end of the quarry. In addition, CCW have requested that an area where graptolite fossils have been found is left exposed, see Photograph 8.

To help ensure long term stability of the exposed rock face and reduce the risk during inspections it is recommended that the face be battered back to a gradient of around 75 to 80° and the face scaled of any loose blocks. This can be carried out by scraping the teeth of the excavator bucket across the face.

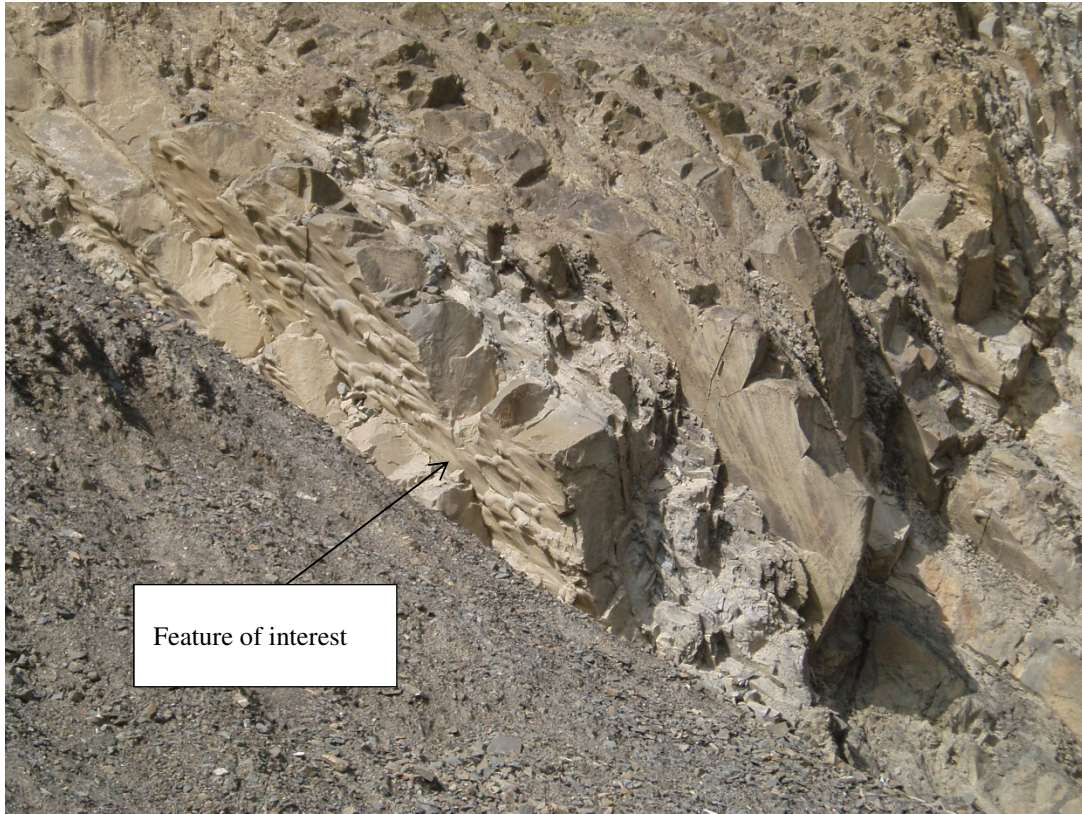
Photograph 9: Showing feature of interest.

It is estimated that this feature is at an elevation of around 195mOD and this should determine the plateau level. It is also required to keep several in situ features available for inspection on the southern corner of the Phase II works. Consequently, access will be formed by lowering the levels locally to these structures. The level of filling in this area is indicated in Photograph 10. A 3m wide access track will be constructed to allow access to both sets of structures.

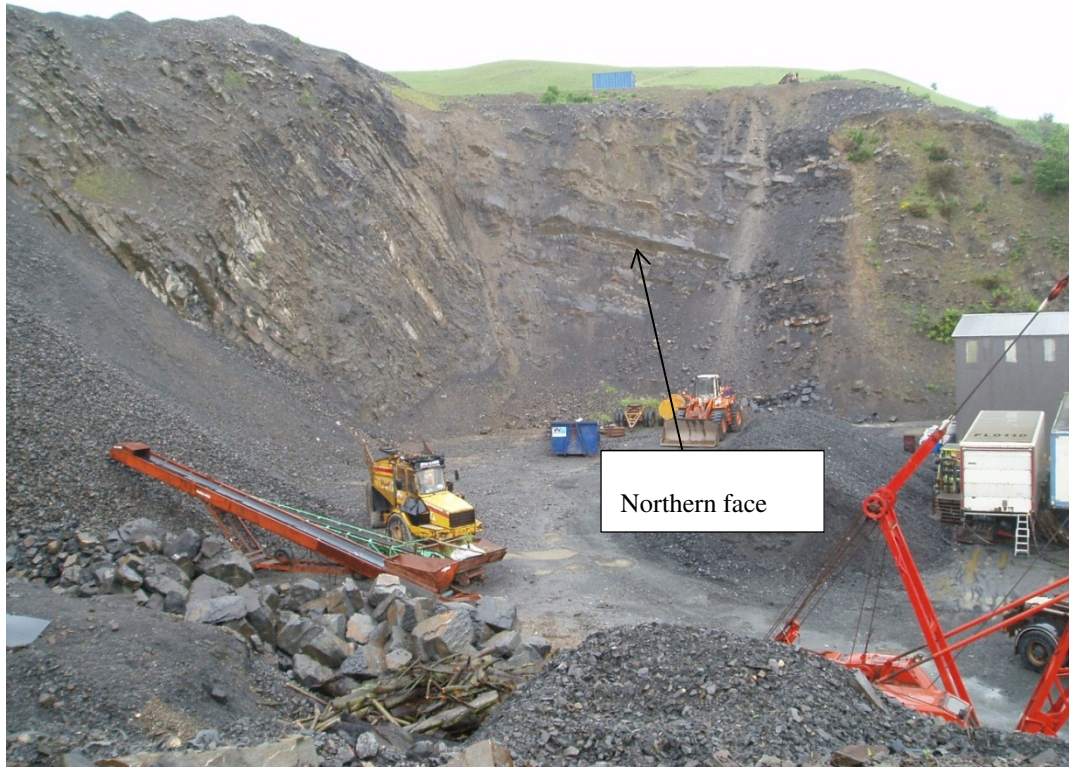
Photograph 11 Lower quarry face

The northern face of the lower quarry, which has the fault is considered to be the most unstable on site and CCW have no objections to this face being completely backfilled, see Photograph 11.

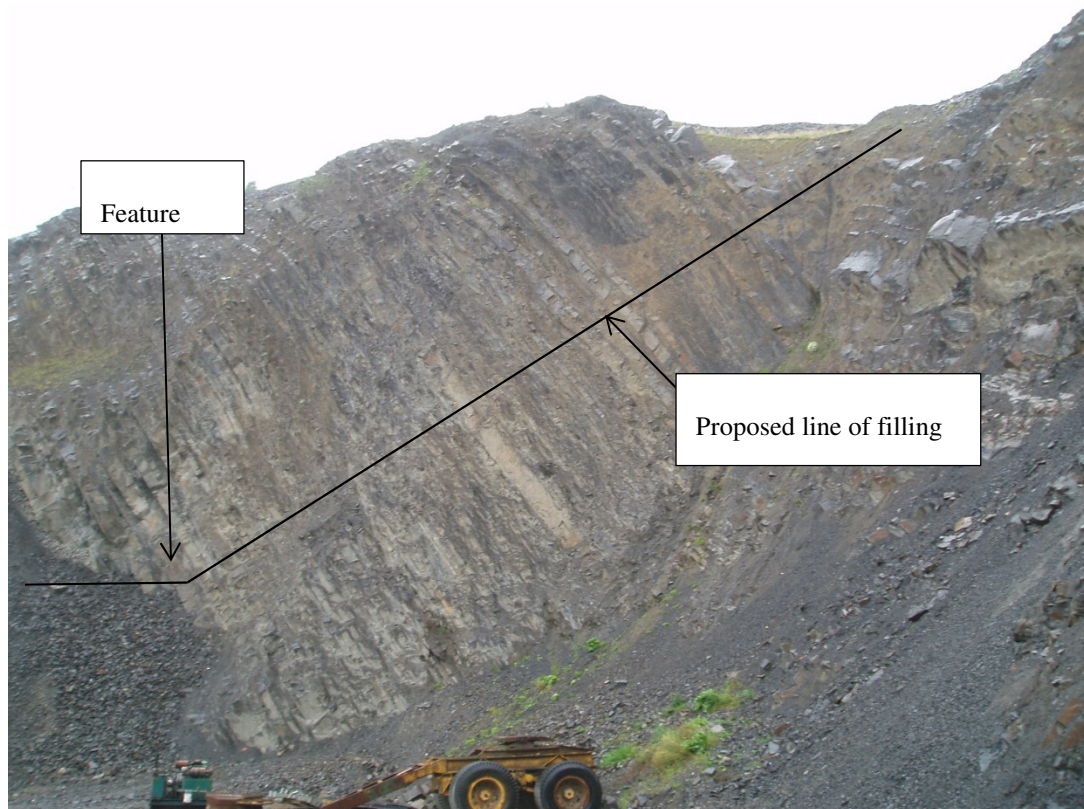
Photograph 13: Showing line of filling

The approximate line of filling is shown below on photograph 12.

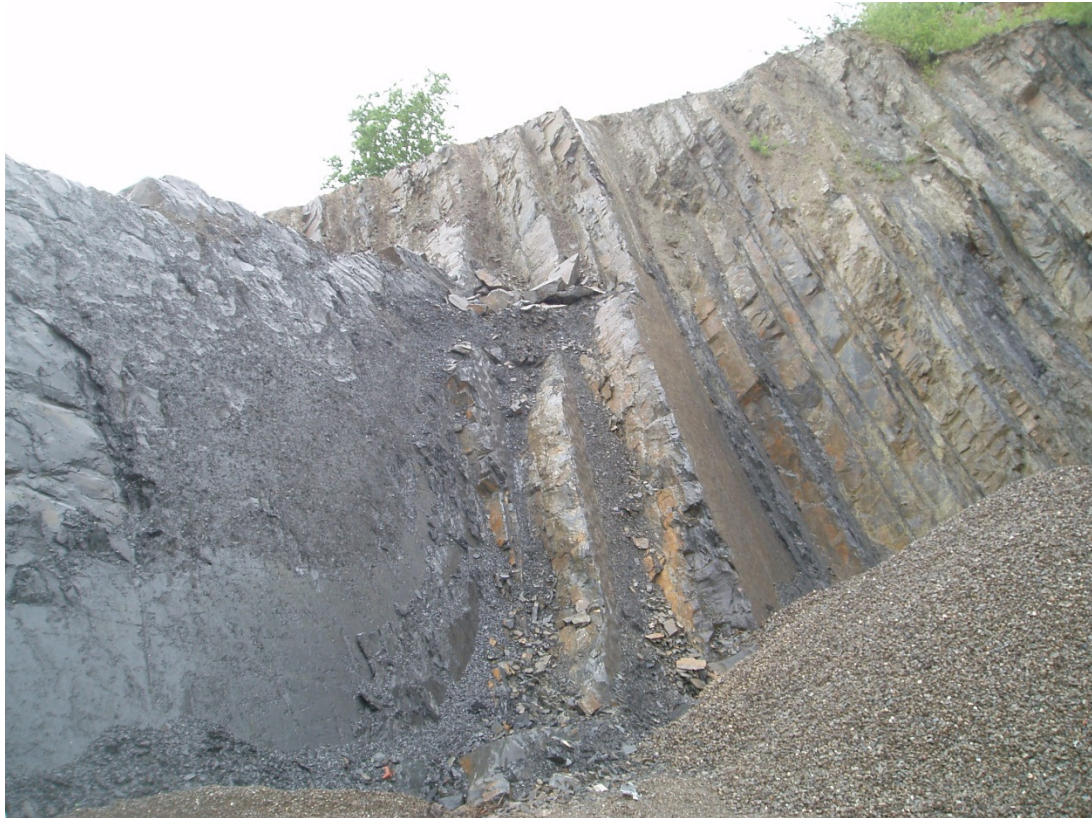
Photograph 14: Location of outcrops on upper face to be left exposed

The outcrops to be left open for inspection are presented in Photographs 14 to 17, with examples of some of the sedimentary structures visible.

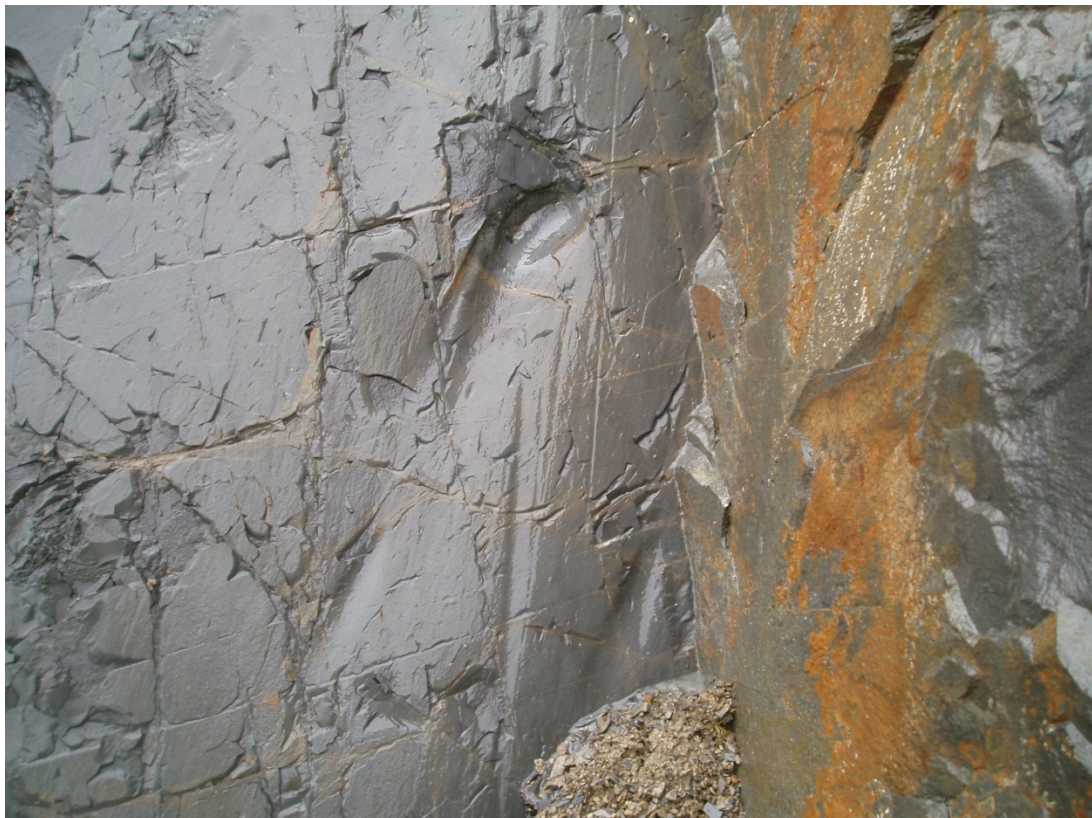
Photograph 15: Tool marks

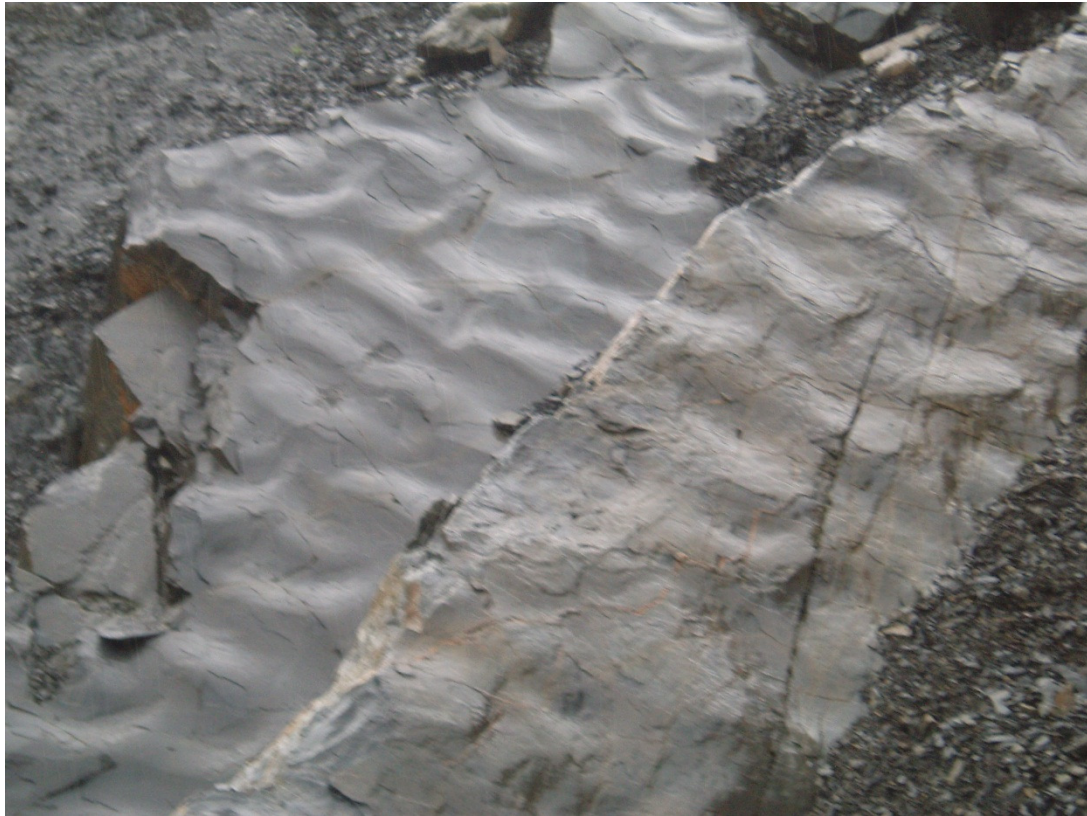
Photograph 16: Surface ripple marks

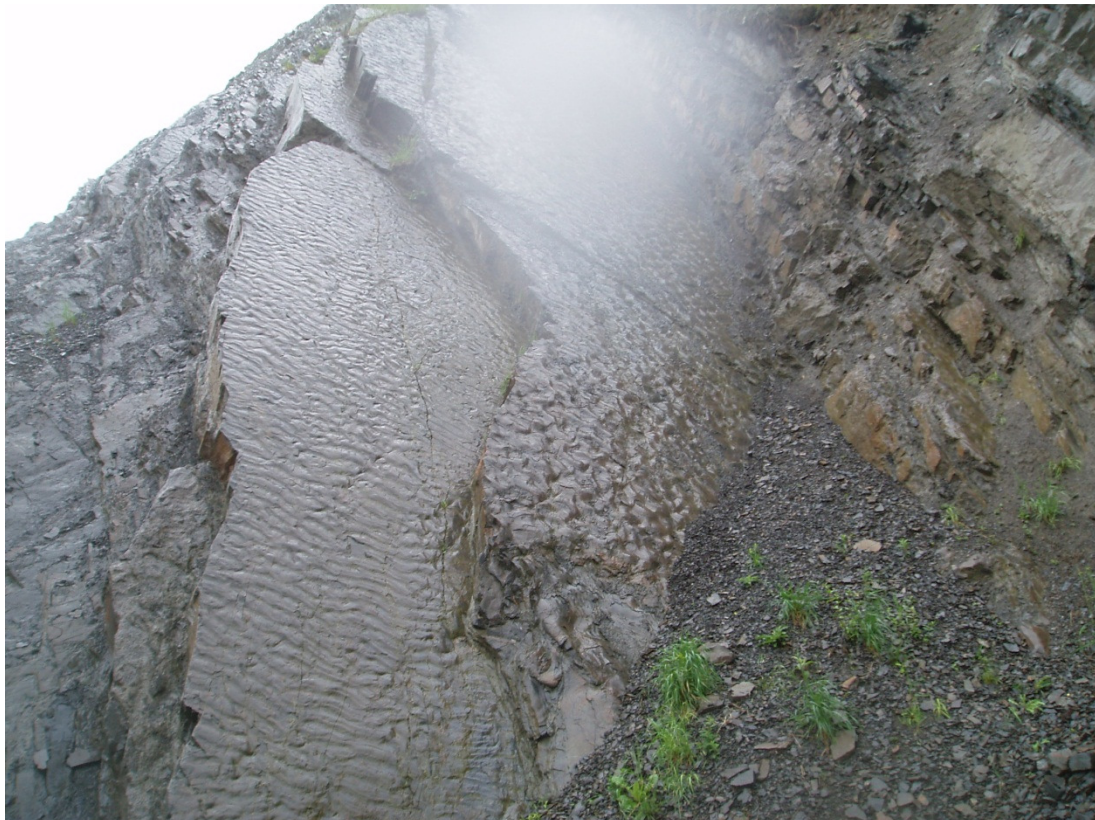
Photograph 17: Outcrops to be left exposed on Lower face

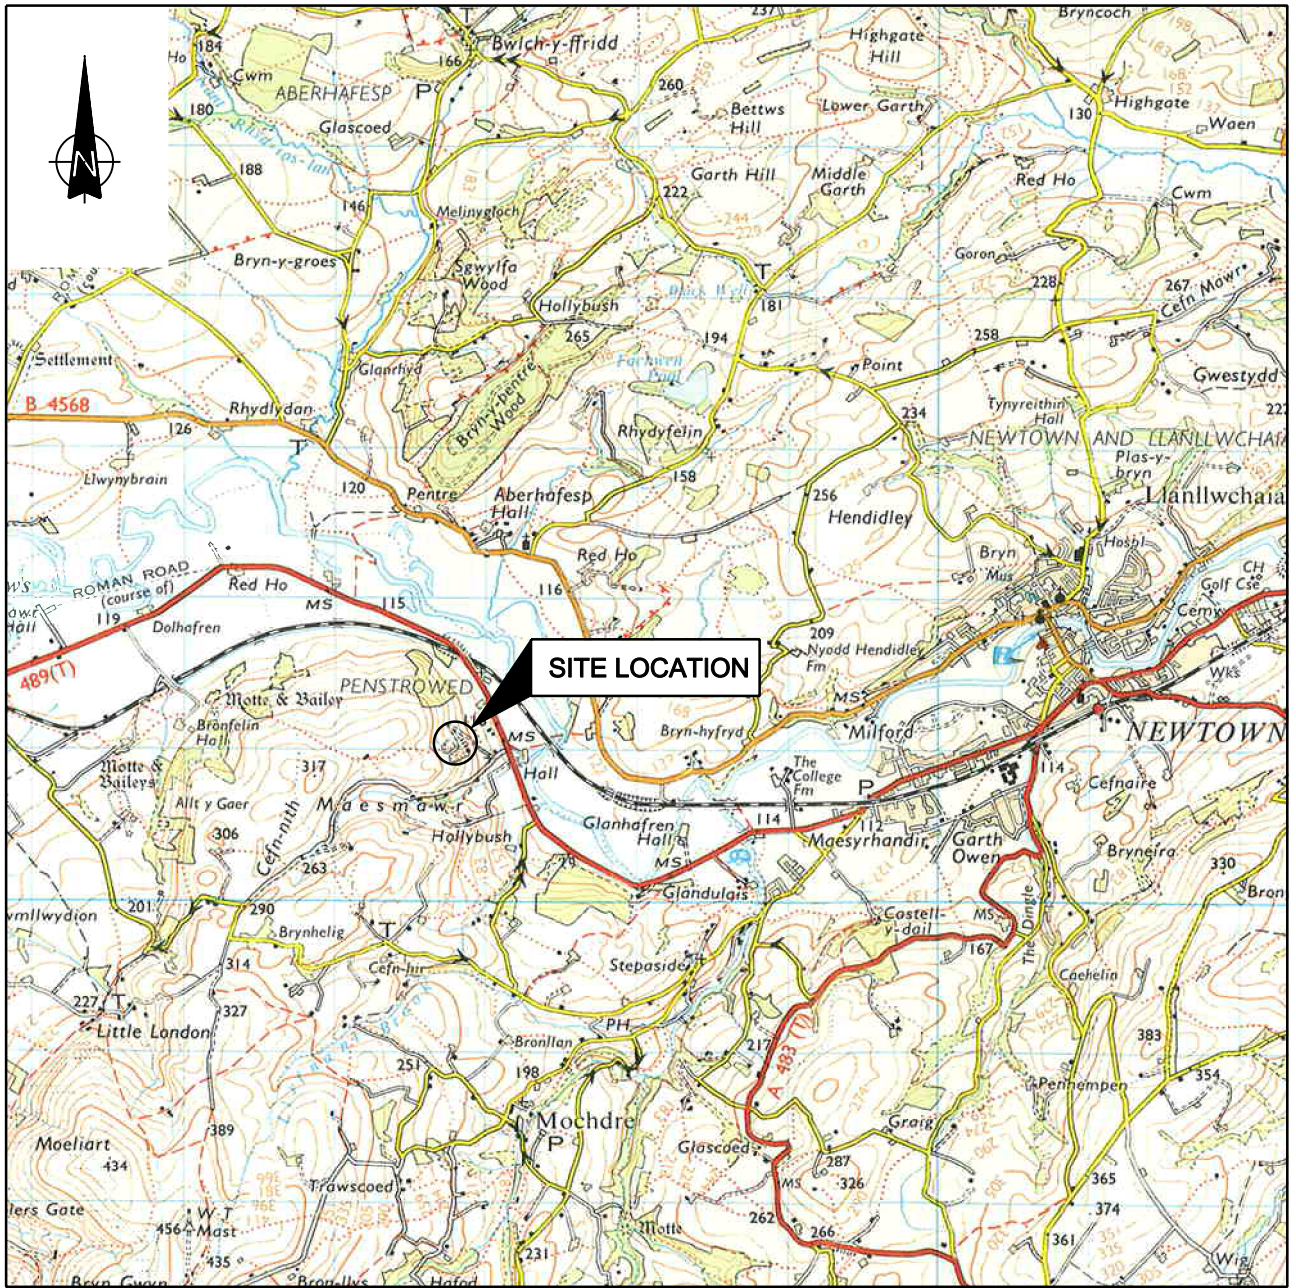
SITE LOCATION
FIGURE 1

The quarry is located some 4km west of Newtown in the hills to the south of the A489T at National Grid Reference SJ 068 910, see Figure 1.

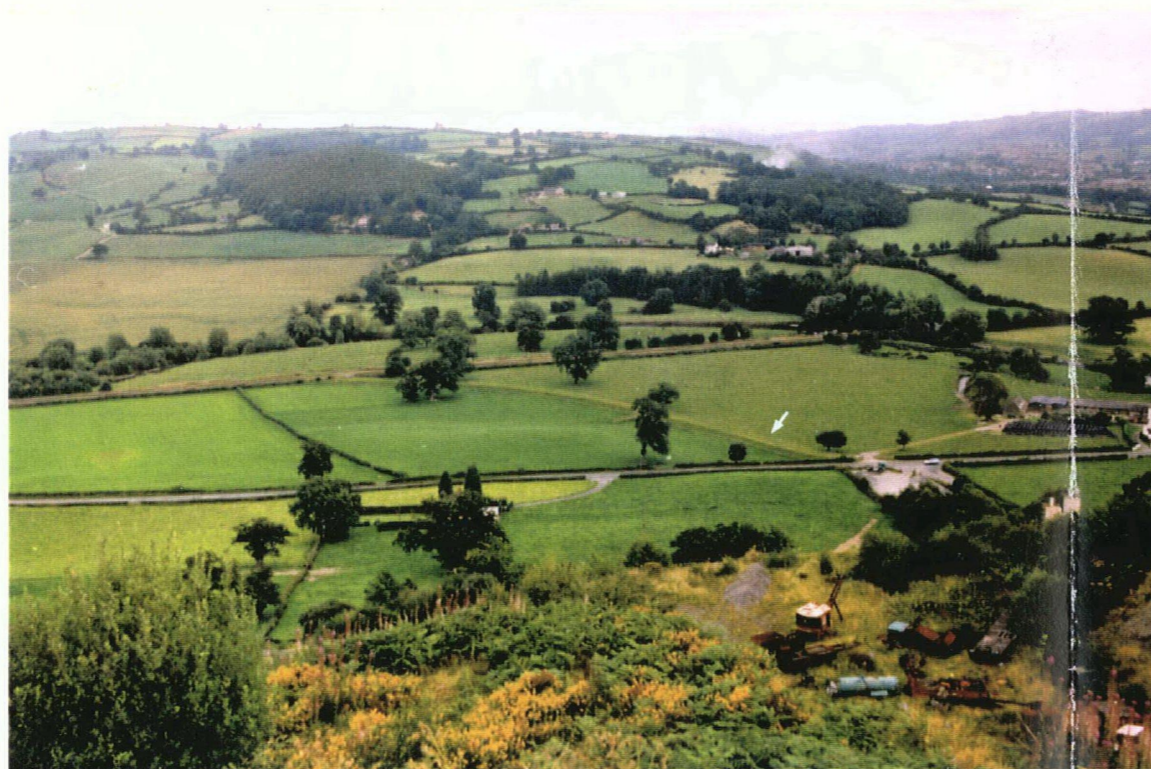
Figure 2 Curved embankment (arrowed) marking the former route of an old rail link from the quarry to the permanent way.

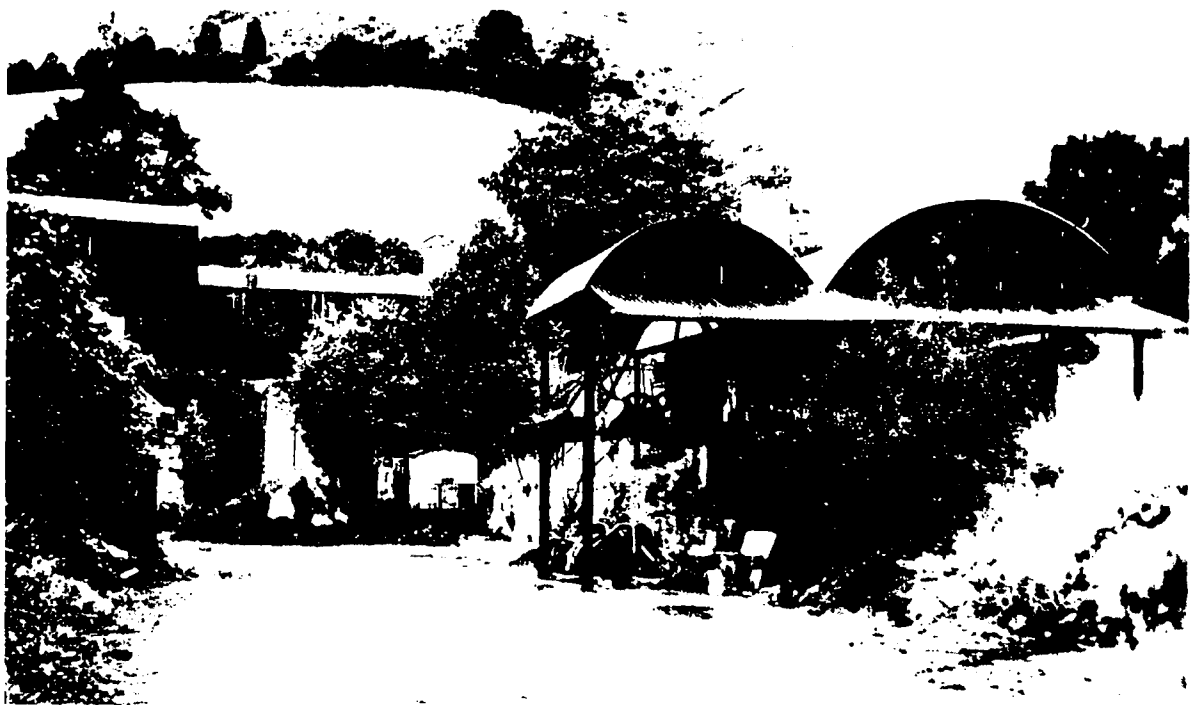
Figure 3 View of the old railway siding at Penstrowed Quarry, where wagons were loaded with aggregate and building stone (Green, 1991). The quarry is visible in the top right of the photograph.

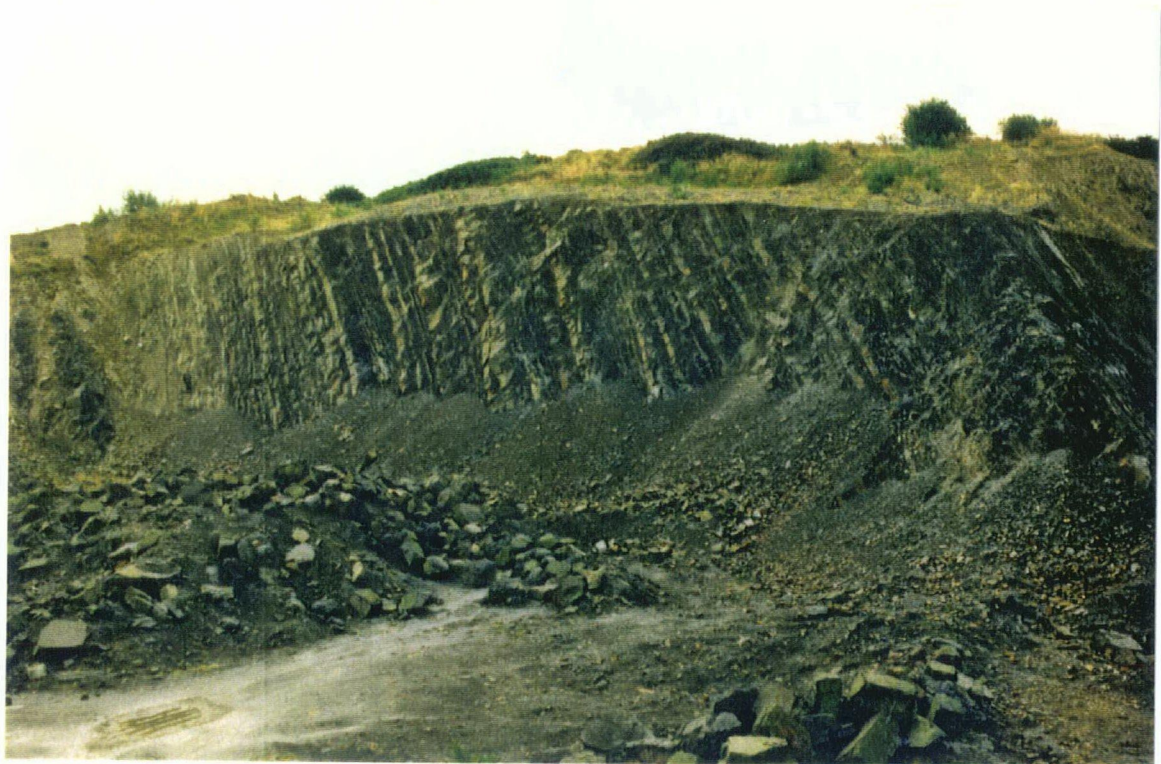
Figure 10 South-west face of upper level showing steeply-inclined, pale-coloured greywacke sandstone beds, interbedded with dark-grey shales.

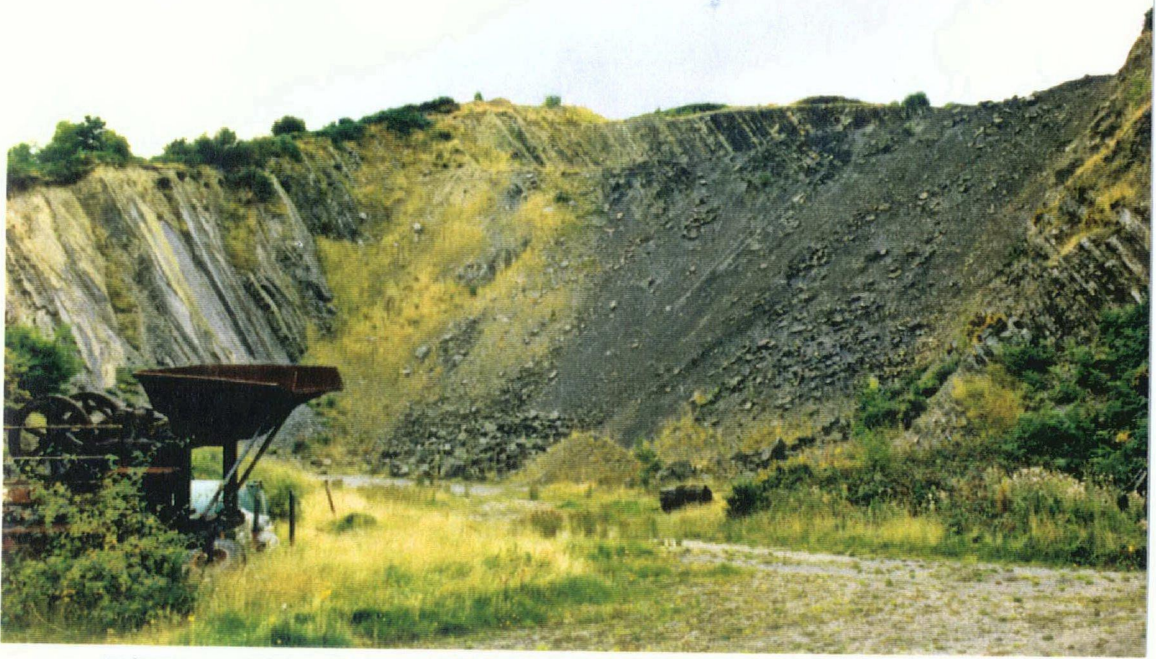
Figure 11 Degraded face of lower level. Bedding surfaces at left of view display excellent ripple marks and quartz/iron-rich dolomite veining.

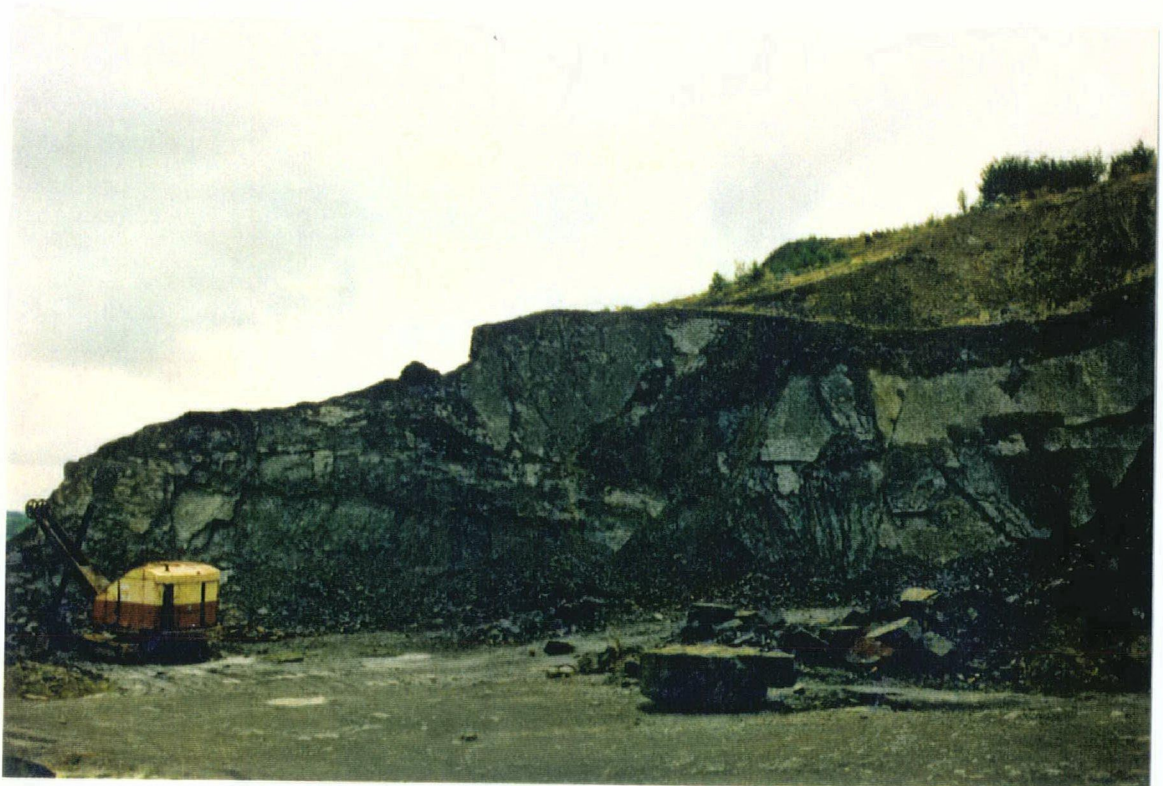
Figure 12 Steeply-inclined bedding planes exposed along rock spur on the upper level provide excellent examples of ripple marks.

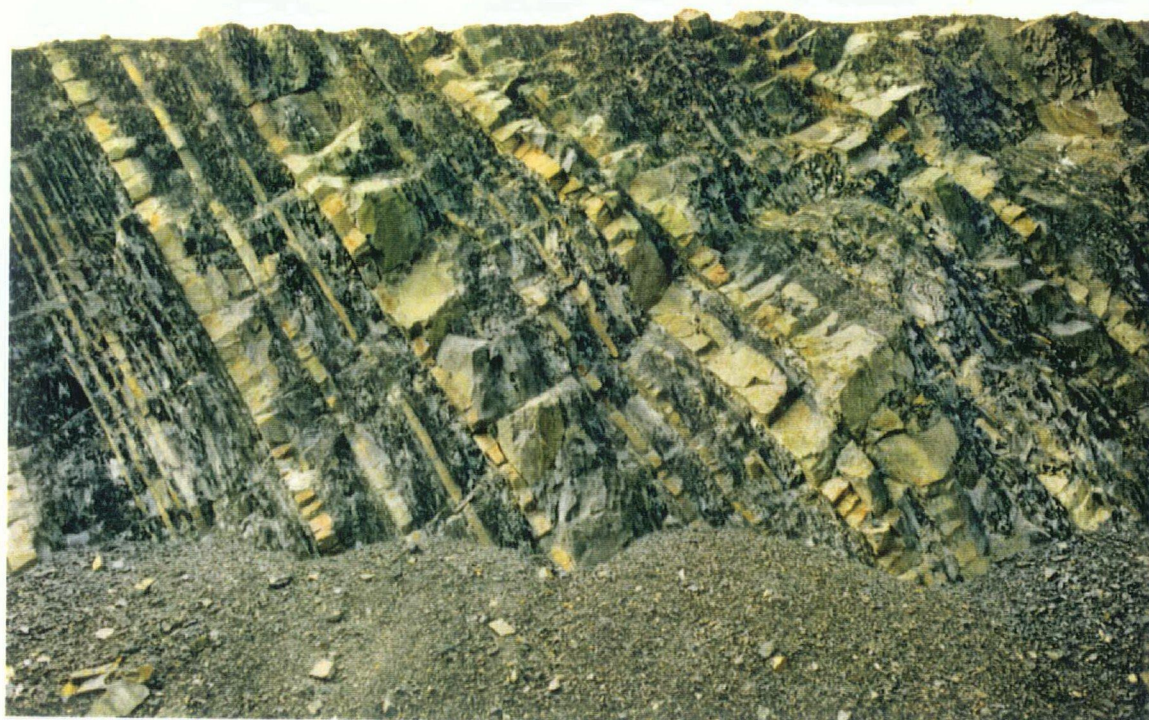
Figure 13 Rhythmic, alternating succession of light-coloured greywacke sandstones and dark-grey shales of the Penstrowed Grits (Loc. 1; Map 4).

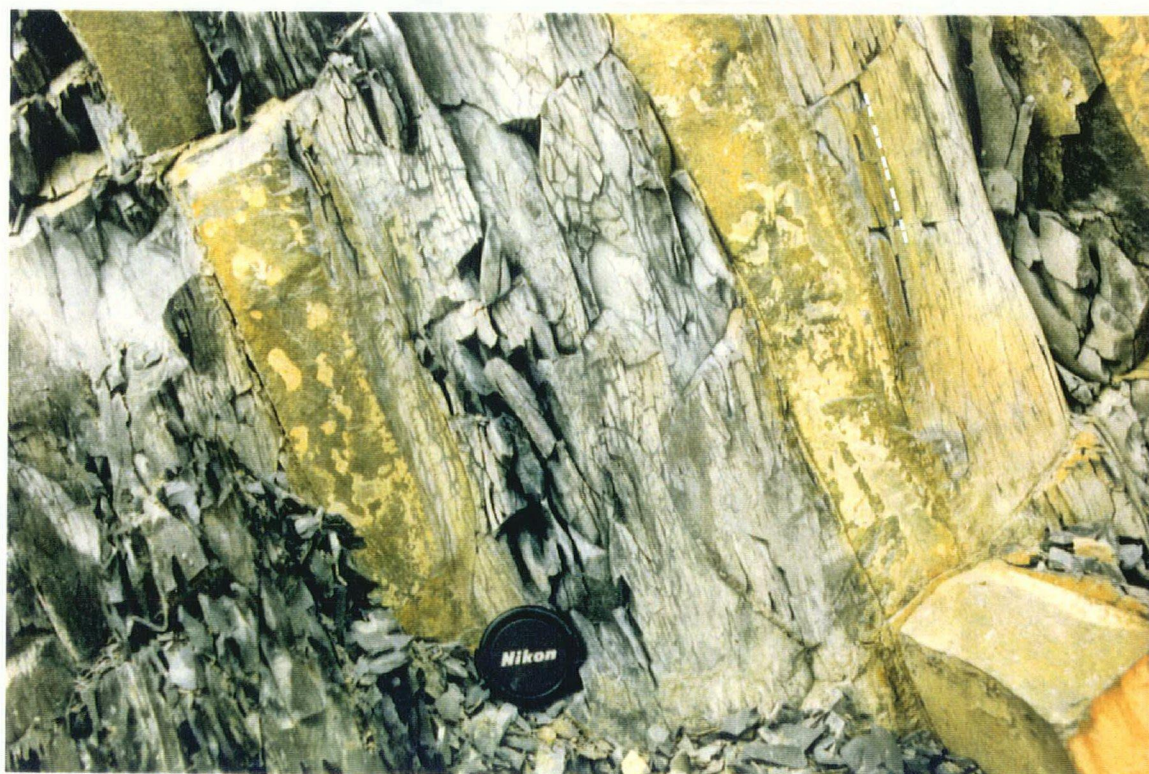
Figure 14 Finely-spaced penetrative cleavage cutting grey shaley mudstones (Loc. 2; Map 4).

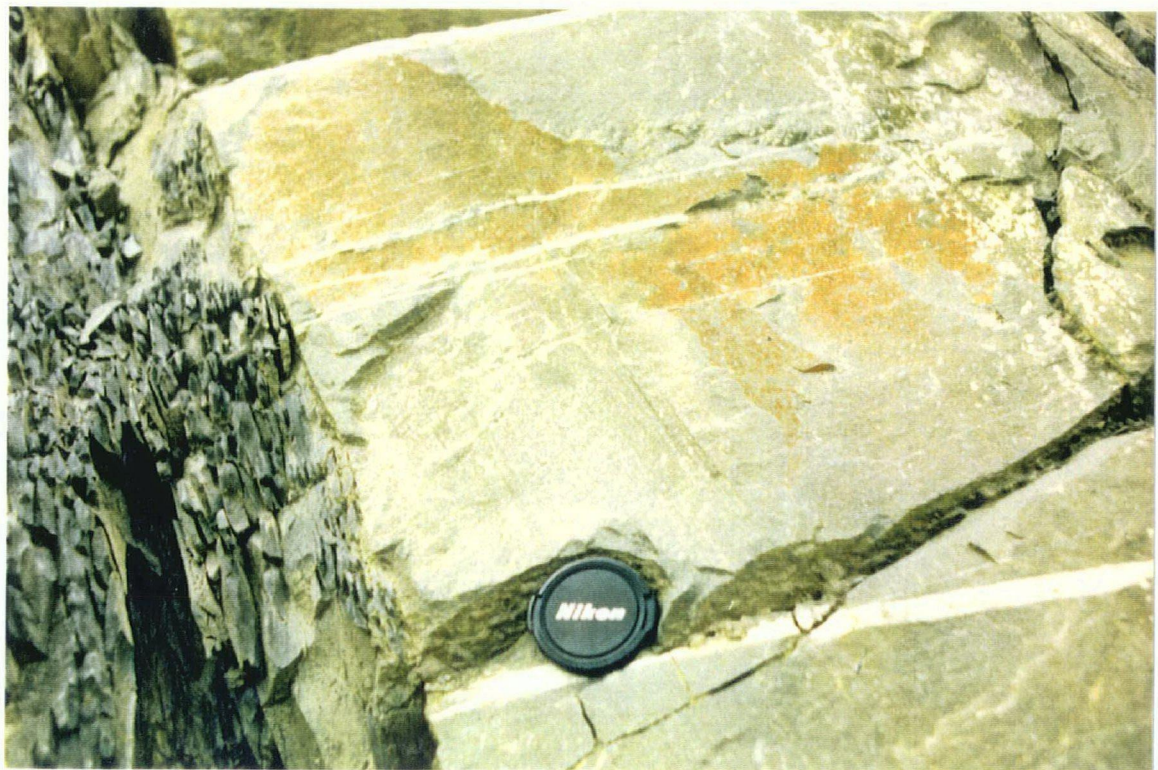
Figure 16 Quartz-filled joint plane in thick greywacke sandstone unit (Loc. 1; Map 4).
