Stabilisation of Penstrowed Quarry, Newtown
by Partial Backfilling
Report in Support of Planning Application Rev-B
G F Grigg Ltd

GroundSolve Ltd
Consulting Geotechnical, Engineering Geology and Environmental Engineers

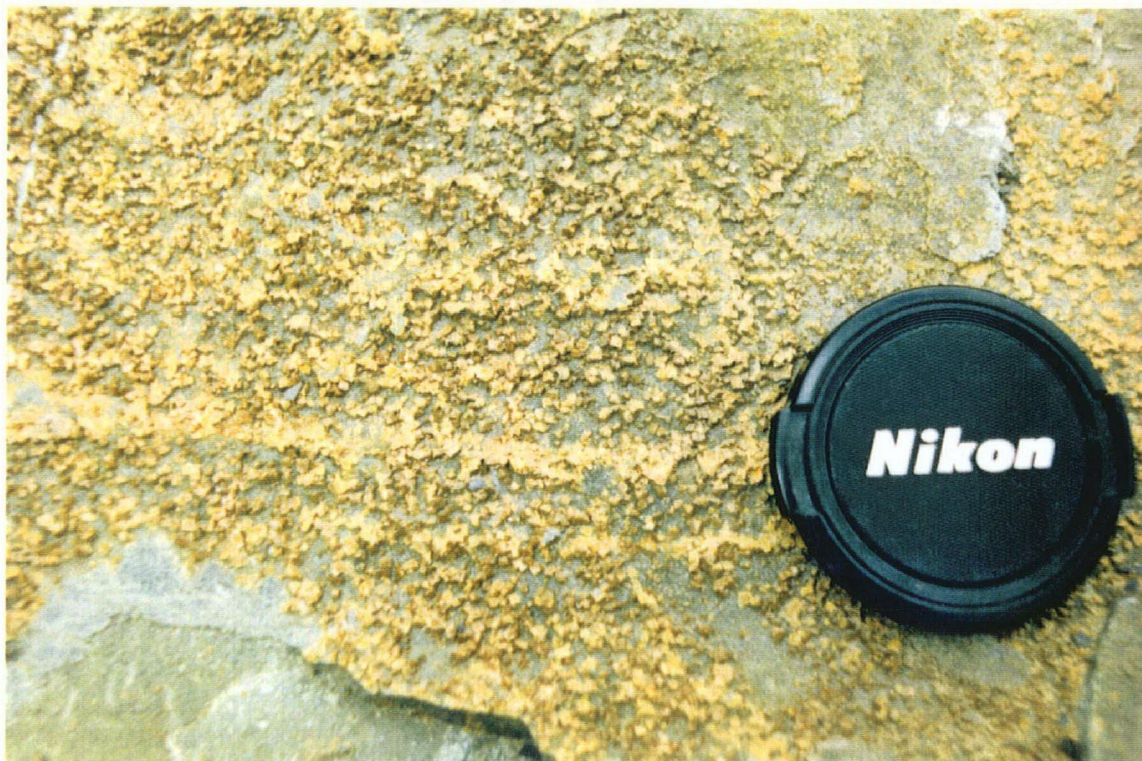
Figure 18 Rhombohedral crystals of dolomite on joint plane. These crystals are locally associated with chalcopyrite mineralization (Loc. 1; Map 4).

The Penstrowed Grits at this locality consist of a rhythmic, alternating succession of cream-coloured greywacke sandstones, and dark-grey siltstones and shaley mudstones. The beds are steeply inclined to the north-west at angles of up to 60° (Figure 13), reflecting their position on the north-west limb of a tight anticlinal fold (see Map 3). The fine-grained mudstones are cut by a finely-spaced cleavage which is oriented sub-parallel to bedding (Figure 14), and the succession is also transected by several north-south striking faults (Figure 15) which have a normal downthrow to the east. Some sandstone beds are cut at high angles by well-defined system of **joints**, which are infilled either by quartz (Figure 16) or by iron-rich dolomite (Figure 17). Interestingly, the latter often occur on the joint planes as discrete rhombohedral crystals (Figure 18) and are frequently associated with chalcopyrite (copper/iron sulphide) mineralization.

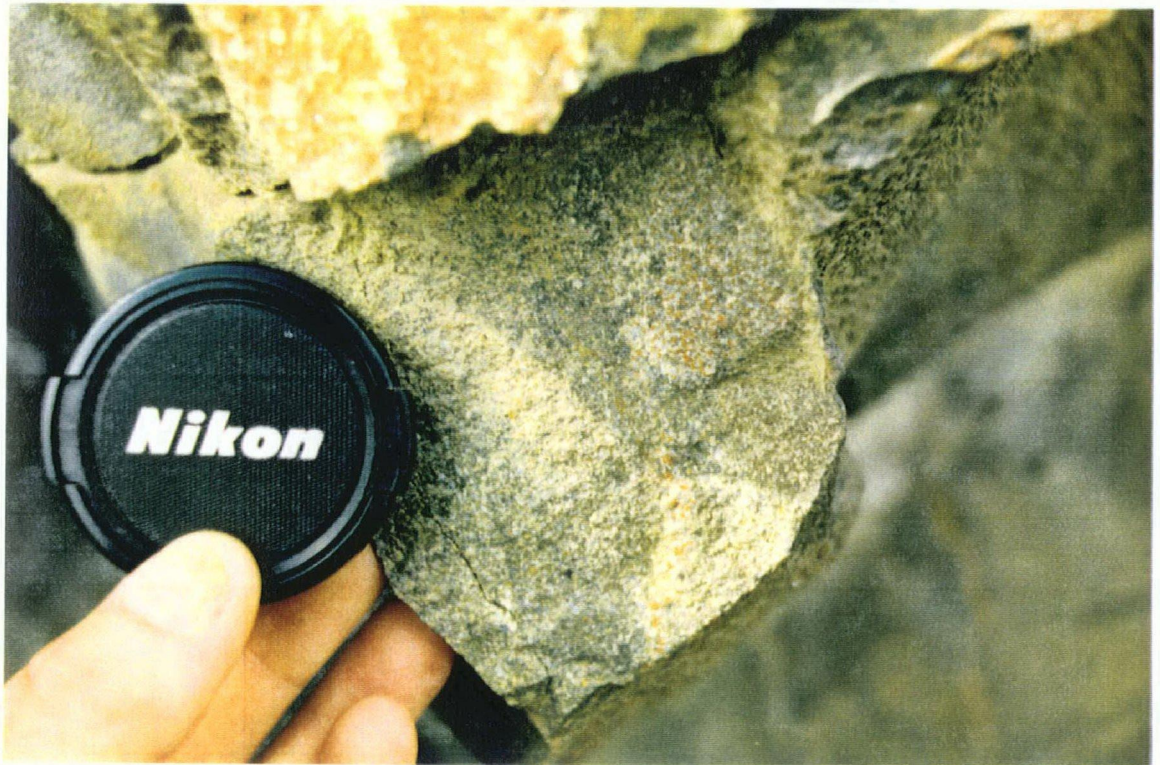
Figure 19 Typical coarse-grained base of greywacke sandstone bed. Grains consist dominantly of sub-angular quartz but with some small rock fragments.

However, the most important geological feature at Penstrowed Quarry, on account of which the site was notified, lies in the wide variety of sedimentary structures found in these rocks. Individual greywacke sandstone units are typically characterized by graded-bedding (Figures 19 and 20), whereby coarse-grained basal zones (T_a ; Figure 7), comprising glassy and milky-white, sub-angular quartz grains in a clay matrix, pass up into finer-grained laminated sandstones ($T_{b/d}$). Occasionally, some sandstone beds display an internal reversal of grading, with the appearance of coarse-grained horizons higher up in the bed (Figure 21). The bases of many of the sandstone beds are characterized by abundant **sole structures** including flute casts and tool marks. The former are visible as bulbous or ramifying casts (Figures 22 and 23) which were formed when hollows were eroded into the top of the underlying bed and subsequently filled with coarser sediment. The application of cartographic projection techniques, reveals that these structures were formed by a current moving towards 010°, which confirms their derivation from a source terrain lying to the south or south-west. The tool marks appear as linear grooves (Figure 24) and were produced by an object ('tool') such as a pebble, being dragged under traction along the sea floor. The tops of many sandstone beds often display well-defined ripple marks which can be seen both in plan view (Figure 25) and also in cross-section (Figure 26).

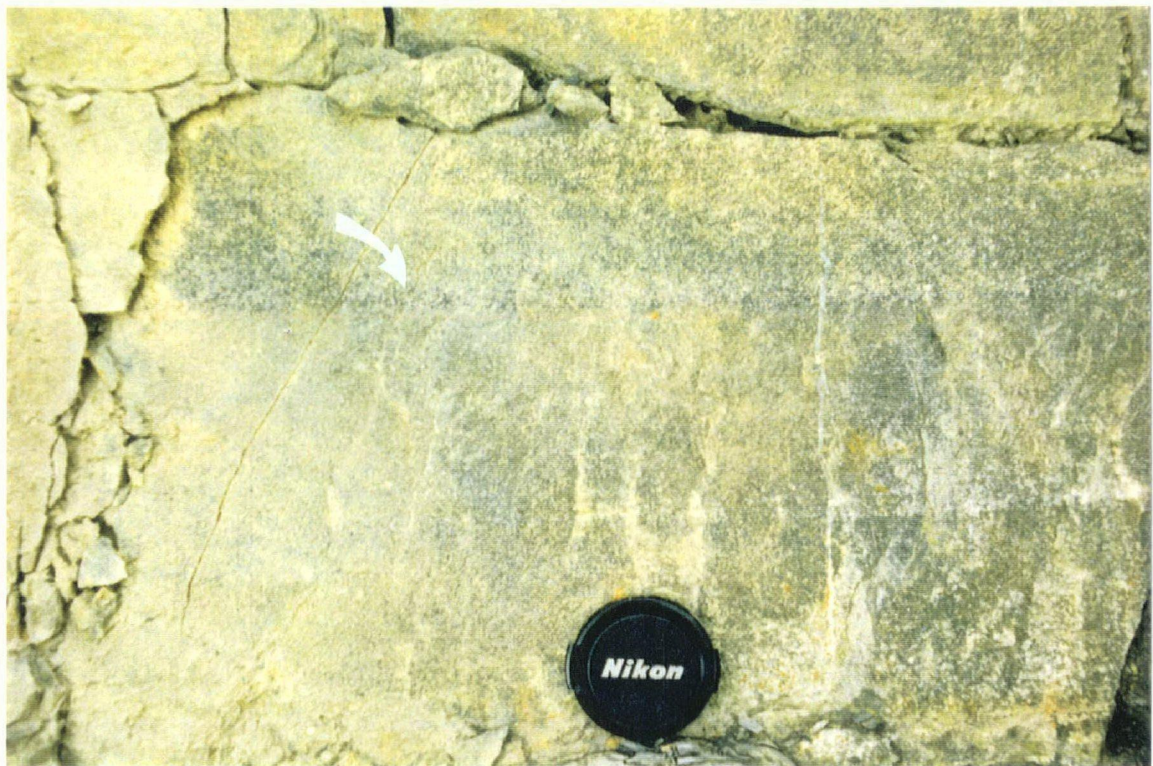
Figure 21 Typical example of reverse grading within sandstone bed, with the appearance of coarser-grained horizons (marked).

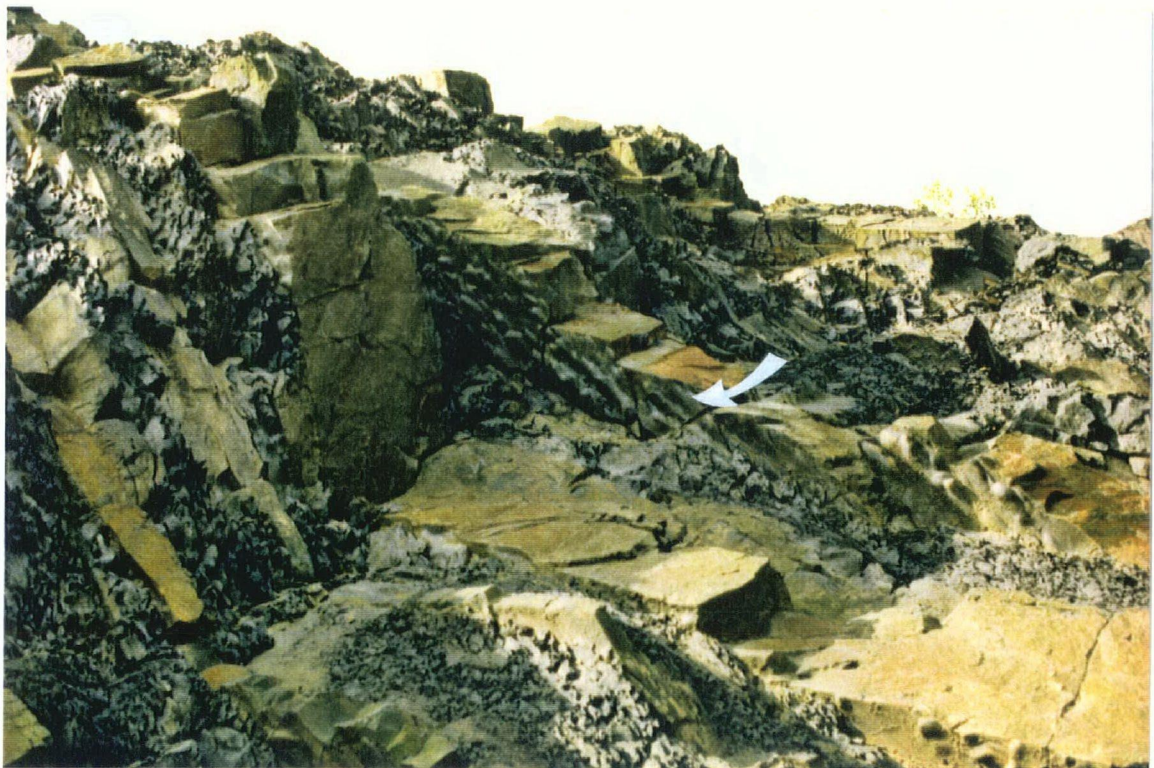
Figure 22 Base of sandstone unit characterized by the development of numerous bulbous load casts (marked). Location 1, Map 4.

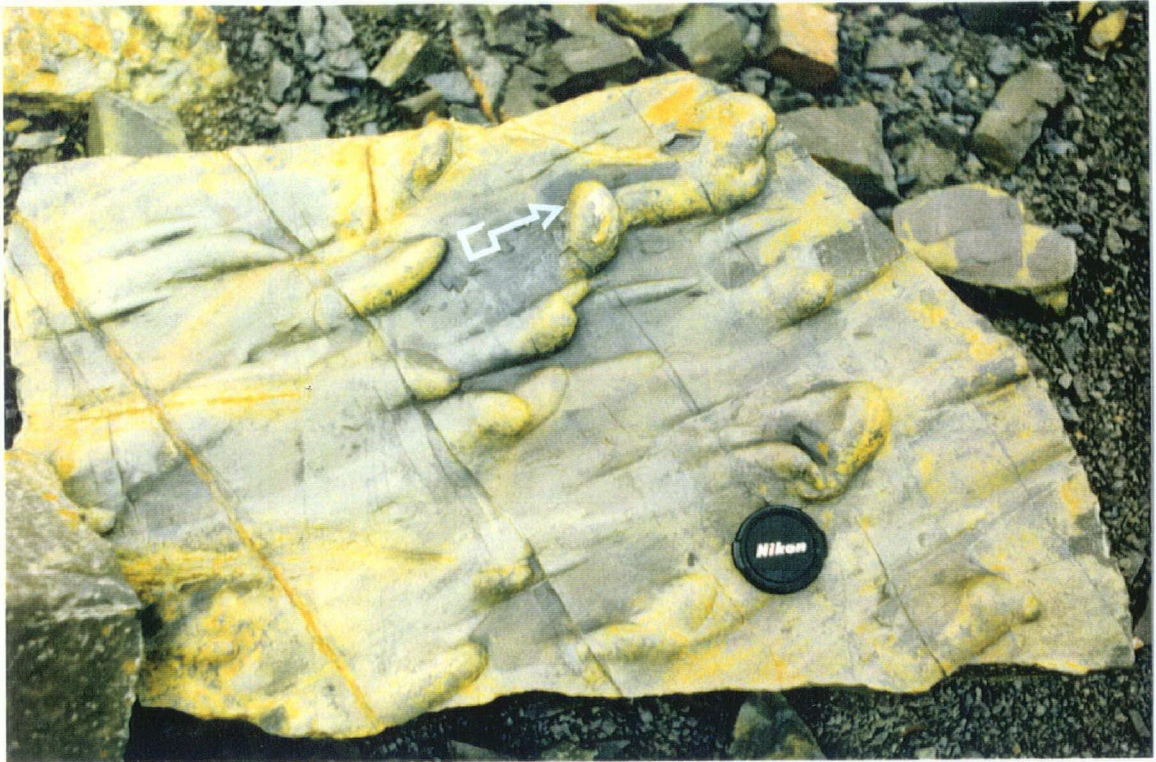
Figure 23 Load casts exposed on block lying on floor of upper level. Note how these structures show a preferential alignment (marked) which is used to determine palaeocurrent direction.

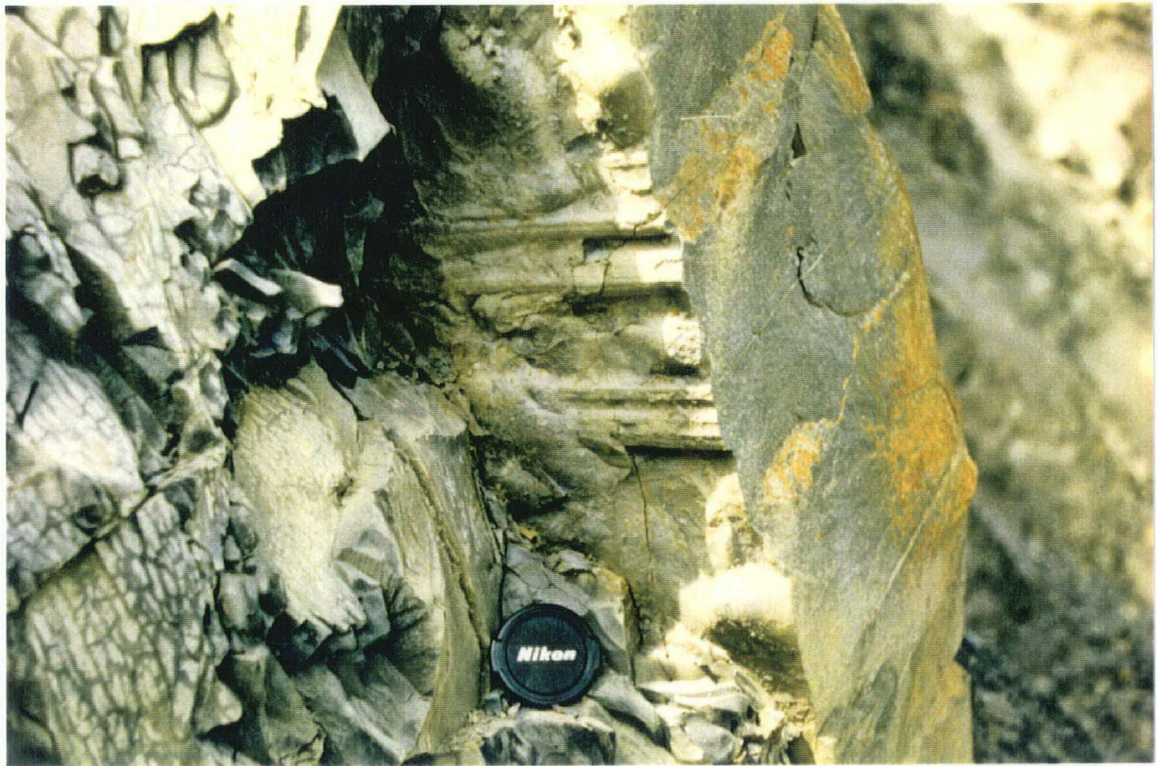
Figure 24 Linear groove casts exposed on underside of greywacke sandstone are commonly seen *in situ* along the faces of the upper level. These structures are widely used to determine palaeocurrent direction.

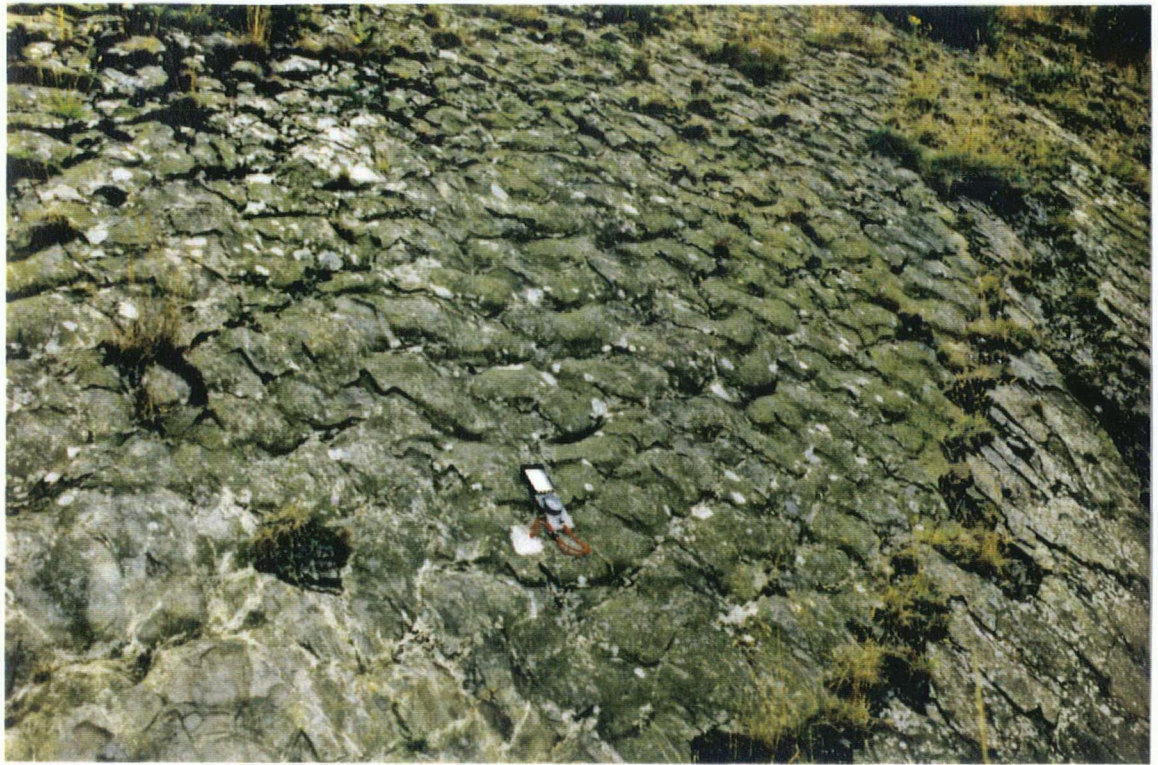
Figure 25 Ripple marks on the top surface of greywacke sandstone bed (Loc. 4; Map 4).

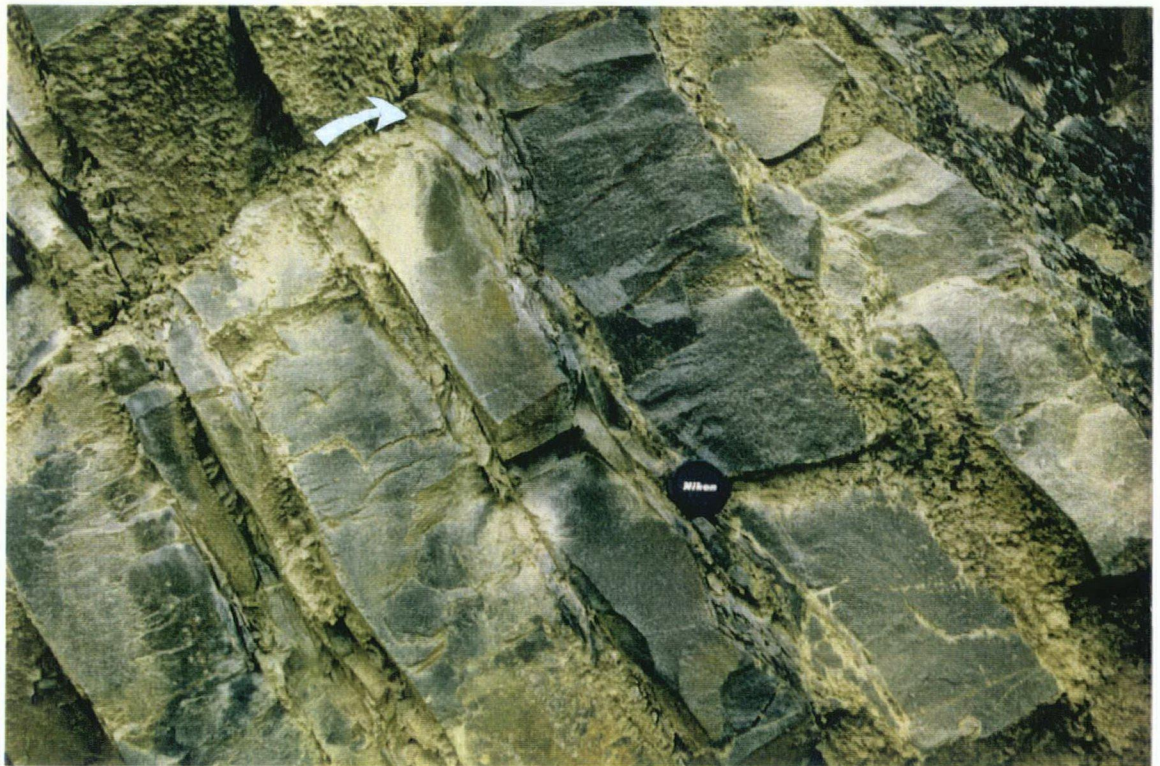
Figure 26 Ripple-marked surface of sandstone in cross-section. Surface is covered by thin mudstone band, prior to the deposition of next sandstone unit (Loc. 1; Map 4).

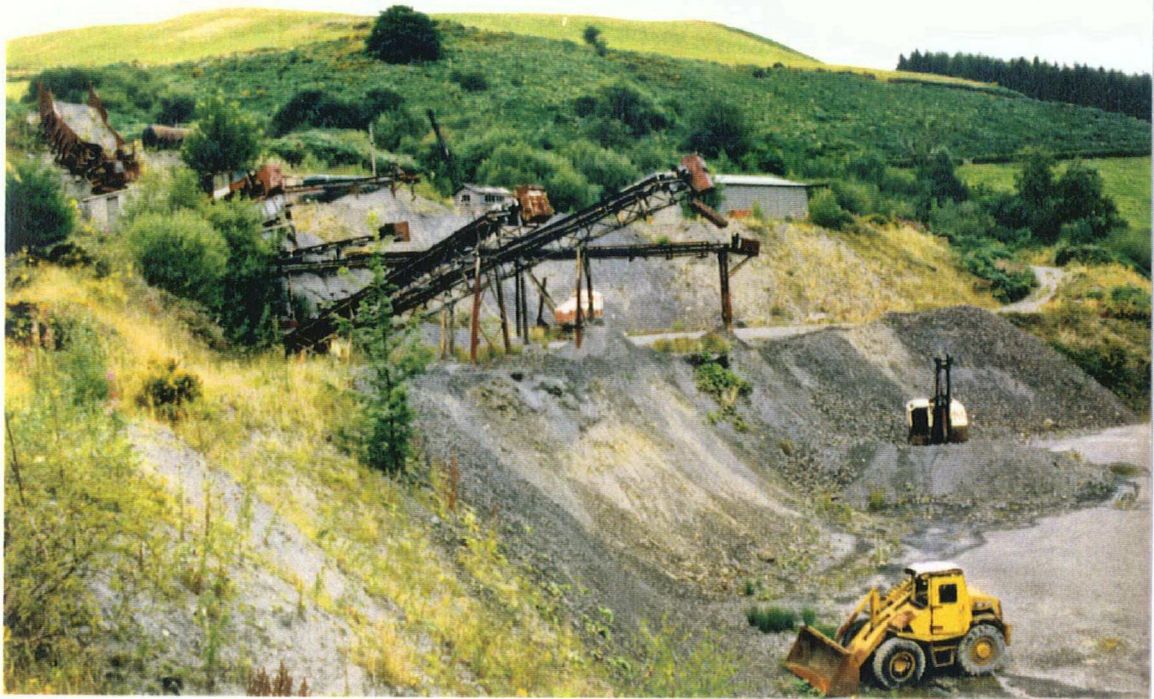
Figure 27 Crushing plant and conveyor belts which were used for processing and transporting stone to distribution point.

This GCR site was once a currently abandoned quarry, which was notified in April 1985 on account of the Wenlock turbidites which are exposed along the quarry faces. Operations at Penstrowed Quarry apparently ceased within the last 10 years, and most of the plant, including drilling, excavating and crushing equipment, was left on site (Figures 1, 27 and 28), often in the places where last used.

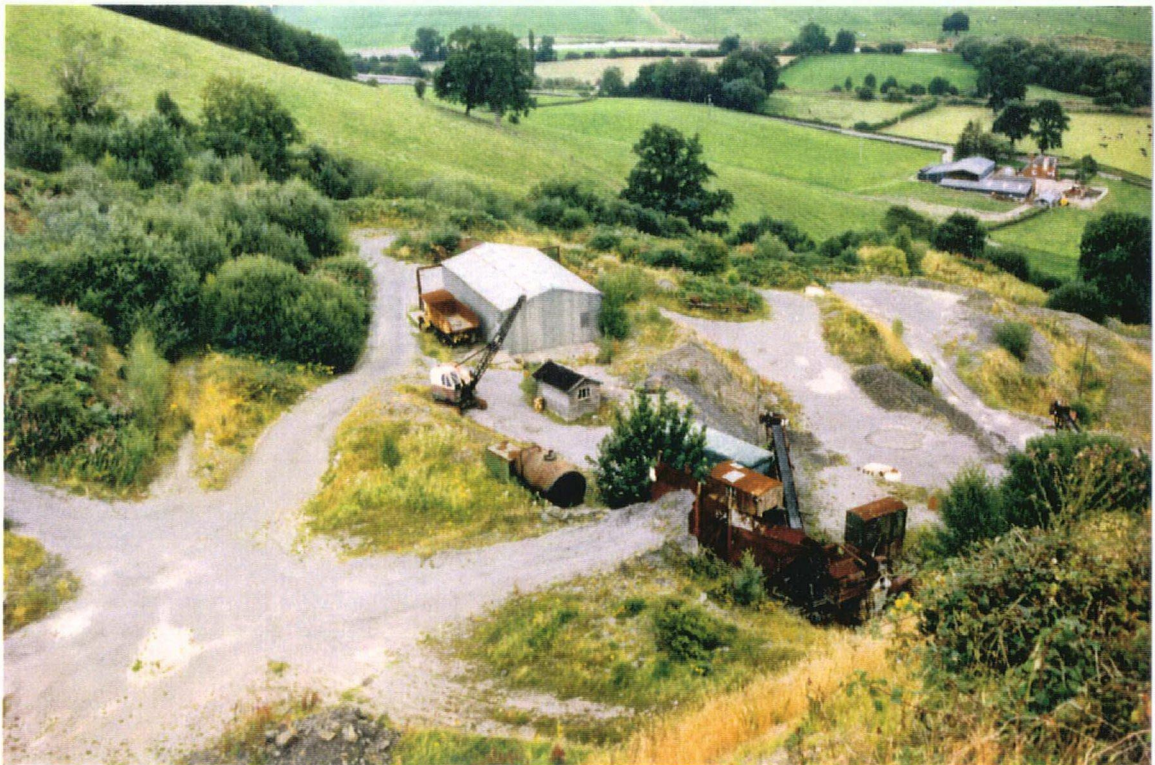
Figure 28 Crushing plant and fuel storage facility at on the north-eastern margin of the GCR site. Drilling equipment is currently stored behind the corrugated iron shed in background.

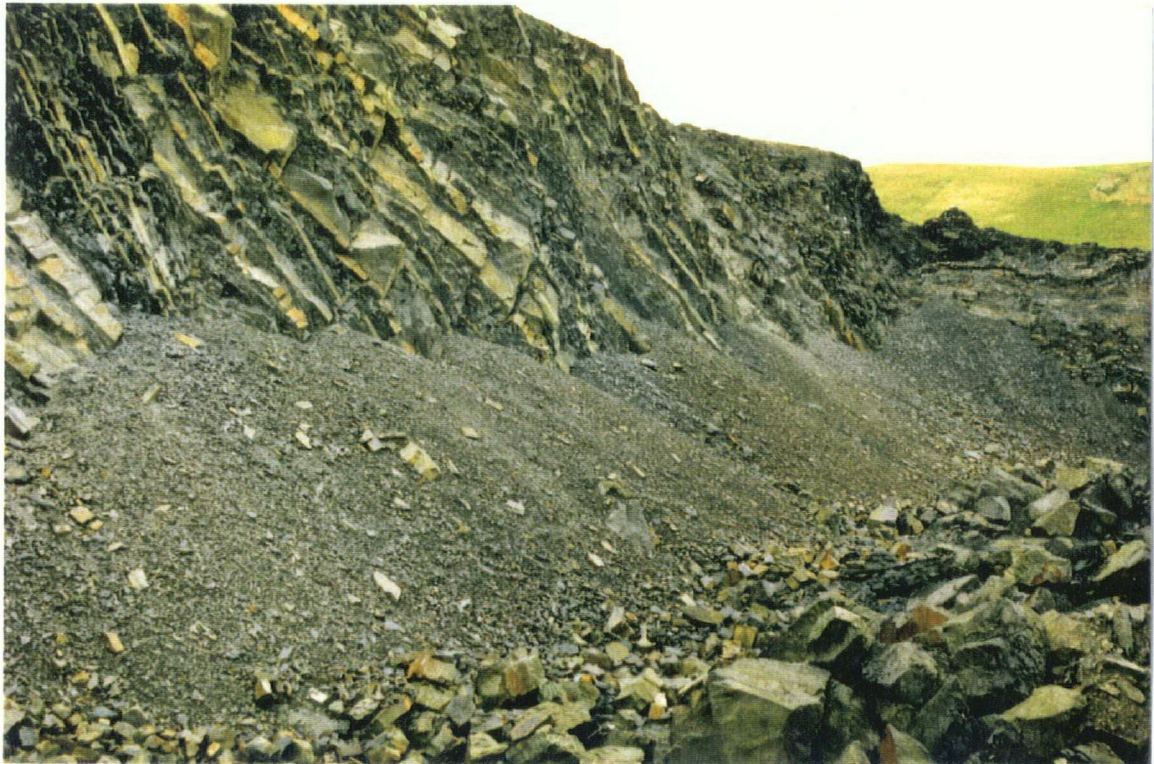
Figure 29 Accumulation of scree at base of unstable faces along the upper level. The continued build-up of this material will eventually result in the loss of exposure. Without further quarrying at the site, some clearance may eventually become necessary.
