Seaton West Walk Public Toilets, Seaton, Devon

Ecological Impact Assessment (Bats and Birds)

November 2023

Ref: 2178-EcIA-TS

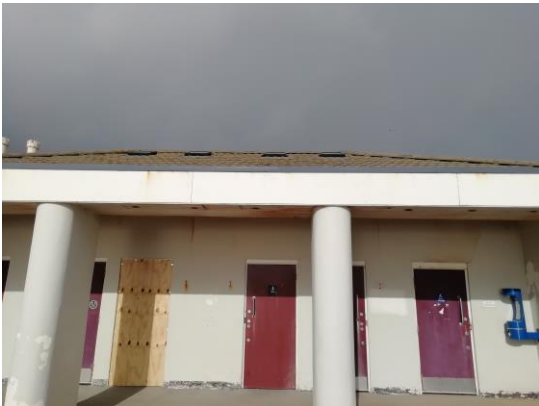
Description	Bat evidence/ access points/ potential features	Photograph	Category (based on Collins 2023)
<p>The toilet block is constructed of rendered blockwork with a concrete tile double-pitched hipped roof. Skylights are present on the southern elevation of the roof. Individual toilet cubicles are present along the southern and eastern elevations of the building with tight-fitting doors (one boarded up due to storm damage at the time of the survey). There is a storage room at the western end of the building with a service corridor running behind the toilet cubicles. An outside shower area is present at the far eastern extent of the building beyond the toilets.</p> <p>Internally, there is one large, uncluttered roof void lined with breathable membrane. Dense cobwebs were noted throughout.</p> <p>A retaining wall was built into the slope immediately to the north of the toilet block.</p>	<p>Exterior –A small gap along the hipped ridge is present at the southwest corner of the building caused by missing mortar. However, due to the exposed coastal location and prevailing south-westerly winds, it has negligible bat roosting potential. Windows and doors are tight-fitting and all panes intact.</p> <p>Interior – No evidence of bats was found. No gaps were identified that would allow bats to enter therefore bat presence is considered unlikely. The roof void was brightly lit due to the presence of skylights along the length of the front (southern elevation) of the roof. Lighting and frequent human activity within the building is likely to further deter bats from roosting within the building.</p>

<p>Southern elevation of the toilet block</p>

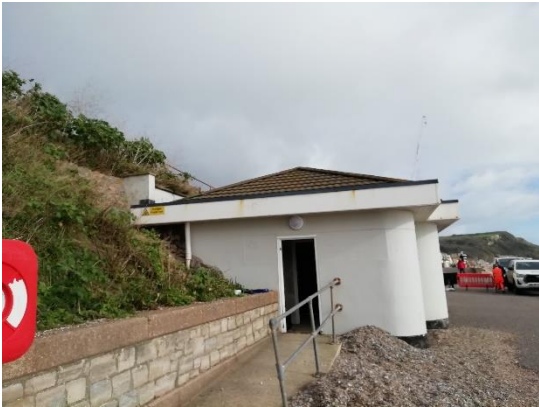
No evidence of bats was recorded within the survey area. The toilet block had negligible-low potential to support roosting bats with the presence of a potential roosting feature associated with the southwestern hipped ridge where mortar was missing. However, due to the highly exposed coastal nature of this potential roosting feature facing into the prevailing south-westerly wind, and lack of connectivity into the main roof void, it is considered that this feature is not likely to be utilised by bats. Furthermore, a thorough search of

<p>Western elevation of the toilet block</p>	<p>Negligible</p>

No evidence of bats was recorded within the toilet block and surrounds. The toilet block offered extremely limited roosting potential with a single potential bat roosting feature associated with the southwestern hipped ridge. However, this feature is considered unsuitable for bats due to the extremely exposed coastal location facing into the prevailing wind, and lack of connection to the roof void. No other potential bat roosting features or bat access points were identified during the survey. Conditions within the roof void are considered unsuitable for roosting due to the high levels of lighting.
