**Preliminary Ecological  
Appraisal Including a  
Protected Species  
Assessment at:  
Gate House Cottage, School  
Road, Risby, Suffolk. IP28 6RG.**

**Mothersole Builders**

**September 2023**

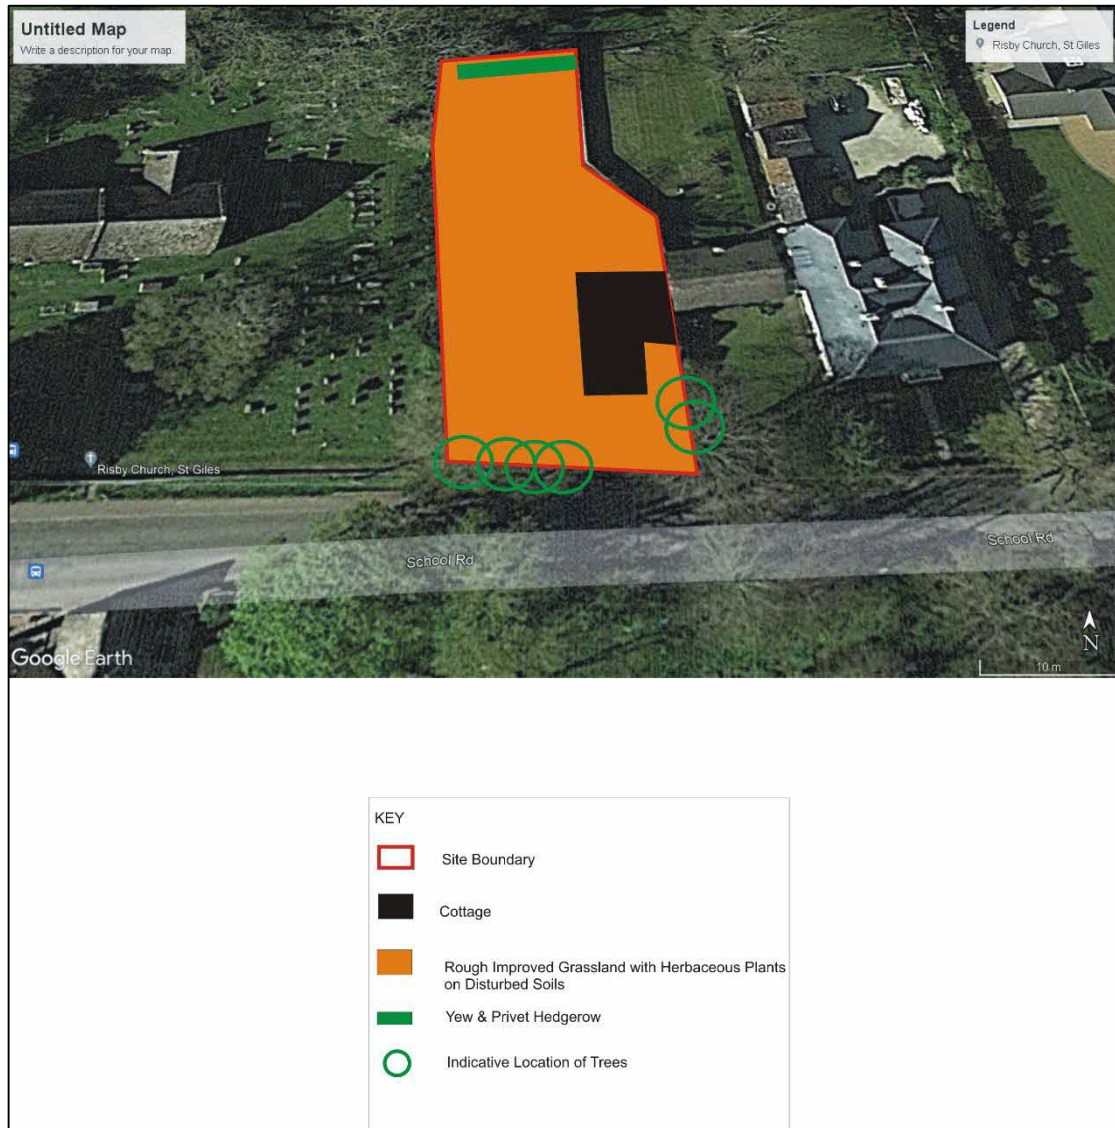
Figure 1: Habitat map.

3.4.1 Habitats included: unmanaged rough improved grassland with common herbaceous plants on disturbed soils. Scattered ornamental plants were also present in the grassland. Boundary yew and privet hedgerow was present on the northern boundary. Six early mature lime *Tilia* sp. trees were present on the southern (roadside) boundary.

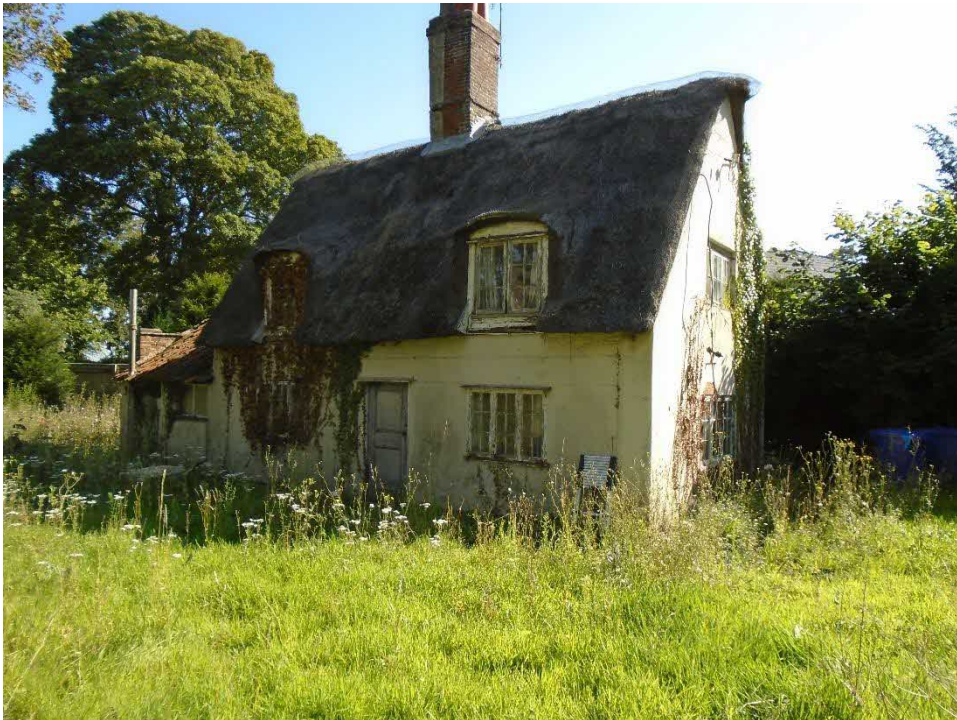
### Photograph 1: Western & southern elevations at Gate House Cottage

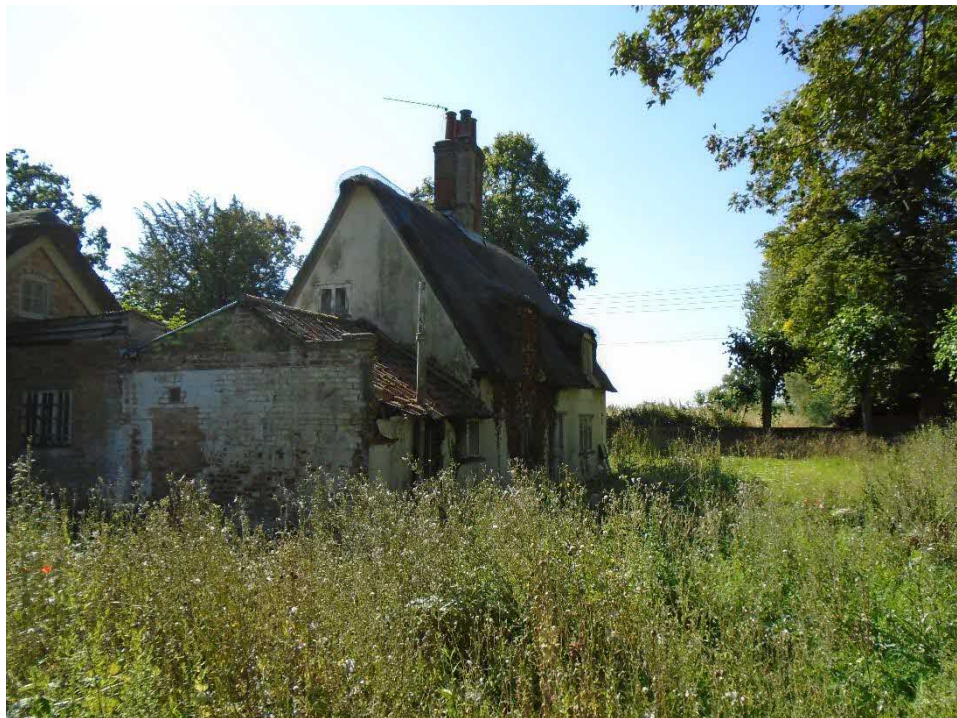
### Photograph 2: Northern & western elevations at Gate House Cottage

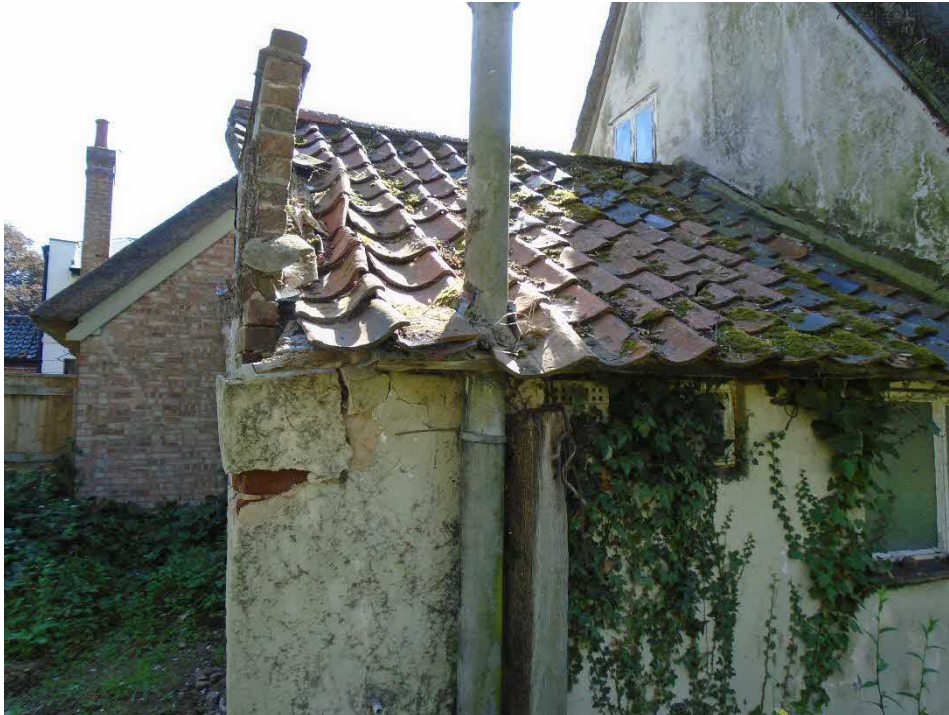
- 3.4.4 The main area of the cottage was well-sealed to bats with thick overhanging thatch covered in wire mesh negligible in suitability for roosting bats and preventing access for bats to roof areas. The single-storey, brick extension was in a dilapidated condition with clear water ingress negligible in potential for roosting bats. The gaps present were all through gaps with cobwebs and dirt, the pitch of the roof was also very shallow meaning that bats would need to sit under tiles rather than perch. All areas around the tiled section of roof were easily accessible with ladder and endoscope and all considered negligible in suitability for external or internal roosting. No signs or evidence of bats were observed associated with the cottage.

**Photograph 3: Northern extension at Gate House Cottage.**

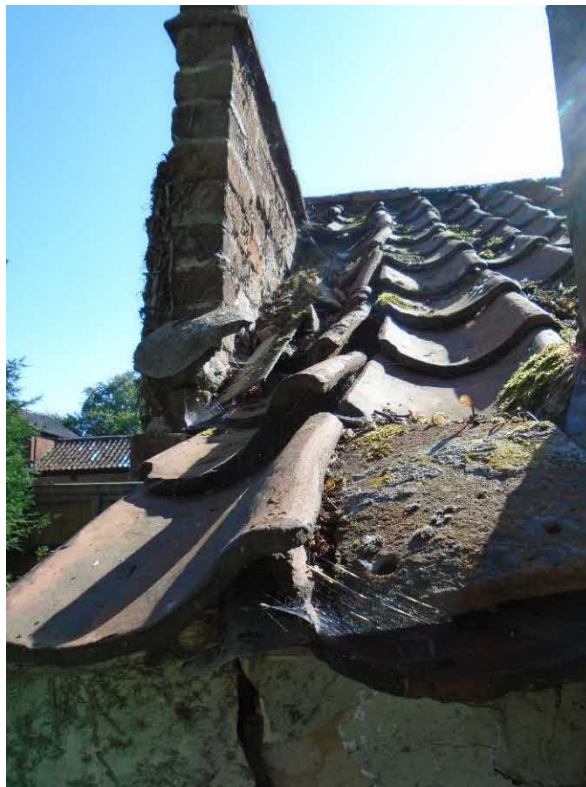
**Photograph 4: Tile movement allowing water damage and poor conditions for roosting bats at Gate House Cottage**

During works roof tiles should be removed by hand, if at any point bats or evidence of bats (droppings) are found works should stop and an ecologist called for advice;

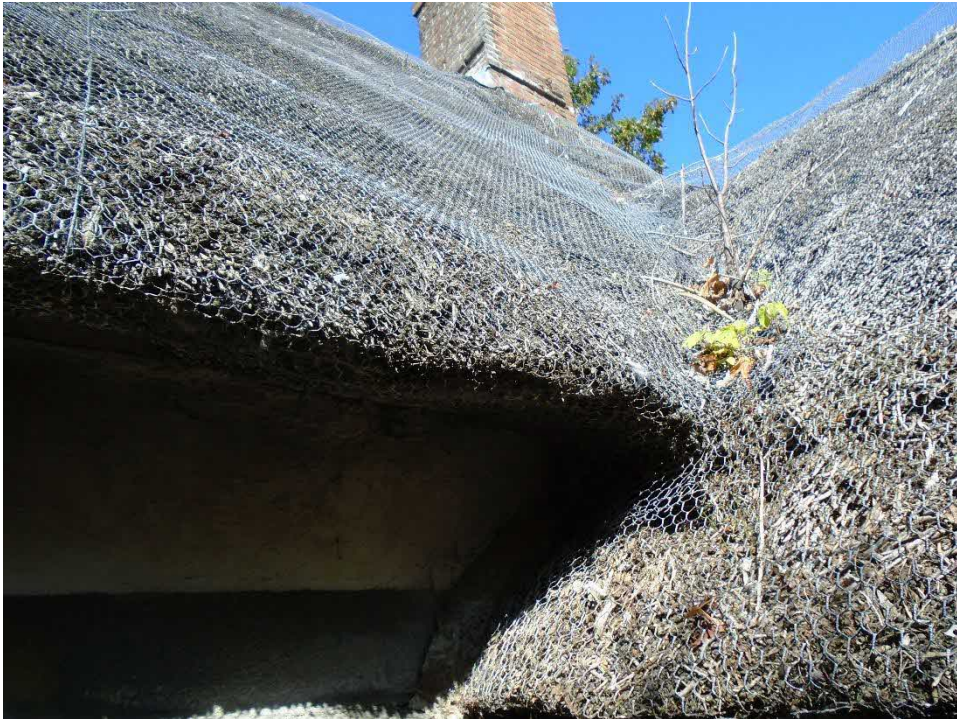
**Photograph 5: Tightly fitting thatch with wire mesh at Gate House Cottage**

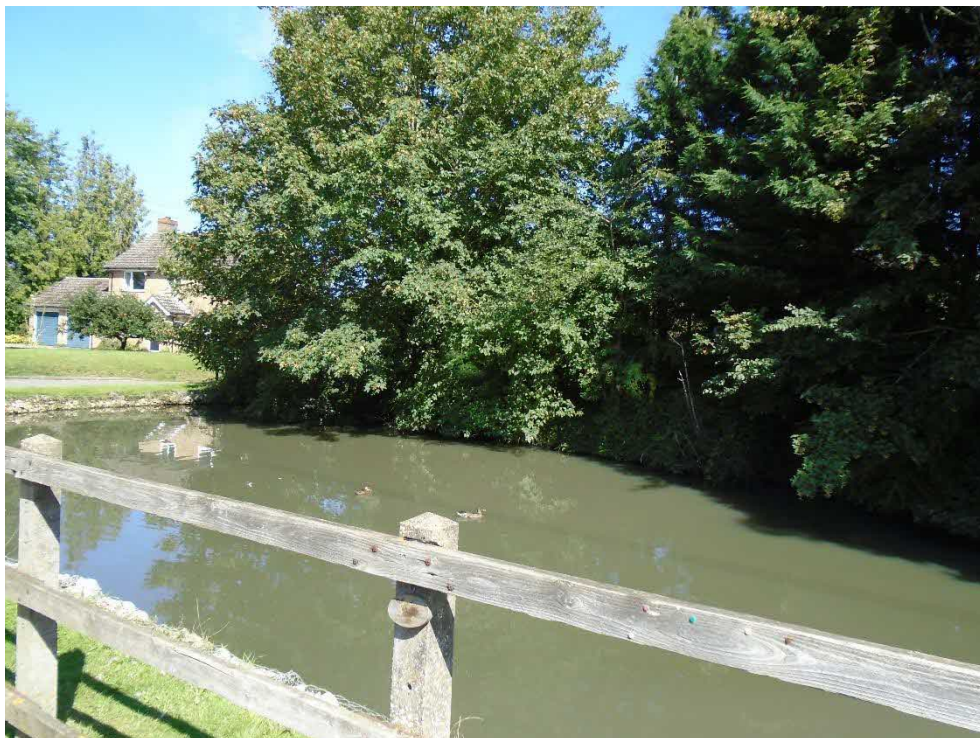
- 3.1.2 Immediately adjacent to the site habitats included: residential housing to the east and south (across School Road), churchyard to the west and neighbouring gardens to the north.
- 3.1.3 One ponds was identified within 250m of the site. The pond (Pond 1) is a village duck pond adjacent to School Road approximately 195m west. Several waterfowl were present, the water was turbid and lacked aquatic vegetation. Fish may also be present.

**Photograph 6: Pond 1 (village duck pond) 195m west of the site at Gate House Cottage**
