# LITTLE PLOUGH, REAR OF THE OLD PLOUGH, HURSTBOURNE TARRANT, HAMPSHIRE

## Heritage Statement

Document No: ACD1814/1/0

Date: April 2018

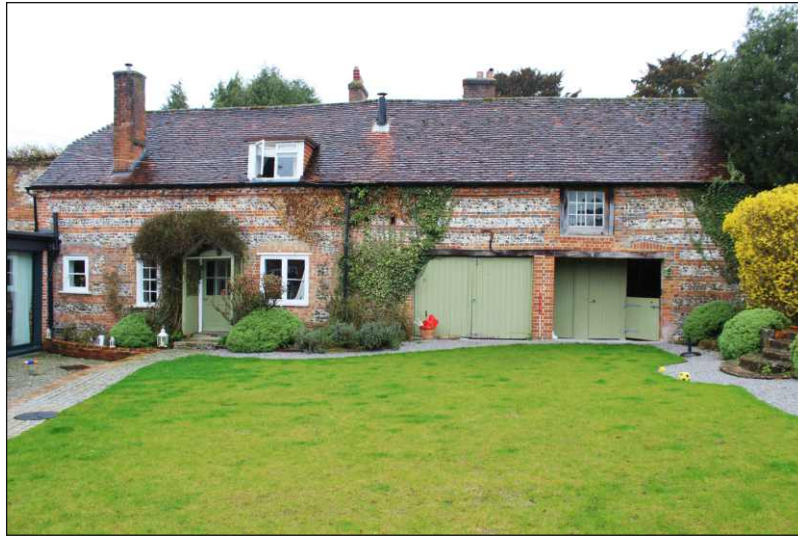
Plate 1: South exterior elevation, looking north. (1m scale)

5.3 In the south elevation there is a vertical break between the dwelling and garages. To the east side of this break the lacing courses of brick have been laid differently to the west side to form an alternating header and stretcher pattern forming repeating bands of flintwork-header-stretcher-flintwork-stretcher-header. At ground-floor level at the west end there is a change in the pattern of the masonry with three courses of brick for the lacing courses rather than two courses present for the rest of the building. It is of a similar design to the early 19th-century masonry at the rear of The Old Plough (including the Chimney Stack date 1835). There is also some modern repair to this area including the voussoirs of the openings, carried out using cement rather than the white lime mortar used elsewhere in the building.

5.4 On the ground floor of the south elevation, at the west end, there are three windows under arched brick heads. The west end window is a small two-pane sash within a former wide doorway probably infilled in the early 19th century. The central narrow window is of eight panes in a fixed frame, also of 19th-century date. The eastern window is a late 20th-century two-light casement almost certainly within an earlier, probably narrower, opening. The door to the dwelling is located between the central and eastern window, and again is under an arched brick head. The door is 19th-century with three lower panels and six upper glazed panes. It is under a wooden trellis porch with a double pitched slate roof. On the first floor of the dwelling there is a late 20th-/early 21st-century dormer fitted with a two-light window.

5.5 At the east end of the elevation are two large ground-floor, rectangular openings under a pair of timber lintels supported on a late 20th-/early 21st-century brick pier. The doors themselves are modern. Overlying the lintel is a reverse s-shape wrought iron wall tie, probably of early 20th-century date. At the east end, above the lintel, is an arched brick head above a former opening, predating the current eastern garage door. On the first floor, offset towards the east, there is a 12-pane fixed frame window within an original taking-in door for the hayloft above the stables. Below the modern cement sill is an area of modern repair.

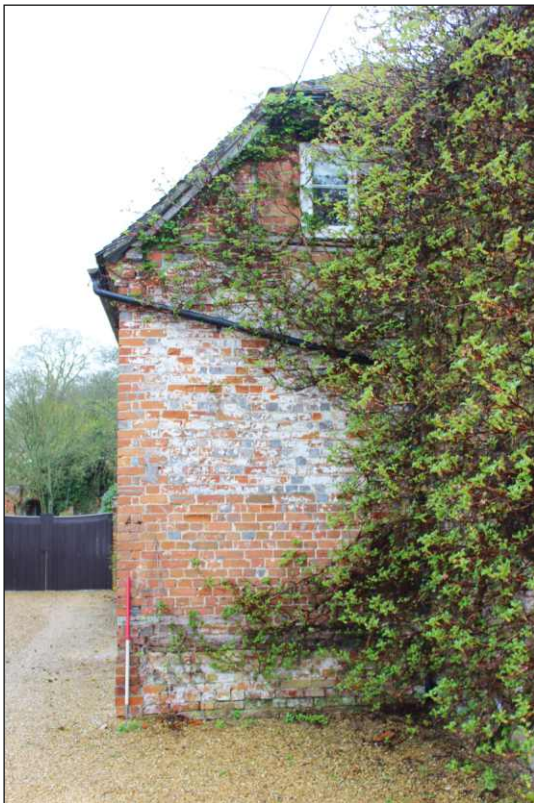
Plate 2: North end of west exterior elevation, looking east. (1m scale)

- 5.6** At ground-floor level the south end of the west elevation is now within the recent extension to The Old Plough. It is constructed of plain brickwork. At first-floor level, within the gable, there is a modern casement window. The north end of the elevation extends beyond line of the main house, extending into the entrance of Bourne House. The elevation here is again brickwork, with no clearly discernible bond, and the remnants of a lime wash finish. Towards the base is a horizontal timber, and at the apex of the elevation, below the half-hipped roof, is a timber frames, with brick noggin. Here there is a second first-floor window, which again is a 20th-century casement, set within modern brickwork.

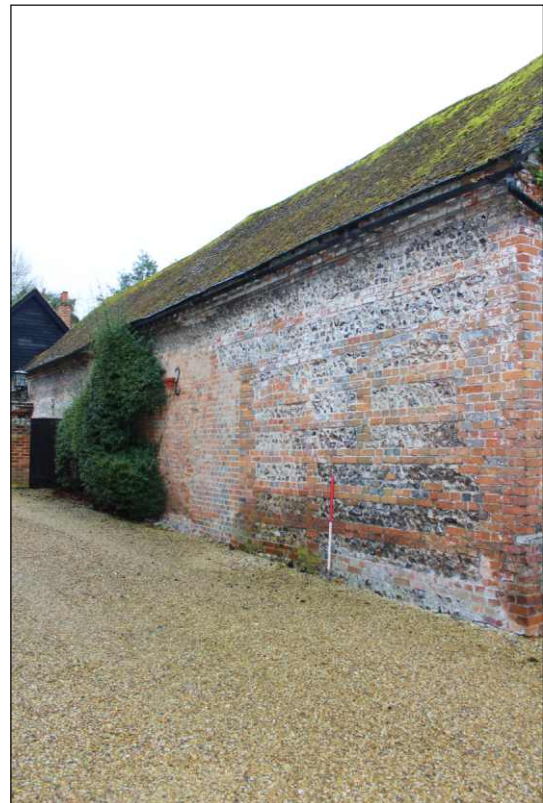
Plate 3: North exterior elevation, showing infilled window, doorway and brick rebuild, looking southeast. (1m scale)

- 5.7** The north elevation overlooks the grounds of Bourne House, and is constructed of coursed split flints (three courses at ground floor level, four to five courses for the first floor) with brick lacing courses (of two courses of bricks). At the west end the brickwork of the lacing courses is laid alternating between headers and stretchers. Central to the elevation there is a large growth of vegetation, behind which a vertical break correlating with the break recorded on the south elevation is visible. To the east side of this break the lacing courses are the same repeating bands of flintwork-header-stretcher present in the south elevation. The materials used on the east and west side of the north elevation are identical and this change in pattern may represent an accidental difference in the laying of the bricks rather than a rebuild as the base of the wall starts off with the indented pattern. However, the building break almost certainly indicates that the east end of the building was constructed first with the west end added as an extension shortly after.

- 5.8** At the west end of the north elevation there is an infilled doorway and window; both appear to be original openings blocked in the early 19th century. Directly to the east of these is an area of brickwork repair which appears to be 20th century in date. This incorporates a wide brick arched head that appears to be purely decorative rather than evidence for a former opening. Towards the east end of the elevation at first-floor level there is an infilled taking-in door that was blocked in the early 19th century. Passing through the elevation there are two reverse s-shape wrought iron wall ties; the eastern tie is early 20th century in date, whilst the western tie is modern.

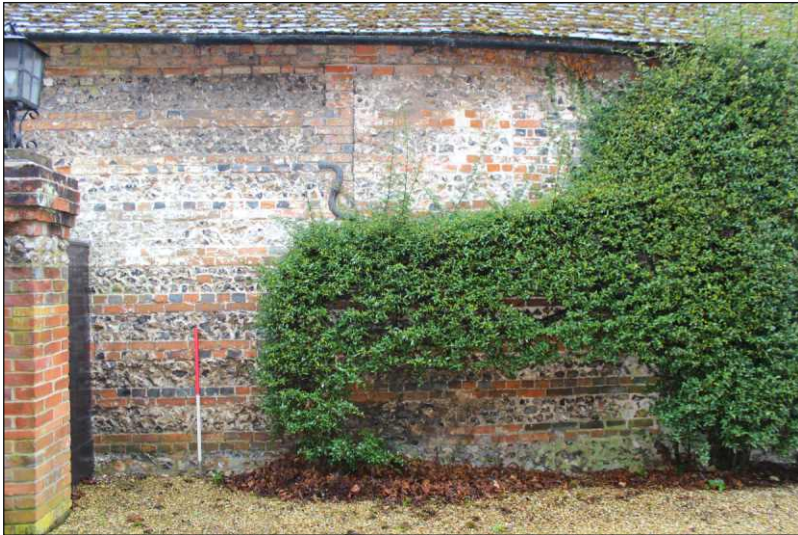
Plate 4: East end of north exterior elevation, showing blocked taking-in door, looking south. (1m scale)

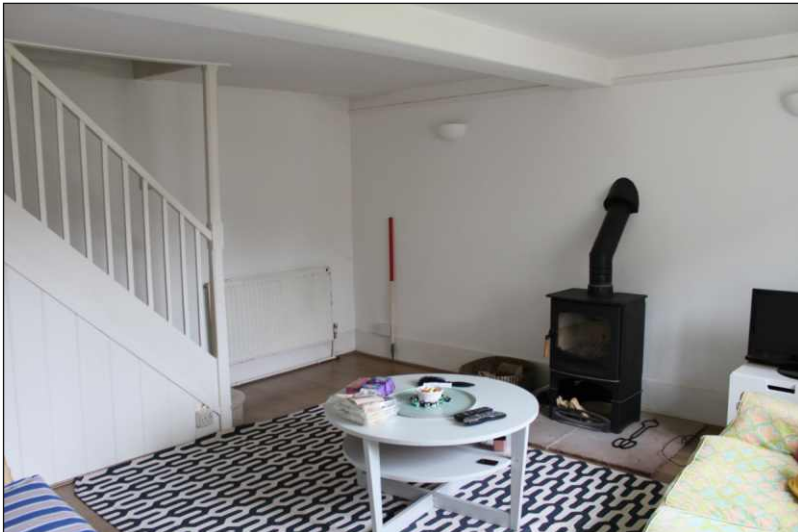
Plate 5: General view of ground-floor east room of dwelling, looking northeast. (1m scale)

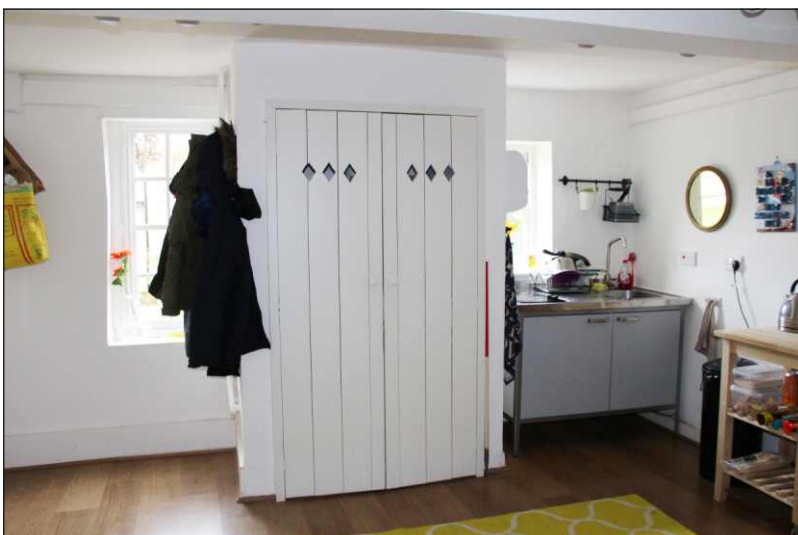
Plate 6: Altered fireplace in ground-floor west room of dwelling, looking south. (1m scale)

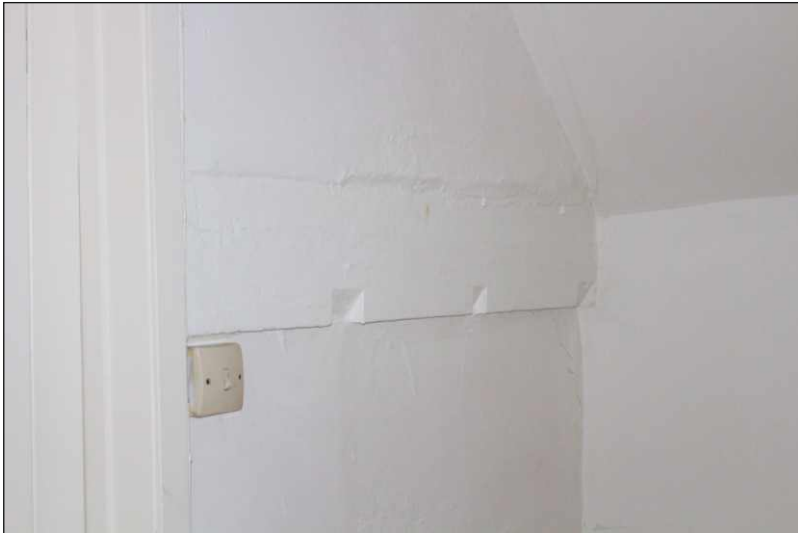
Plate 7: Detail of tie of A-frame truss in landing of first floor dwelling, looking northwest

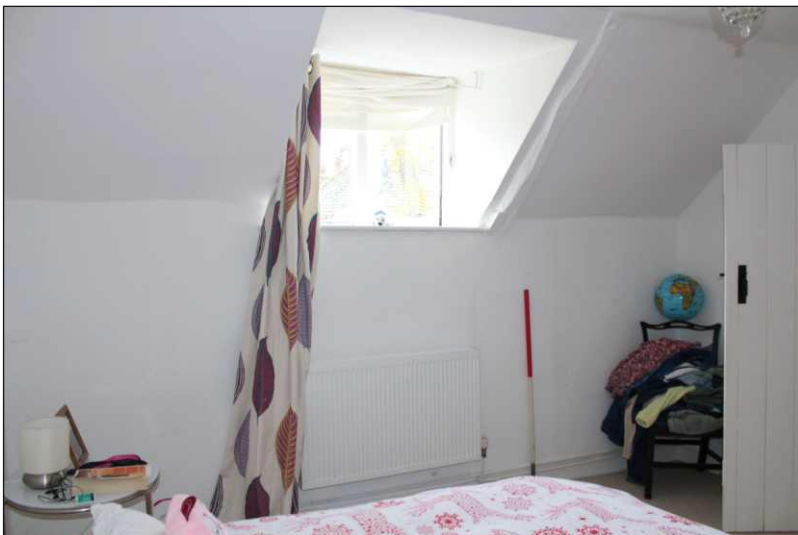
Plate 8: General view of first-floor east room of dwelling showing part of original A-frame truss, looking southeast. (1m scale)

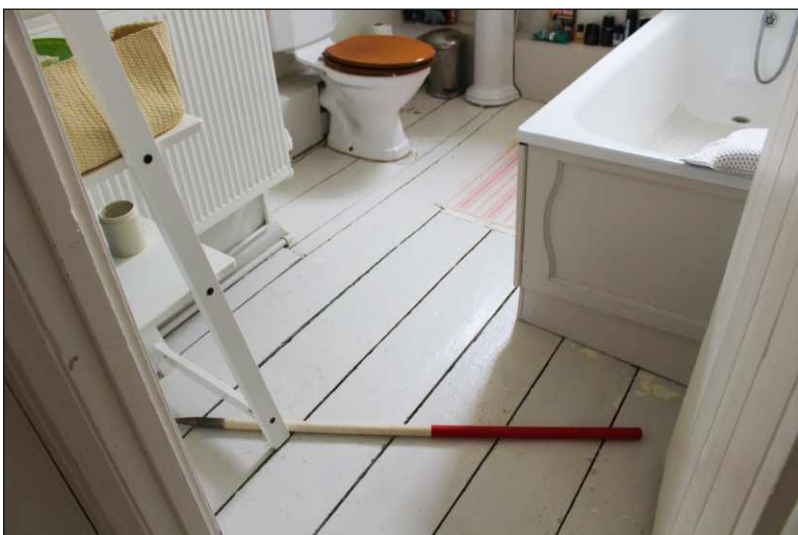
Plate 9: Detail of floorboards in southwest room of first-floor dwelling, looking southwest. (1m scale)

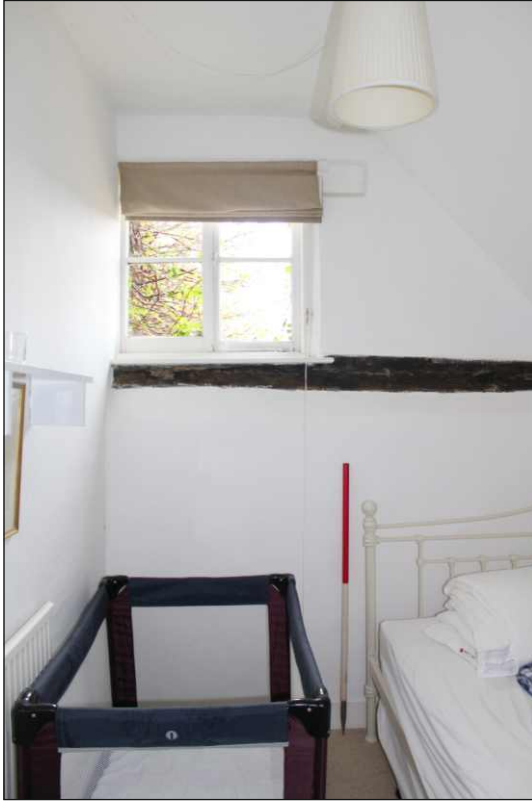
Plate 10: General view of northwest room of first-floor dwelling, looking west. (1m scale)

- 5.11** The staircase opens to a northeast landing with two rooms to the west and a single room to the east. The stack serving the former ground-floor fireplace rises within the landing and has been converted, in the late 20th century, into an airing cupboard. Also visible within the landing is a potential original purlin (on the north side of the roof), as well as, in the western partition, a tie beam forming part of an original truss. The four door surrounds are of 19th-century date hung with plank and batten doors. The door at the top of the stairs is of 20th-century date constructed of tongue and groove planks. The eastern room has probable 19th-century skirting and picture rail, and a 20th-century fitted wardrobe. The southwest room has a modern bathroom finish, and an original purlin on the south side of the roof is visible. Another purlin is exposed in the north roof pitch in the northwest room.

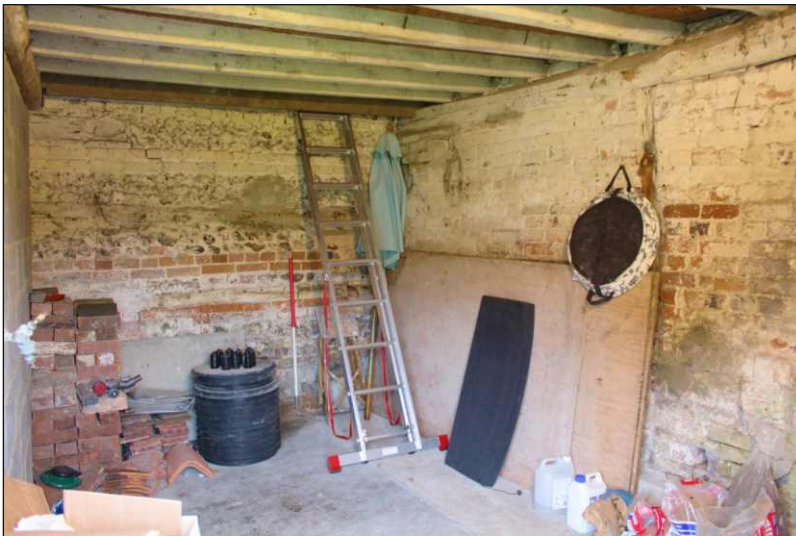
Plate 11: General view of east room of garages, looking northeast. (1m scale)

- 5.13** The eastern end room has two north-south aligned cross beams; the western beam has a chamfered lower edge and appears to be original, whilst the eastern beam is partially incorporated into the east elevation, and is also possibly original. The joists appear to be 19th-century, along with some 20th-century, replacements. The floor above is chipboard and mdf sheets. In the east elevation is a small air vent, fitted with a modern concrete grill. In front of the opening, attached to the cross beam, is a piece of shaped timber with a circular empty socket; the form of the timber is indicative of use with a piece of machinery.

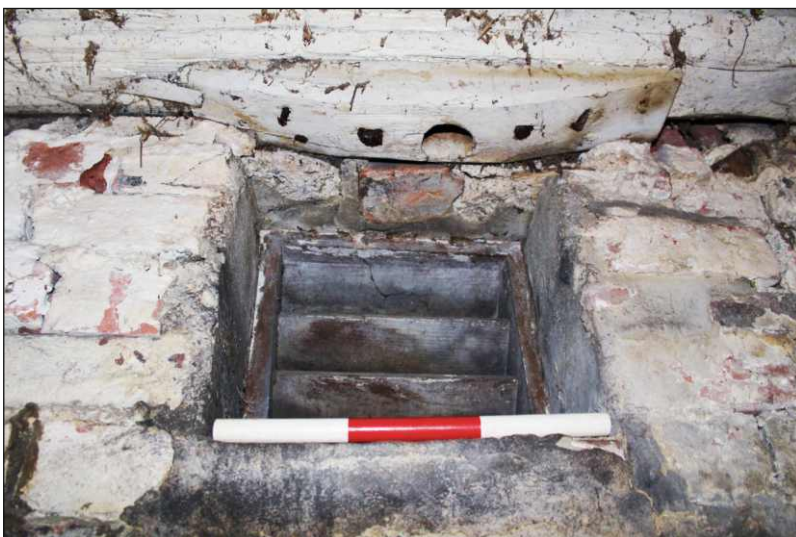
Plate 12: Detail of air vent, with moulded timber, looking east. (0.30m scale)

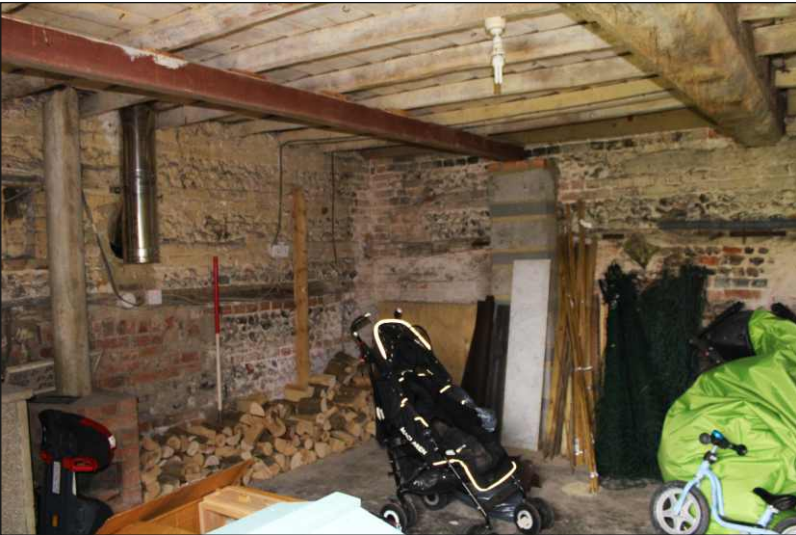
Plate 13: General view of west room of garages, looking northwest. (1m scale)

- 5.15** The ceiling of the western room is supported on an original north-south aligned cross-beam with a chamfered lower face. The joists appear to be 19th- and 20th-century replacements, whilst the floorboards above are of 19th-century date. There is a concrete block pillar towards the western end of the north wall supporting a modern cross beam. There is a blocked air vent with a brick mullion in the west wall. This is further evidence (along with the vertical breaks visible externally), to indicate that the two halves of the building are of different dates.

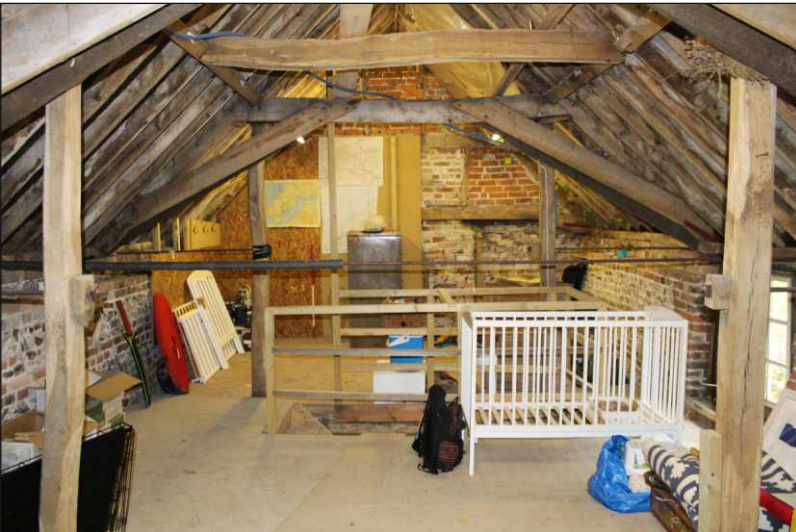
Plate 14: East end of attic, looking east. (1m scale)

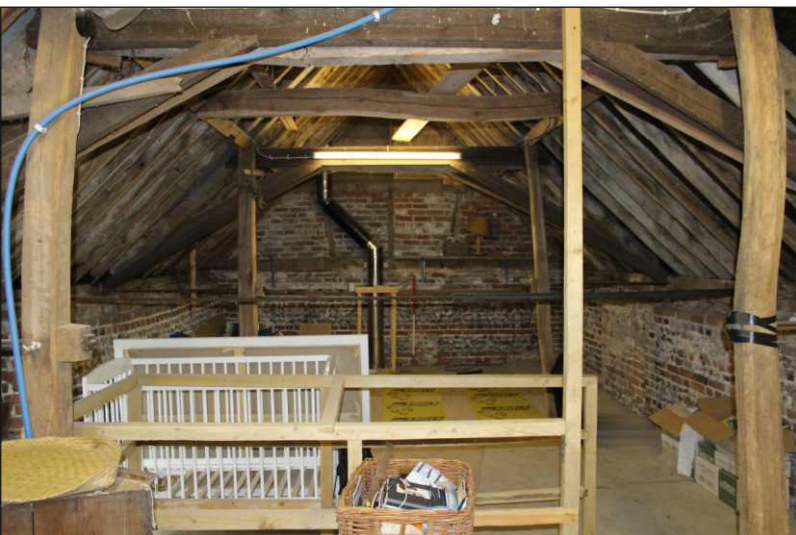
Plate 15: West end of attic, looking west. (1m scale)

- 5.16** The attic is a single space accessed from the modern central staircase. At the apex of the west elevation there is a modern timber hatch leading to attic space above the dwelling and original wide timber planks to the south side. The roof has been replaced and repaired in the 19th and 20th century with parts of the original three mortise and tenon jointed A-frame trusses surviving. The collar and lower half of the A-frames are original with the struts and upper sections being 19th and 20th century in date, raising the height of the roof. Additional internal posts and steel braces have been added to support the roof. The purlin along the south side is original.

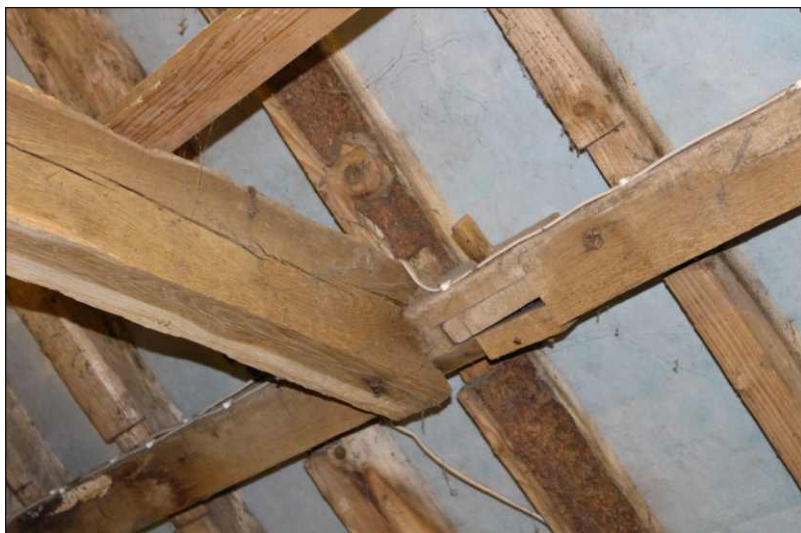
Plate 16: Detail of mortise and tenon joint of south side purlin, looking southeast
