# THE OLD PLOUGH, HURSTBOURNE TARRANT, HAMPSHIRE

## Heritage Statement

Document No: ACD1323/1/1

Date: February 2016

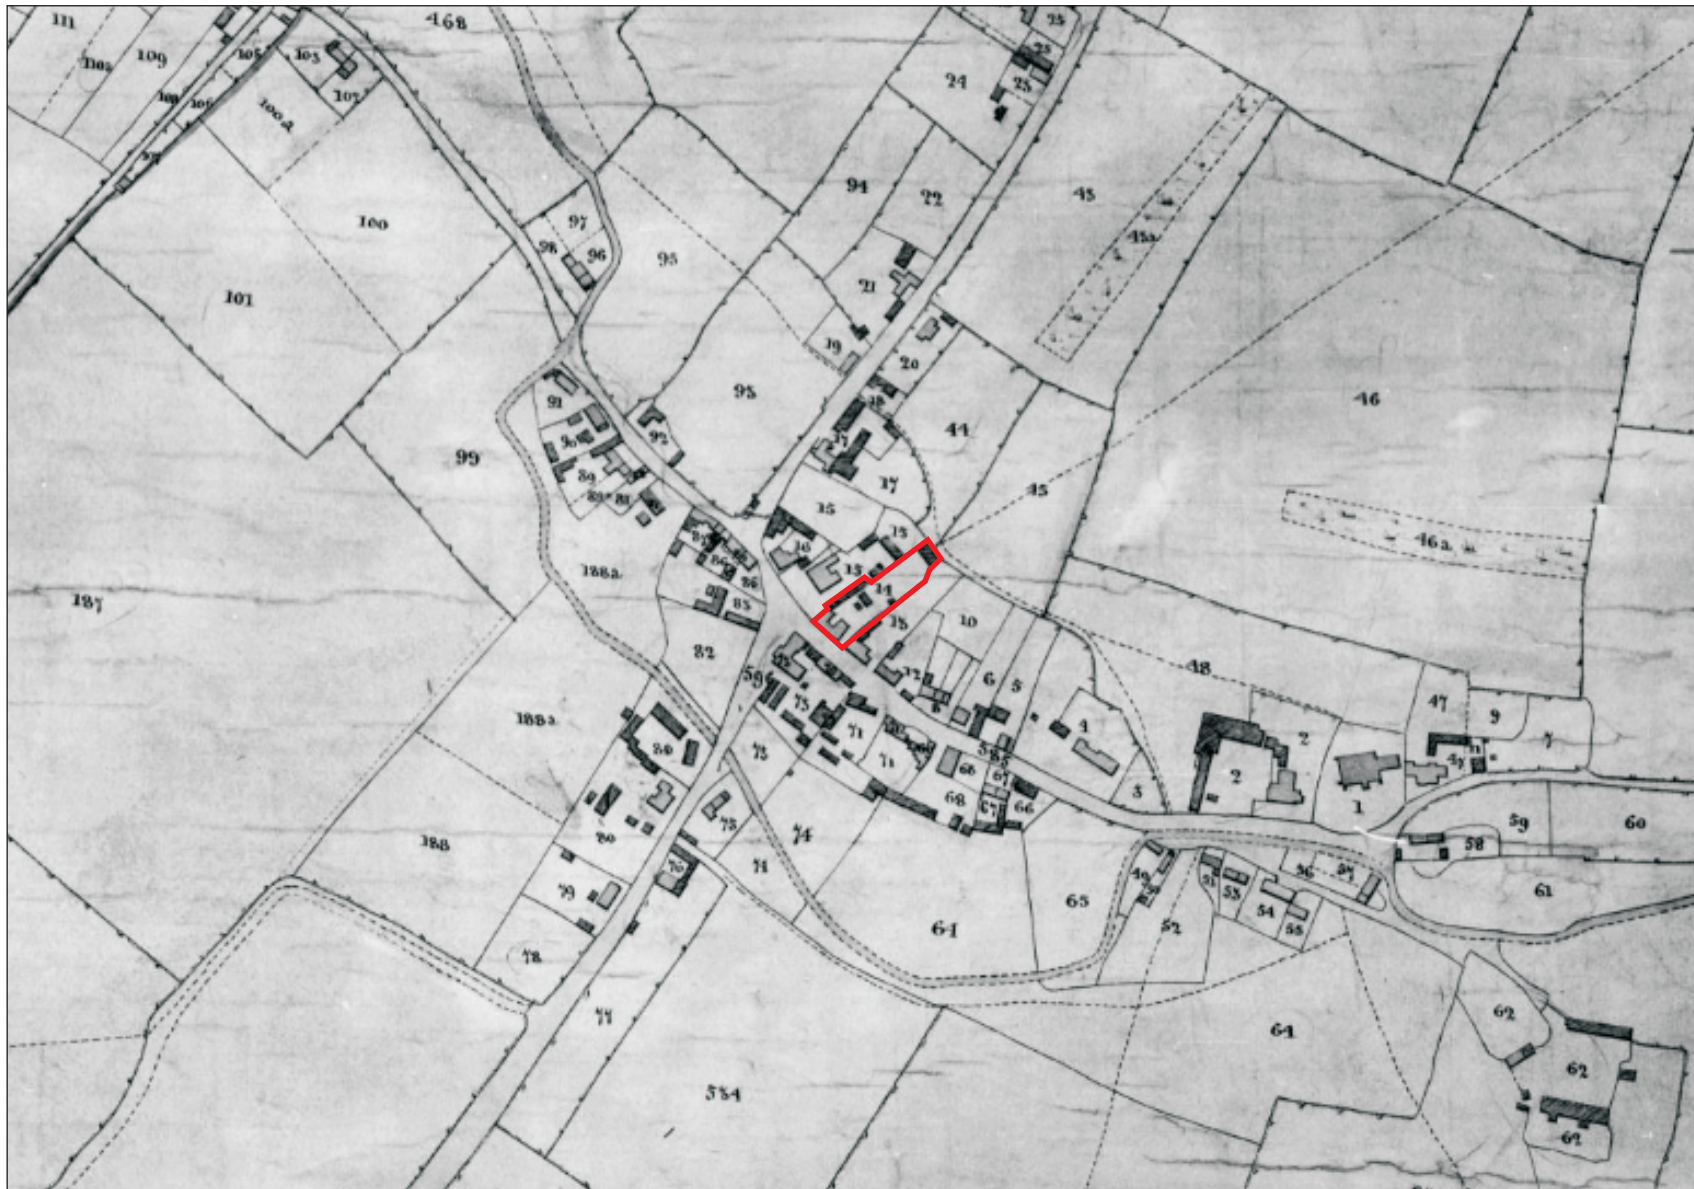
Fig. 2: Extract from the  
Hurstbourne Tarrant with  
Vernham's Dean tithe  
map, 1841

**4.2** The Old Plough is first depicted on the 1842 Hurstbourne Tarrant with Vernham's Dean tithe map as a 'C' shaped building abutting the road on a narrow plot (Fig. 2). Four other smaller buildings are also shown primarily within plot, including a long rectangular range along the northern boundary of the property. The accompanying apportionment of 1841 identifies this plot (no. 14) as The Plough Inn along with its gardens, yard and buildings. It was owned by John Medhurst and occupied by Cornelius Knight, who also occupied one of the fields (plot 45) to the rear of the property.

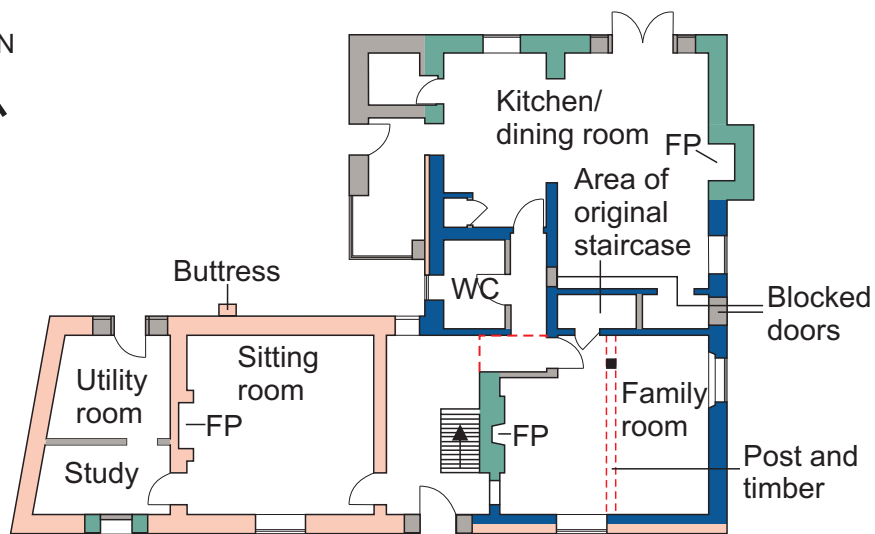
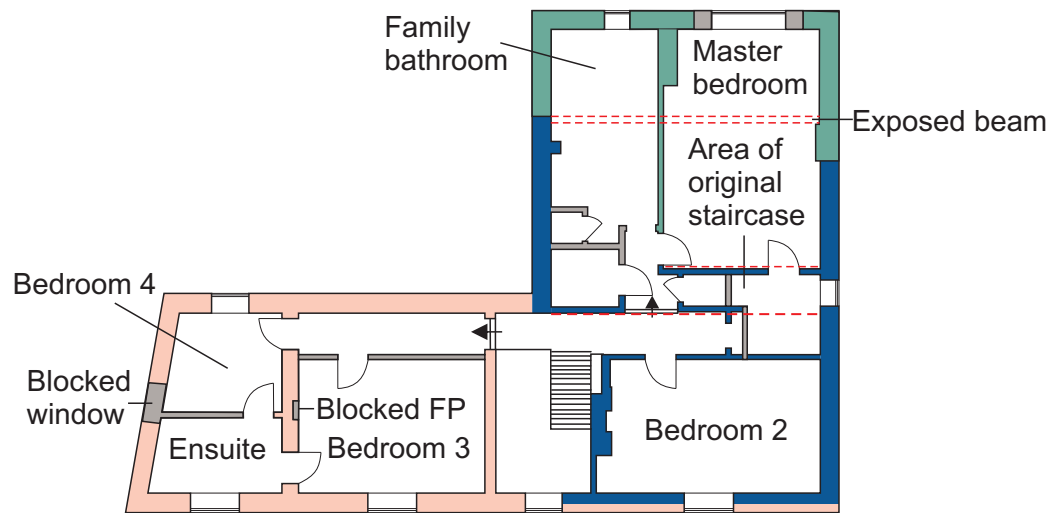
TITLE  
Fig. 5: Phased floor plans

- 6.1** The earliest part of the building was a 16th-century timber-framed house, which forms the southern end of the building. On the evidence of the visible timber framing the building was probably originally rectangular with two ground-floor rooms divided by a central corridor. This corridor and entrance from the south was maintained during the later history of the building.

- 6.3** By 1842 the building had been extended to the north and become The Plough public house and coaching inn. These alterations probably took place during the later 18th century (or perhaps the early 19th century). These alterations also included the provision of a north range, which included a now demolished rear section of the west range and a stables and carriage block (Little Plough), which were constructed using bands of knapped flint and bricks. The functions of the stables and carriage block can be identified from the fenestration of the building, but the layout of the public house cannot be easily deduced. It seems likely that the present, modern front door replaces an earlier entrance to the public house. Whether there was a staircase here to first-floor guest accommodation is unknown, although such an arrangement was put forward during the 2012 application for the creation of the current staircase (*Heritage Statement* prepared by Kevin Stubbs). It seems likely that the main public bars were located within the west range, and perhaps within the now-demolished rear range. The earlier south door seems to have been maintained as a private entrance to the rear of the property and the first-floor accommodation.

- 6.4** There is little evidence for 19th-century alterations to the building. The cartographic evidence may indicate that the rear range was extended, whilst in 1835 a new fireplace (and associated stack) was added to the southeast range. The masonry to the east of this stack is different to and later than elsewhere and, taken with the evidence of the earlier timbers inside this range, probably indicates that the range was extended at this date.

- 6.5** Following the closure of the public house the rear range was demolished, and later replaced with smaller utility rooms. The building was divided into two houses with new staircases added in the present study and family room. In 2008 the building was converted back into a single dwelling, and in 2012 the 20th-century staircases were removed and the present stairs erected.

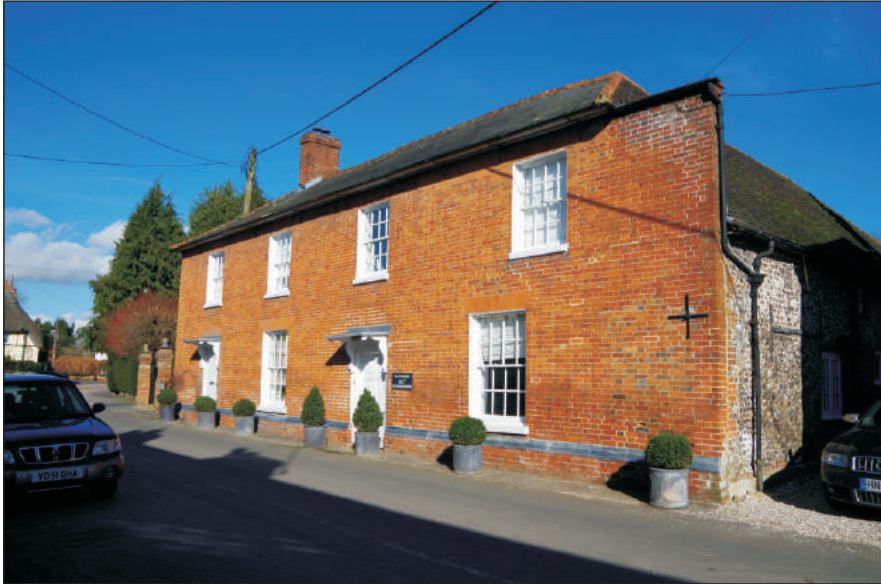
Plate 1: Main, west elevation, looking northeast

The main elevation to the west is constructed in Flemish bond brickwork which continues to the south as a parapet wall above the pitch of the roof (Plate 1). This elevation appears to have been refronted in the mid to late 18th century. The front is of four bays with two doors and two windows on the ground floor and four windows on the first floor. The windows are all 16-pane sashes with those on the ground floor being larger than those on the first floor. The door to the south is of six panels whilst the door to the north of four panels. Both doors have small canopies supported on carved wooden brackets. All the openings, with the exception of the doorway to the south, have rubbed flat brick arches above them. On the south side of the elevation is a cross plate.

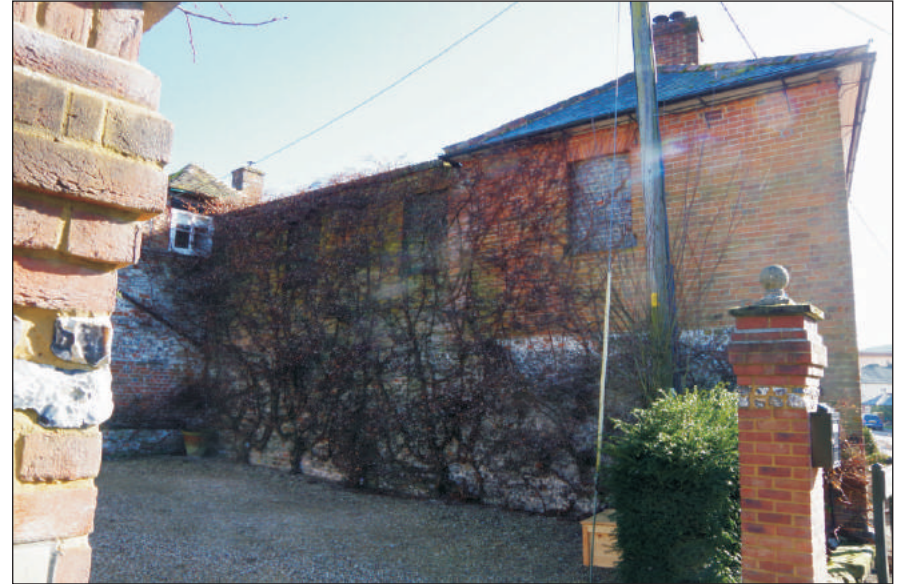
Plate 2: North elevation of the west range, looking southeast

On the north elevation of the west range the ground floor is constructed of knapped flints, which continues beyond the current rear elevation of the house. The first floor is constructed in Flemish bond brickwork and is a continuation of the brickwork of the west elevation (Plate 2). This incorporates a window on the first floor, this has a rubbed flat brick arch above it and has been blocked with blue industrial bricks.

The wall linking the north end of the building with Little Plough has its north elevation covered with vegetation but appears to be built in knapped flints within

brickwork above as per the main building (Plate 2). Within the first floor brickwork there are two windows blocked with blue industrial bricks. The south elevation is an irregular mix of knapped flint and brickwork (Plate 22).

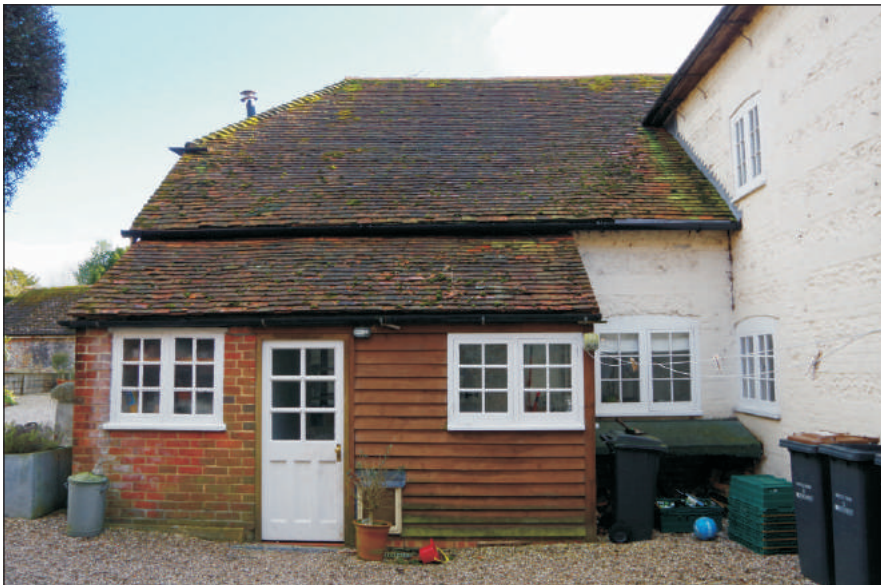
Plate 3: North elevation of the southeast range, looking south

The north elevation of the southeast range is constructed of bands of knapped flints and brickwork, and incorporates a two-light casement window on the ground floor (Plate 3). Attached to this elevation is a modern lean-to extension. This has been constructed in brick laid in stretcher bond and timber framing clad in planks. It has a sloping clay tile roof. There are three, two-light casements and a door.

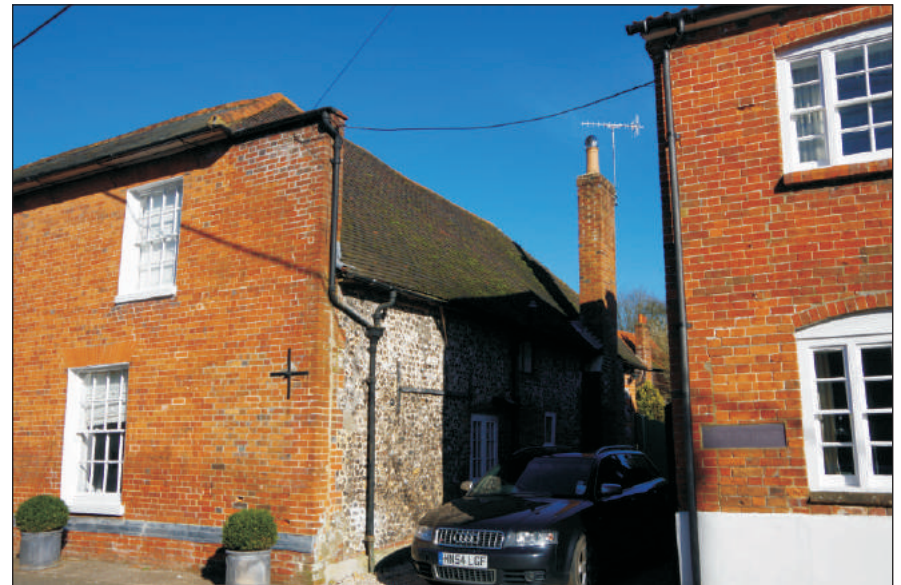
Plate 4: South elevation, looking northeast

The south elevation is divided by an inserted, projecting brick chimney stack towards the east side (Plate 4); this has the date 1835 marked on it. To the east of this stack the wall is constructed of bands of knapped flints and brickwork, whilst to the west it is constructed of knapped flints with patches of brickwork in the centre of the elevation around the openings. On the ground floor there is a two-light casement and a single-light casement; between them is a blocked doorway. On the first floor is a two-light fixed window. Towards the east side of the elevation there is a cross plate, whilst on the west side there is a horizontal tie plate.

- 6.2** No evidence for the original infilling of the external timber frame was observed, but the south elevation was refaced in knapped flint at an early date.

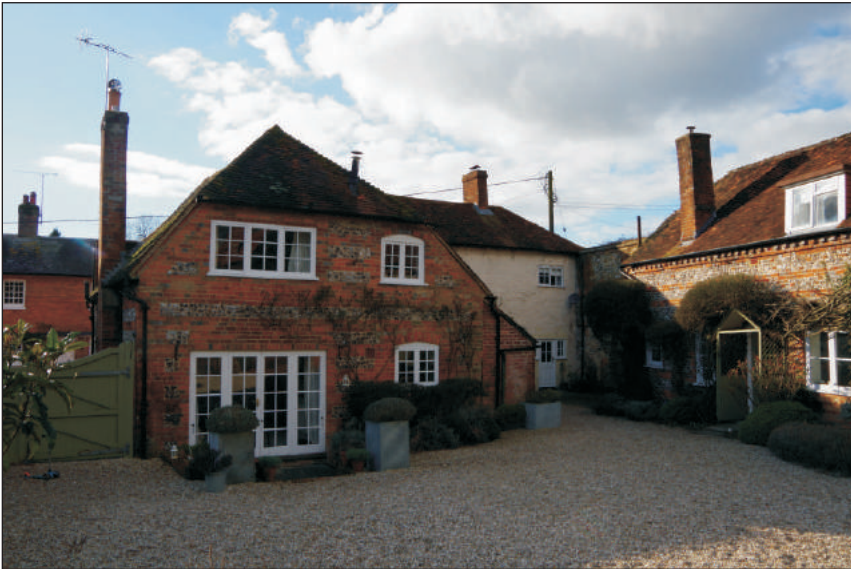
Plate 5: East elevation of the south rangeeast, looking northwest

The east elevation of the southeast range is constructed of thin bands of knapped flints set within brickwork (Plate 5). Modern French doors have been inserted on the ground floor and there is a two-light window to the north of this under a brick arch. On the first floor there is another two-light window and a three-light fixed window.

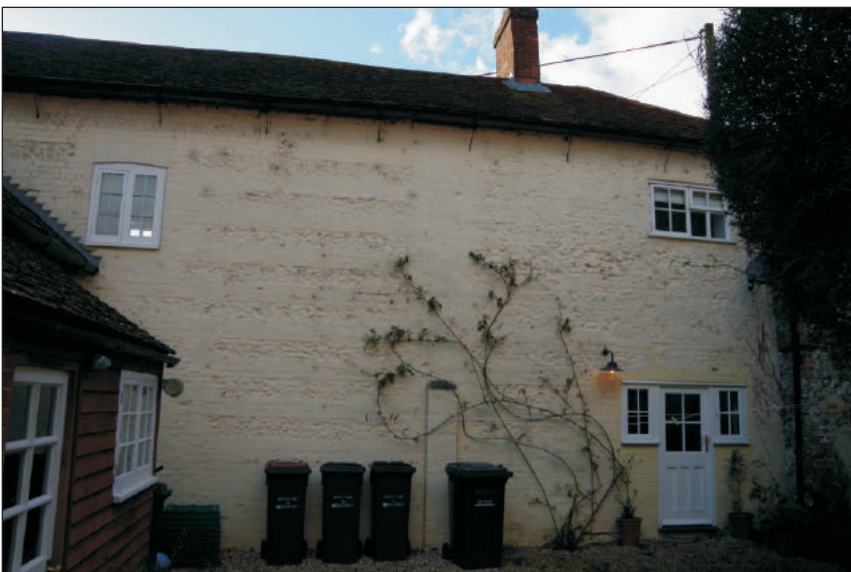
Plate 6: East elevation of the west range, looking west

The east elevation of the west range is constructed of bands of knapped flints and brickwork in the centre but the rest is an irregular mix of knapped flint and brickwork (Plate 6). Roughly in the centre of the elevation there is a brick buttress on the ground floor which has a line of brickwork above it to the eaves. This probably

reflects the line of the now demolished northeast range. On the south side of the ground floor there is a two-light casement, whilst to the north is a modern doorway with fixed windows either side. On the first floor there are two, two-light casement windows. All the openings, with the exception of the first floor window to the north are under brick arches.

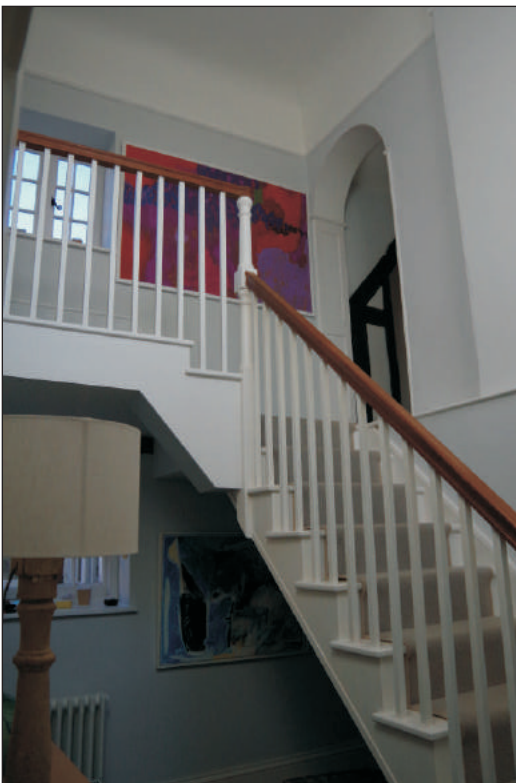
Plate 7: General view of entrance hall and staircase, looking southeast

The current main entrance to the house is via the southern doorway in the west elevation. This leads into a small entrance hall which contains the staircase to the first floor (Plate 7). In the south wall there is an internal window and above the window in the east wall is an exposed beam with empty sockets for vertical and horizontal beams. There is a central moulded plaster rose on the ceiling above the light fitting and a simple four-panel door to the sitting room. The stairs are a straight flight onto a landing along the east side of the range. The stairs have square balustrades and simple handrails (Plate 7).

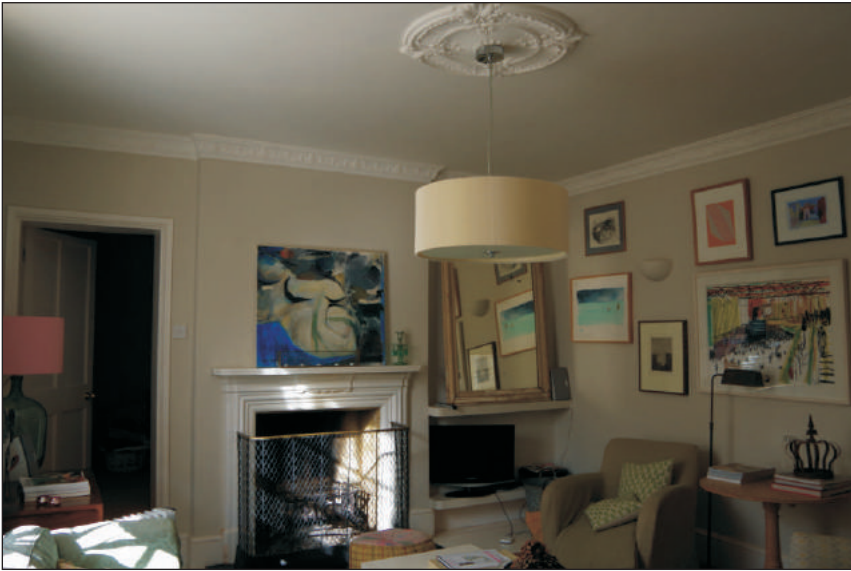
Plate 8: General view of sitting room, looking northeast

The sitting room has decorative plaster coving and a ceiling rose. There is a fireplace on the north wall with a simple wooden surround and metal grate (Plate 8). There is a four-panel door to the study.

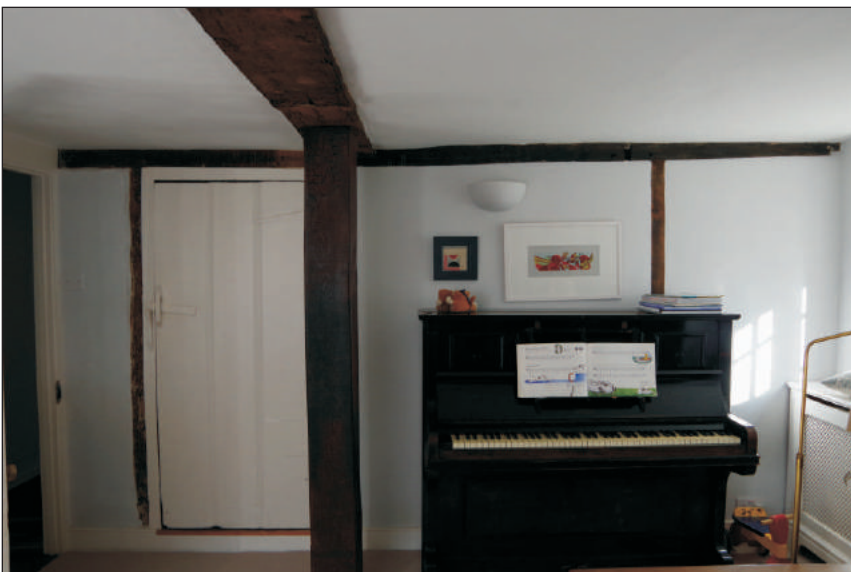
Plate 9: View of timbers in family room, looking east

In the family room there are timber beams and posts with peg joints visible in the east wall and another across the ceiling in the centre of the room (Plate 9). A post has been added to support this timber. There is a fireplace in the north wall with a decorative wooden surround, painted iron grate and tiled hearth. The door to the family room has 16 small glass panels at the top and two wooden panels at the base (Plate 10). In the east wall there is a wooden plank door giving access to a cupboard that would have been under the stairs before they were moved to their current location. The cupboard has a brick floor.

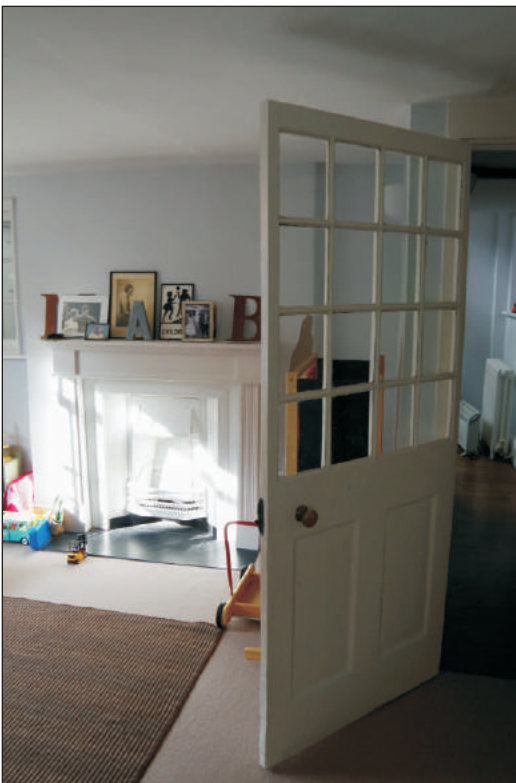
Plate 10: General view of fireplace and door in the family room, looking north-northwest

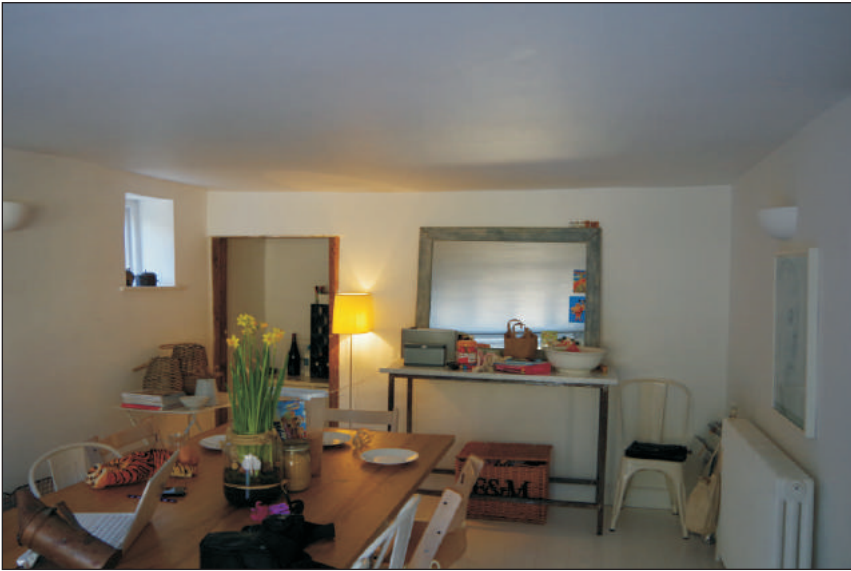
Plate 11: West wall of kitchen, looking west

In the corridor to the kitchen there are exposed beams with empty sockets; at the angle to the corridor the timber has a cambered head indicating the position of an original doorway, which has subsequently been widened. The door to the WC has four panels, with that to the kitchen having six glass panels. The kitchen and dining room have an open plan and there is a central Aga set within a former wall line. Above this is a reused beam in the ceiling that displays empty sockets. There are doors in the north wall giving access to a modern north extension. There is also a door in the west wall giving access to a cupboard. The opening is timber framed, and could represent the line of an early partition. This is where an earlier entrance hall and stairs would have been located (Plate 11). There is a fireplace in the south wall, which contains decorative blue and white tiles and a modern log burner (Plate 12).

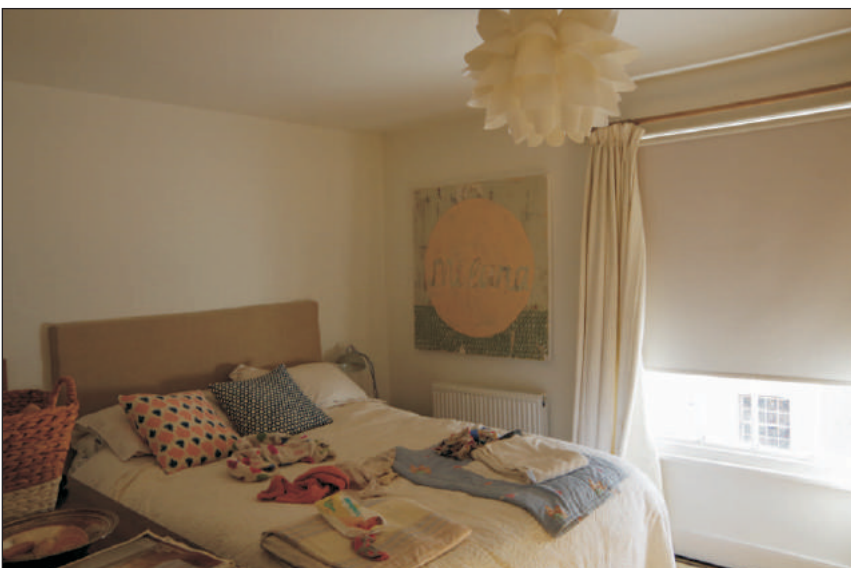
Plate 13: General view of bedroom 3, looking southwest

provides access to most of the rooms; in the landing there are arched openings into this corridor with timber panels on the sides. The floor is on slightly different levels with steps up to the range to the north and to the rooms to the east. All the floors are wooden. There is a four-panel door to bedroom 3 within which is a further four panel door to the en-suite (Plate 13). There is probably a blocked fireplace in the north wall. There is a deep doorway to bedroom 4 faced with timber panels on the sides and with a four-panel door. There is another four-panel door of a later design giving access to the en-suite. The en-suite is shared by bedrooms 3 and 4.

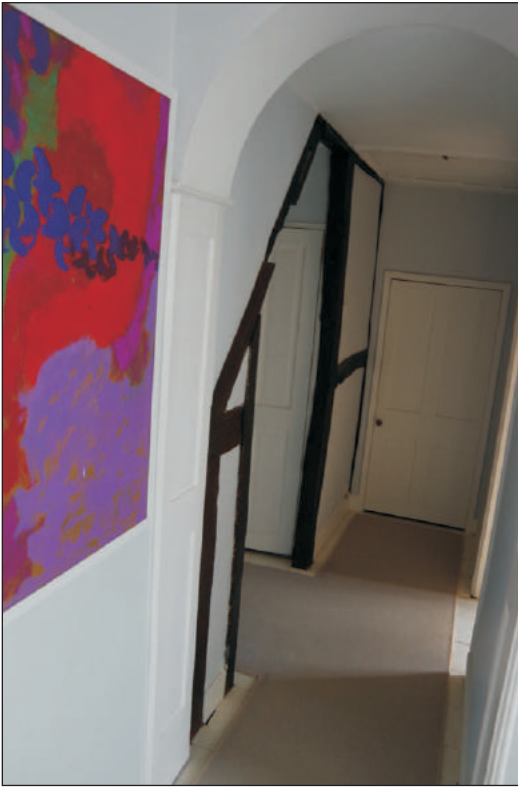
Plate 14: General view of timber framing in corridor on the first floor, looking southeast

In the corridor in the southeast range of the building timber framing is visible; this contains empty sockets and one carpenter's mark was noted (Plates 14 and 15). The diagonal beam to the north and the one at the ceiling may be part of a roof truss and collar. Empty sockets in the base of the collar may suggest that the partition wall continued in the area that is now a doorway. There is an empty socket in the truss that may have been for a now removed wind brace. There are three cupboards at this end of the corridor; two have four-panel doors whilst the third has a wooden plank door with metal strap hinges.

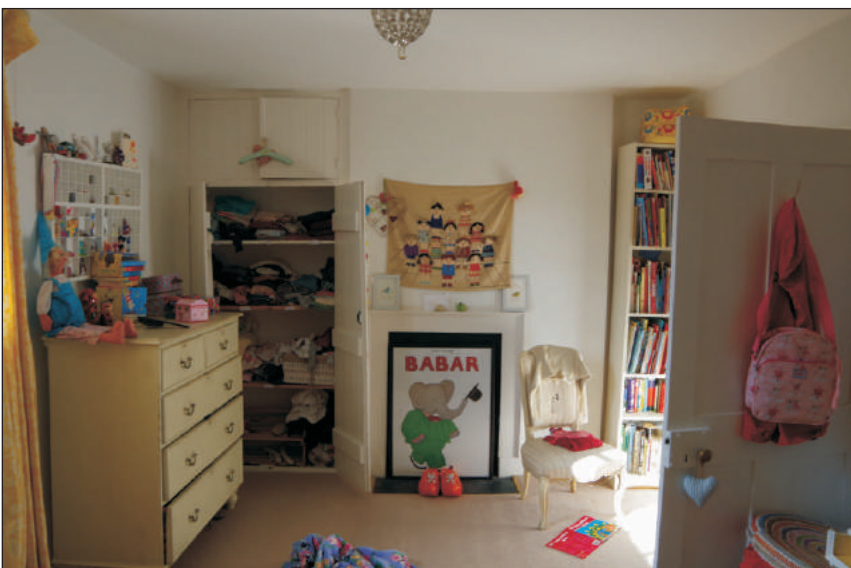
Plate 16: General view of bedroom 2, looking north

There is a four-panel door to bedroom 2. This room has a fireplace on the north wall with a simple wooden surround and a cast iron grate (Plate 16). To the left of the fireplace is a built-in cupboard with wooden doors.

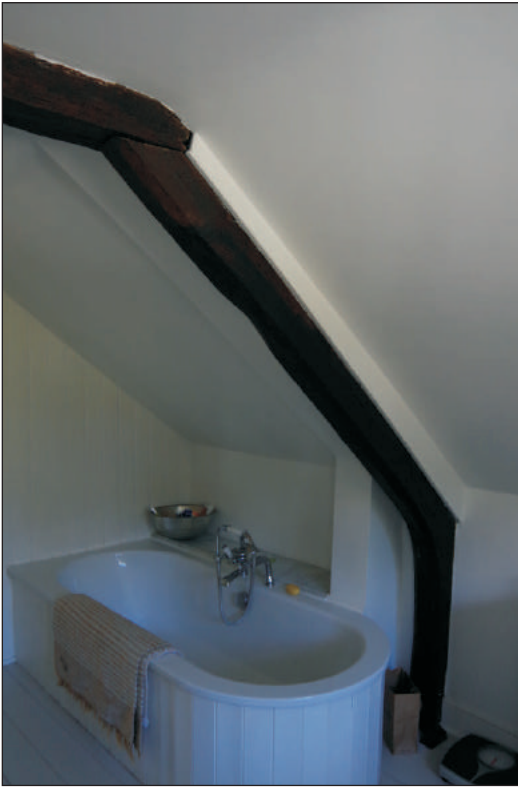
Plate 17: View of jointed cruck in the family bathroom, looking northwest

The doors to the family bathroom and the master bedroom are of wooden planks with projecting wooden brackets. Within the family bathroom part of a chamfered jointed (probable base) cruck truss is exposed, along with a beam at ceiling level (Plate 17). This truss is also exposed in the master bedroom to the south (Plate 18), and the horizontal beam displays empty sockets for a now removed partition (Plate 19) formed from studs and diagonally-set laths. These may represent evidence for a window indicating that the building has been extended to the east. The cruck has empty joints that would have been for a lapped collar and a through purlin. Two metal straps have been added to the timbers to strengthen them. Adjacent to the truss is a slightly projecting chimney stack from the fireplace below.

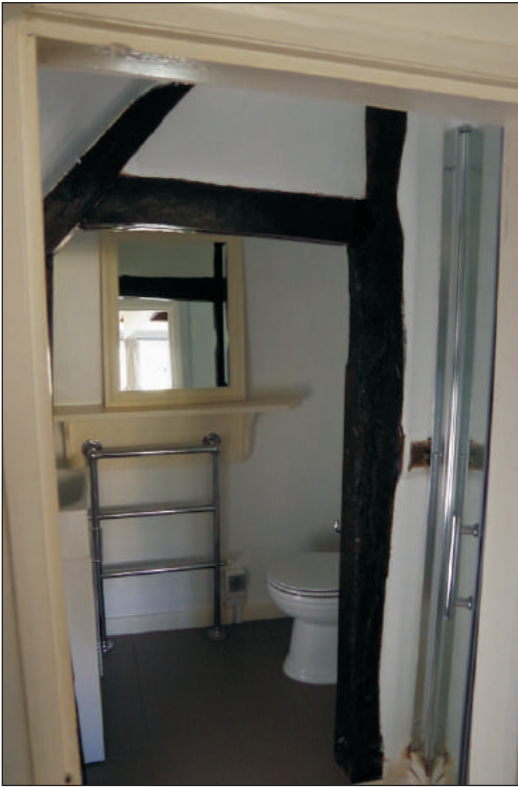
Plate 20: General view of timber framing in en-suite bathroom, looking west-northwest

In the adjacent en-suite bathroom further is more timber framing visible (Plate 20). The timbers form a partition below a roof truss. One of the panels has been removed to open up the room allowing access to the inner part of the bathroom.

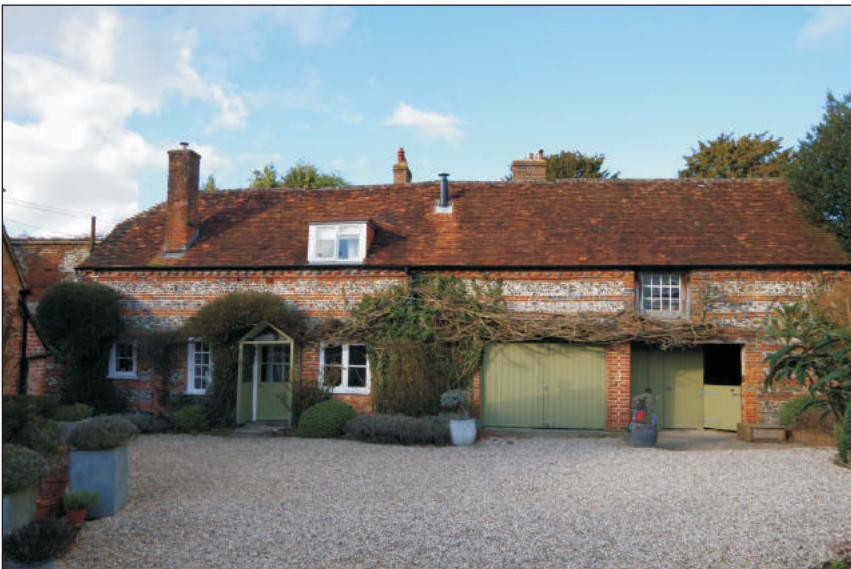
Plate 21: South elevation of Little Plough, looking north

Little Plough, the former stable block is constructed of bands of knapped flints and brickwork, incorporating a row of dentils just below the eaves (Plate 21). It has a clay tiled roof which is gabled to the east and has a half hip at the west end. A brick chimney stack situated towards the west end and a central modern flue project above the roof. On the ground floor are three windows under bricked arched heads. One is a two-pane sash, one is of eight panes in a fixed frame and the last is a two-light casement; the former two are probably in original openings, whereas the latter may be a 20th-century insertion, perhaps within a former doorway. There is a single door and two double doors. The single door is of wood and glass under a small wooden porch; the other doors are modern wooden replacements within original, but altered openings. On the first floor there is a 12-pane fixed frame window, and an inserted two-light dormer window.

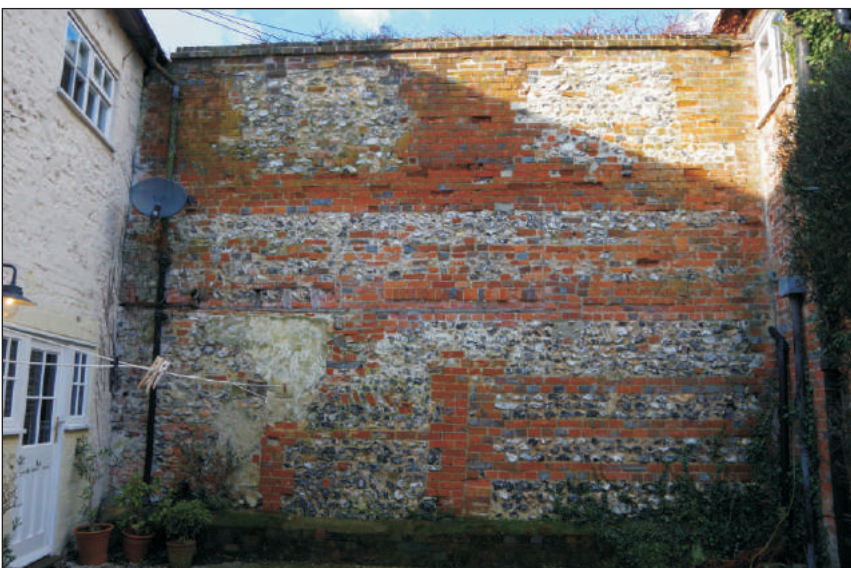
Plate 22: South elevation of wall linking the north end of the building with Little Plough, looking north

At first-floor level there is a line of brickwork which incorporates a series of sawn-off joists, along with other blocked openings and projecting bricks. Below this where is a wide, brick and flint blocked, opening with evidence for an arched brick head and possible two timber lintels at different heights. Part of this opening is covered by an area of lime plaster, which matches the sawn-off joists above. At first floor level the window openings have been crudely infilled with flints and rubble brickwork.
