## Bat Report

65 High Field Gardens, Barnet

1.1 The Ecology Partnership was commissioned by Iguana Architects to undertake a Preliminary Roost Assessment (PRA) at 65 Highfield Gardens, Barnet, Greater London, NW11 9HA, hereafter referred to as the 'site' (Figure 1). The PRA determined that the building has low suitability for roosting bats and the building was subject to a single dusk emergence survey in August 2023.

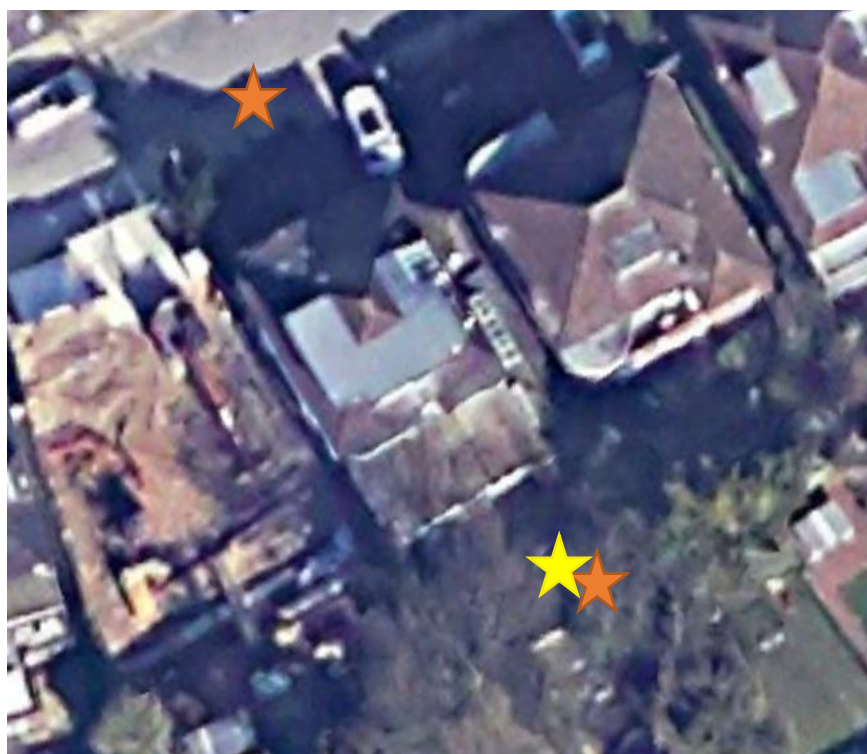
*Figure 2: Surveyor positions (orange stars) and IR camera positions (yellow stars)*

- 2.5 A dusk emergence survey was carried out on 24<sup>th</sup> August 2023. The survey started 15 minutes before sunset and was completed 1 and a half hours after sunset. The survey followed Bat Conservation Trust guidelines (Collins 2016 & Interim Guidance Note 2022). Surveyors were positioned to cover all aspects of the building and areas of interest (Figure 3). An Infra-Red (IR) camera (Canon XA20) was utilised during the survey to support surveyors. All surveyors were equipped with an Echo Meter Touch 2 Pro. Surveyors included Dominic Marten BSc (Hons) QCIEEM and Carl Marshall BSc (Hons).

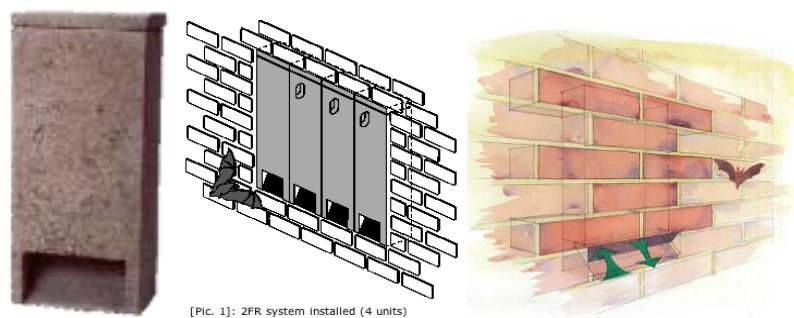
*Figure 3: Bat tubes incorporated into the wall of a building to provide roosting space.*

4.3 To enhance the local bat population and provide additional roosting opportunities within the site, bat boxes can be hung on trees within the site or installed onto the brickwork of the building (Figure 3). These provide good opportunities for crevice-dwelling species such as pipistrelles. The bat box/tube opening will be the only section visible and they are designed to require little to no maintenance. Several of these tubes can be established in a row together providing a good-sized roost space. The bat tubes should be inserted in the brickwork at least 4m from ground level in a location not illuminated by artificial lighting. Habitat, in association with the Bat Conservation Trust, provides a range of boxes which are unfaced for rendering or designed to match the brickwork of the building.

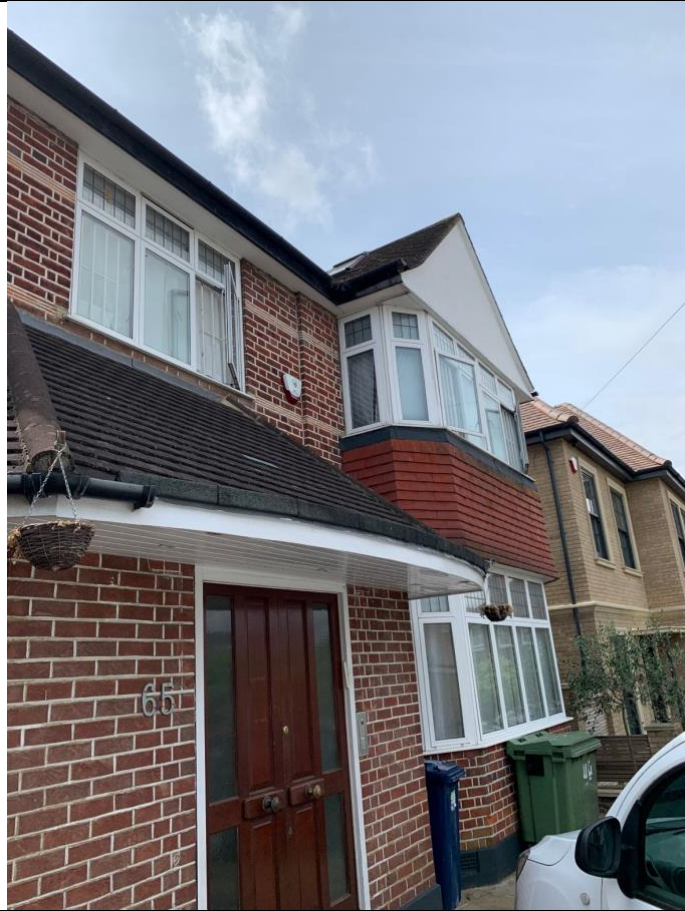
**Photograph 1: Front of the house.**

- 3.4 The house is three-storeys with a converted roof with dormer windows present on the eastern, southern, and western aspects of the house. The house is constructed of brick with plastic soffit boards and a clay tile roof. The house includes hanging tiles on the dormer windows as well as on the front aspect of the house.

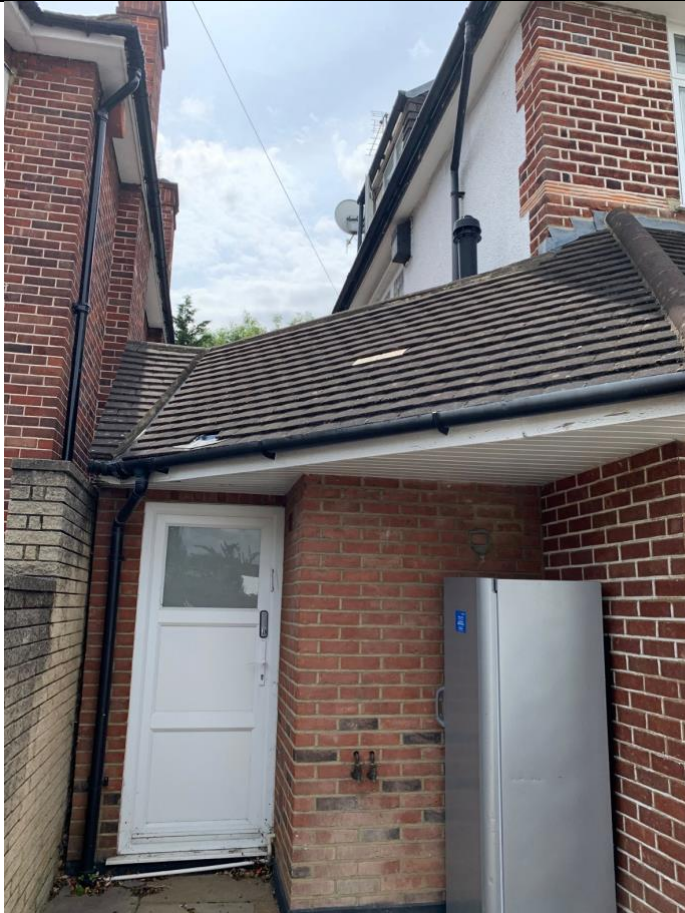
**Photograph 2: Missing tiles on the front of the house.**

- 3.6 No evidence of bat presence was recorded internally and the house supported limited PFRs in the form of naturally lifted hanging tiles and a few missing roof tiles. As such, the house was determined to have 'low' suitability for roosting bats.

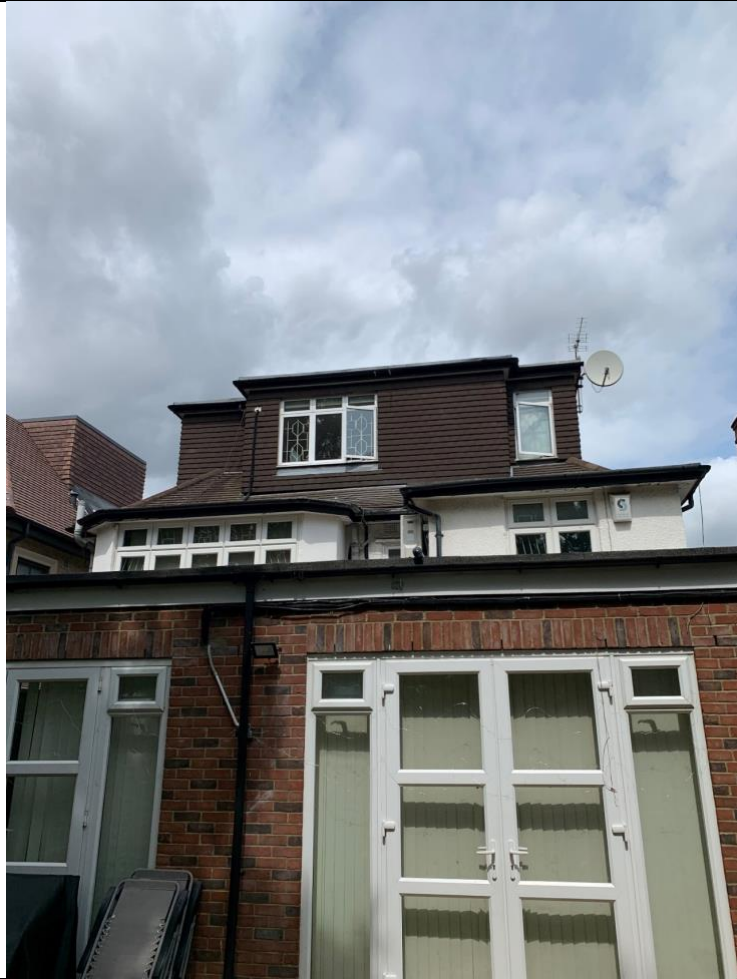
**Photograph 3: Back of the house.**

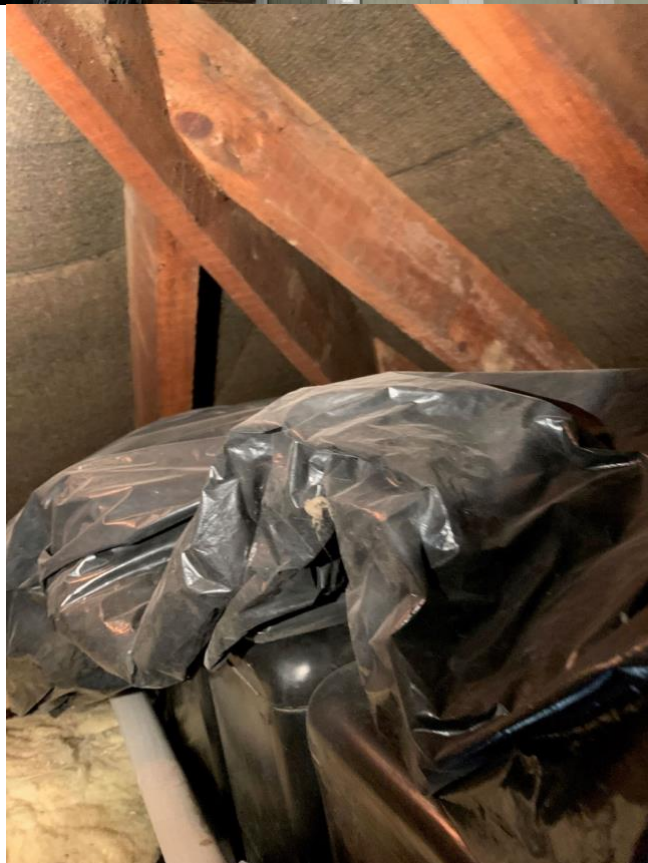
**Photograph 4: Main loft void.**

- 3.5 Internally the house supported one main loft void and two lower loft voids. The main loft was accessed via the loft hatch and the lower loft voids were accessed via panels in the rooms. The loft voids are constructed of wooden beams with a felt lining. The main loft void has insulation on the floor whereas the two lower loft voids are carpeted. No evidence of bats was recorded in any of the loft voids.

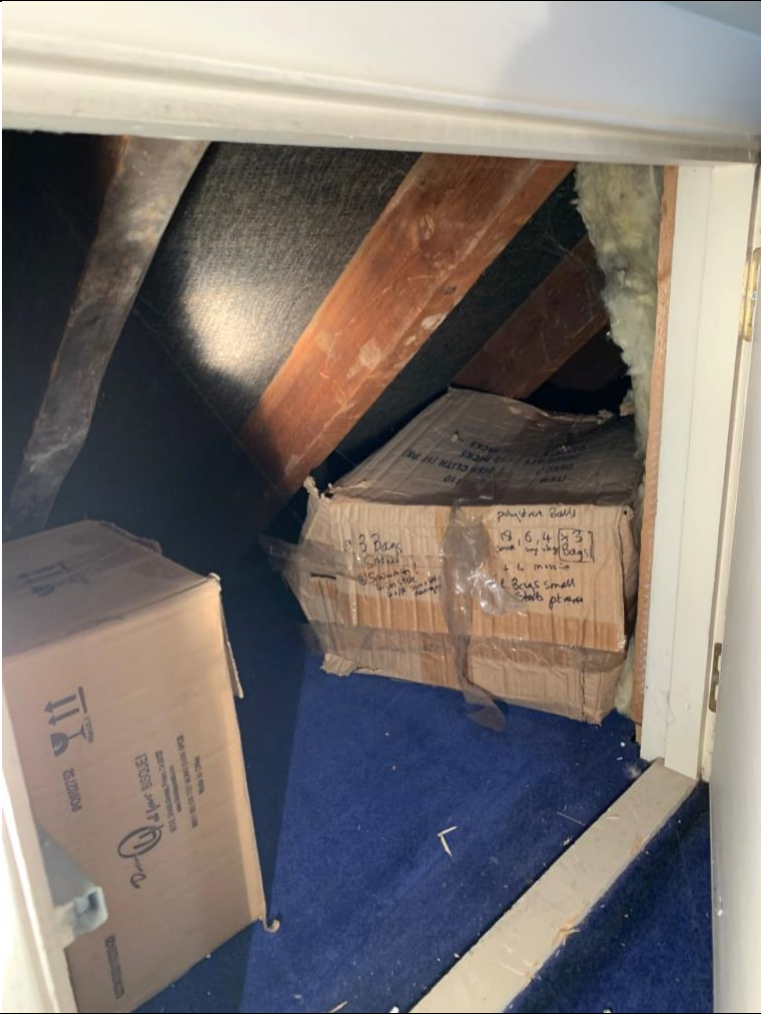
**Photograph 5: Lower loft void.**
