cornwall
environmental
consultants LTD

Bat and Barn Owl Assessment
82 Trevethan Road
Falmouth
Cornwall
TR11 2AU

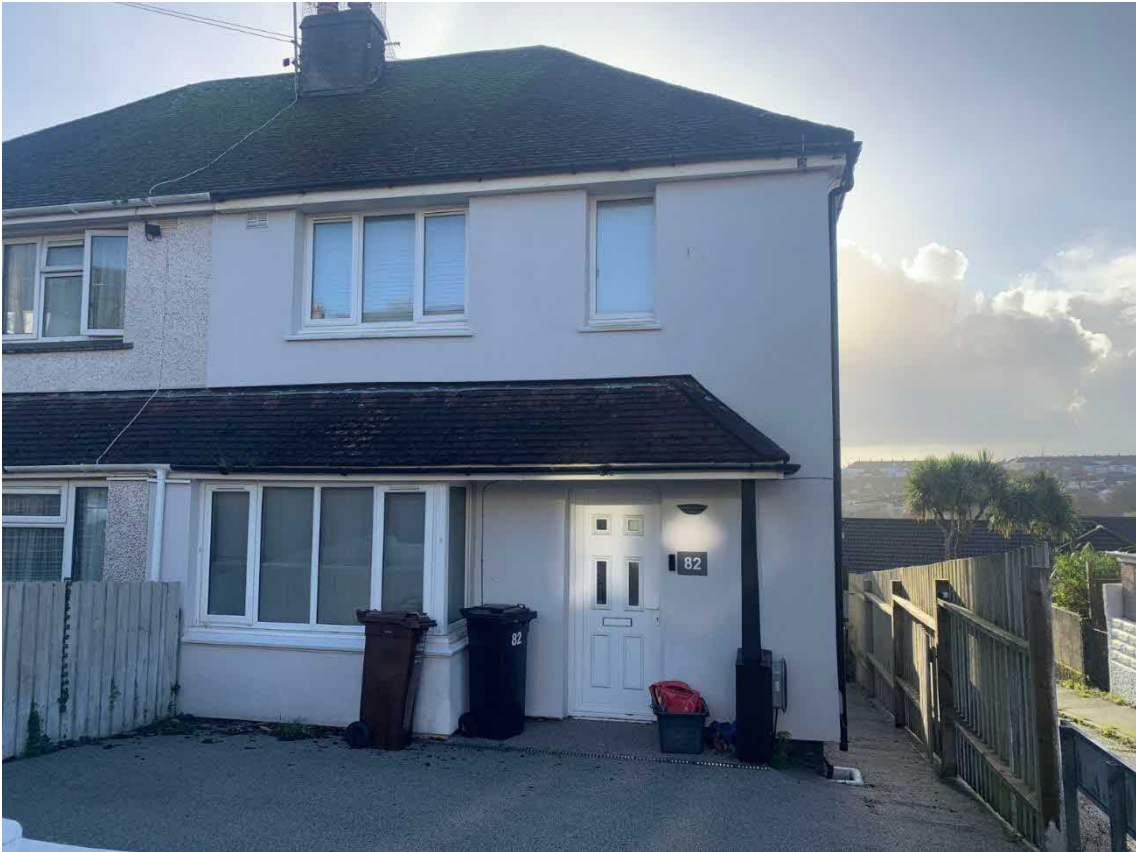
Figure 1: North-western elevation of property assessed

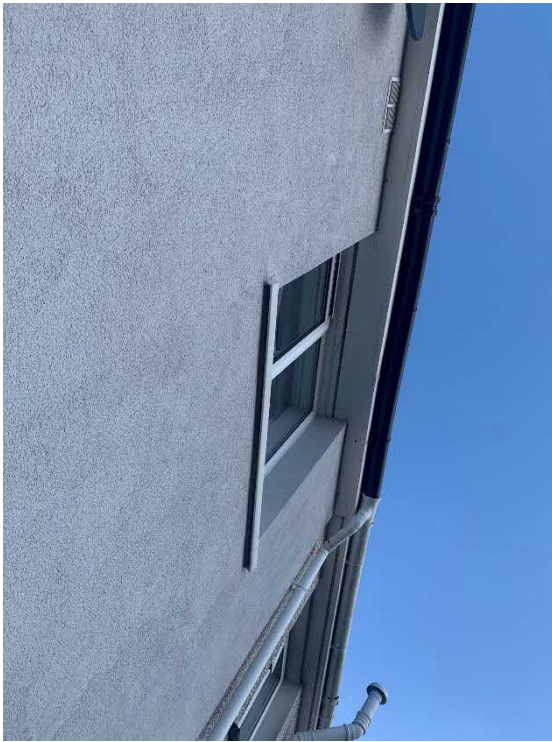
Externally the property appears well sealed in both soffits and the roof tiles, there is a gap in the reveal above the bedroom window which on closer inspection using a ladder was confirmed that bats would not be able to gain entry (figure 2).

Figure 2: South-eastern elevation

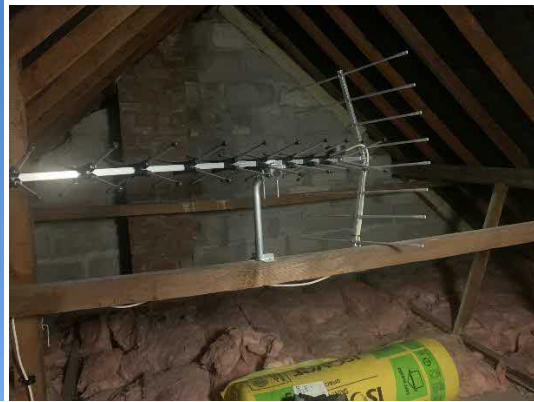
The loft void is approximately 2.4m in height to the loft apex and has mineral wool insulation on the floor. A search of the loft included the rafters, partition wall and insulation was undertaken.

No evidence of bats was found on the property at the time of the assessment.

Figure 3: Loft interior
