cornwall  
environmental  
consultants LTD

Bat and Barn Owl Assessment  
Goonreath  
Gweek  
TR12 6UH

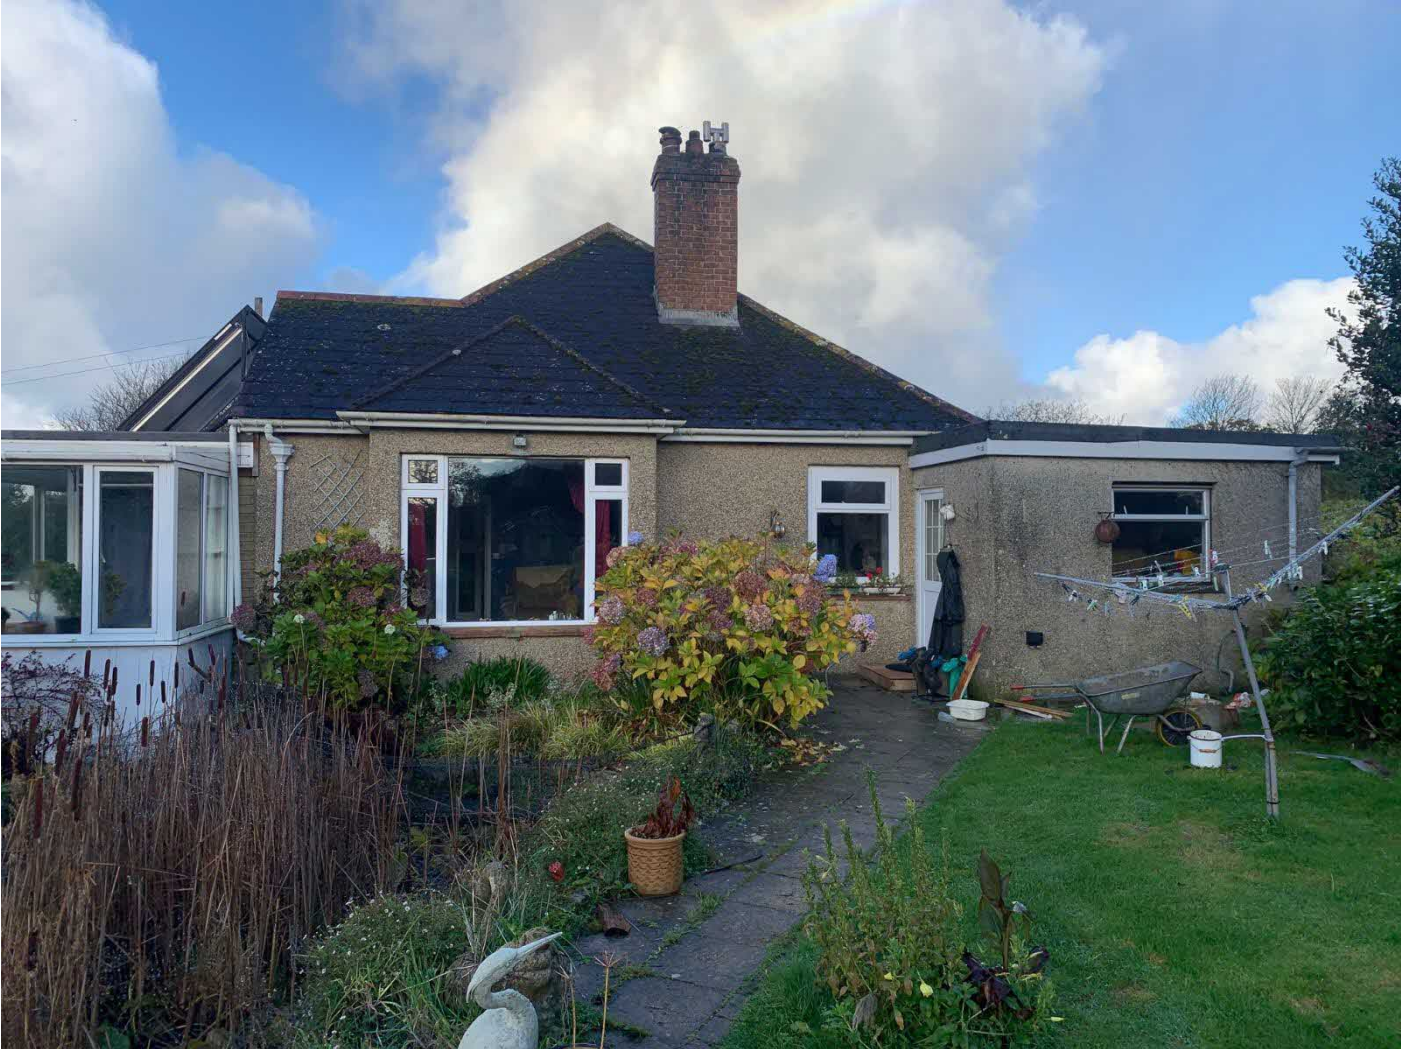
*Figure 1: South-eastern elevation of building*

The property is a detached residential bungalow with a flat roofed ground floor extension on the north-eastern elevation and a flat roofed conservatory on the south-western elevation, the main building is constructed from rendered block cavity walls with composite tiles underlined with a non-breathable membrane and wooden soffits. The ground floor extension has a roofing felt covering and UPVC fascia boards and the conservatory has a roofing felt covering, with ventilated wooden soffits and hanging tiles below the windows on the south-western elevation.

The exterior of the building appears well sealed with no gaps visible under the soffits or between the roof or ridge tiles. There is a small hole under the fascia board of the north-eastern extension and the underside of the hanging tiles on the conservatory has some gaps that may be large enough for bats but neither area will be affected by the proposed works (figures 3 & 4). The walls floor and windowsills around the exterior of the building were searched.

Although no current evidence of roosting bats was found it cannot be assumed that bats are not present when works commence. Care should therefore be taken during the work as bats could roost unseen deep within crevices in the structure, particularly under ridge tiles, beneath wall plates, or between or above lintels. If any bats are discovered during the work they must not be handled: works must stop immediately and advice sought from CEC (tel 01872 245510).

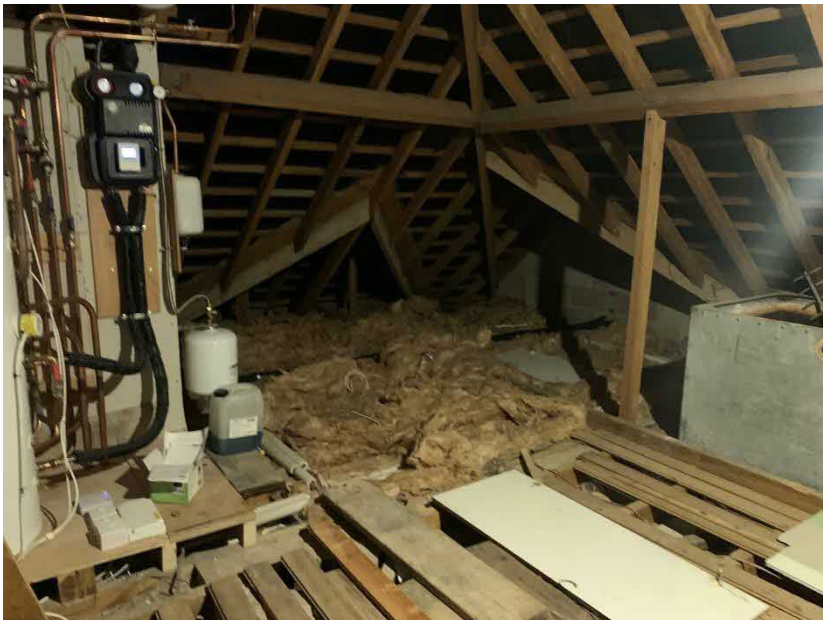
*Figure 2: Loft interior*

The loft interior is approximately 3m in height at the apex and is partially insulated with mineral wool insulation on the floor. The interior was searched, including the rafters, gable walls, floor, chimney breast and insulation.

No evidence of bats was found on the property at the time of the assessment.
