Preliminary Bat & Bird Assessment

12 Stratton Terrace, Falmouth, TR11 2SY

16th May 2023

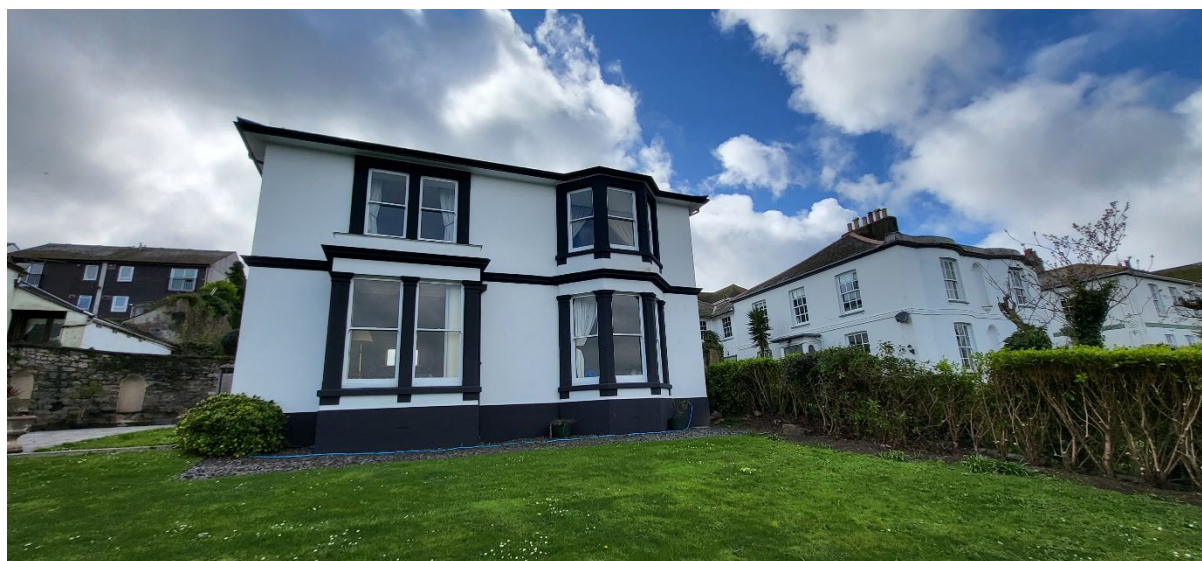
12 Stratton Terrace is a Grade II listed Georgian Villa of granite block construction, rendered and painted (Figure 1). The main house is two-storey with a double pitched and hipped roof set around a central valley. The main house has two concrete cast chimneys and a traditional slate roof with clay ridge and hip tiles. The main entrance is on the south elevation with a courtyard garden and entrance to the annexe also on the south elevation.

Figure 1: 12 Stratton Terrace; Grade II listed Georgian Villa, east elevation

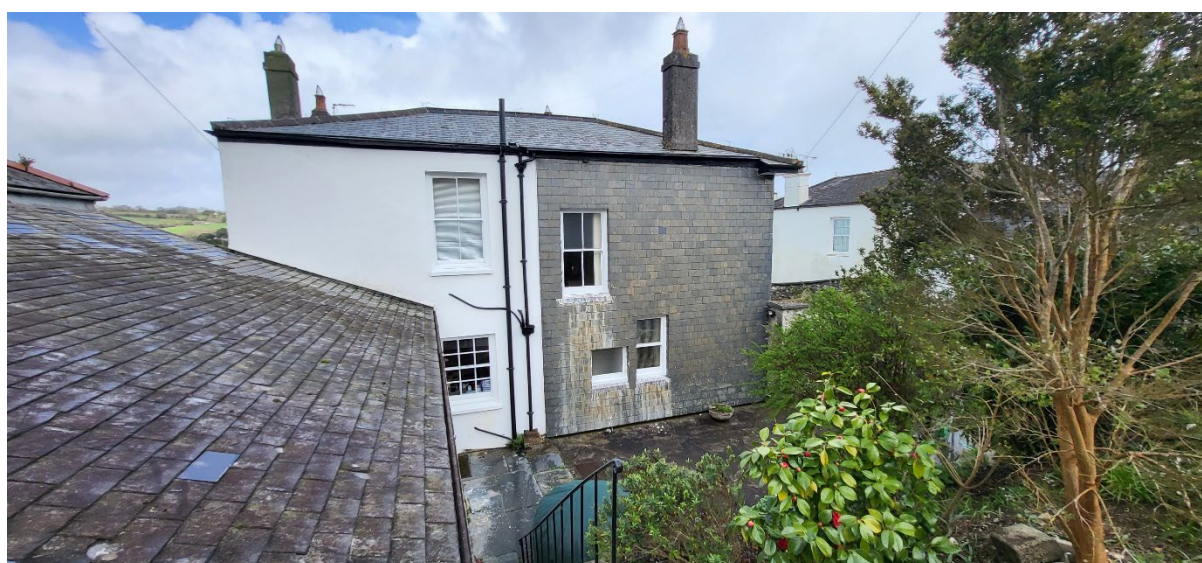
One half of the building (southern half) on the west elevation is completely faced with hanging slate tiles, the other half rendered and painted. One concrete chimney with a terracotta stack is located on this elevation and lead flashing around the base of the chimney has come away slightly, providing a potential crevice for bats and possible access into the main roof void (Figure 3). There is a roof vent on this elevation with a surround of lead flashing which may also provide a crevice for bats and/or access into the roof void (Figure 4). There are also small crevices behind the hanging slate tiles on the exterior wall that may provide roosting sites for bats (Figure 5). There is a painted timber fascia board and soffit on the west elevation. The fascia board is tight to the wall and does not appear to provide any suitable crevices for roosting bats. The timber soffit also has no cracks or crevices and is unlikely to provide access for bats.

Figure 2: West elevation of 12 Stratton Terrace

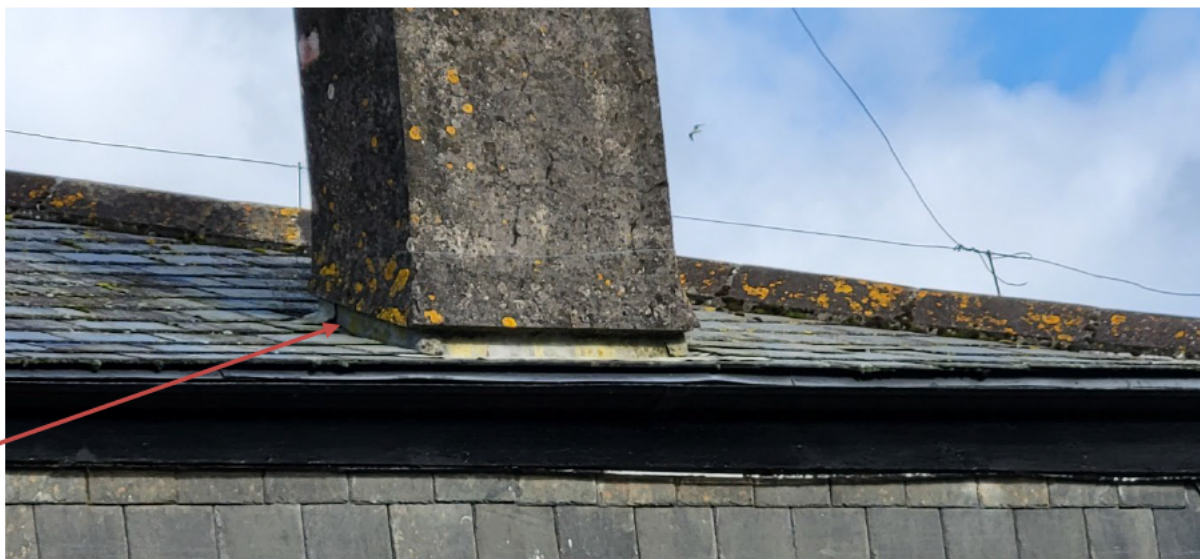
Figure 3: Crevice beneath lead flashing at the base of the chimney on the West elevation may provide an access point for roosting bats

Works must be informed with at least two bat emergence or re-entry surveys undertaken between May and September; one of which should be carried out between May and August. A static monitoring survey between May-September of the roof void is also recommended. The survey information will be required to inform the planning application and subsequent building works. The surveys will determine the bat species present, number of individuals, bat access points and timings of usage.

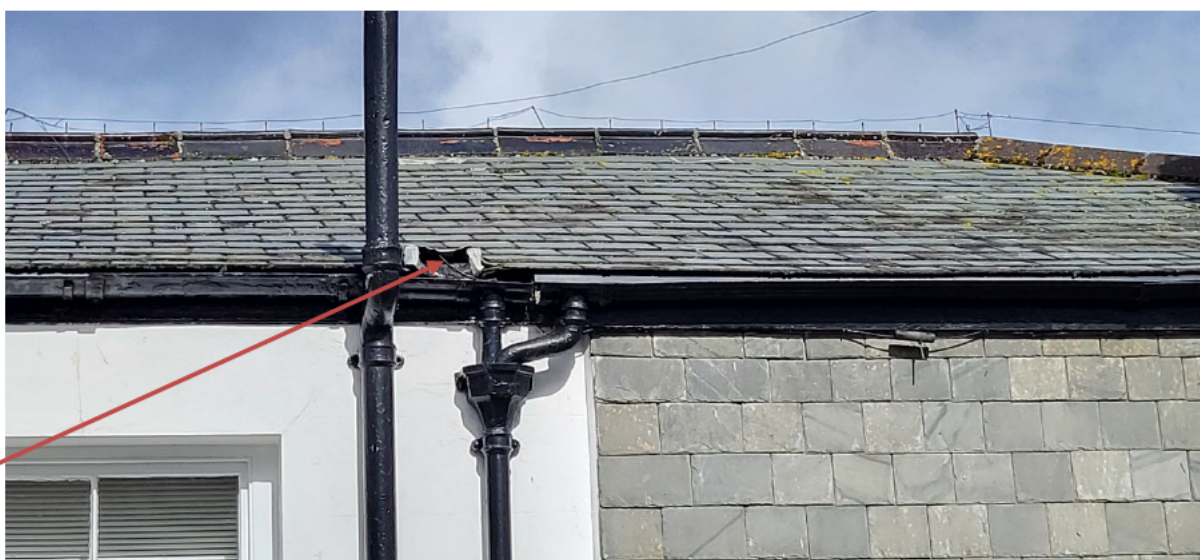
Figure 3: Vent on the roof of the west elevation may provide a crevice for roosting bats and / or access into the roof interior

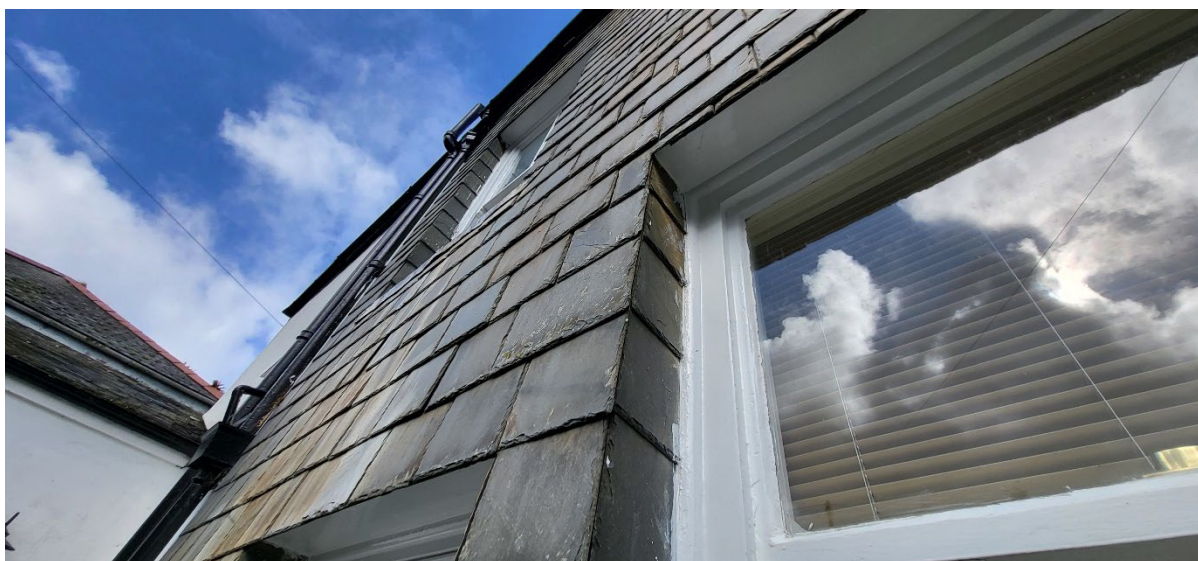
Figure 5: Small gaps behind hanging slates on the west elevation may provide roosting sites for bats

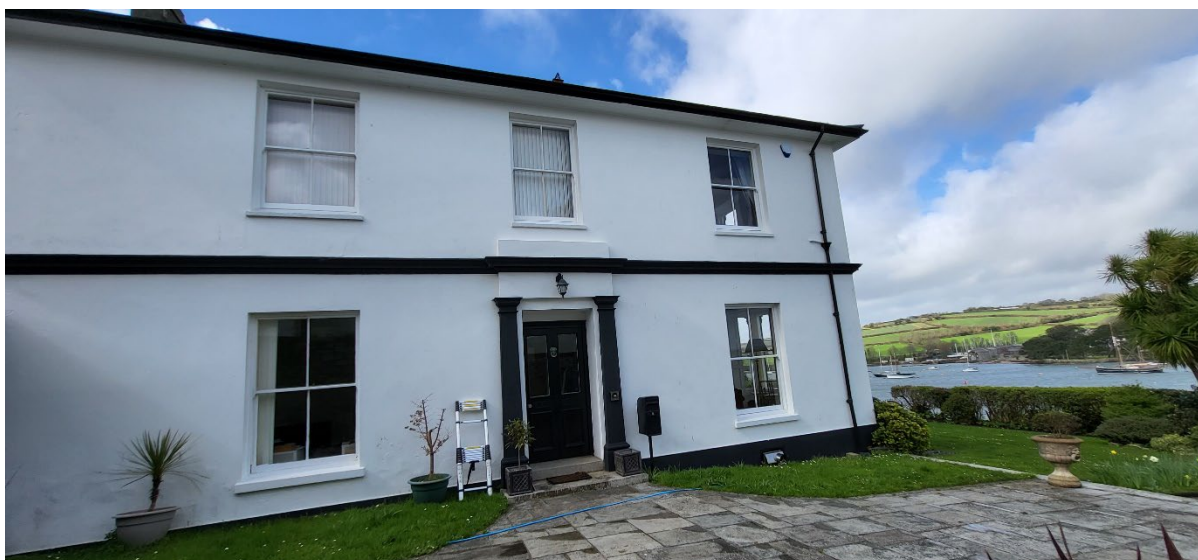
The main entrance to the house is on the south elevation (Figure 6). The walls are painted and rendered granite block with a timber fascia board and soffit. There are no holes or cracks in the soffit or gaps behind the fascia board. The stonework is tight and there are no potential access points for bats on this elevation. It was not possible to view the roof from this elevation and there may be suitable cracks and crevices within the slate roof structure that could provide bat access into the roof void. The entrance of the annexe is also on the south elevation, and this is constructed from rendered painted granite block. The roof is mono-pitched and there are numerous crevices behind the slates on this roof that may provide roosting opportunities for bats (Figure 7).

Figure 6: South elevation of the house, with main entrance

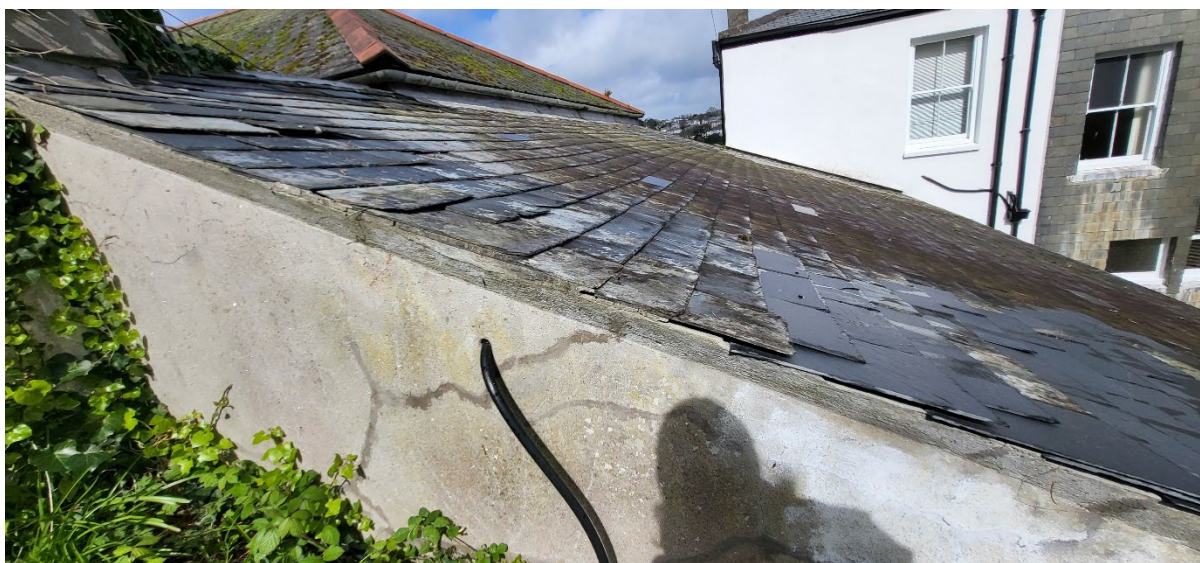
Figure 7: Roof of the annexe with slipped slates and gaps between slates which may provide potential roosting sites for crevice dwelling bats and / or allow access into the interior

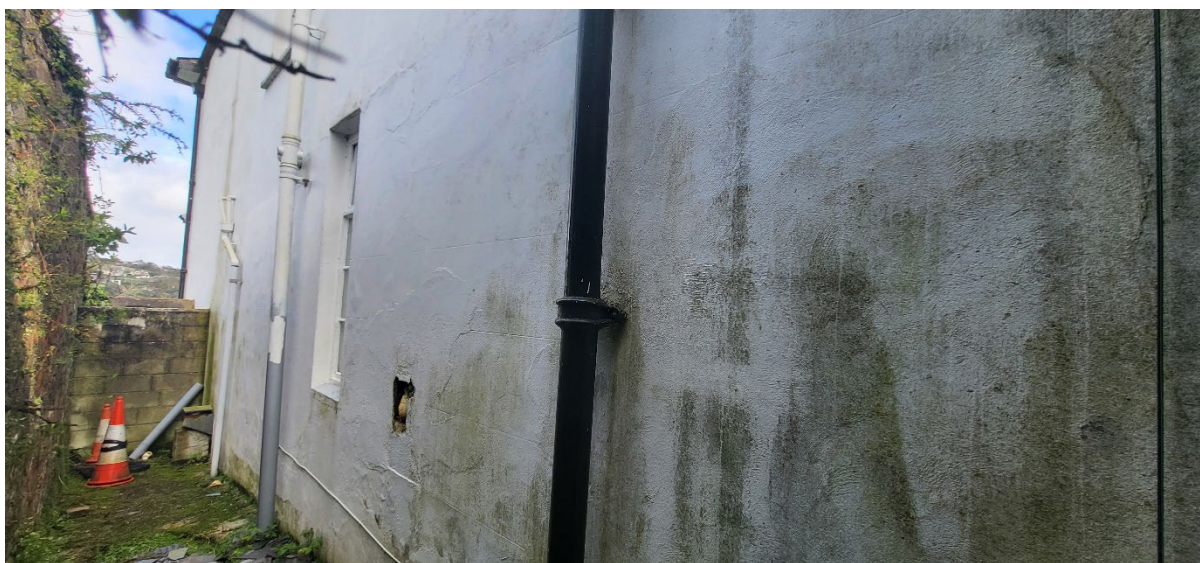
The north elevation is also of painted, rendered granite block construction. There is very little space between the wall of the neighbouring property and the north elevation of the house (Figure 8). There is a timber fascia board which is tight to the wall with no potential crevices for roosting bats. There are two concrete cast chimneys on this elevation. The slate roof is not visible from this elevation and although there appeared to be no obvious visible features for bats, there may be suitable cracks and crevices within the slate roof structure that were not visible during the survey.

Figure 8: North elevation

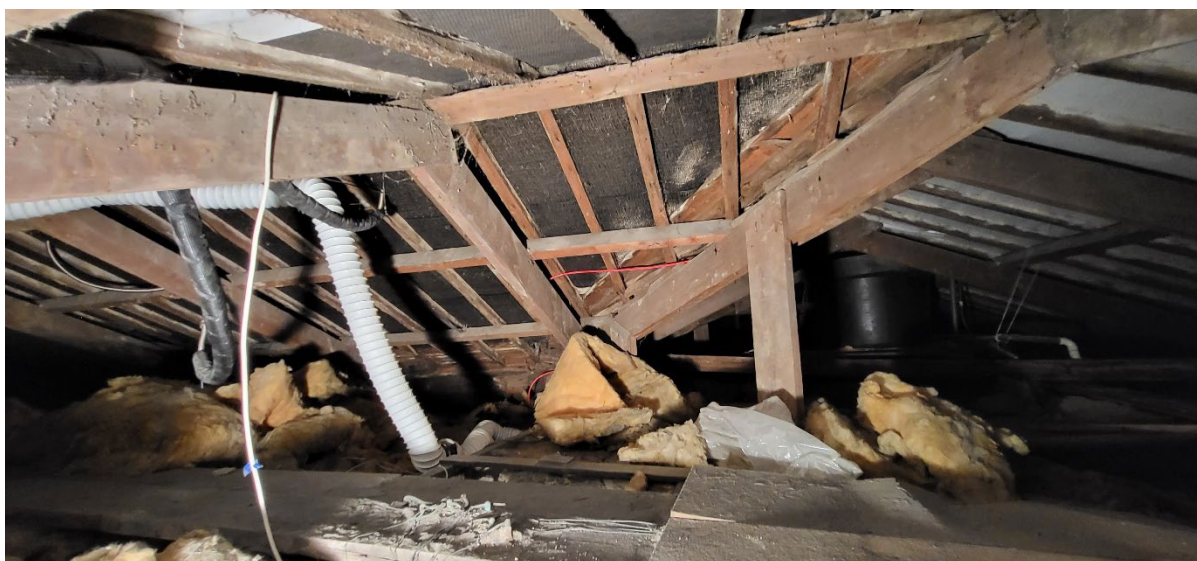
The roof structure consists of a double pitched and hipped structure set around a central valley. In effect this creates four distinct but connected roof voids set around the central rectangular valley. The roof void is currently unused and is for the most part un-boarded so access was limited to a small section close to the entrance hatch. The internal structure is of timber construction and the roof is partly lined with bitumen roofing felt and partly lined with a breathable membrane (Figure 9). There are numerous roosting opportunities for bats within this roof void and there are some possible access points visible from the interior between the base of the roof structure and the tops of the walls, as indicated by the penetration of light into the roof void (Figure 10). No bat droppings were found during the survey but full access to the void interior was not possible on health and safety grounds.

Figure 9: Internal structure of the roof void. Timber frame and slates lined partly with bitumen roofing felt and partly a breathable membrane

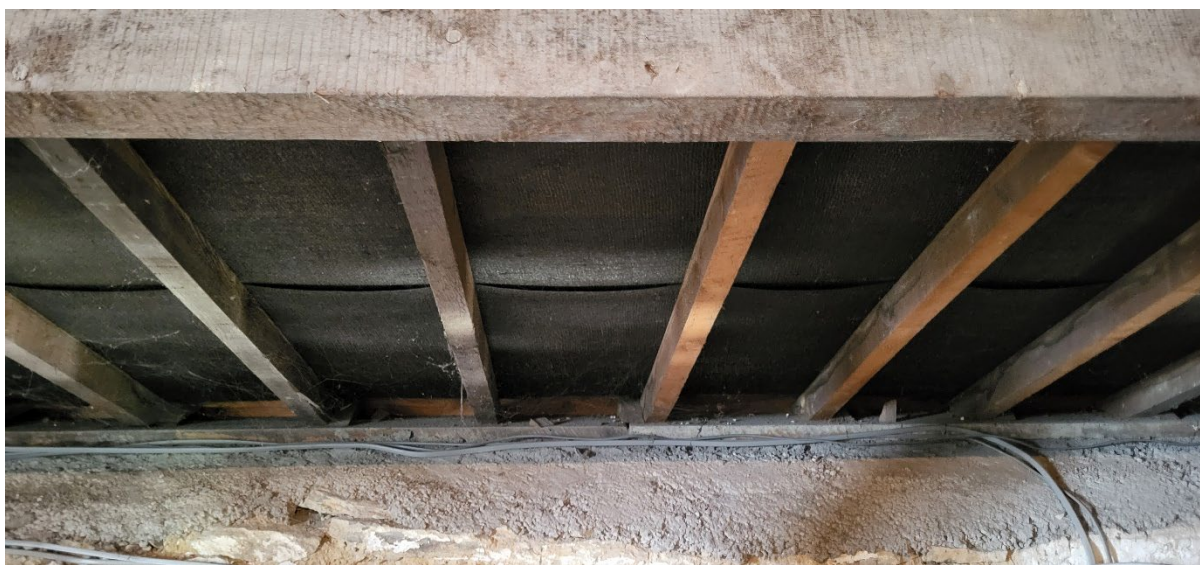
The internal roof structure of the annexe is of timber construction and is lined with bitumen roofing felt (Figure 11). The roof space has a window allowing light into the void, a timber floor and has open access by staircase to the downstairs. It is currently used for storage (Figure 12). There are potential roosting opportunities for bats behind the bitumen roofing felt and at the tops of the walls, but it is unlikely that the main void would be used by bats as it is light and bright and the space is not enclosed. No droppings or other evidence of bats was observed during the survey.

Figure 11: Internal structure of the roof of the annexe (timber lined with bitumen roofing felt)

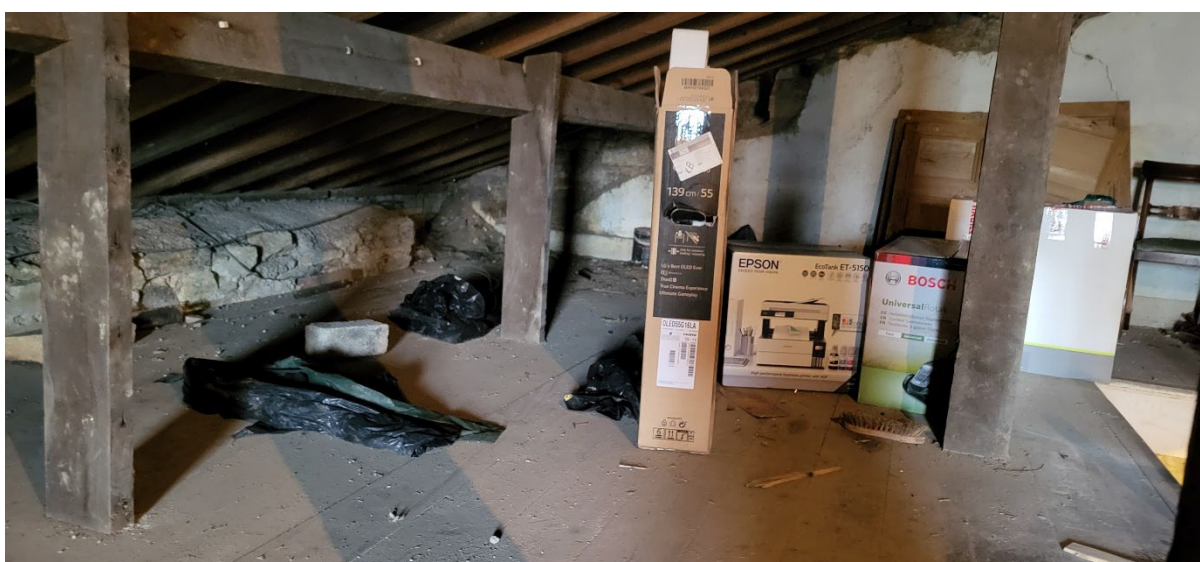
Figure 12: Interior of the roof space of the annexe
