Phase 1 bat and nesting bird survey & Phase 2 bat emergence survey report

Site: 111 Egloshayle Road,
Wadebridge,
Cornwall,
PL27 6AG

For: Mr. & Mrs. Hughes

Reference Number: DCE1605

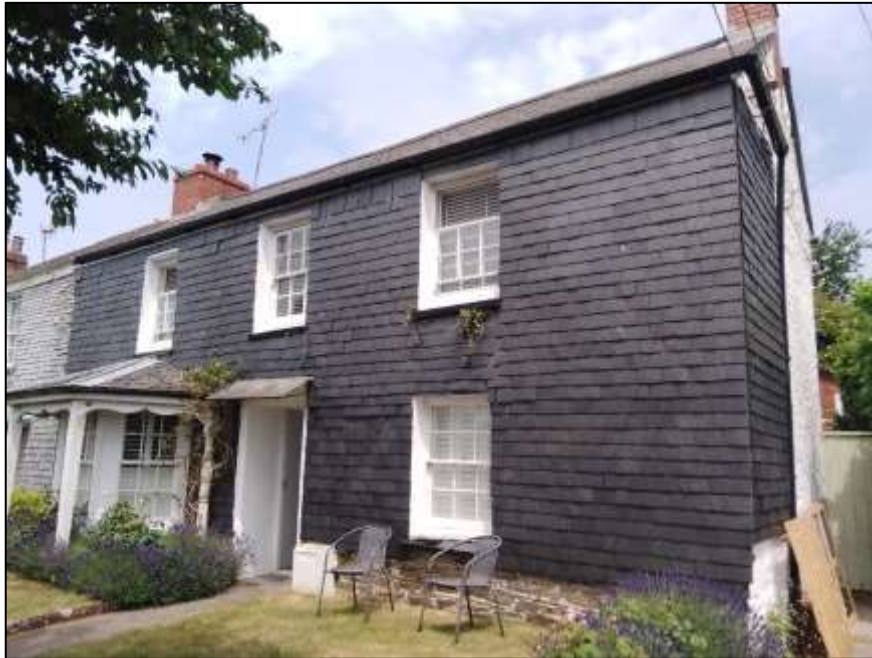
Photograph 1– View of the south aspect of the building.

- The building is a two storey semi-detached cottage with an existing two storey extension and a single storey lean-to structure. The proposals include the construction of a single storey extension to tie-in at the eaves of the north aspect.

- The majority of the building is a stone construction with a pitched roof. Slate and fibre cement roof tiles and concrete ridge tiles are present. These are in mostly good condition with a few small gaps noted beneath ridge tiles. However, these features are unaffected by the proposed development and unlikely to be disturbed during works.

- The lean-to structure has a mono-pitched slate roof with a lead seal. Small gaps were noted beneath the lead flashing but are considered too small and shallow to be used by bats.

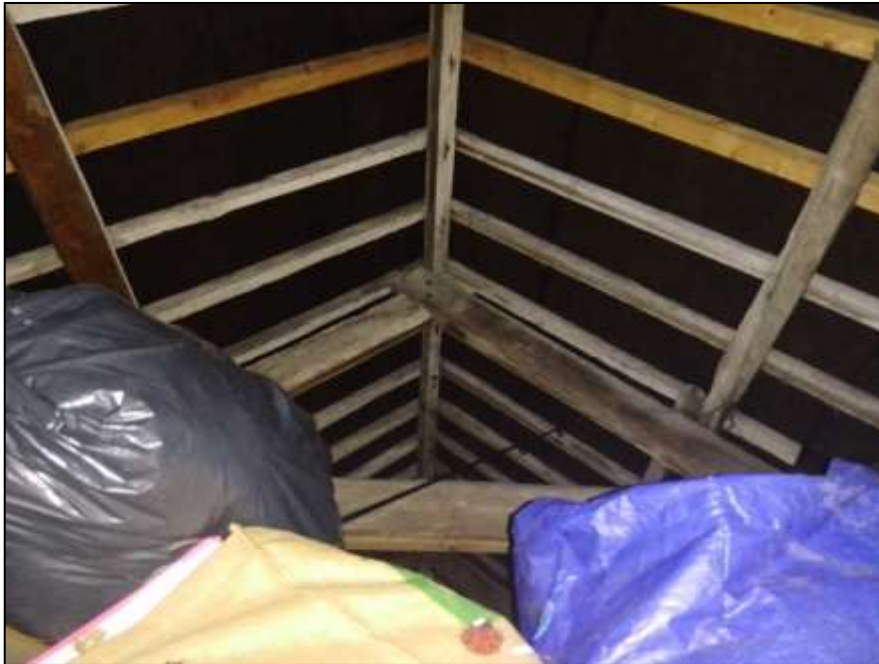
Photograph 2– View of the building interior.

- The building has a small internal void with a maximum approximate height of 1.5m and 3.5m in width. The height drops from 1.5m to approximately 1.2m for the majority of the void space.
- The void has a traditional roof structure with a ridge beam and purlin supports. The internal space was noted as being lightly cobwebbed throughout.
- Bituminous felt is present and in good condition. No holes were noted.
- The void is insulated. This insulation was noted as being dusty but otherwise clean. No evidence of bats was recorded.
- The void is heavily cluttered with stored items. These could be checked and no evidence of bats was recorded on the items.

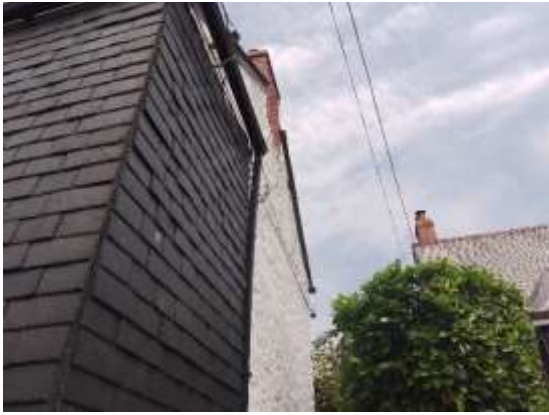
- One chimney is present on the main roof. This is lead sealed with no significant gaps noted around the seal.
- Holes were noted in the stonework/brickwork and beneath slate bargeboards on the east gable end. The were assessed as having **moderate** potential for bats but are located outside of the proposed work area. Nevertheless, these features were observed during subsequent surveys.

Photograph 1 – View of the east aspect of the building

- All bargeboards and/or soffits will be carefully dismantled using hand tools. The reverse of each board will be inspected for bats before being lowered to ground level. Should bats be encountered all work will cease immediately and a licensed ecologist will be consulted.

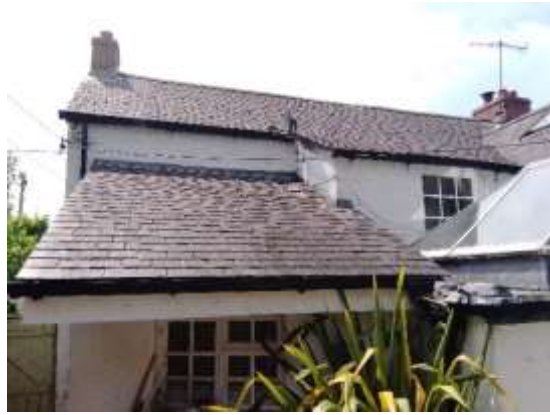
During the survey the surveyor and recording equipment were positioned to watch all potential access points for bat emergence or re-entry. As no potential bat features were recorded on the north aspect in the proposed work area, the focus of the survey was the hanging slate tiles on the south aspect and small

Photograph 2 – View of the north aspect.

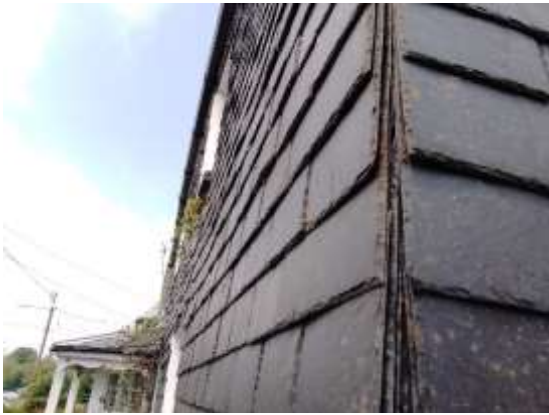
- Wooden soffits and uPVC guttering is present and in good condition. No holes are present in the soffits. No gaps were noted behind the guttering.
- The south and part of the east aspect of the building are covered with hanging slate tiles. These tiles are in need of refixing, with multiple gaps noted beneath slipped, crooked or missing tiles. Given the overall urban environment, these were assessed as having **moderate** potential only.

Photograph 3 – View of the hanging tiles.

- All roof tiles and hanging tiles will be removed by lifting them from the batons or ridge. The tiles will not be slid from the roof as this can cause accidentally crushing injuries if bats are present. The reverse side of all tiles will be inspected to ensure no bats are present. Should bats be encountered during this process, all work will cease immediately and a licensed ecologist will be consulted.
